**CAR PARK, GODSTONE ROAD,
ST MARGARETS, TW1 1JS
Phase 1 Contaminated Land Assessment**

Client: Godstone Development Limited

Reference: CB/CC/P20-2043/01 Rev A

Date: August 2020

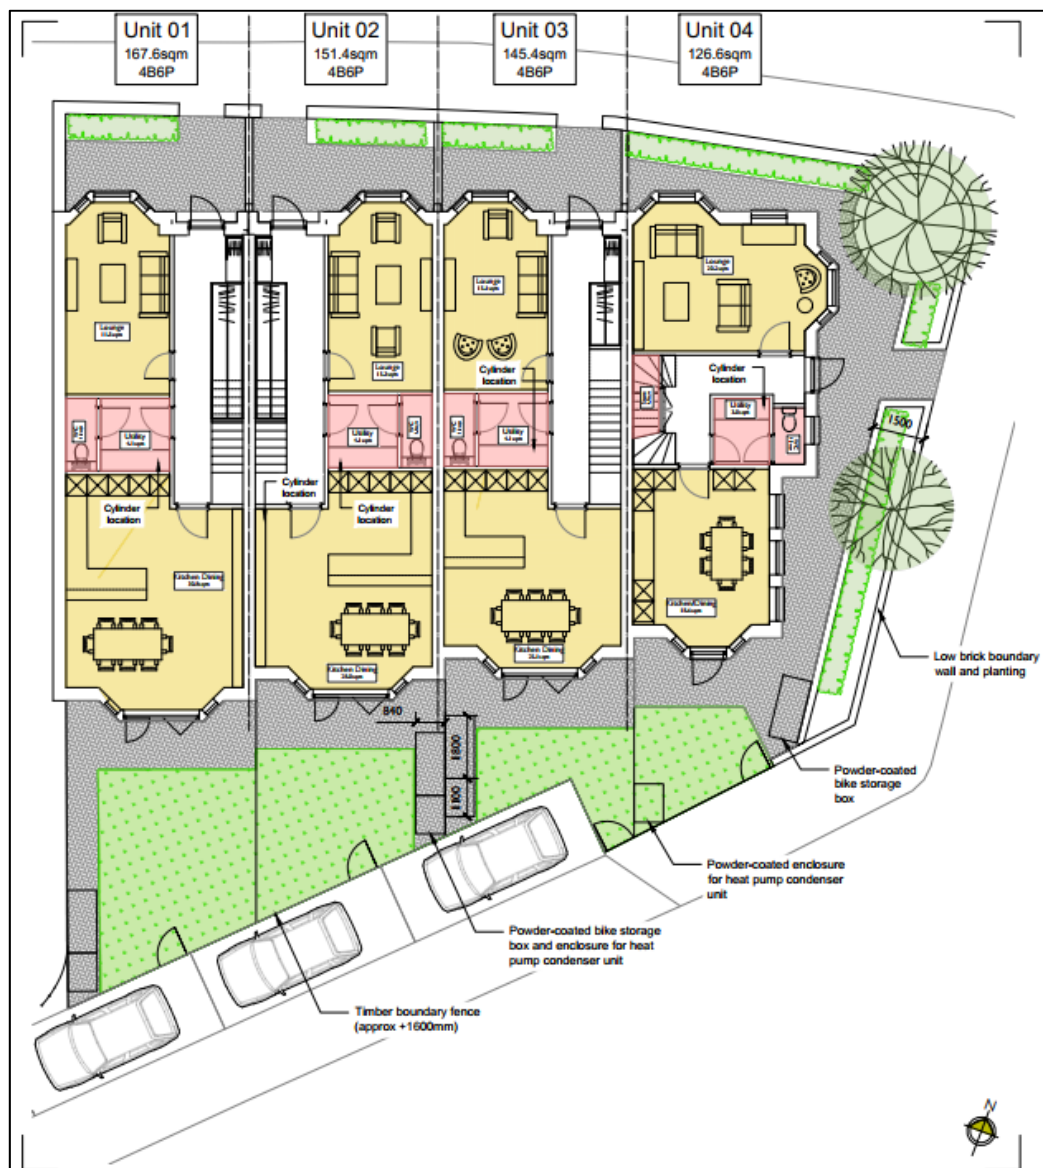
Figure 1.1: Proposed Development Plan (Silverline Architects Drawing P-001)

- 1.2 The Client intends to submit a planning application for the development of the Site to provide 4No. residential dwellings (Class C3) with private gardens, parking and associated landscaping.
- 1.3 The proposed development layout is illustrated in Figure 1.1 below.

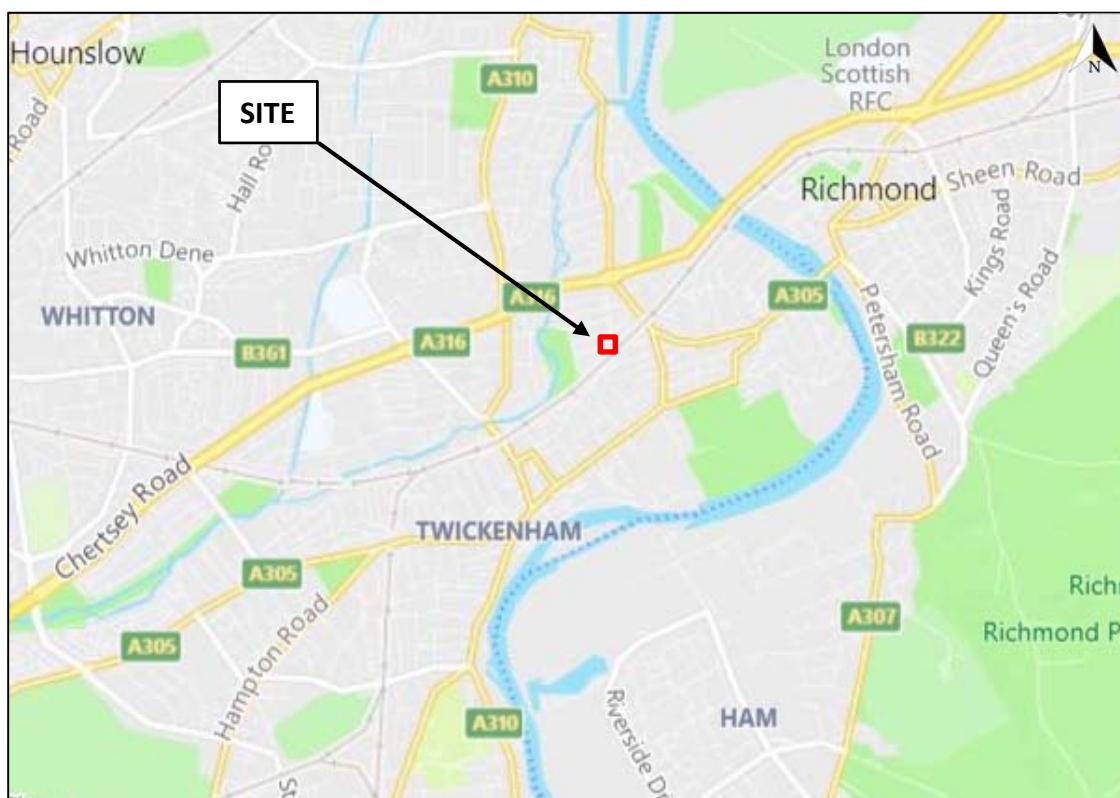
Figure 3.1: Site Location Plan

- 3.1 The Site comprises an irregular parcel of land located on the corner of Godstone Road (to the north) and Winchester Road (to the east) in St Margarets, and adjacent to the main railway line (to the southeast). The Site is located at approximate National Grid Reference 516644E, 174121N and the nearest postcode is TW1 1JS.
- 3.2 The Site location is shown in Figure 3.1, below

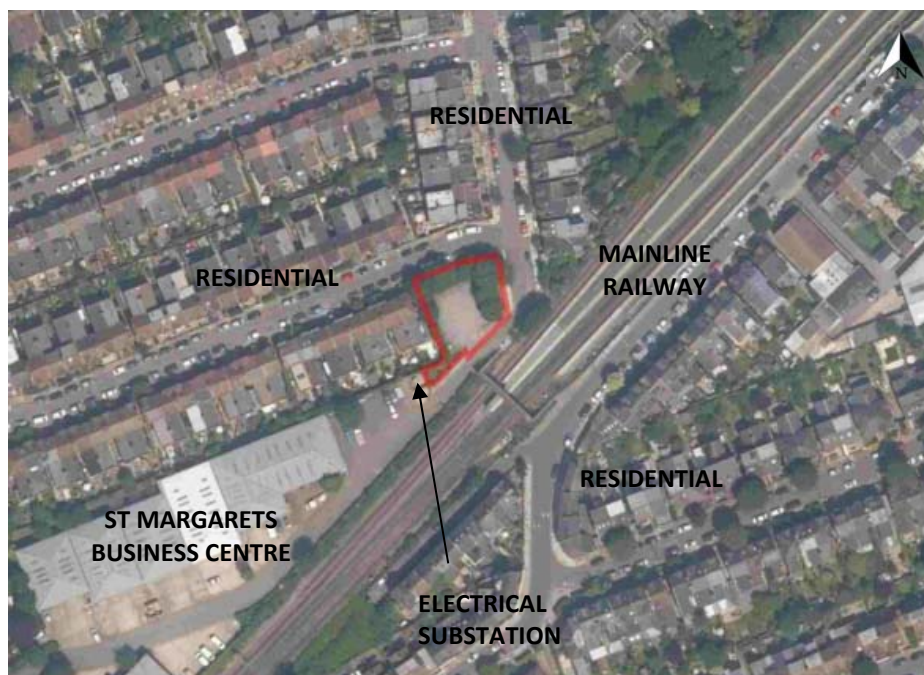
Figure 3.3: Surrounding Land Use Plan (Google Earth, 2019)

- 3.9 The Site was located within a predominantly residential area with houses to the west, north and east (Plates P6 and 7, Appendix A). To the southwest was St Margarets Business Centre (Plate P5, Appendix A) comprising seven units and occupied by a range of commercial enterprises. In the eastern corner of the business centre site was an electricity substation, immediately adjacent to the Site. This comprised an open unit (with one unit removed) on a concrete block with gravel surround (Plate P8, Appendix A). To the south, beyond Winchester Road, lies the mainline railway into London with further residential dwellings beyond.
- 3.10 An overview of the surrounding area is provided in Figure 3.3, below:

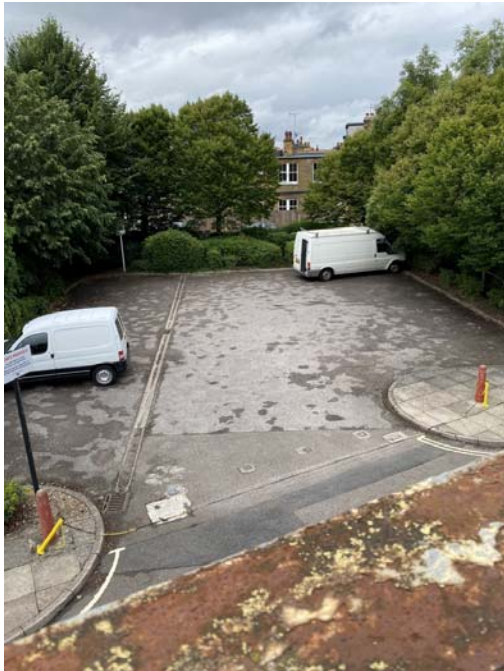
Plate P1: Site with access from Winchester Road and central drainage run (looking northwest)

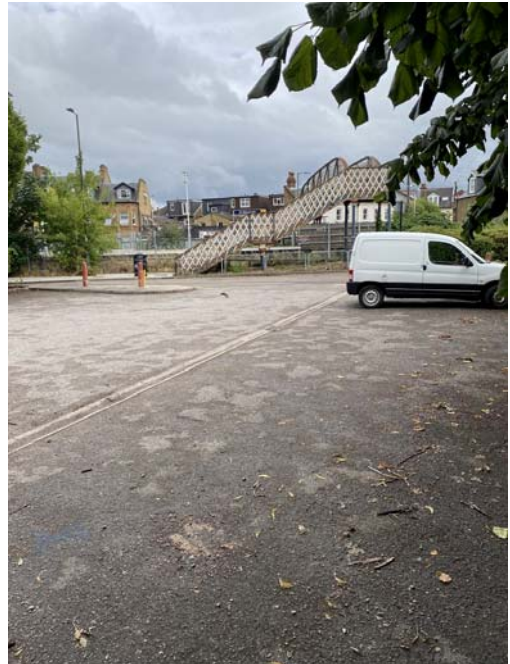
- 3.5 The Site comprised an area of hardstanding, formerly providing an overflow car park for the adjacent business centre although is now surplus to requirements, and accessed via Winchester Road to the south. The parking area incorporated a central surface water drainage run (see Plate P1, Appendix A) and vegetation (shrubs and mature trees) to the north, east, west, and an extended area to the southwest (see Plates P2-4, Appendix A).

Plate P2: Site with railway and pedestrian footbridge beyond (looking southeast)

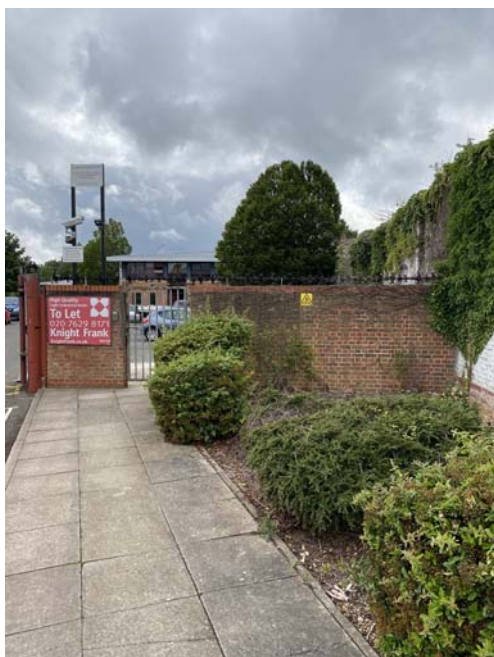
Plate P3: Vegetation in SW corner with substation and business centre beyond (looking west)

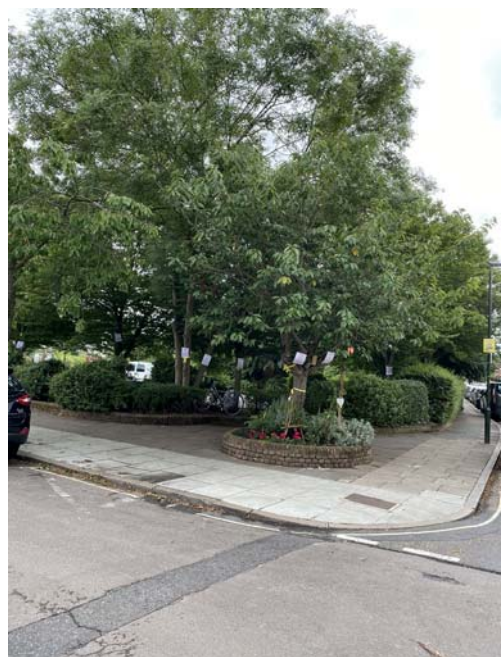
Plate P4: Site at junction with Godstone Road and Winchester Road, with mature trees and shrubs (looking southwest)

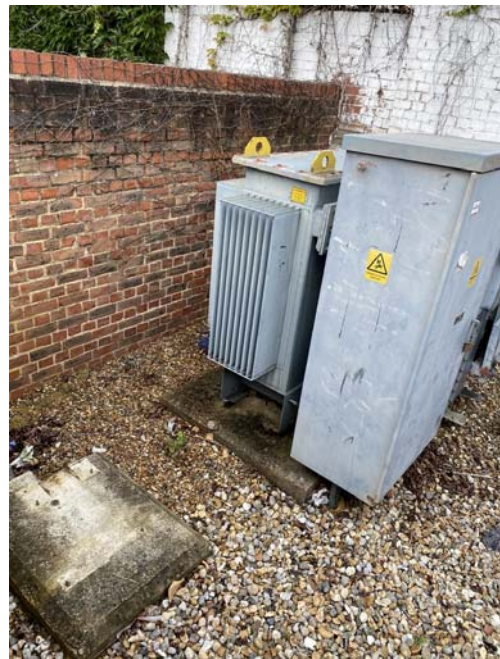
- 3.6 The Site boundaries were delineated by Godstone Road to the north, a high wall with residential dwellings to the west, an electricity substation within St Margarets Business Centre to the south west, Winchester Road to the south and east, and with the mainline railway line beyond Winchester Road to the south.

Plate P8: Electricity substation adjacent to southwest of Site with grave surface.
