## **RE: Barnes School Bat Surveys**

JFA Environmental Planning were commissioned to undertake bat surveys of the Barnes School caretaker's cottage, Cross St, London, SW13 0AP (OS Grid Reference TQ216758) prior to an application for planning permission for a new SEN (Special Education Needs) building as shown on drawing LOND01-MCB-XX-ZZ-DR-A-SK03-S4-P1.

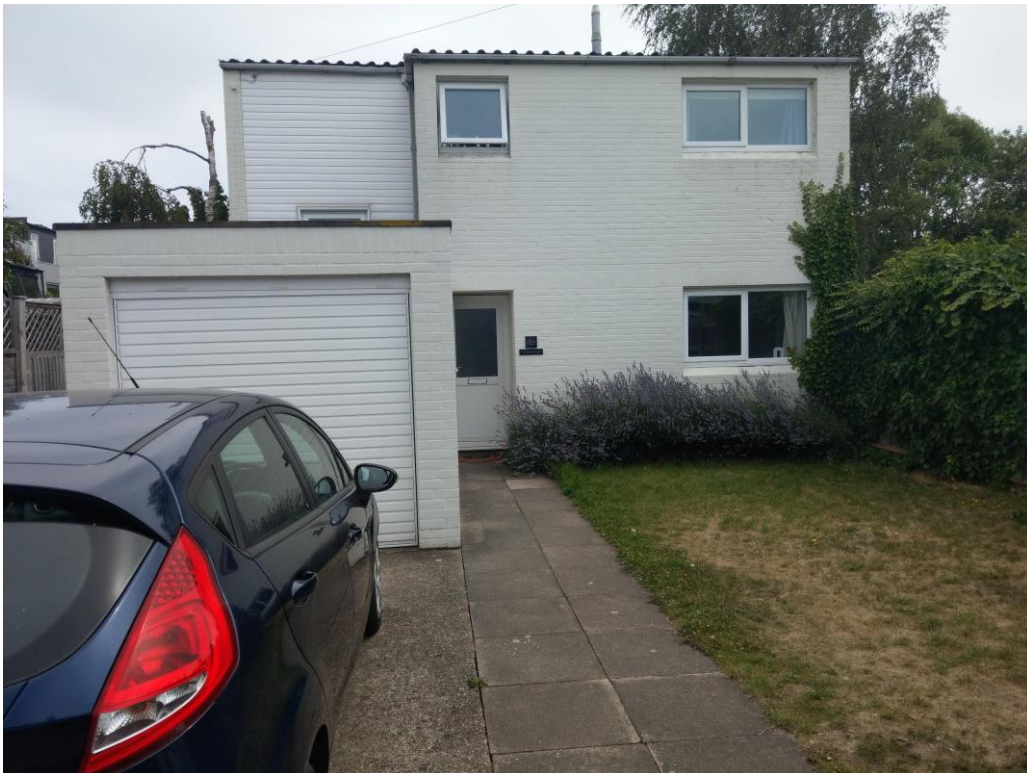
Photo A3.1: Front of caretaker's cottage (south west facing)

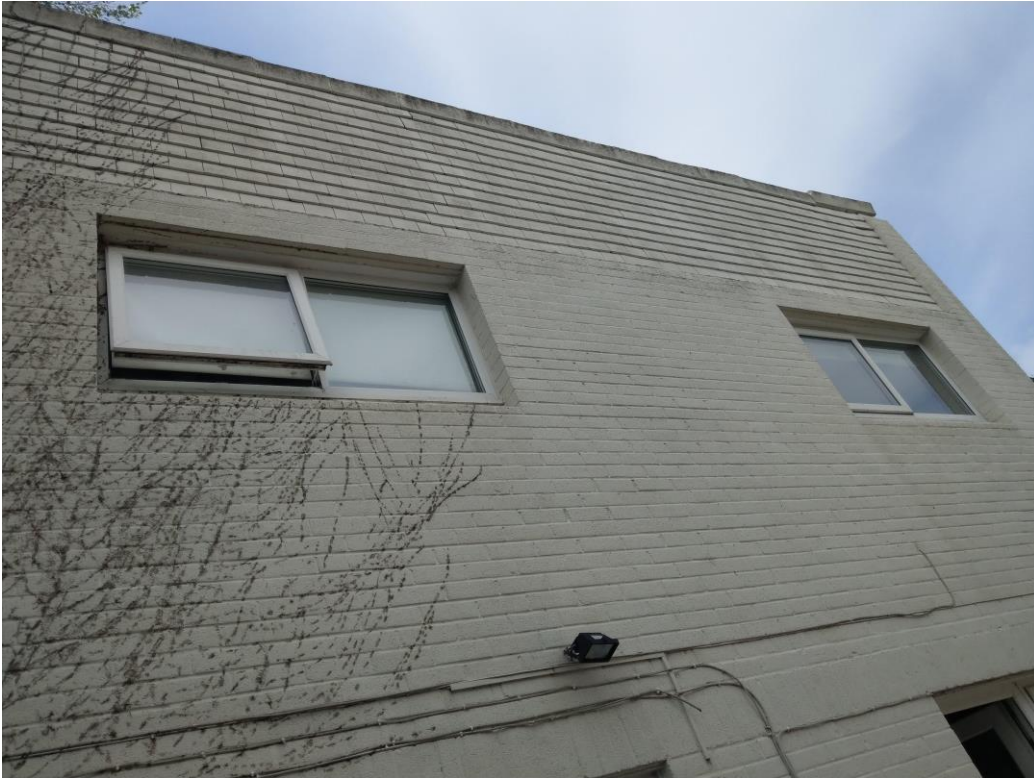
- Several lifted hanging tiles on the north east facing wall (Photo A3.2); and,
- Several lifted roof tiles where they overhang the wall, in both corners on the north east facing wall (Photo A3.3).

Photo A3.2: Rear (north east facing) of caretaker's cottage lifted hanging tiles in corner and gap under roof tile

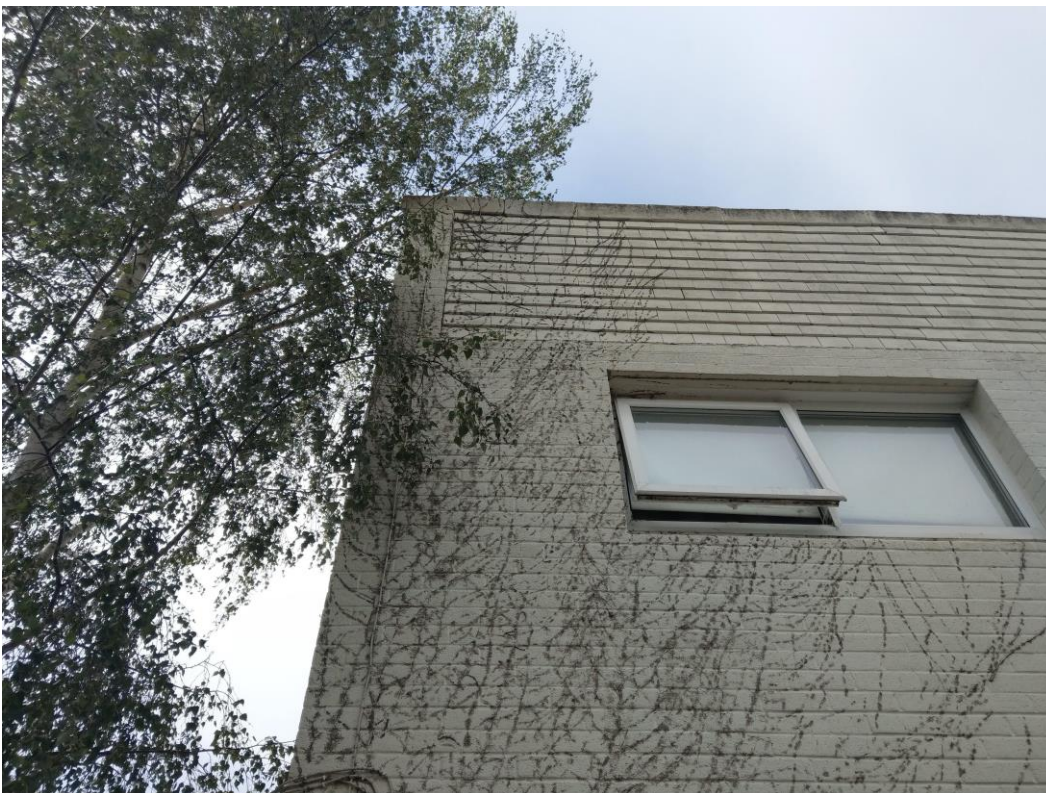
Photo A3.3: Rear (north east facing) of caretaker's cottage, gaps under roof tile

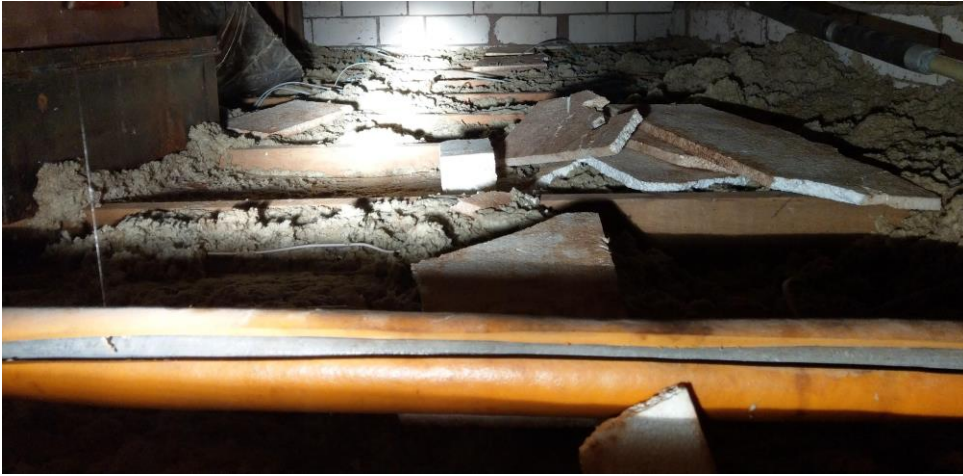
Internally, the roof void was fully accessible and runs the length of the house (Photo A3.4). The floor is part boarded and, covered in fibre glass insulation and no outside light could be seen within the roof void. There were old cobwebs and an old wasp's nest found within the roof void. No evidence of bats was found in the roof void.

Photo A3.4: Internal roof void

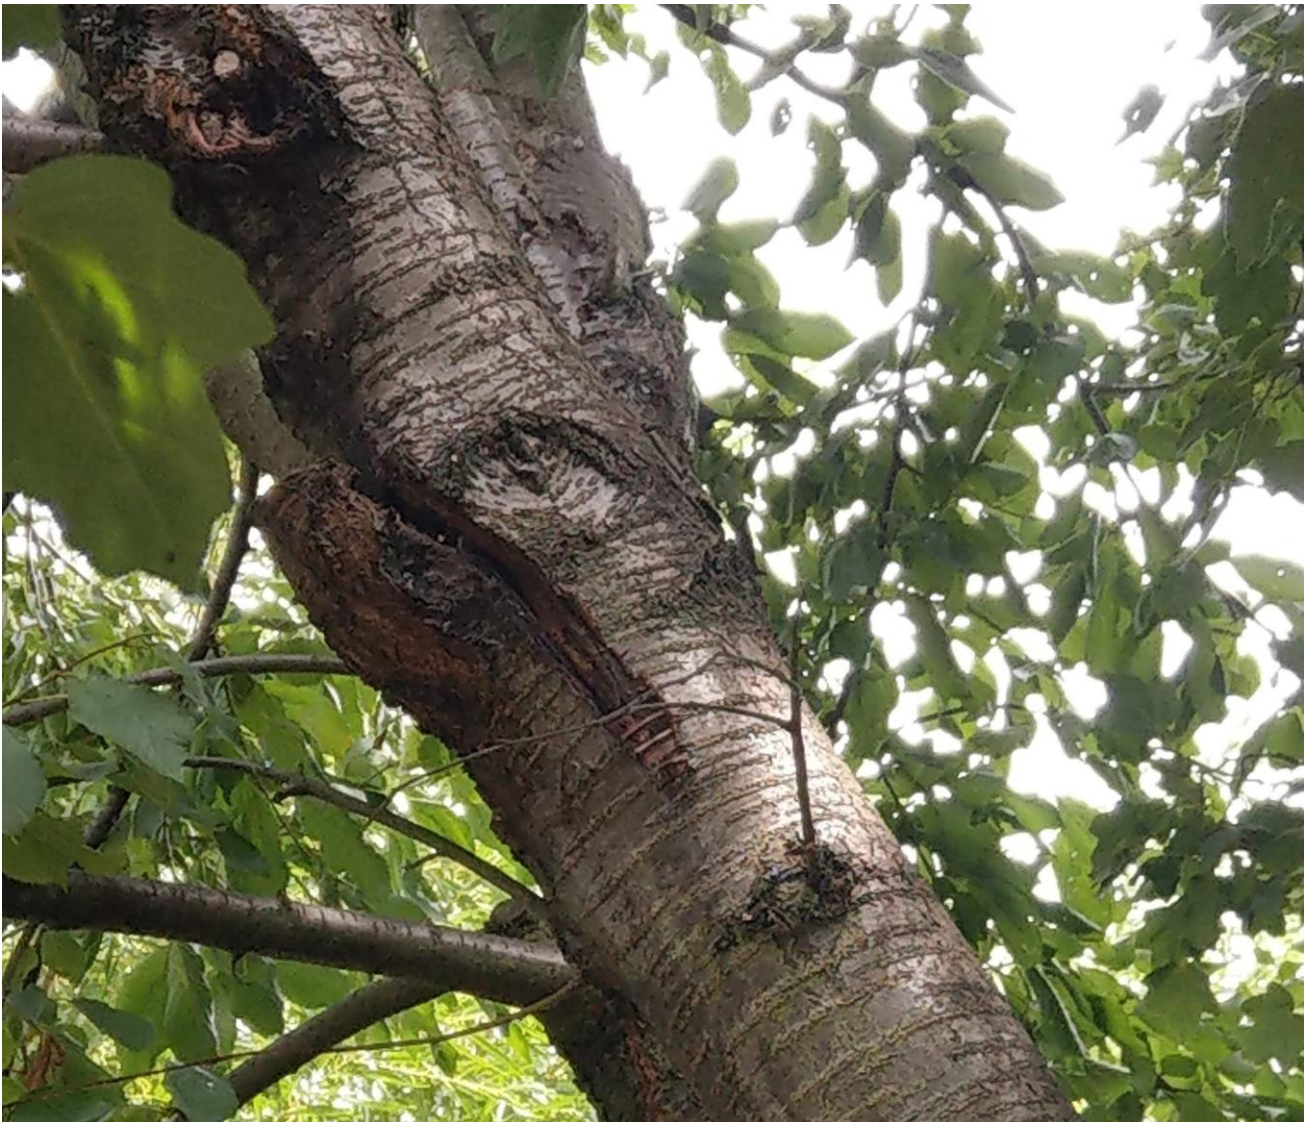
The inspection of the cherry tree found one feature with low potential to support roosting bats, a downward tear (Photo A3.5). The feature was fully inspected, and no evidence of bats was found.

Photo A3.5: Low potential feature on cherry tree in rear of caretaker's cottage rear garden
