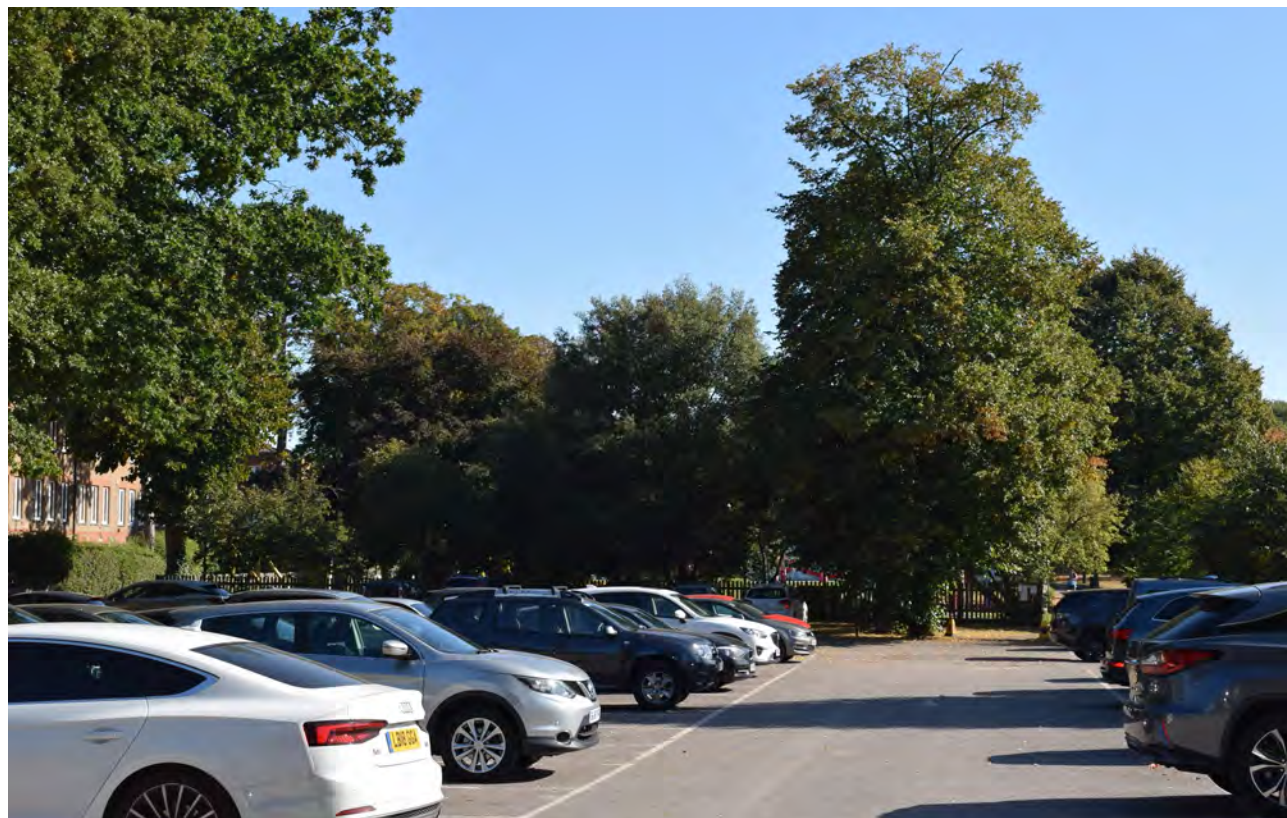
Viewpoint 1: View from western edge of car park within Marble Hill Park approximately 55m from the western site boundary looking east. Glimpsed view into site through boundary vegetation.

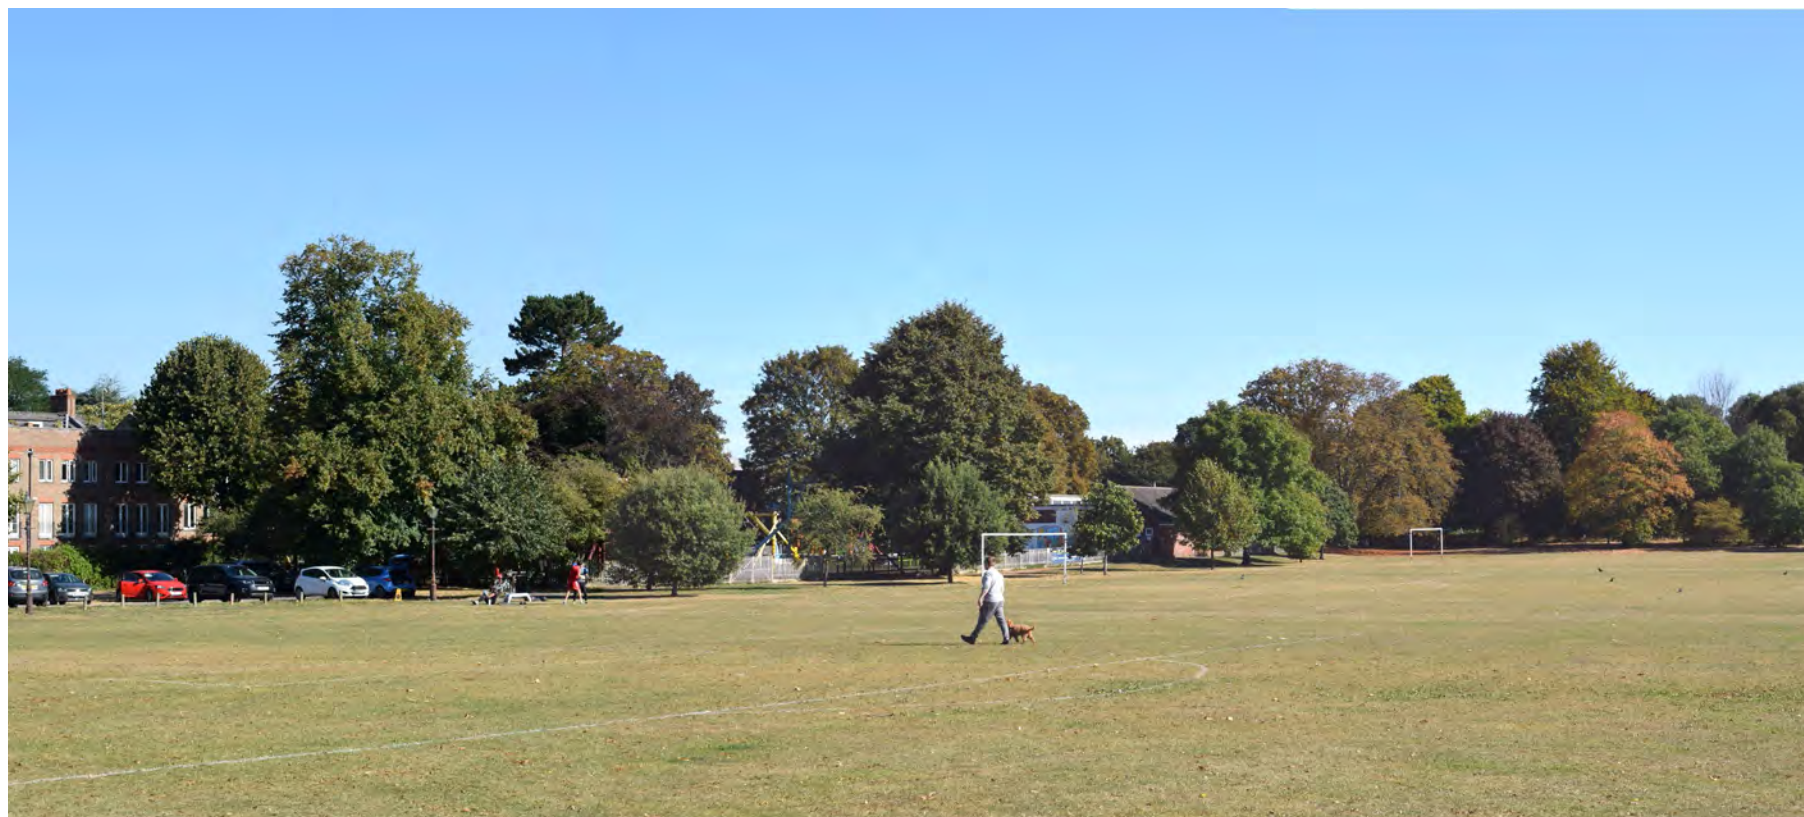
Viewpoint 2: View from public open space within Marble Hill Park approximately 90m from the site boundary looking north east. Partial views of site through adjacent off site trees and boundary vegetation.

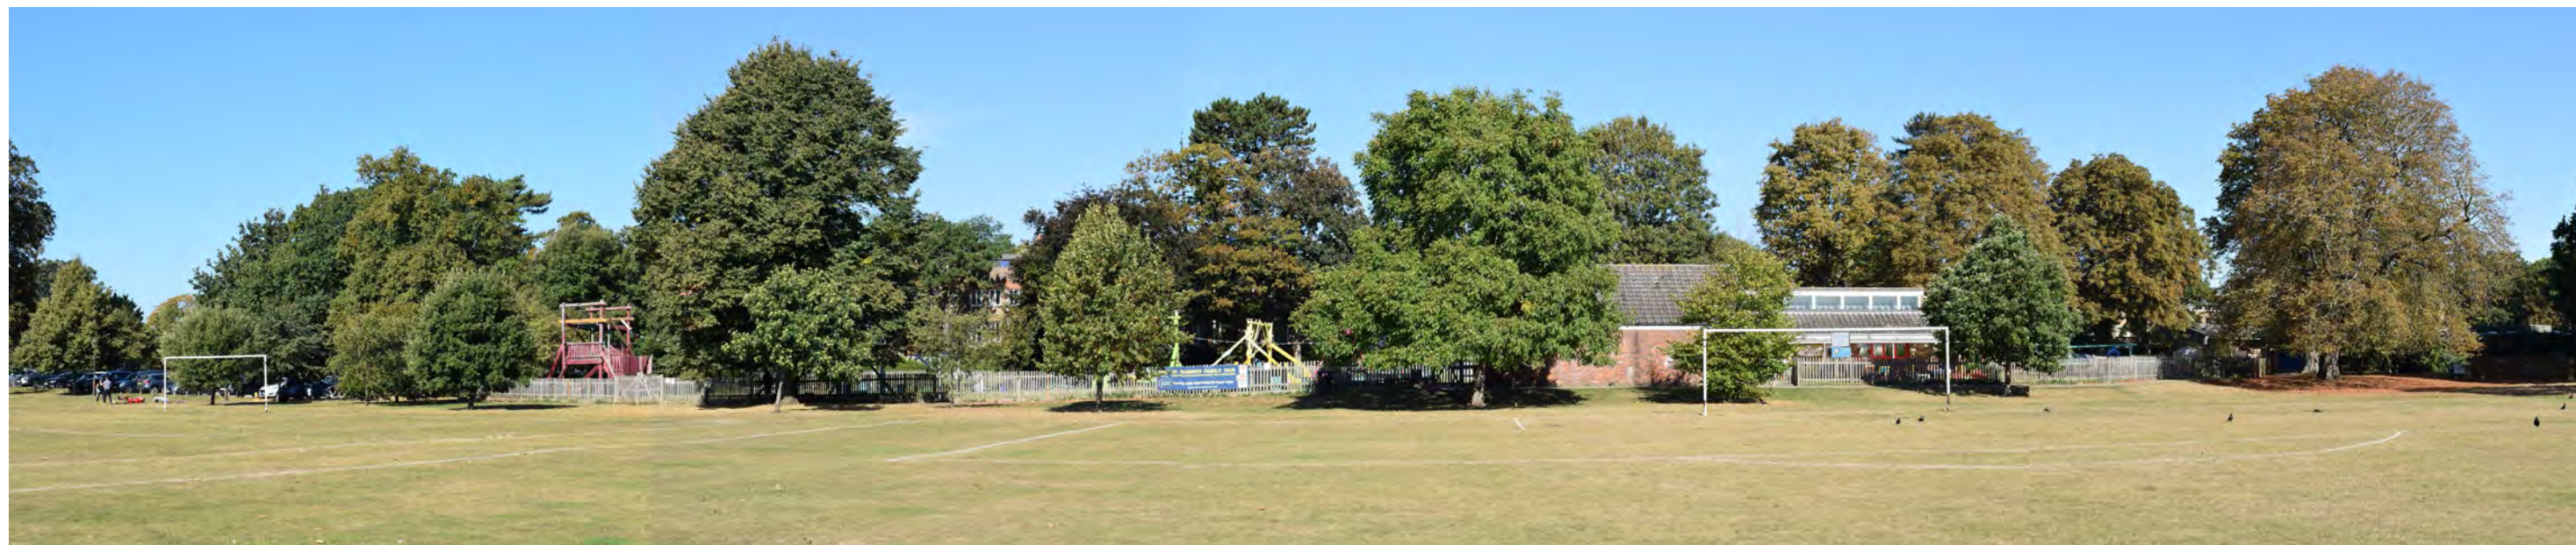
Viewpoint 3: View from public open space in Marble Hill Park approximately 75m from site boundary looking north. Partial views of site between off site trees.

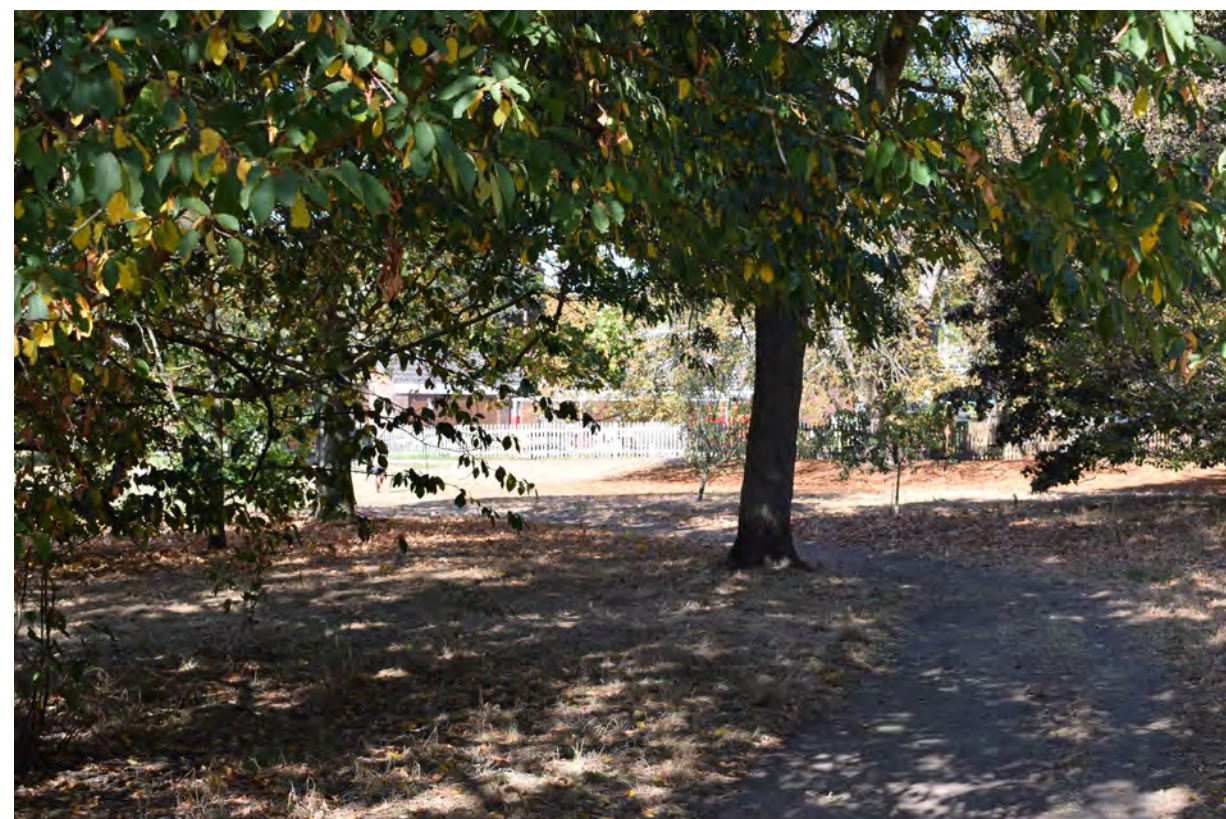
Viewpoint 4: View from path running through wooded area of public open space to east of Marble Hill Park approximately 75m from site boundary looking west. Glimpse views of south eastern area of site through adjacent off site vegetation.

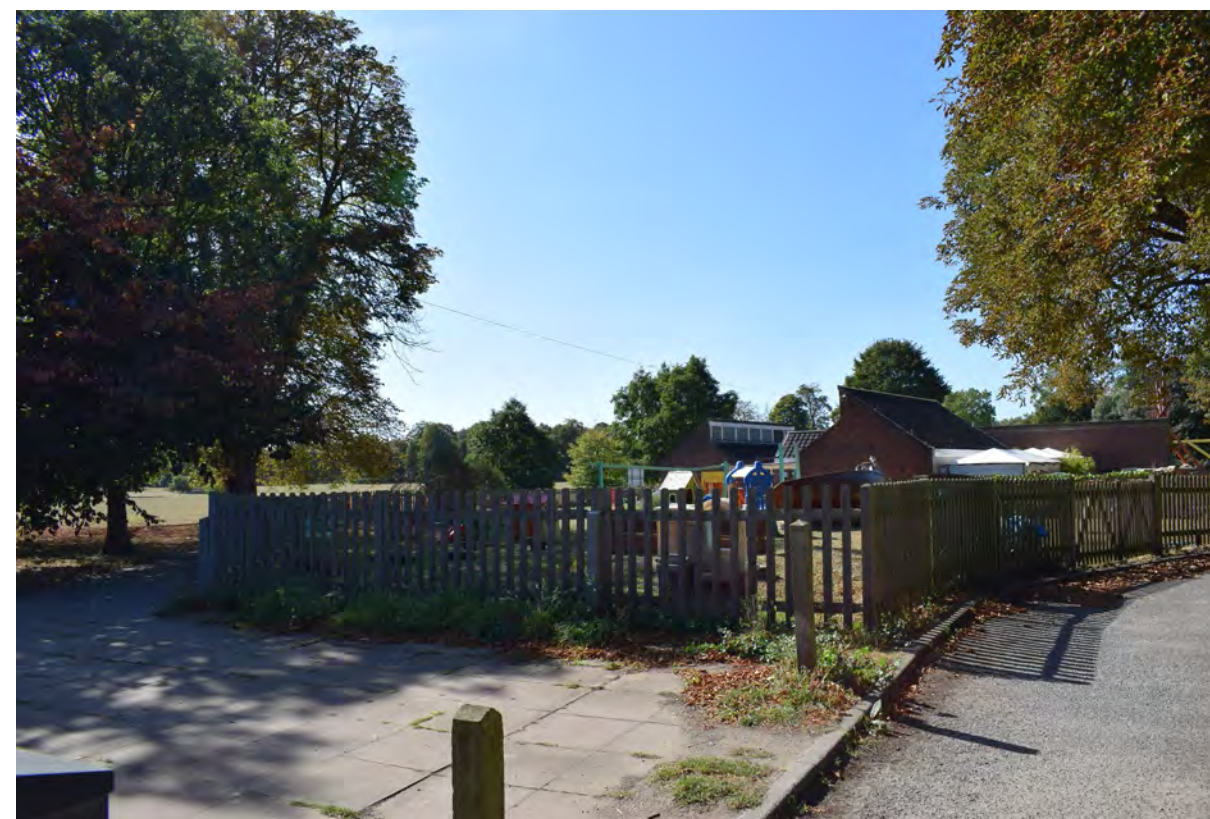
Viewpoint 5: View from maintenance access road approximately 5m from site boundary looking south west. Open views of eastern area of site beyond boundary fence.

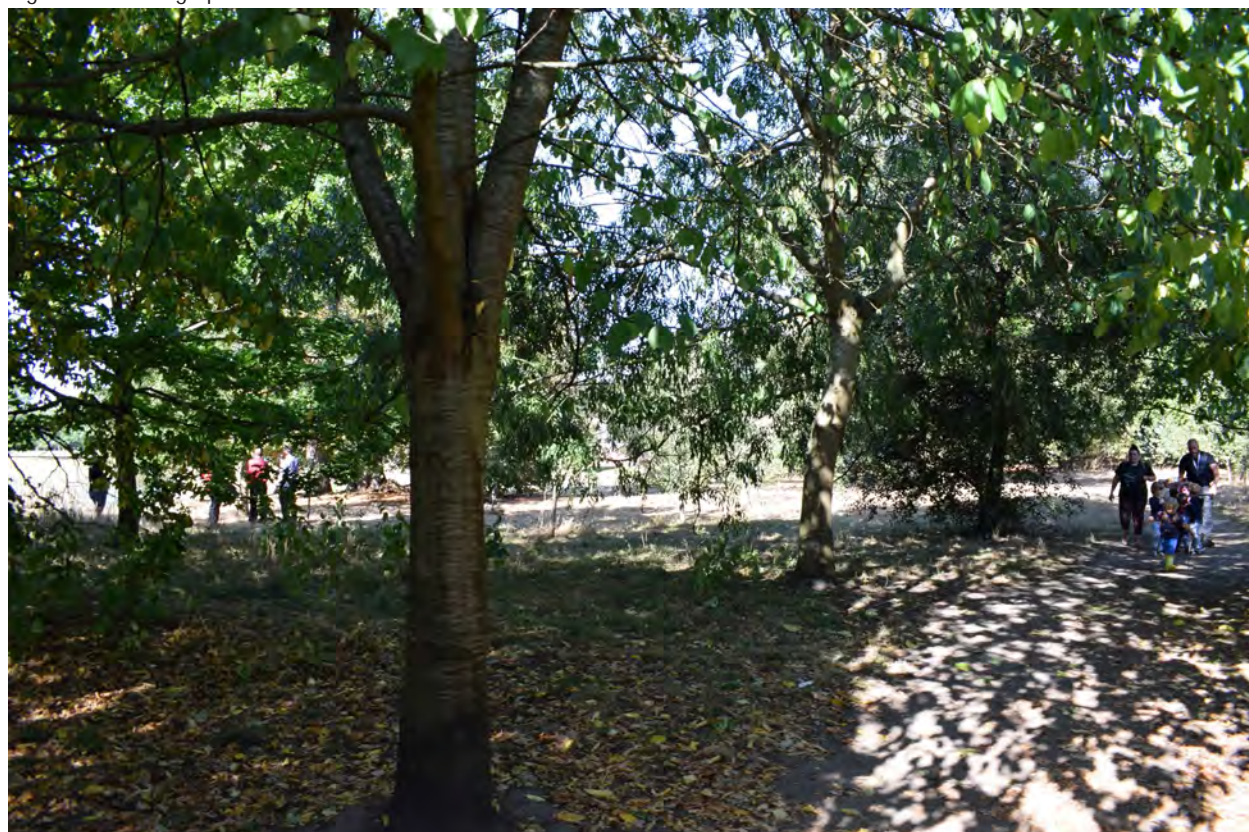
Viewpoint 6: View from path running through wooded area of public open space to east of Marble Hill Park approximately 150m from site boundary looking north west.

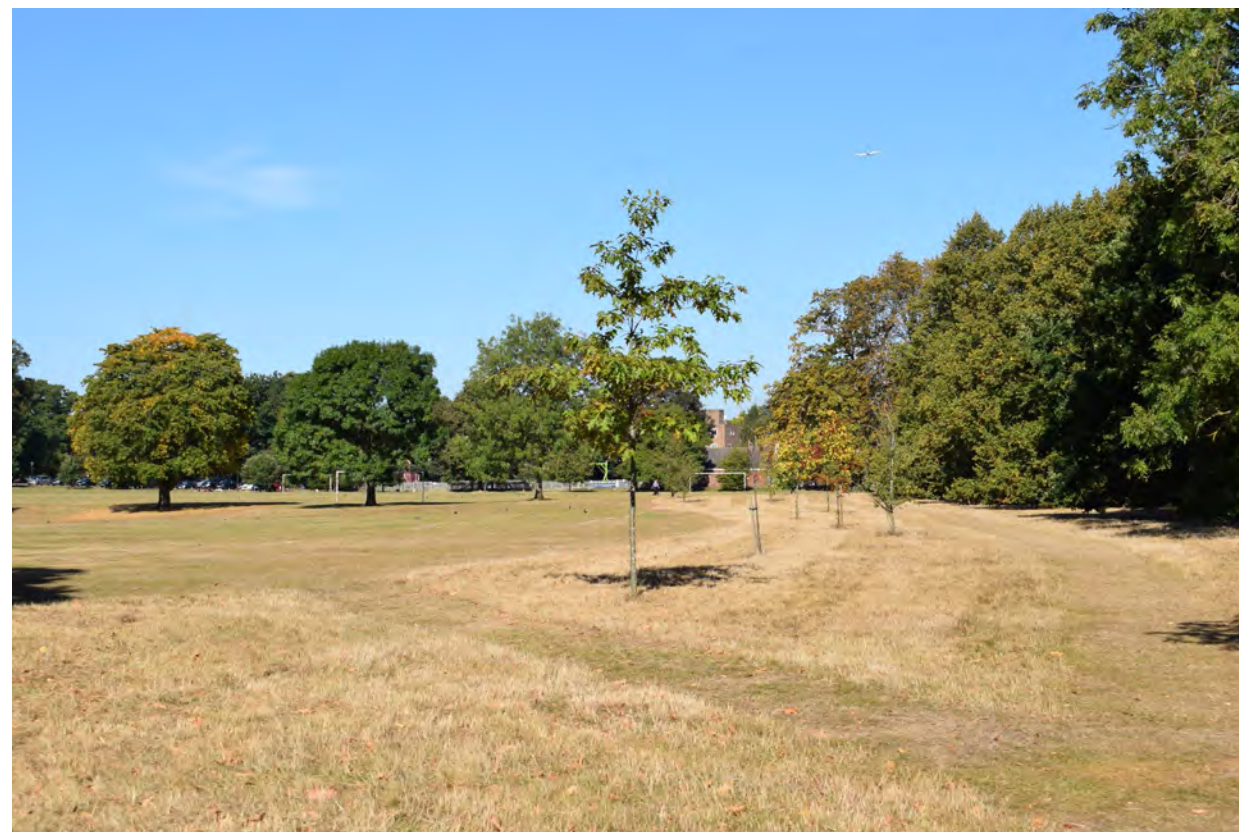
Viewpoint 7: View from public open space in Marble Hill Park approximately 250m from site boundary looking north west.

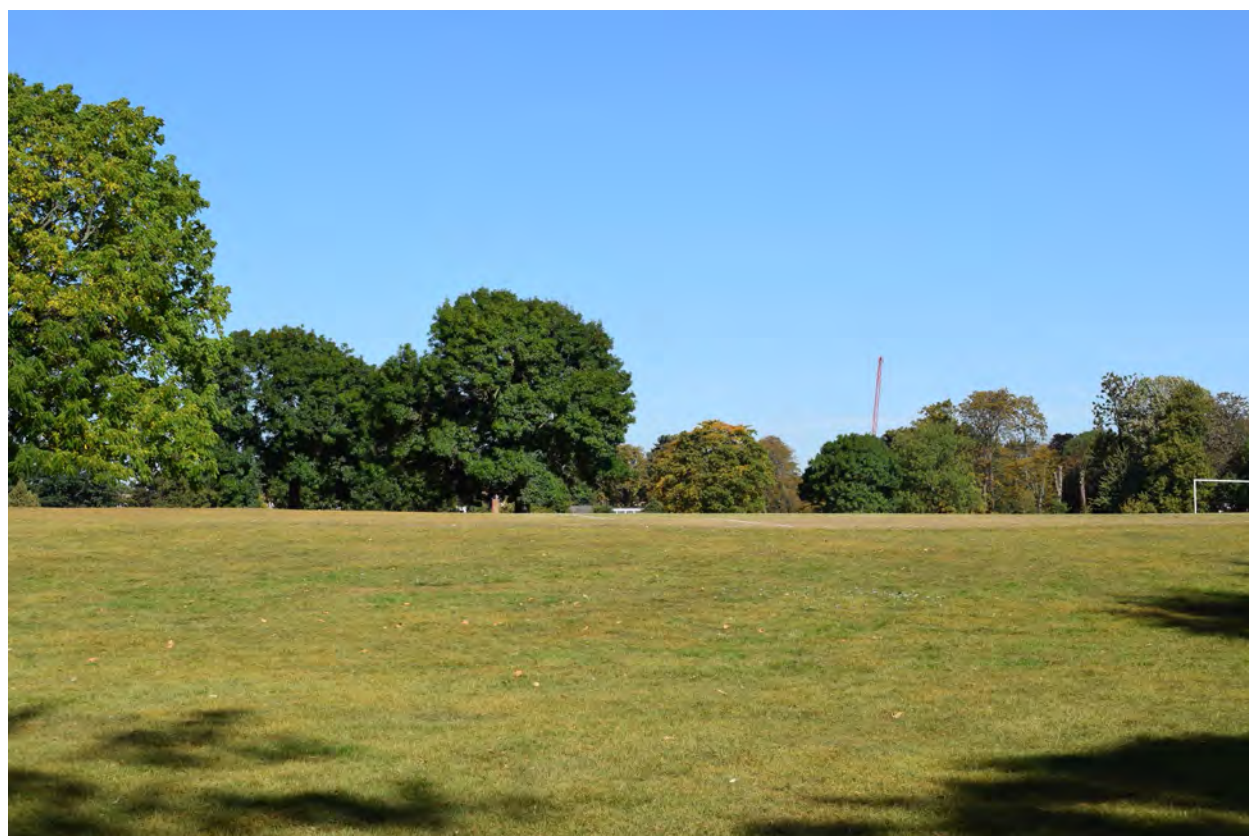
Viewpoint 8: View from public open space in Marble Hill Park approximately 350m from site boundary looking north. Glimpse view of top section of existing built form on site only.

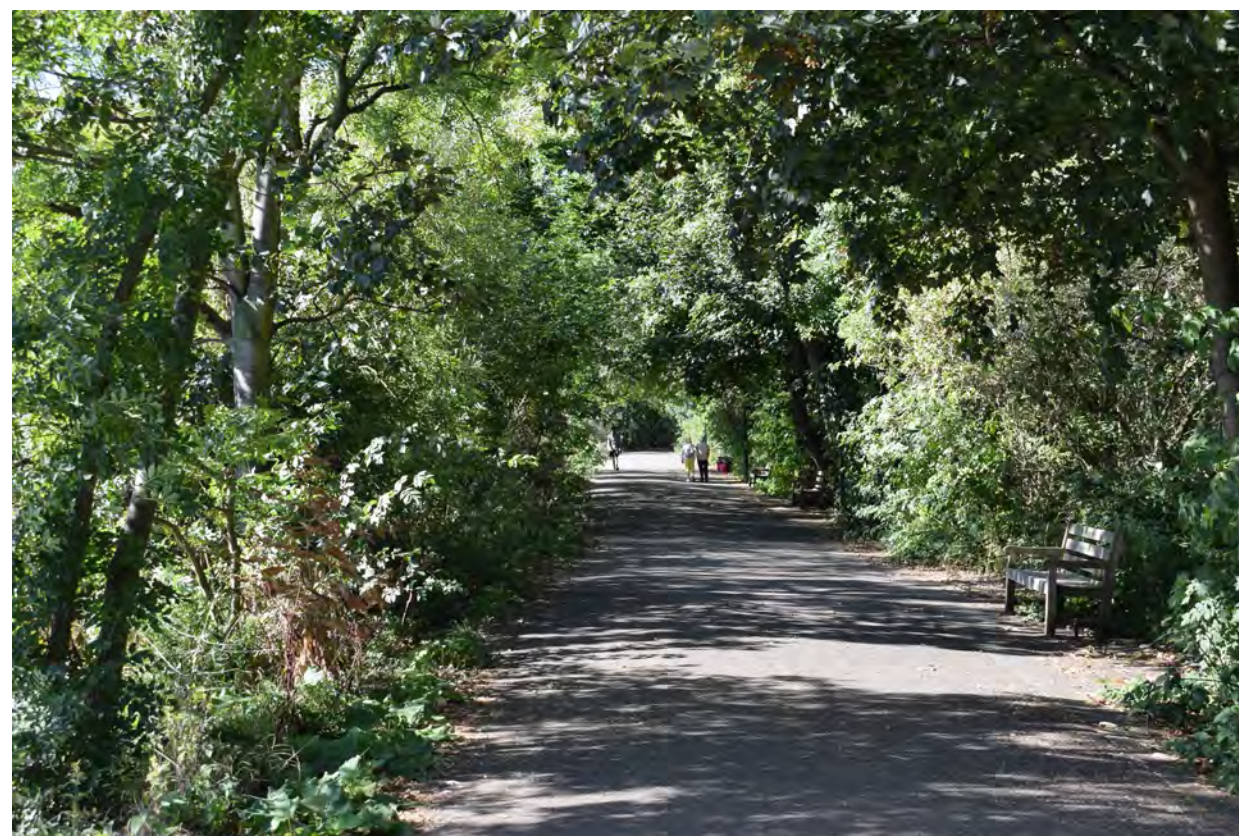
Viewpoint 9: View along northern Thames Path to south of Marble Hill Park looking west (not towards site). Views from Thames Path looking towards the site are restricted by vegetation on Marble Hill Park Boundary.

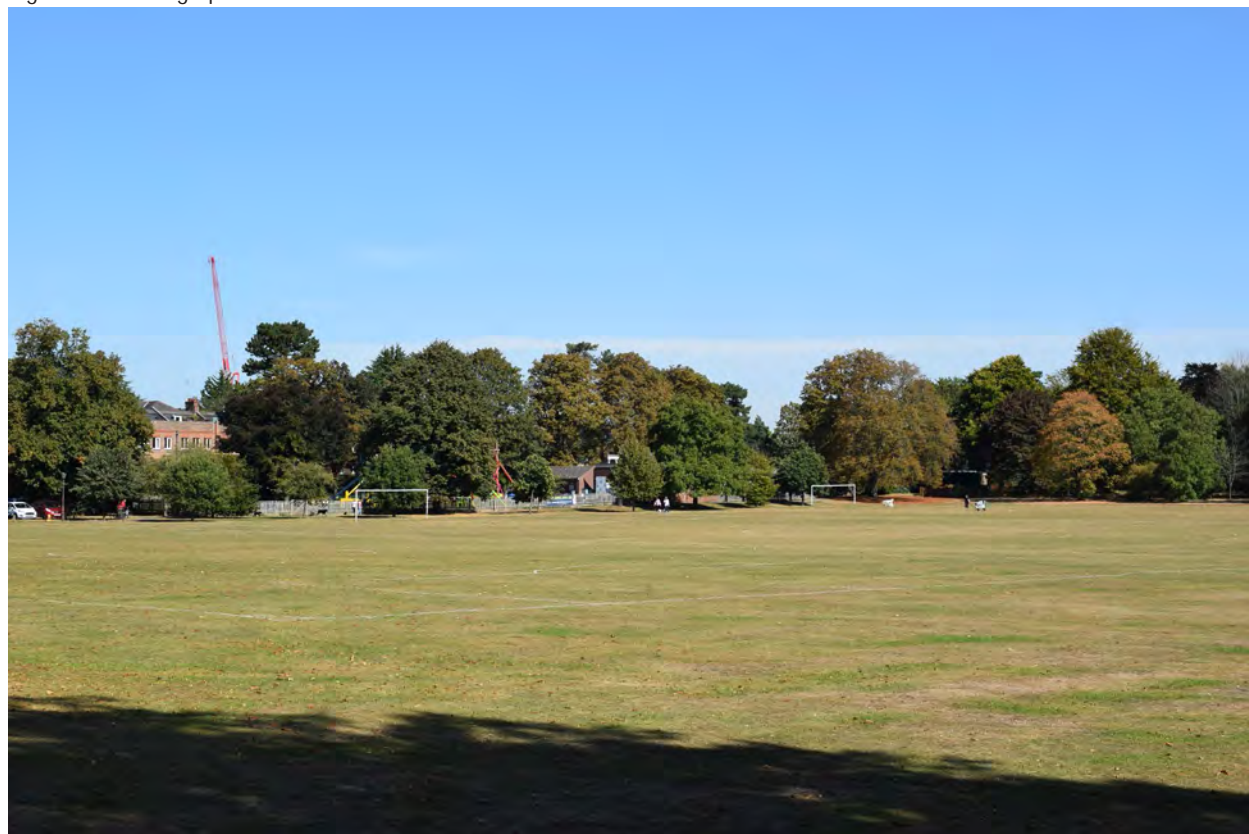
Viewpoint 10: View from public open space in Marble Hill Park to east of Marble Hill House approximately 200m from site boundary looking north east. Partial views of site through adjacent off site trees and boundary vegetation.

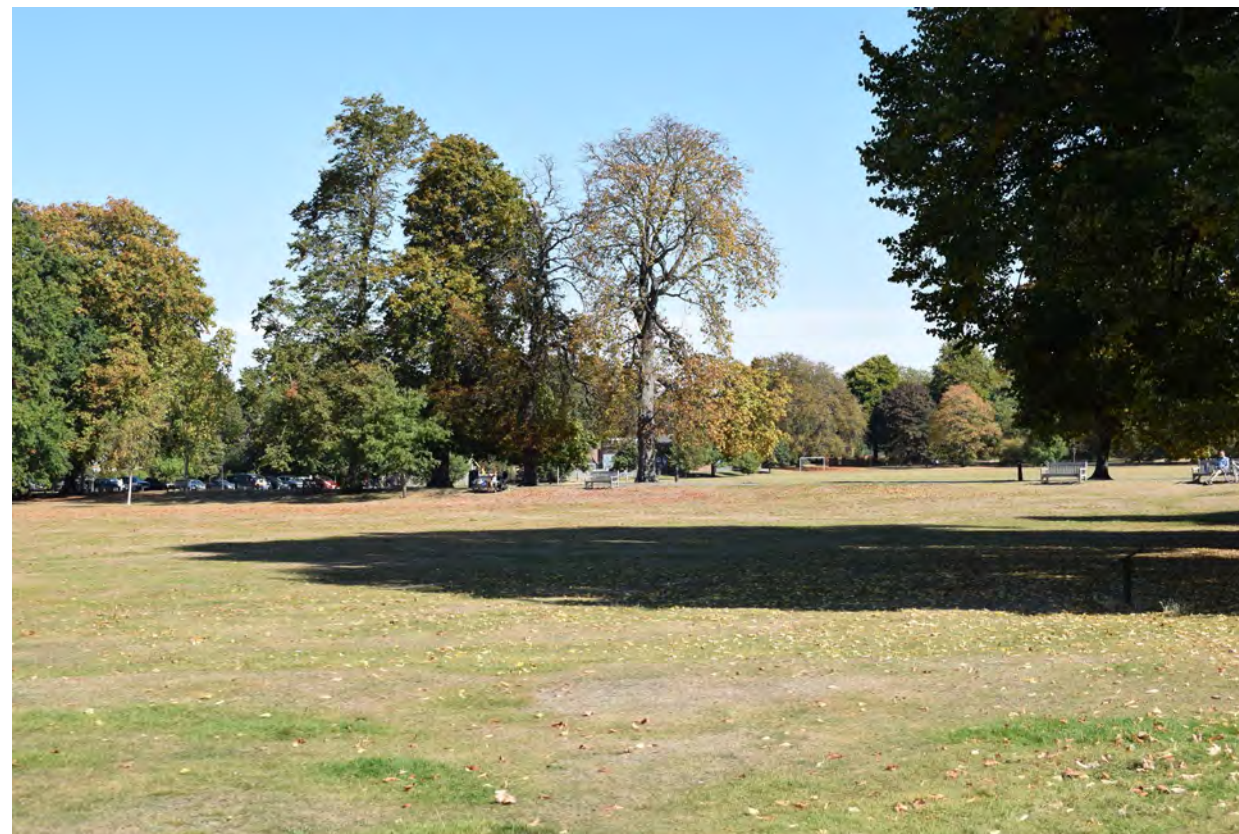
Viewpoint 11: View from public open space in Marble Hill Park to north of Marble Hill House approximately 220m from site boundary looking north east. Glimpse views of site through adjacent off site trees and boundary vegetation.

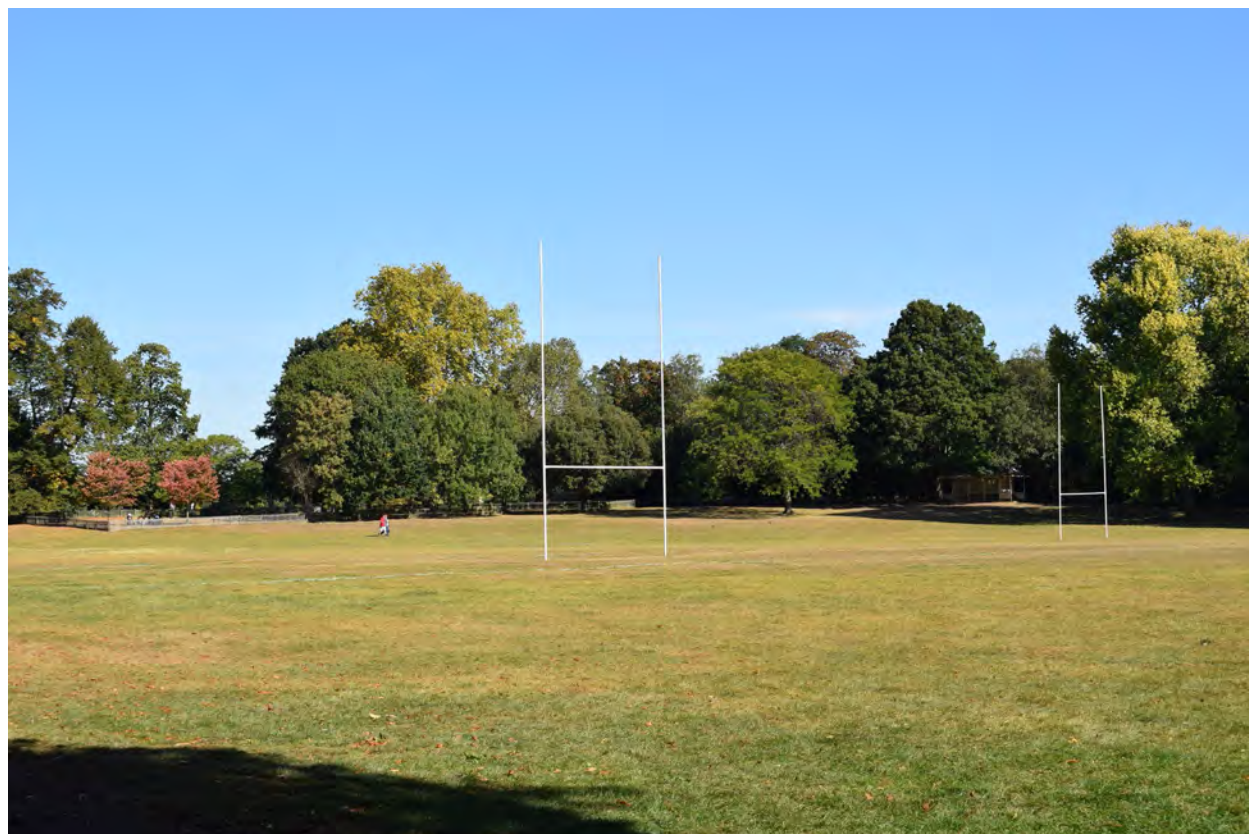
Viewpoint 12: View from public open space in Marble Hill Park to south west of Marble Hill House approximately 500m from site boundary looking north east. No view of site due to intervening vegetation.

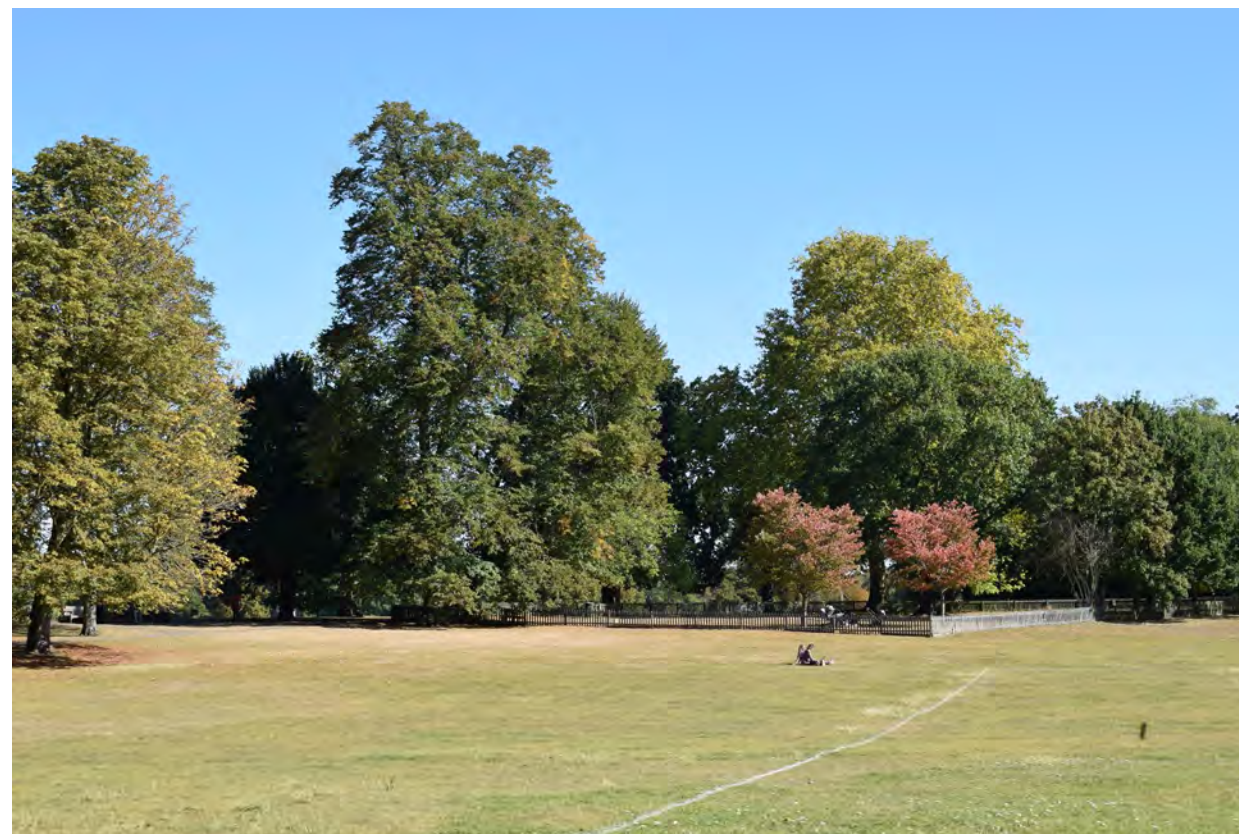
Viewpoint 13: View from public open space in Marble Hill Park to south west of Marble Hill House approximately 450m from site boundary looking north east. No view of site due to intervening vegetation.

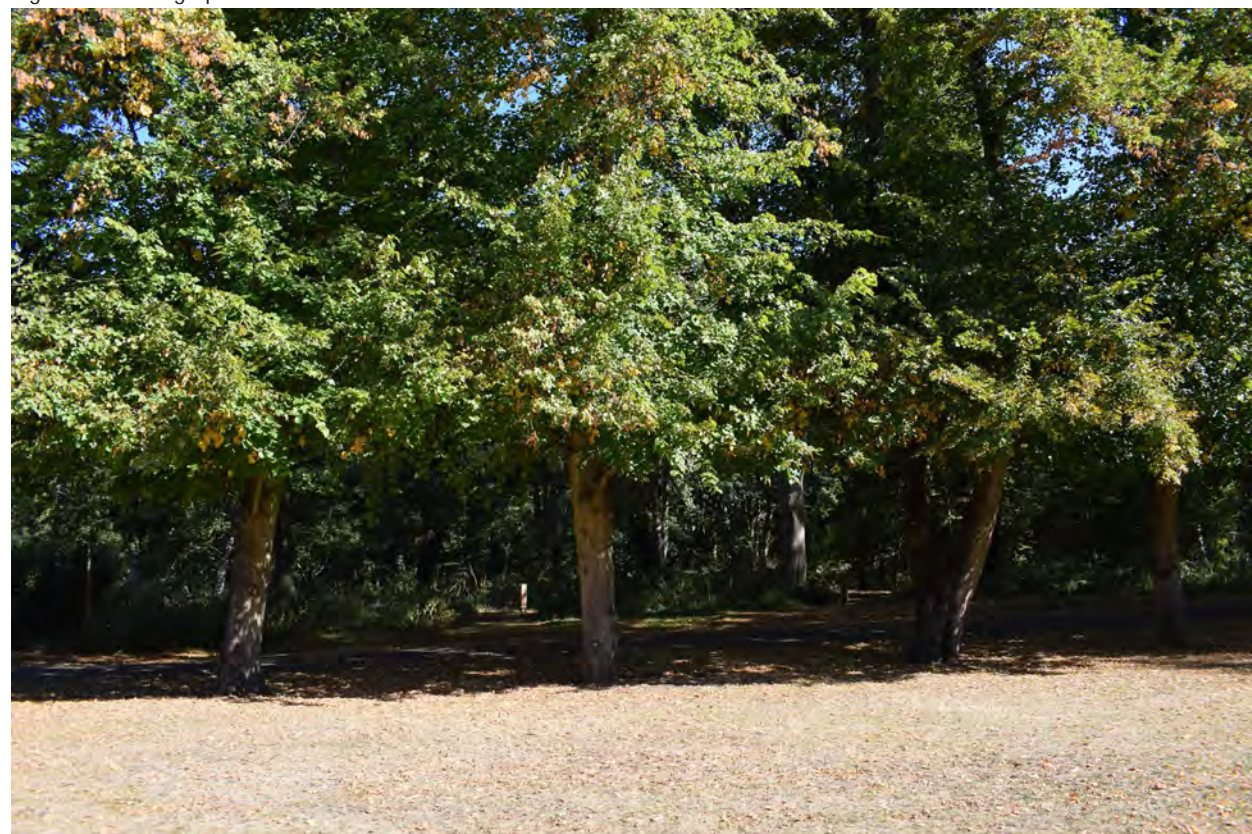
Viewpoint 14: View from public open space in Marble Hill Park to immediate east of Orleans House approximately 650m from site boundary looking north east. No view of site due to intervening vegetation.

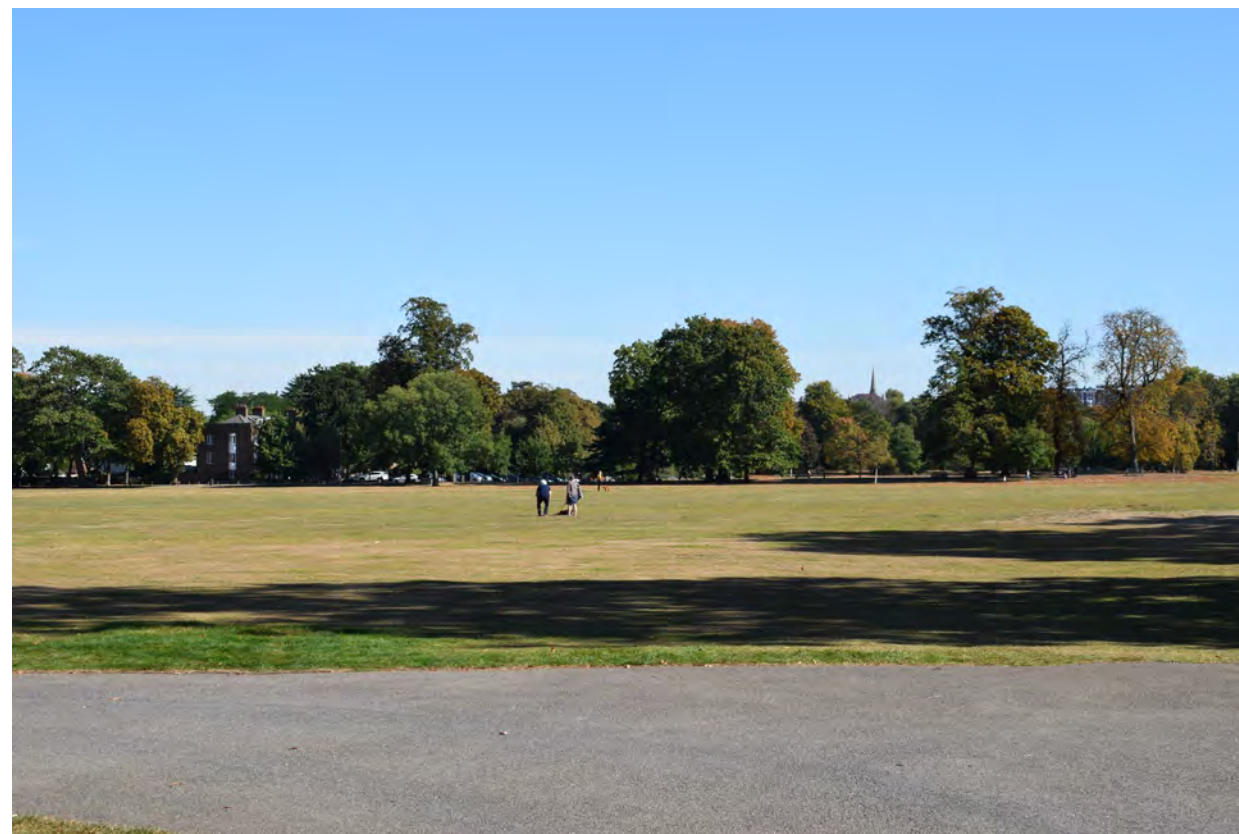
Viewpoint 15: View from public open space in Marble Hill Park to north west of Marble Hill House approximately 300m from site boundary looking north east. No view of site due to intervening vegetation.

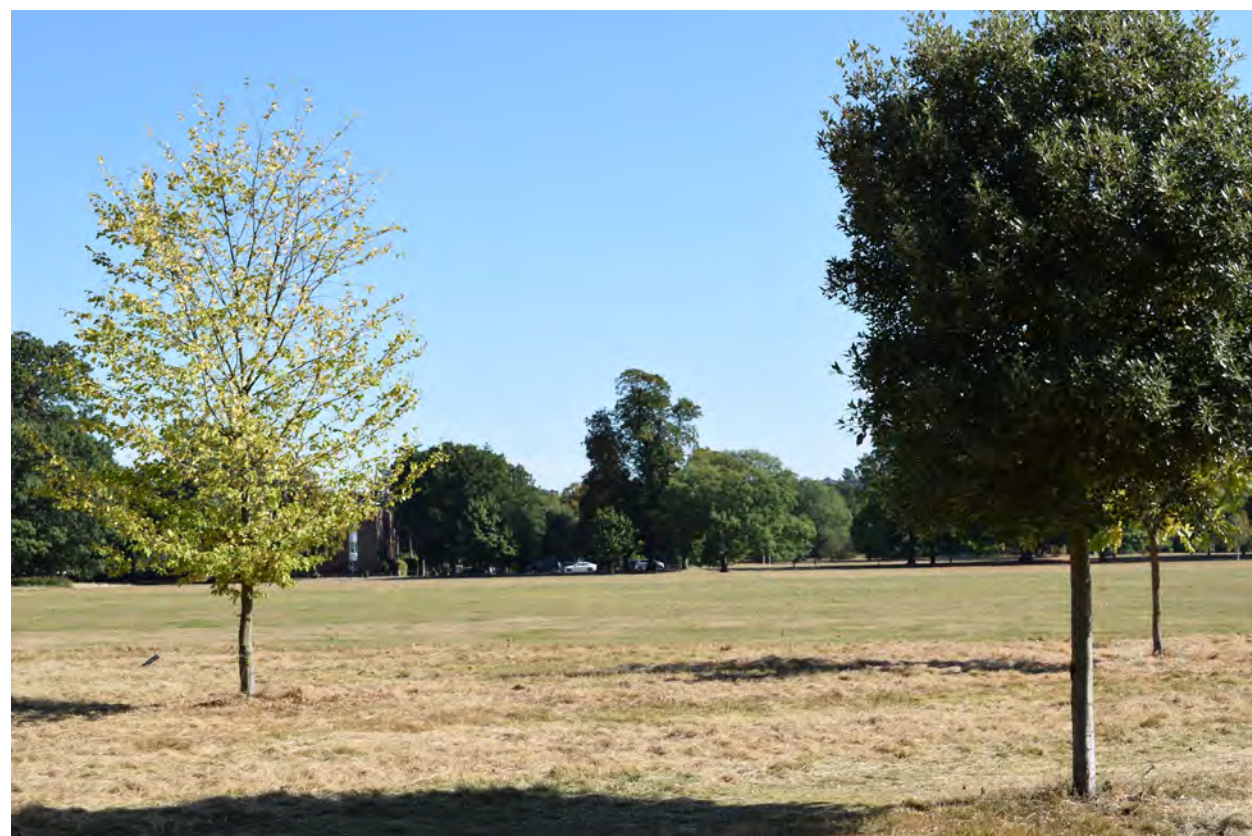
Viewpoint 16: View from public open space in Marble Hill Park approximately 300m from site boundary looking east. No view of site due to intervening vegetation.

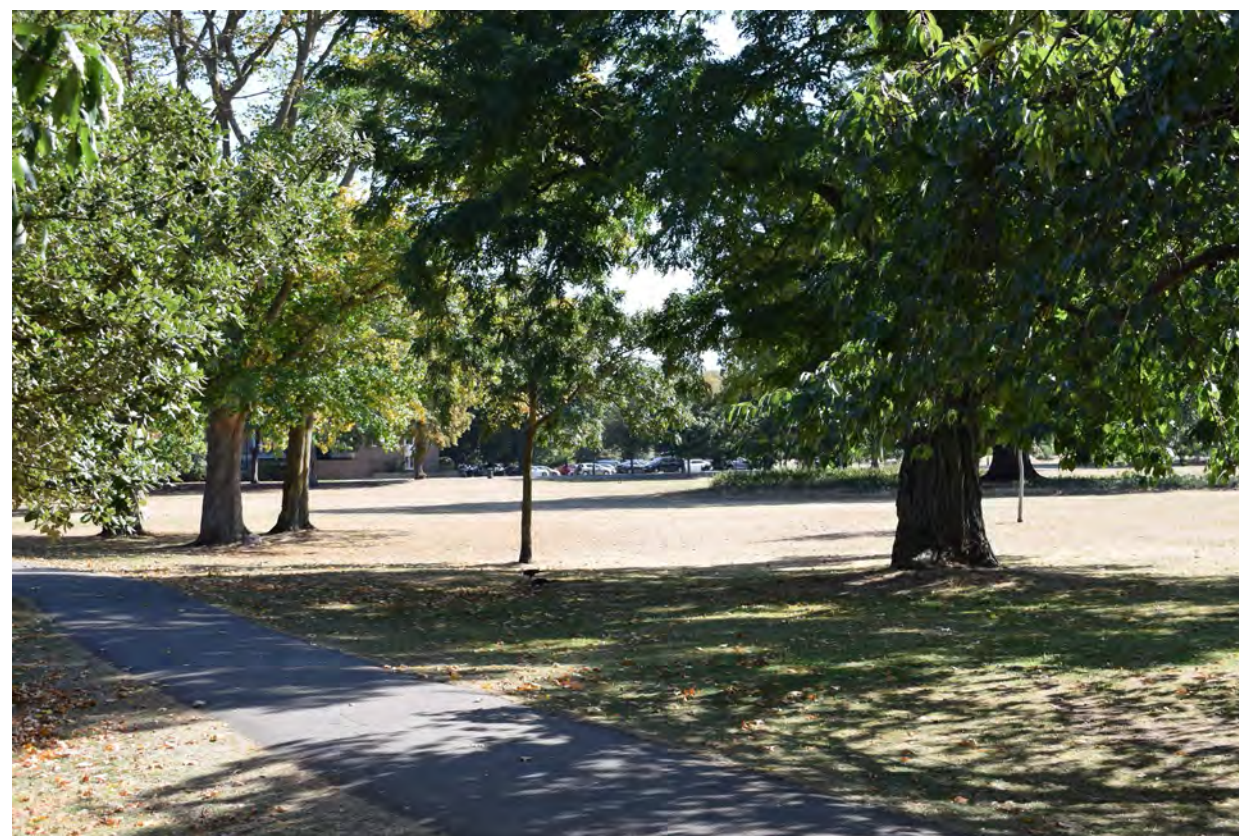
Viewpoint 17: View from public open space in Marble Hill Park adjacent to pedestrian entrance from Richmond Road approximately 270m from site boundary looking south east. No view of site due to intervening vegetation.

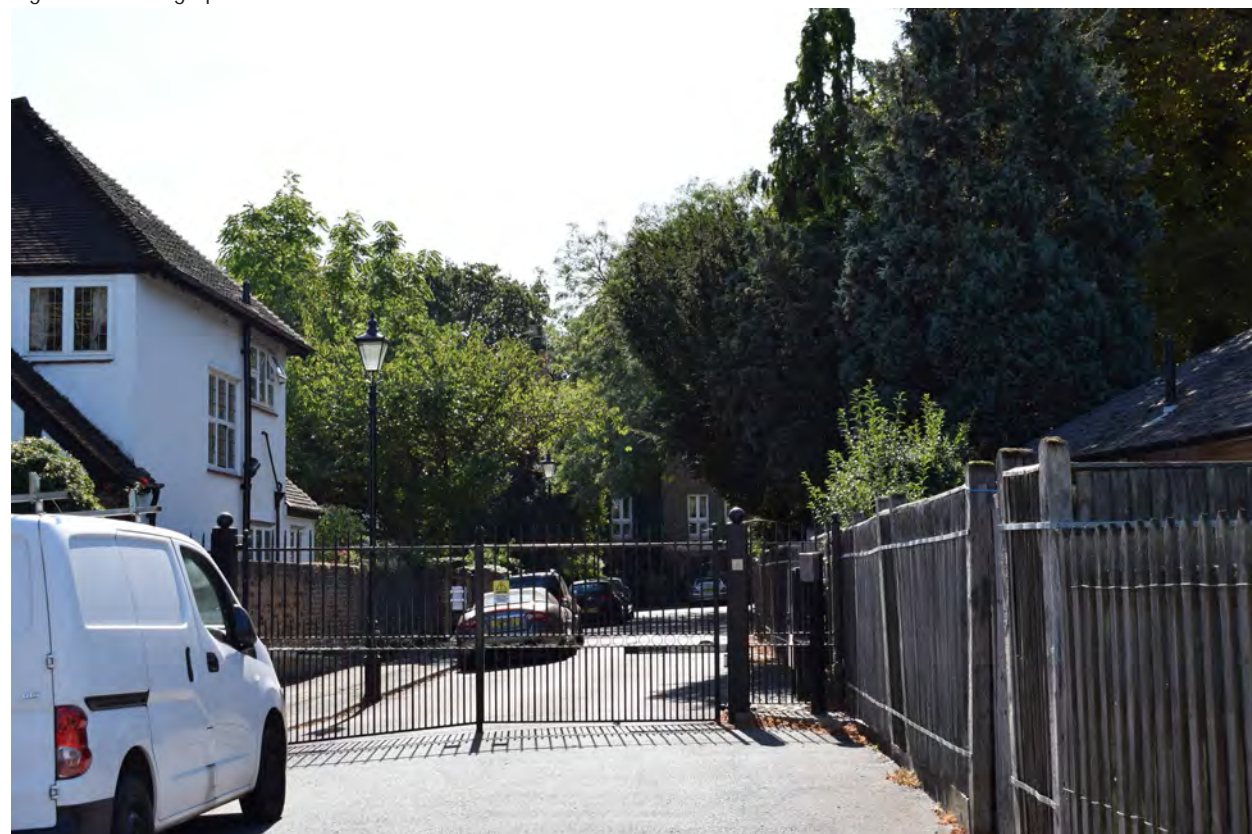
Viewpoint 18: View from Richmond Road looking along gated access to Marble Hill Park approximately 100m from site boundary looking south. No view of site due to intervening built form.

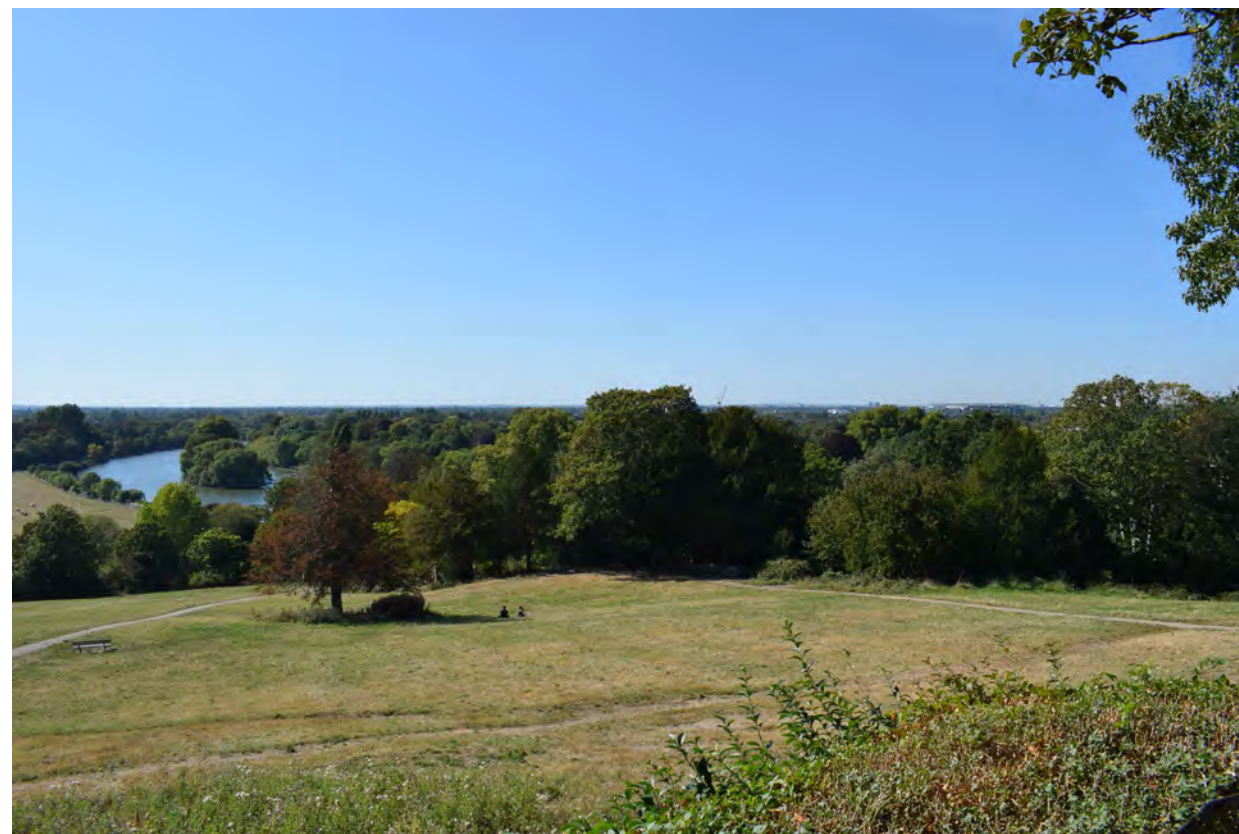
Viewpoint 19: Recognised View from public open space on Richmond Hill approximately 800m from site boundary looking west. No view of site due to intervening vegetation.

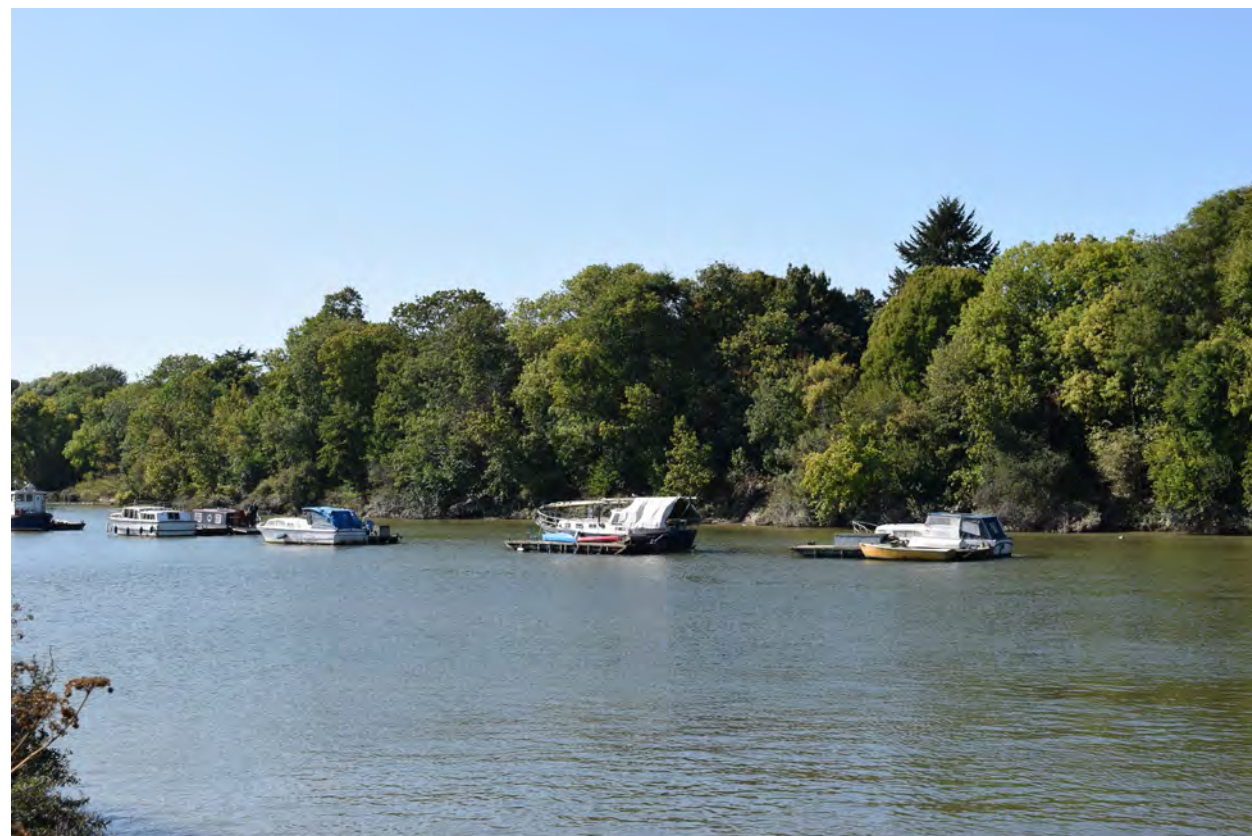
Viewpoint 20: View from southern Thames Path approximately 500m from site boundary looking west. No view of site due to intervening vegetation.
