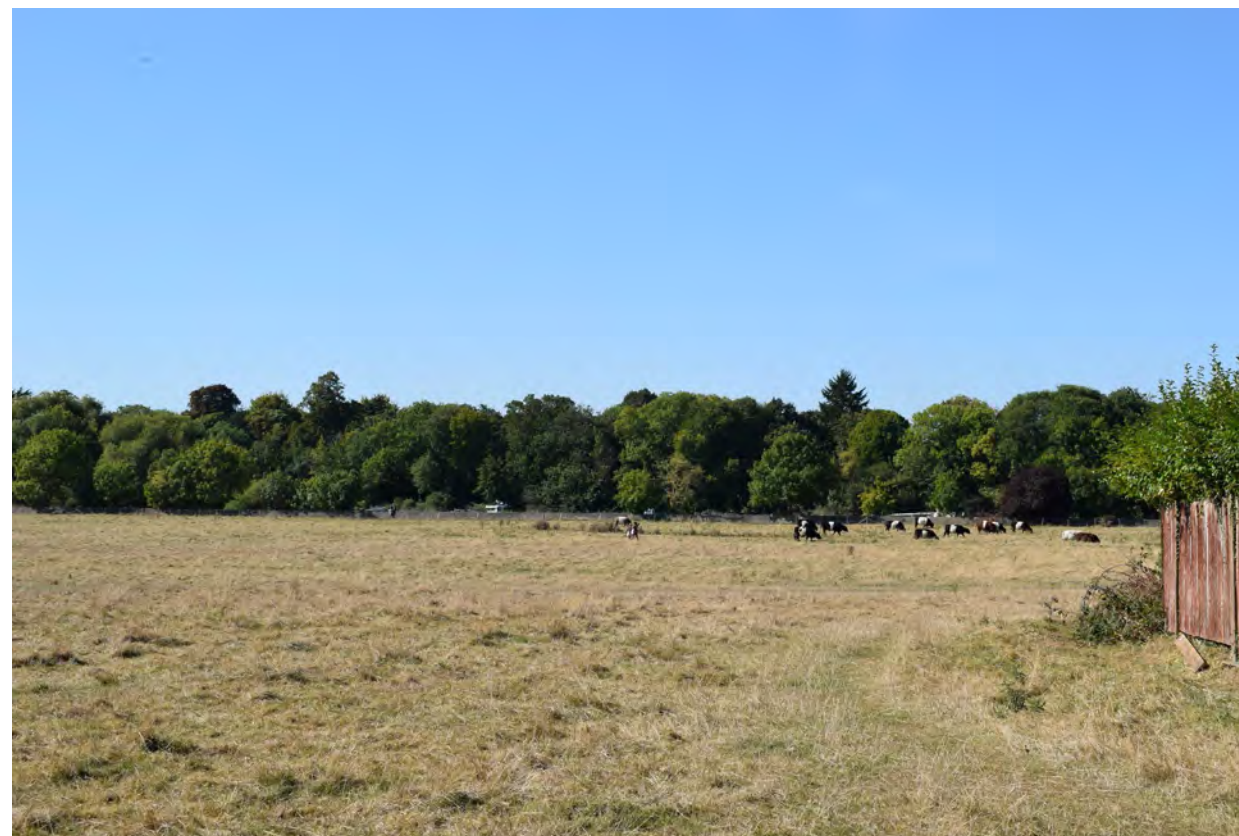
Viewpoint 21: View from footpath across Petersham Meadows (Common Land) approximately 730m from site boundary looking north west. No view of site due to intervening vegetation.

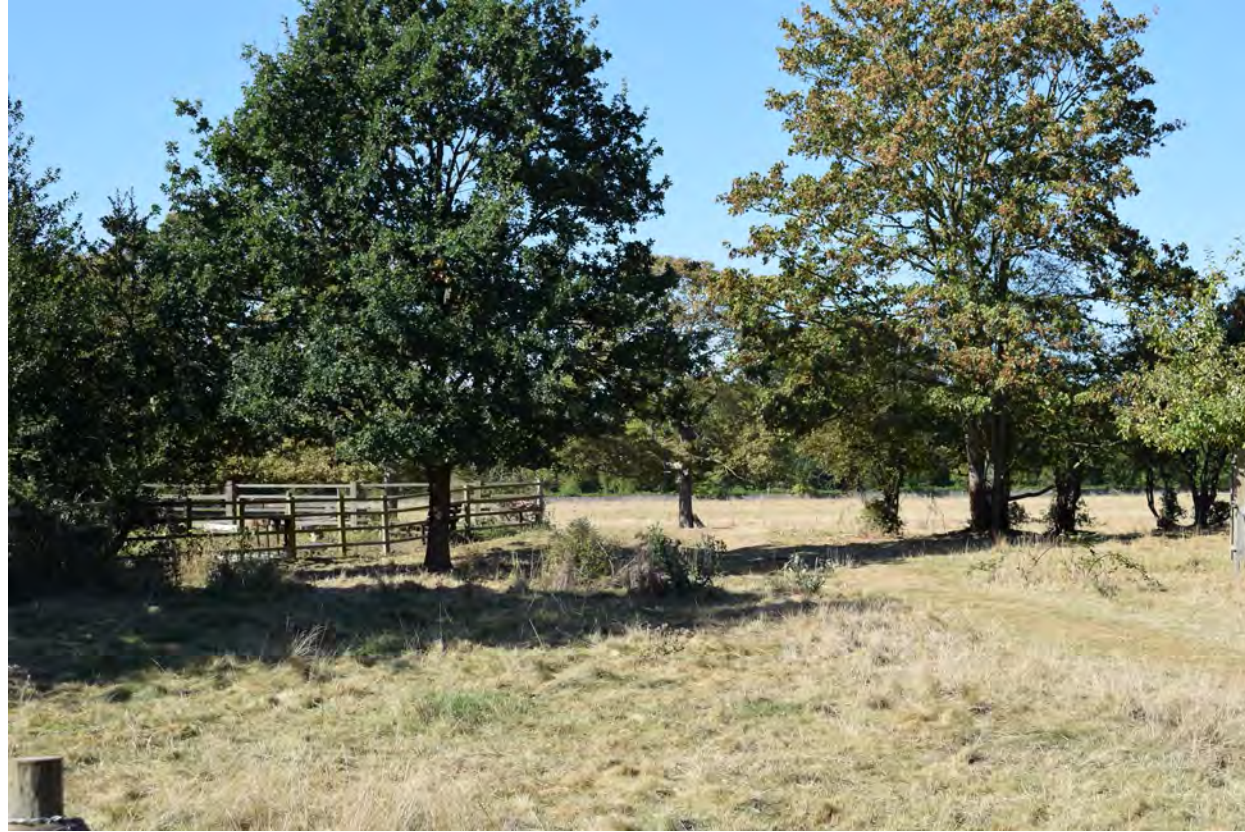
Viewpoint 22: View from public footpath to north of Petersham Nurseries approximately 700m from site boundary looking south. No view of site due to intervening vegetation.

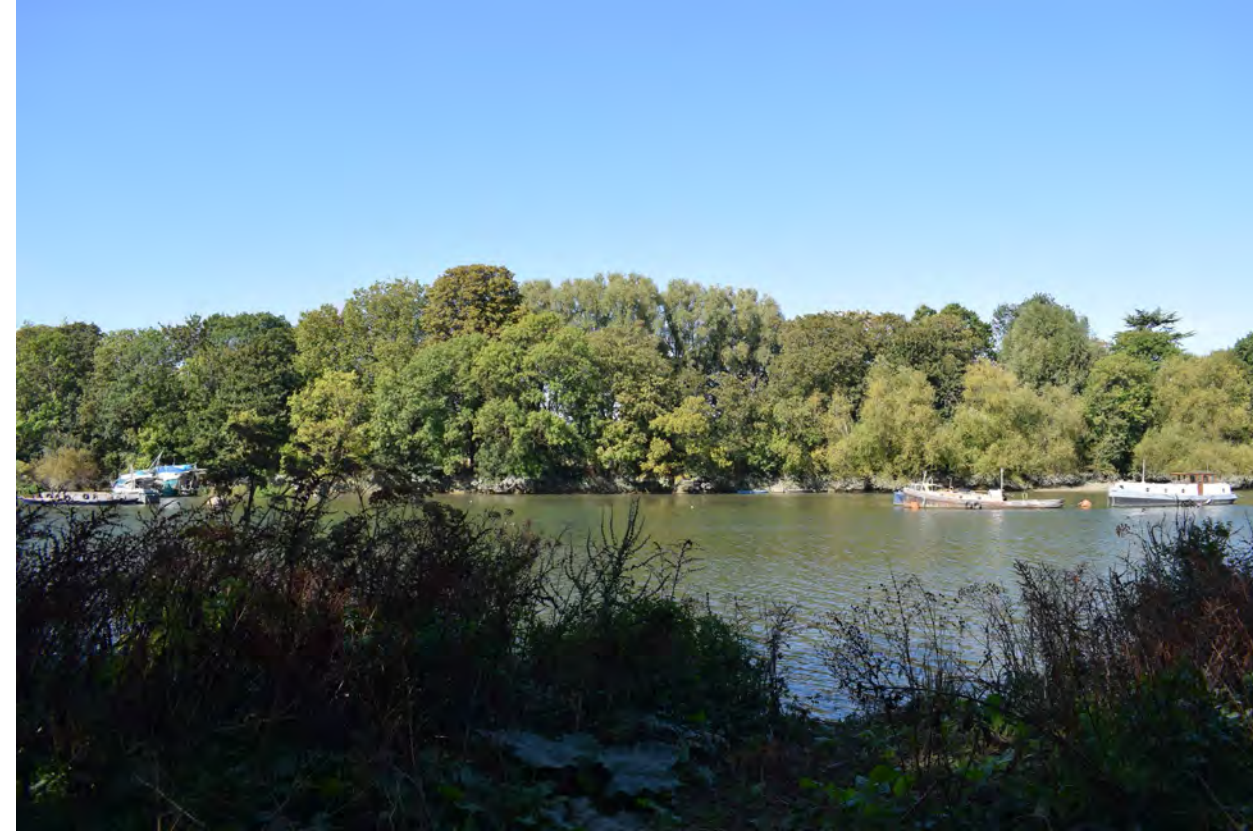
Viewpoint 23: View from southern Thames Path approximately 500m from site boundary looking north. No view of site due to intervening vegetation.

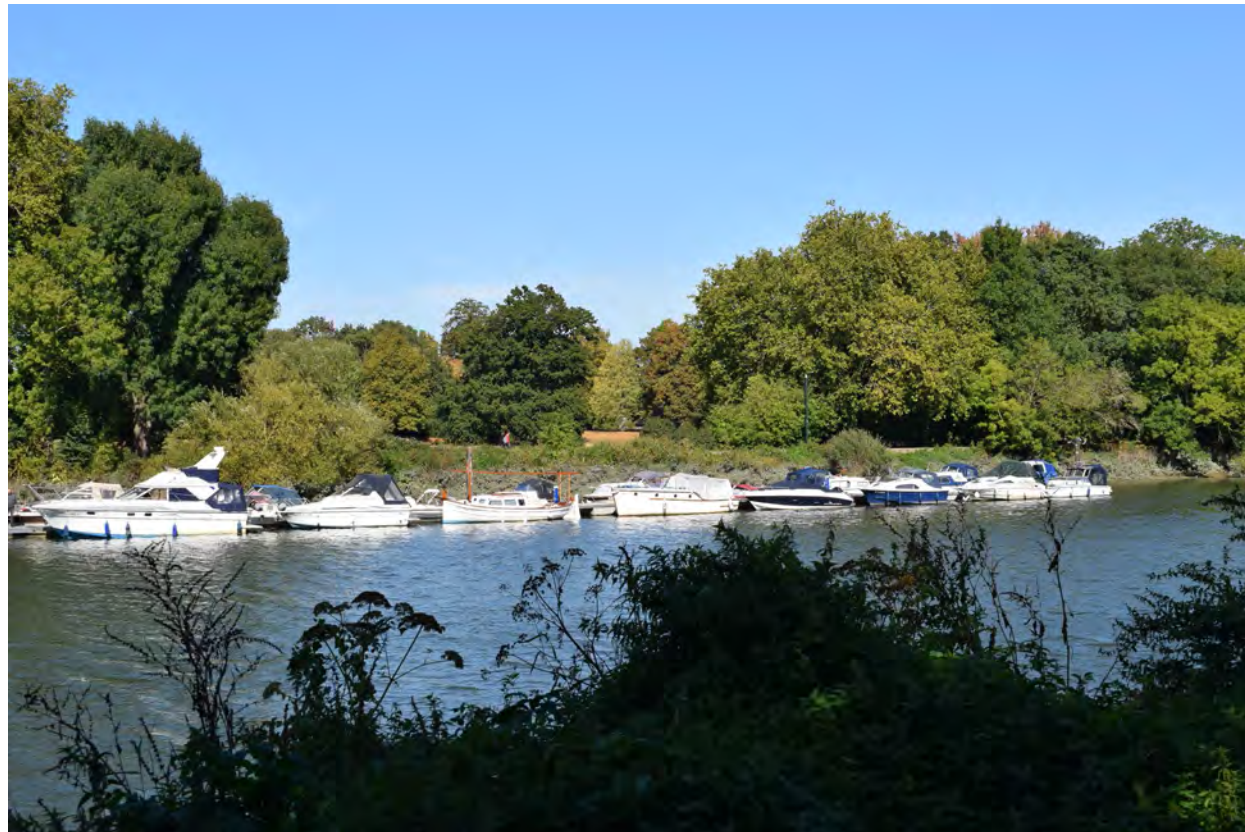
Viewpoint 24: View from southern Thames Path approximately 540m from site boundary looking north. No view of site due to intervening vegetation.

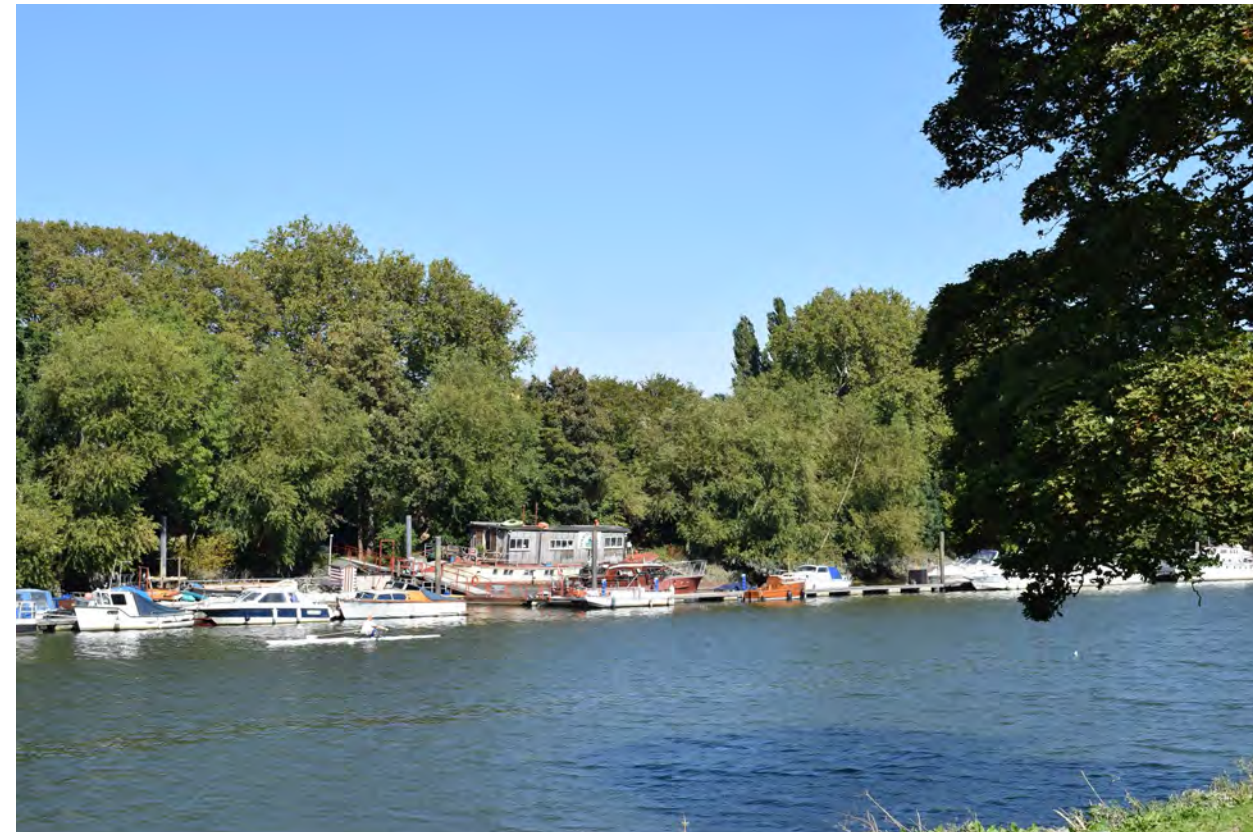
Viewpoint 25: View from ferry boarding point on southern Thames Path approximately 570m from site boundary looking north. No view of site due to intervening vegetation.

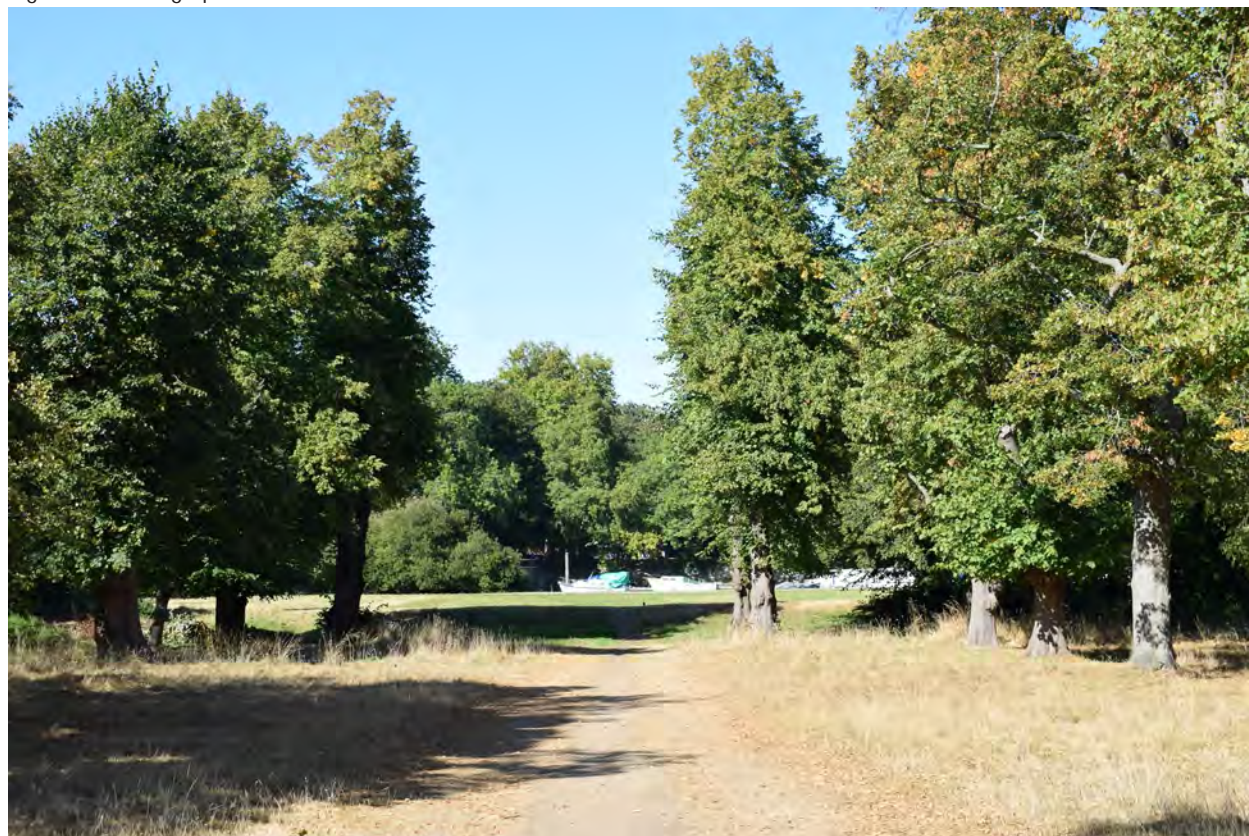
Viewpoint 26: View from footpath adjacent to Ham House northern gate approximately 700m from site boundary looking north. No view of site due to intervening vegetation.

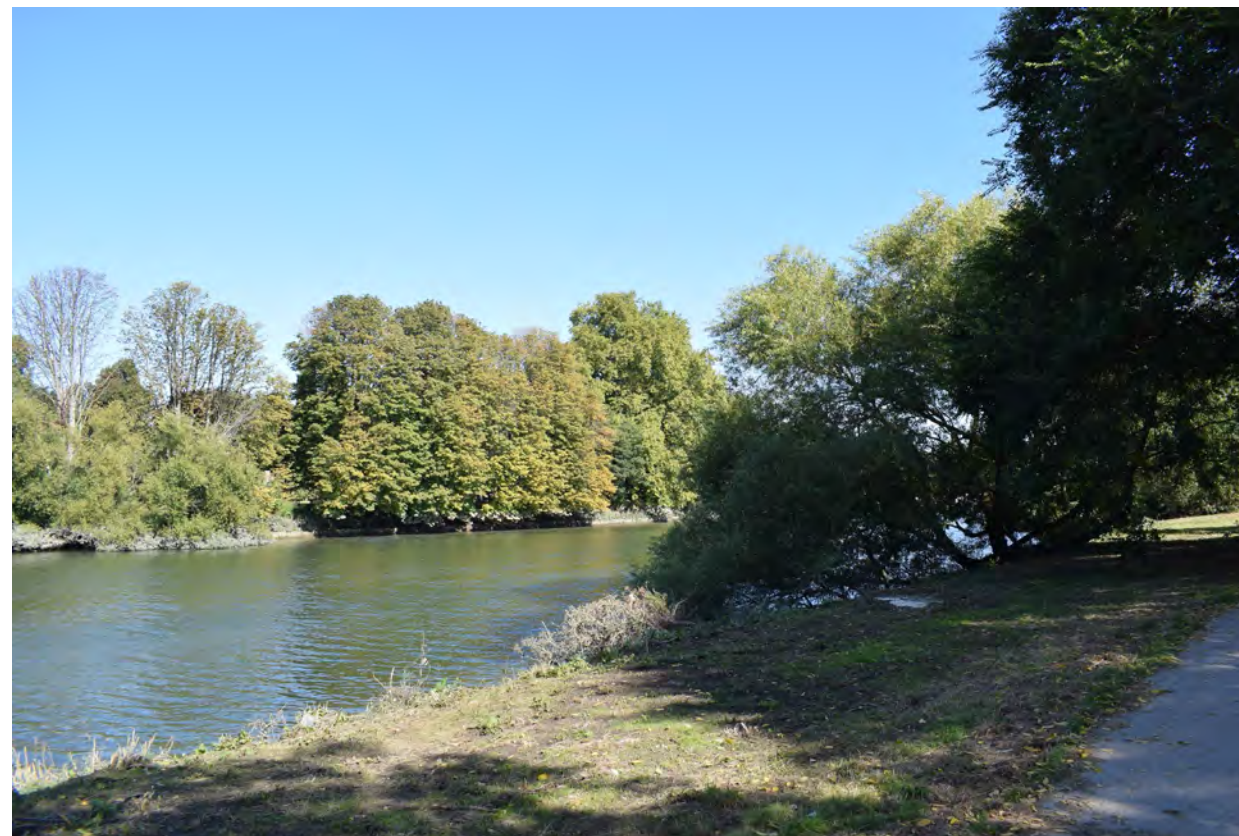
Viewpoint 27: View from southern Thames Path adjacent to public car park approximately 890m from site boundary looking north east. No view of site due to intervening vegetation.
