**GEO-ENVIRONMENTAL ASSESSMENT
(GROUND INVESTIGATION)
REPORT**

**GARAGES AT PLOUGH LANE,
TEDDINGTON,
TW11 9BN**

Report Title: Geo-environmental Assessment Ground Investigation Report for Garages at Plough Lane, Teddington, TW11 9BN

Date of Issue: April 2018

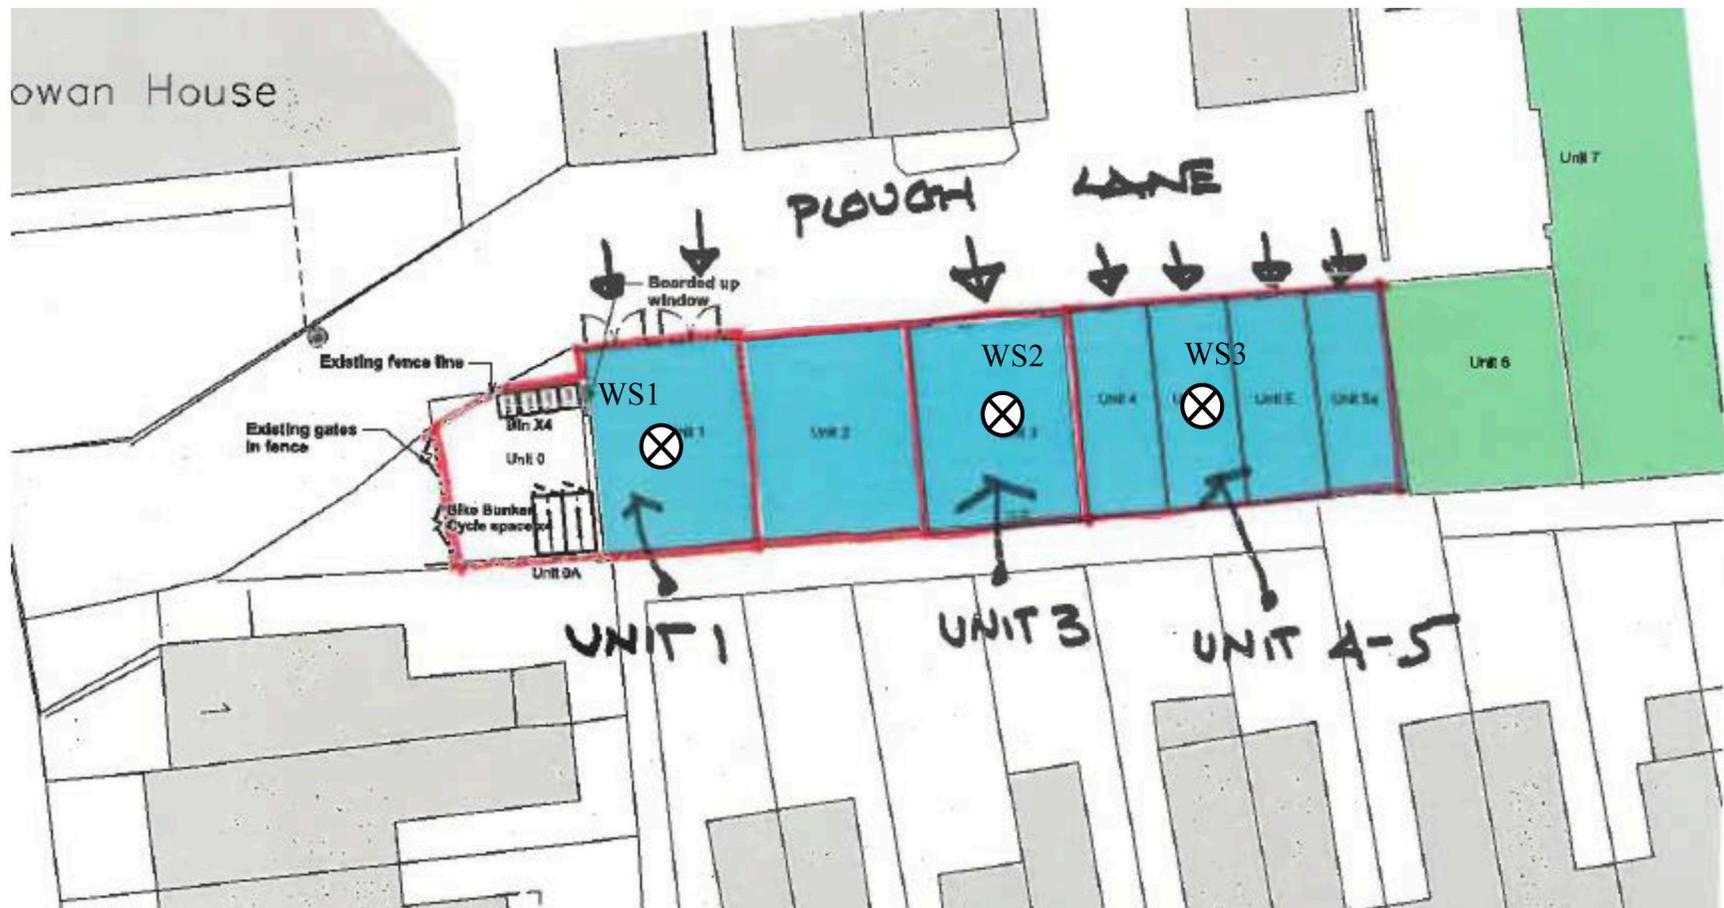
Project Name	Plough Lane, Teddington	Client	Plough Lane Mews Limited
Project No.	P1256J1265	Date	18/12/2017
Title	Proposed GI Plan	Prepared By	SL

3.2.6 Exploratory hole positions were located approximately with reference to known features on site, as shown in the exploratory hole location plan presented in Appendix 1. The exploratory hole records are included in Appendix 2.

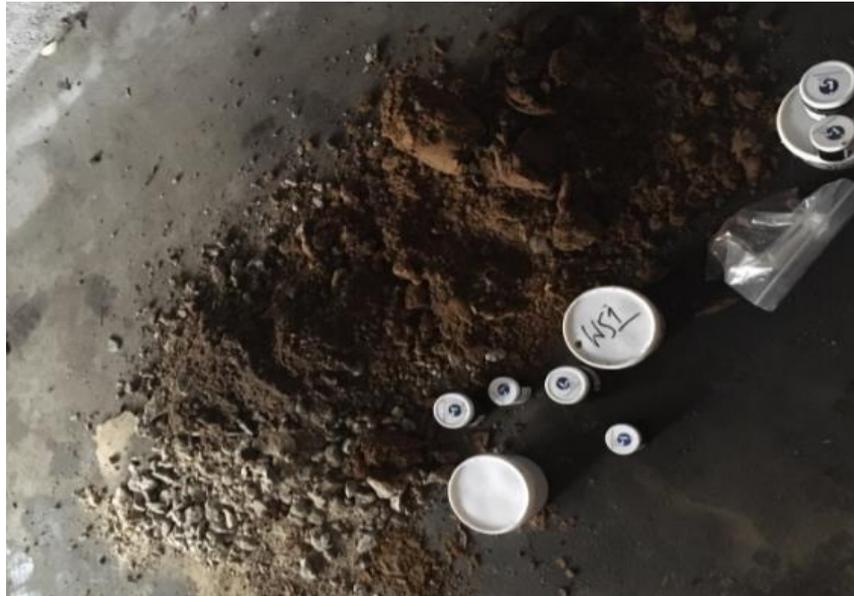
Photo 1: HTP1

3.4.1 WS1 was completed as a hand dug pit (HDP) due to headroom restrictions preventing access for a window sample rig.

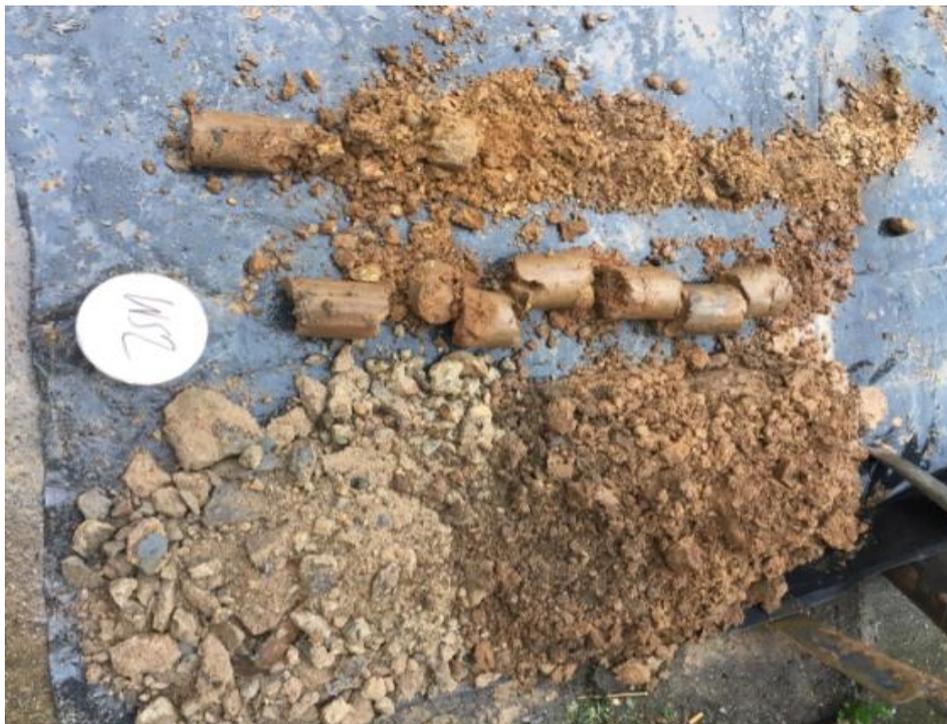
Photo 2: WS2

3.4.2 WS2 and WS3 were terminated at 2.5mbgl on very dense gravel.
