GEO-ENVIRONMENTAL & GEOTECHNICAL ASSESSMENT REPORT

ELLERAY HALL & NORTH LANE DEPOT/EAST CAR PARK
TEDDINGTON, TW11

Report Title: Geo-environmental & Geotechnical Assessment Report for Elleray Hall & North Lane Depot/East Car Park, Teddington

Job No: P3152J2114/TE

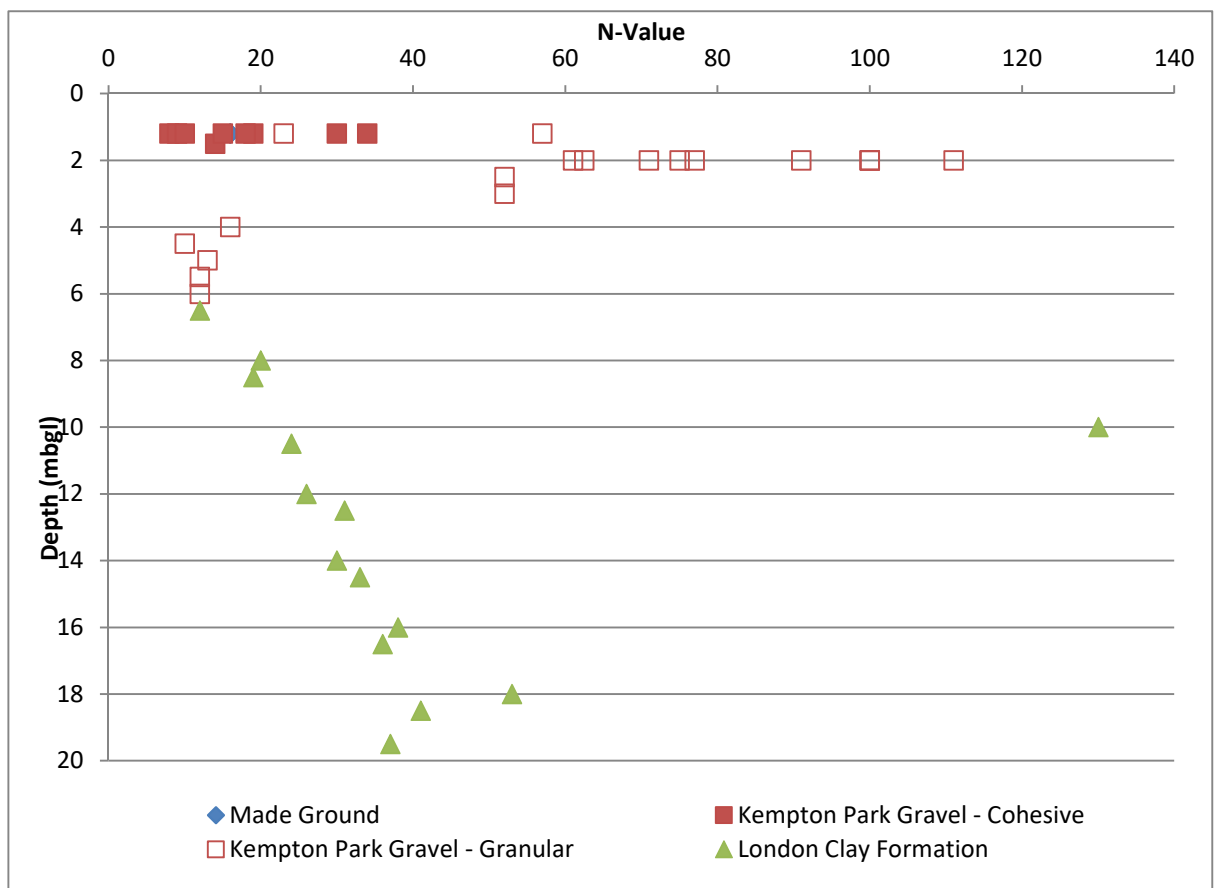
Figure 9.2: SPT ‘N’ Value v Depth

- 9.6.1 Standard Penetration Tests were undertaken at regular intervals throughout the window sampler holes and cable percussive boreholes. The results of the SPTs are plotted against depth in Figure 9.2 below.
- 9.6.2 The strata have been grouped into “Made Ground”, “Kempton Park Gravel Member – Cohesive”, “Kempton Park Gravel – Granular”, and “London Clay Formation”.
- 9.6.3 N_{equi} results have been calculated where the full 300mm of penetration could not be achieved for 50 or more blows.

- 9.6.4 The results are broadly consistent between the two sites, as would be expected between two plots in close proximity with very similar geology. The N-values increase sharply within the granular superficial deposits, before dropping within the London Clay Formation where they start to increase with depth.

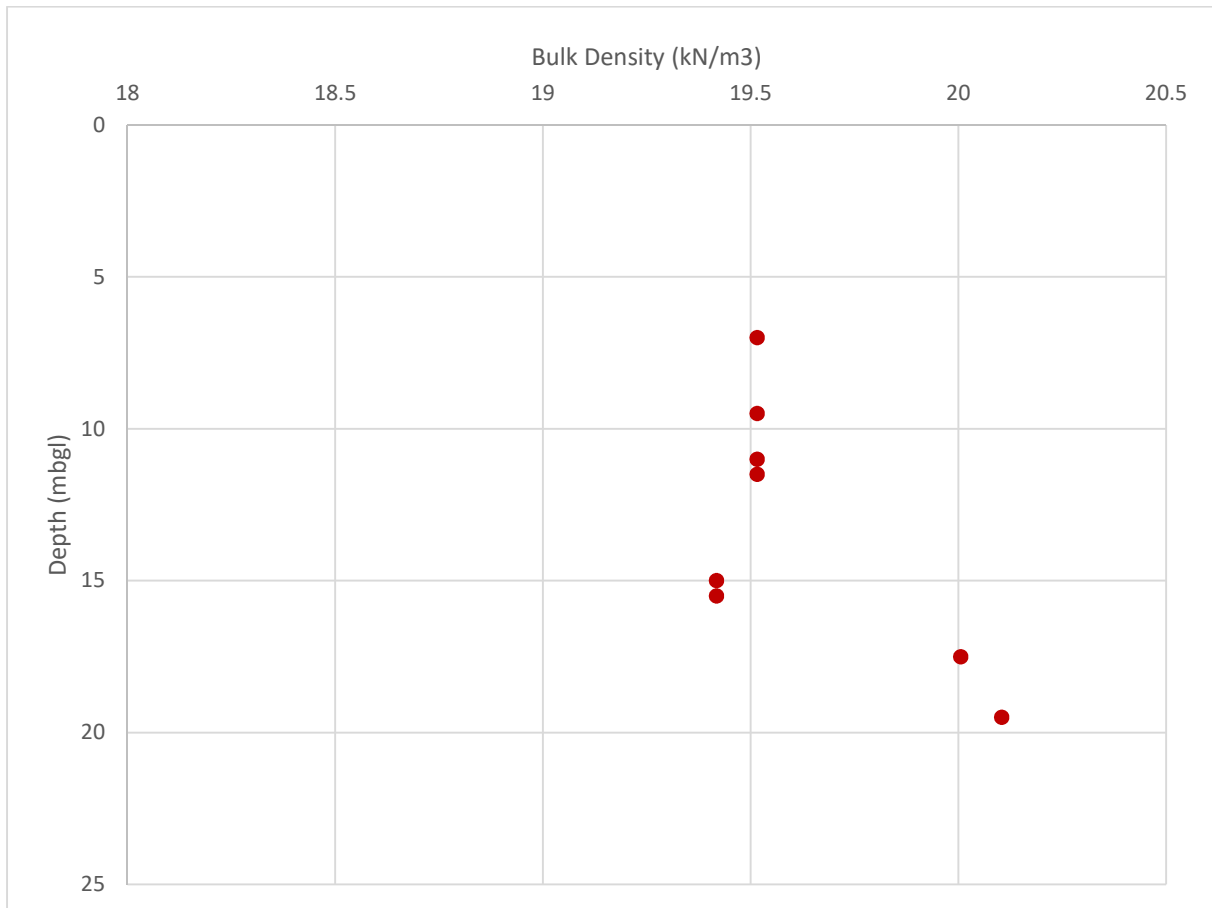
Figure 9.4: Bulk Density of London Clay v Depth

9.8.1 In order to calculate the undrained shear strength of undisturbed sample of London Clay, using the quick undrained triaxial methodology, the bulk density of the materials has to be calculated. These values are provided on the quick undrained triaxial testing certificates in the Concept Factual Report. These results are summarised in the figure below.

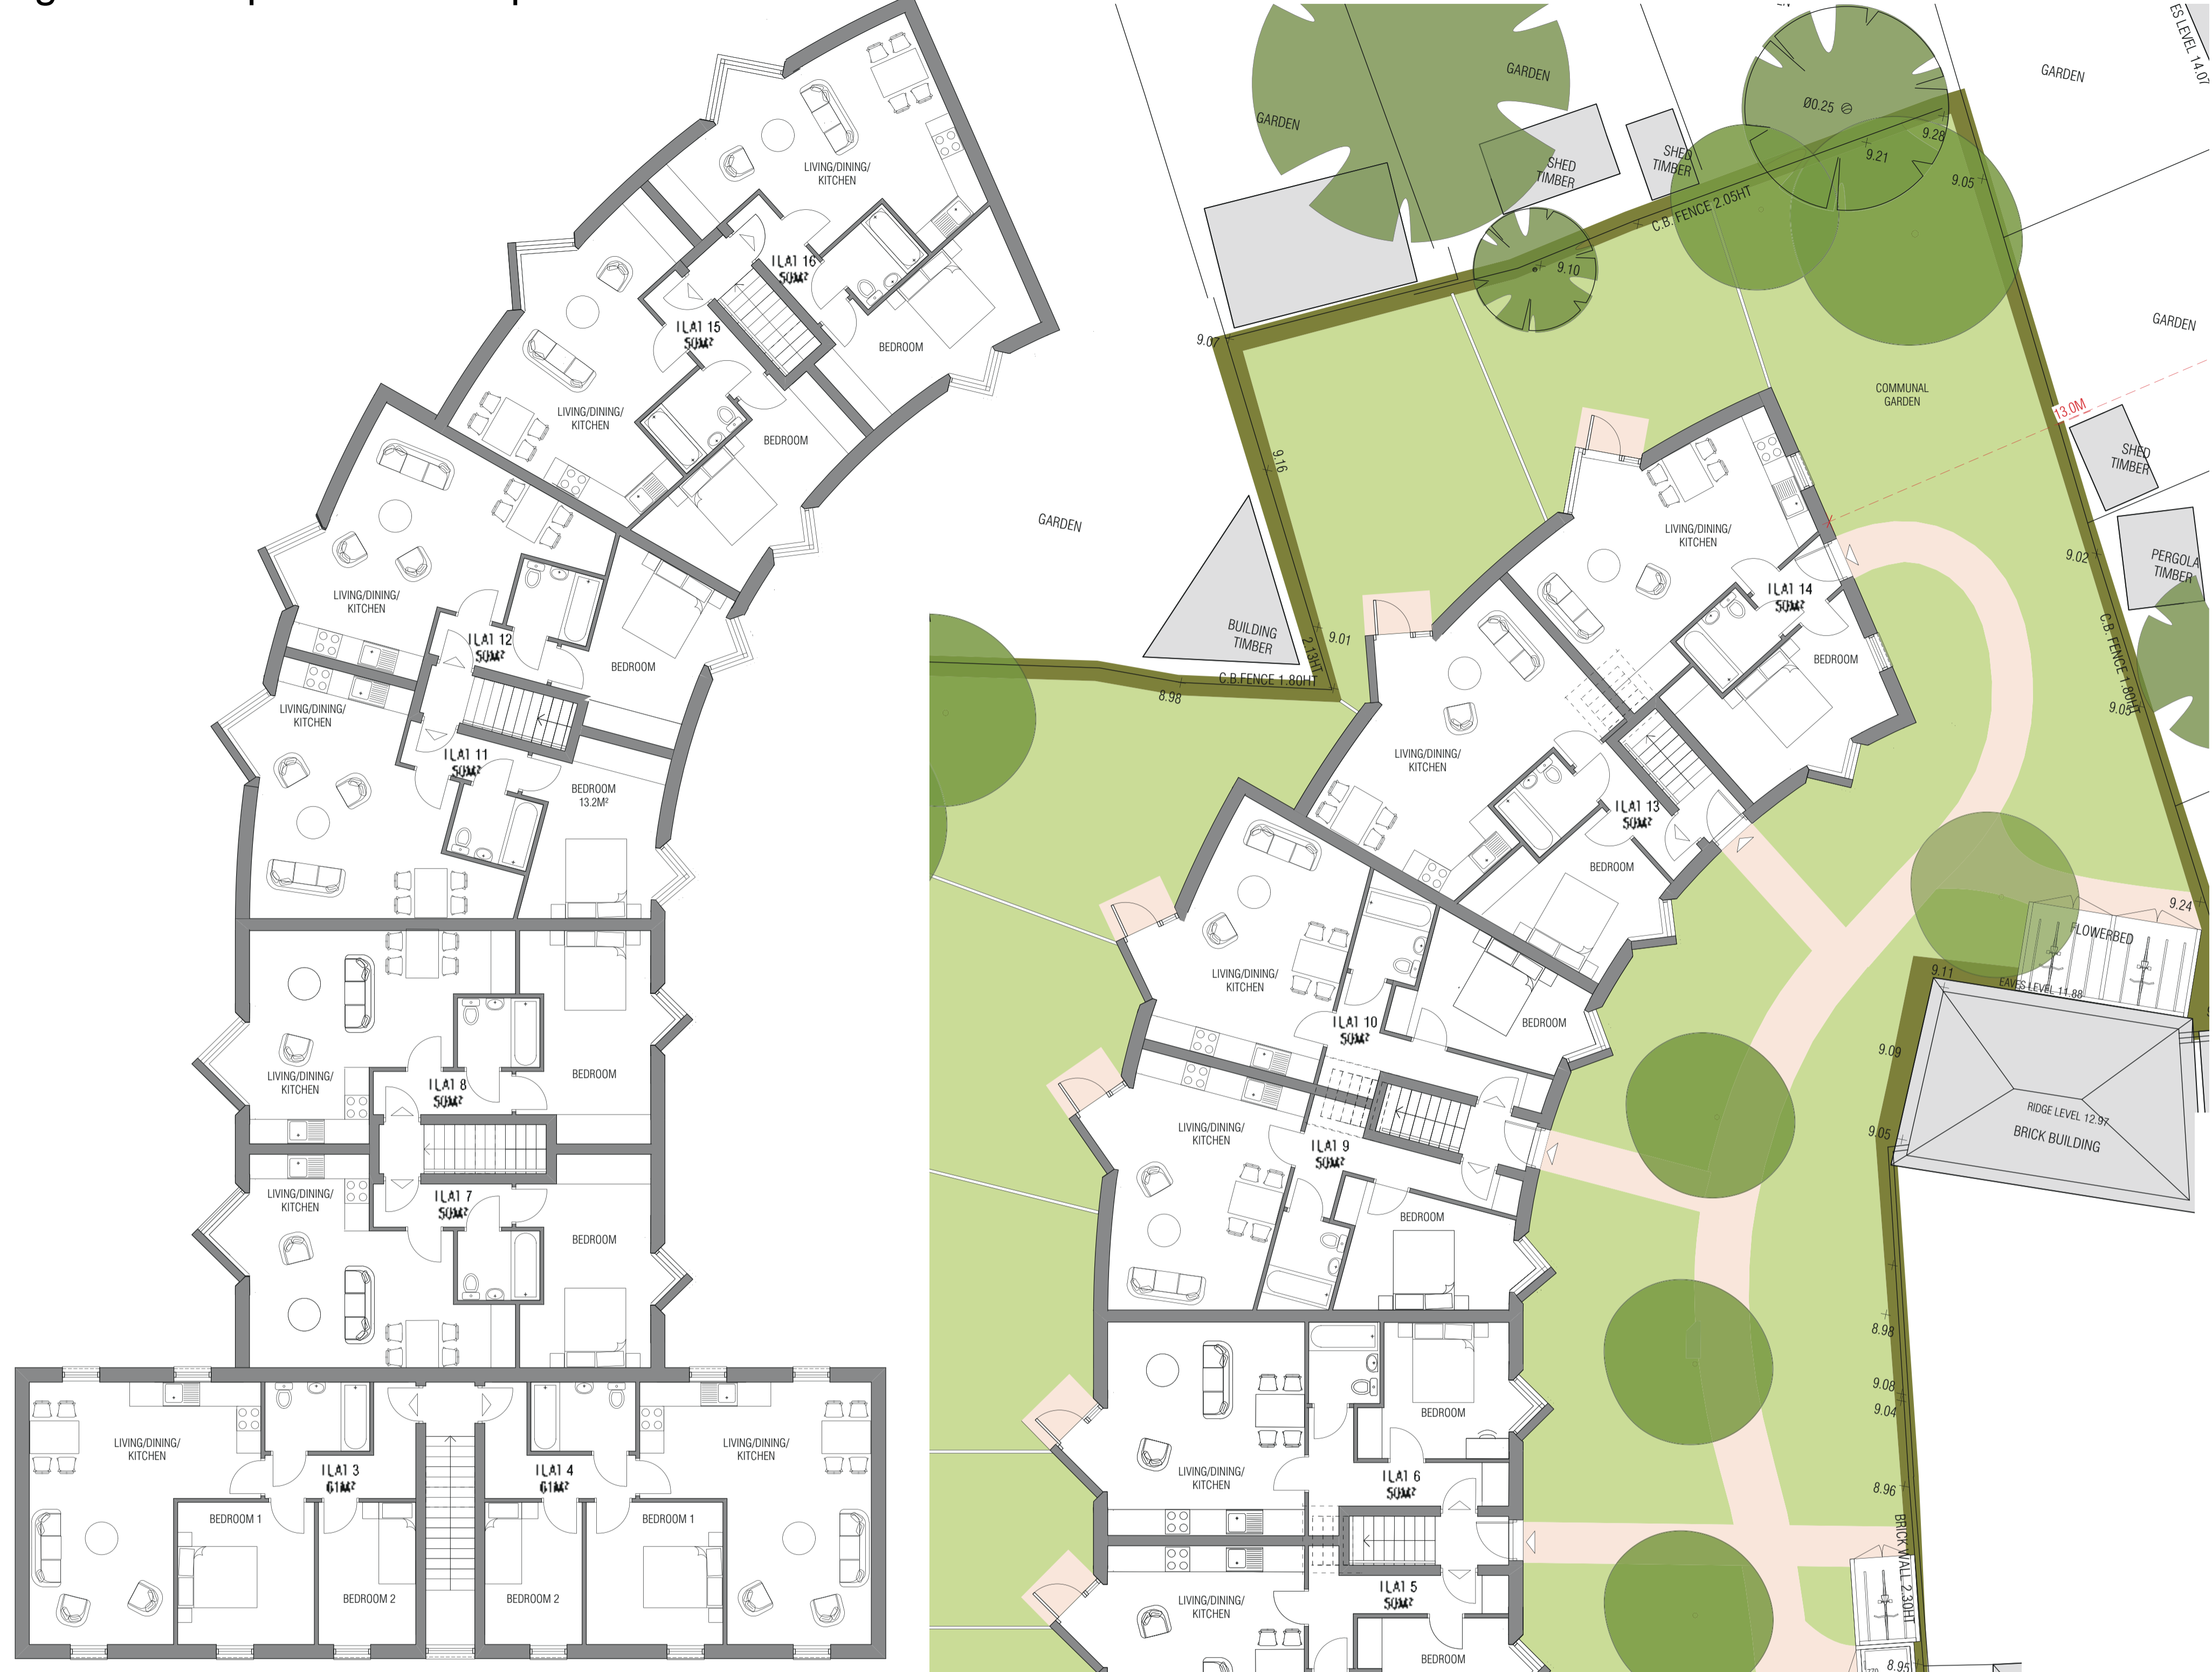
Figure 4: Proposed Development Plan - Southern Plot

FIRST FLOOR PLAN 1:100

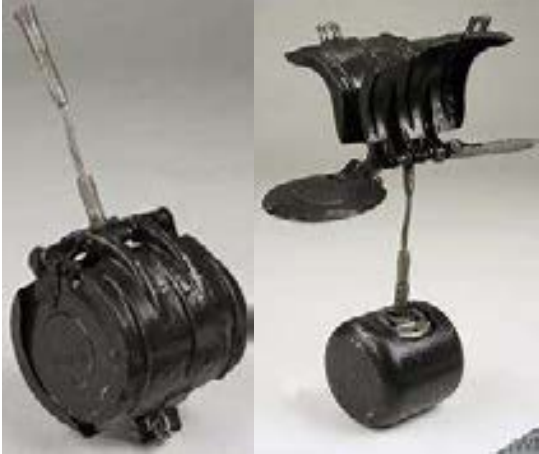
SD-2 Butterfly bomb

Weight	2Kg
	Length	200mm
	Body diameter	80mm
	explosive	Fp 60/40
	NEQ	0.225Kg (0.496lb)
	Fuse	Mechanical Clockwork/ Mechanical time or B1/B2 Harassment
	German 2 kg anti-personnel submunition used by the Luftwaffe during ww2. They were packed into containers holding between 6 and 108 submunitions.

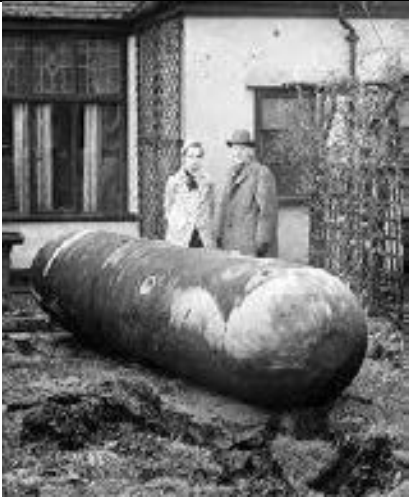
Parachute Mine (Luftmine B / LMB)

Bomb Weight	987.017kg (2176lb)
	ExplosiveWeight	125-130kg (276-287lb)
	Fuze Type	Impact/ Time delay / hydrostatic pressure fuze
	Bomb Dimensions	1640 x 512mm (64.57 x 20.16in)
	Body Diameter	368mm (14.5in)
	Remarks	Parachute Mines were normally carried by HE115 (Naval operations), HE 111 and JU 88 aircraft types. Deployed a parachute when dropped in order to control its descent.

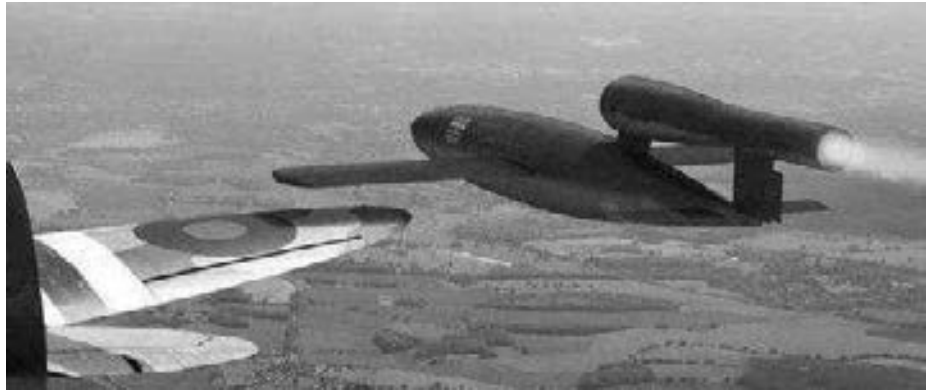
Annex D1 The V1 Flying Bomb

The V1 Flying bomb was the world's first cruise missile, they were also known as Doodle bugs or Vengeance weapon. The V1 was an unmanned plane that delivered a ton of high explosive. Between June 1944 and March 1945, 2419 of them exploded in London. The V1 was capable of inflicting huge damage to buildings, homes, and personnel. In the inner London suburbs where terrace houses were packed together, sometimes up to 20 houses would totally collapse, just at one hit. The blast area of a V1 extended across a radius of 400 -600 yards in each direction. <https://youtu.be/ro4ApX7EhJw>
