ARBORICULTURAL IMPACT ASSESSMENT AND METHOD STATEMENT

62 Bridge Way, TW2 7JJ

19th July 2021

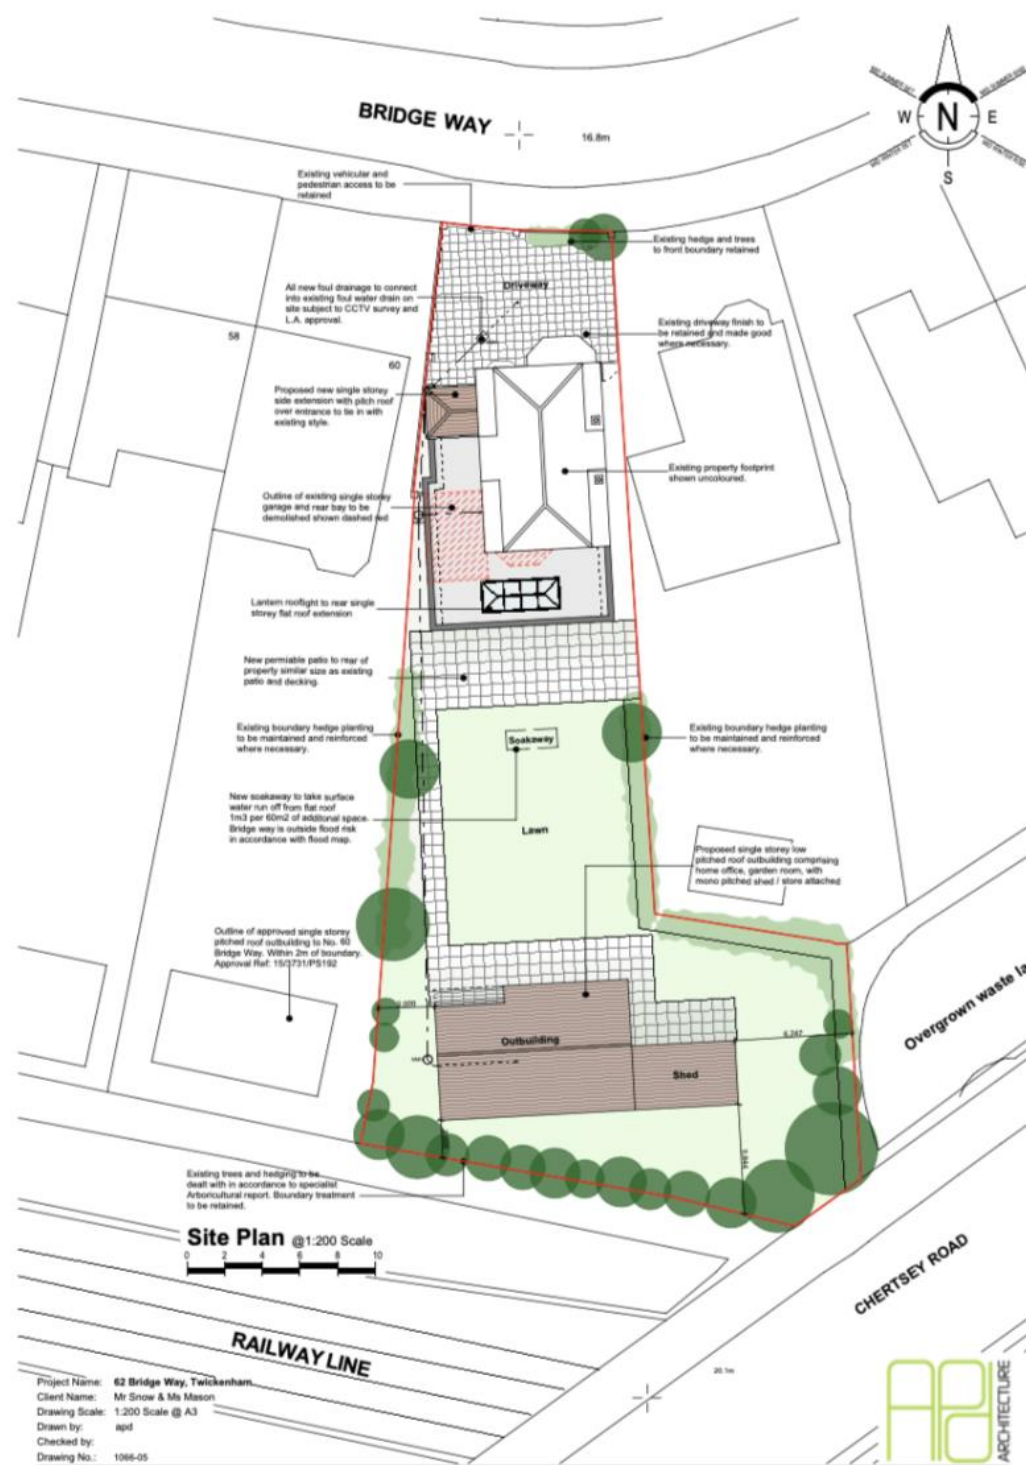
Figure 1 Proposed design scheme

4.1.1 The latest proposal seeks development of rear extension, outbuilding and associated infrastructure (Figure 1).

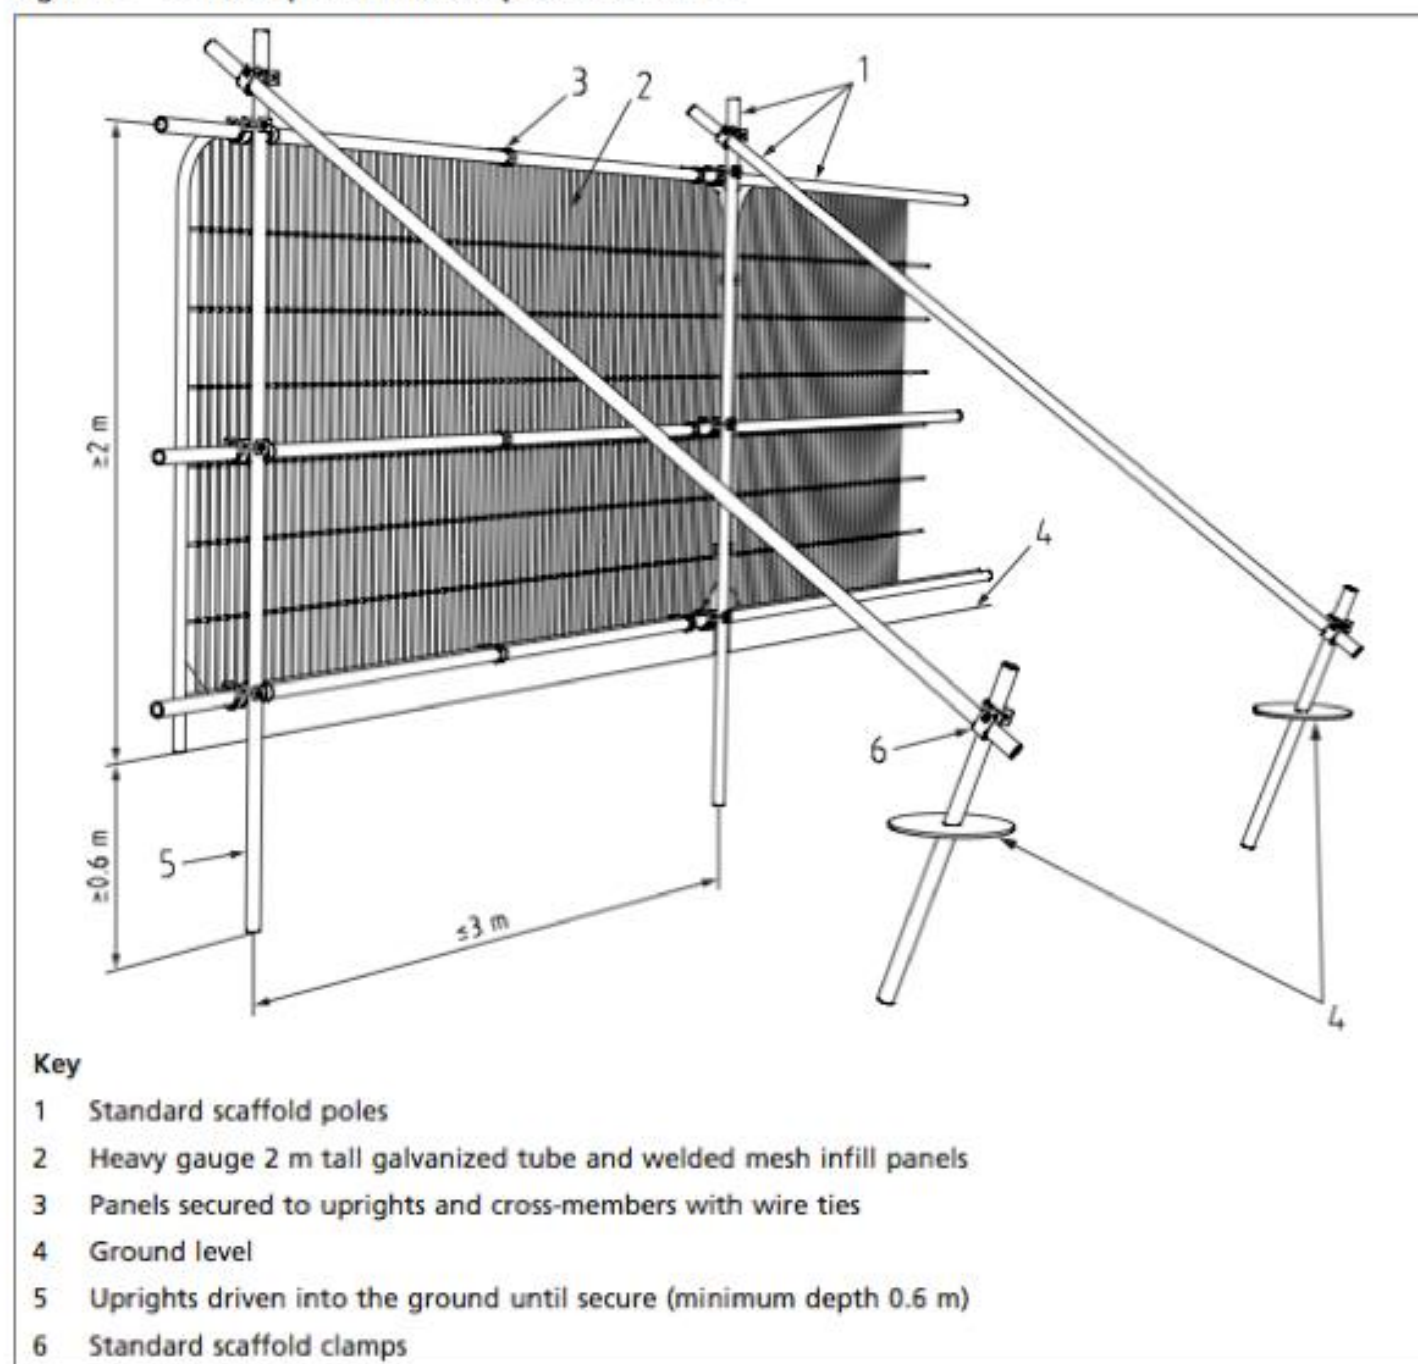
Figure 4 BS5837: 2012 default specification for barriers type

6.2.2 The barriers shall be minimum of 2m high with vertical and horizontal scaffold frameworks. The vertical tubes should be spaced at least 3 m interval and driven securely into the ground. The welded mesh should be securely fixed on the framework. (Figure 4)

6.2.1 Tree protection barriers location is indicated in the Tree Protection Plan (TPP). The barriers must be clearly marked by all-weather signs “Keep Out”(Figure 5) (Figure 4 and Figure 5 BS5837: 2012 default specification for barriers type).
