## **Phase I DESK TOP STUDY REPORT**

**38-42 Vincam Close,  
Whitton,  
TW2 7AB**

**August 2021  
Report No. 16925**

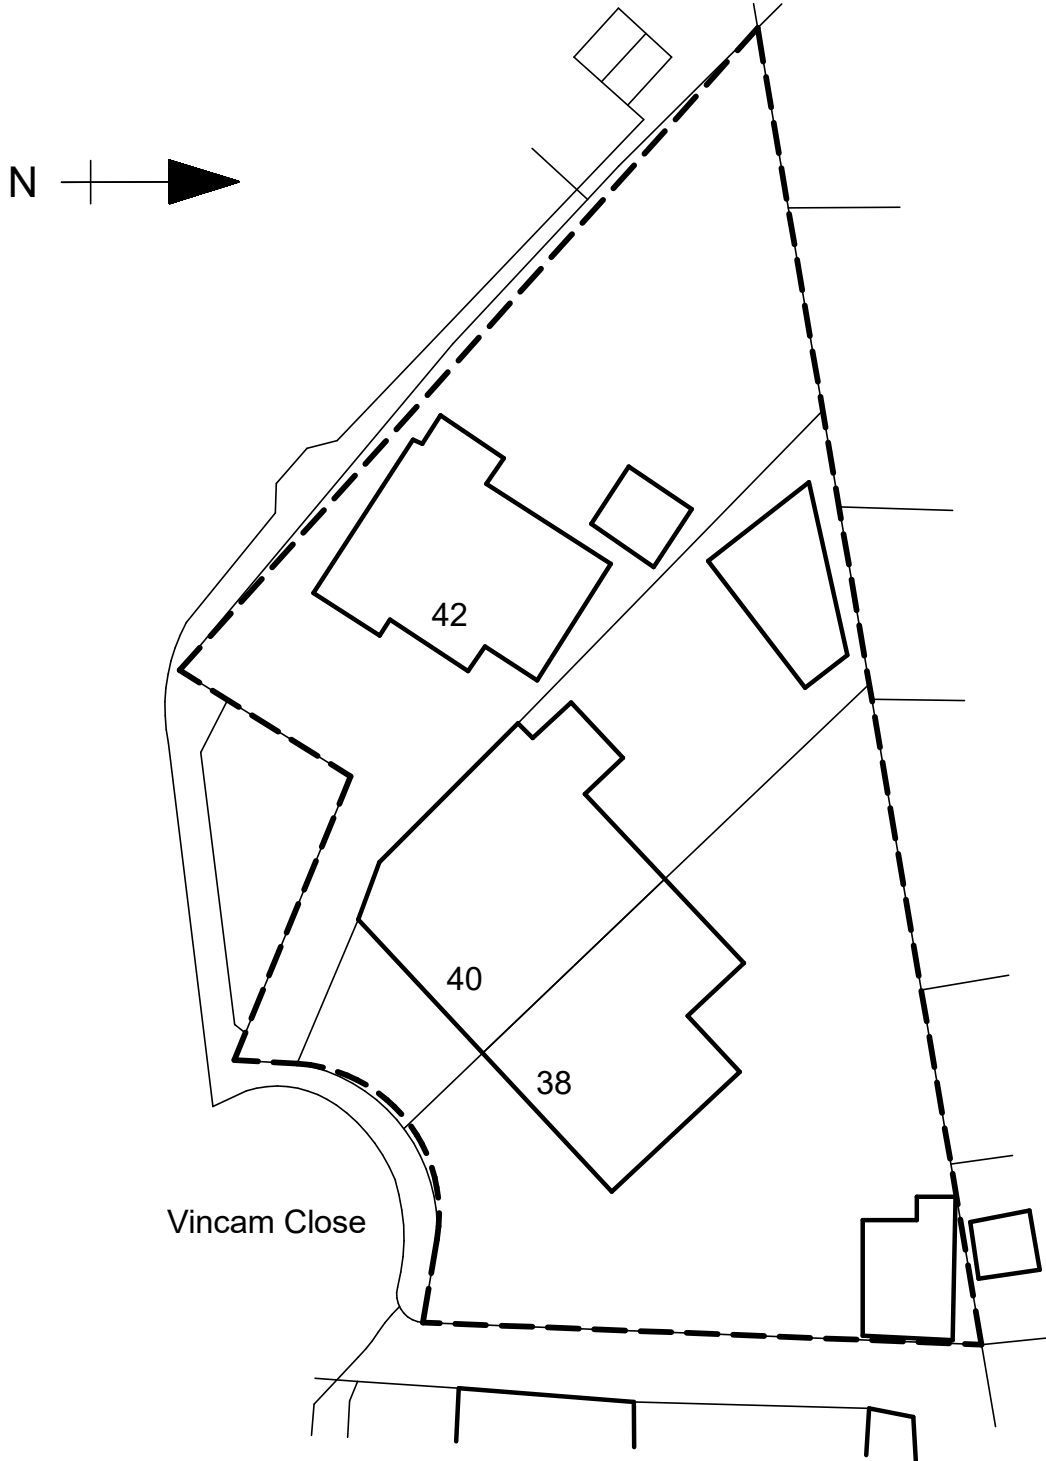
Not to Scale  
Sketch No. : DTS / 16925 / 02 / 02

Existing Site Plan
