Star Land Realty UK Limited c/o LS Estates Limited

Former Barnes Hospital (Plot A), South Worple Way, SW14 8SU

Geo-environmental and Geotechnical Site Assessment

1920884 R01 (03)

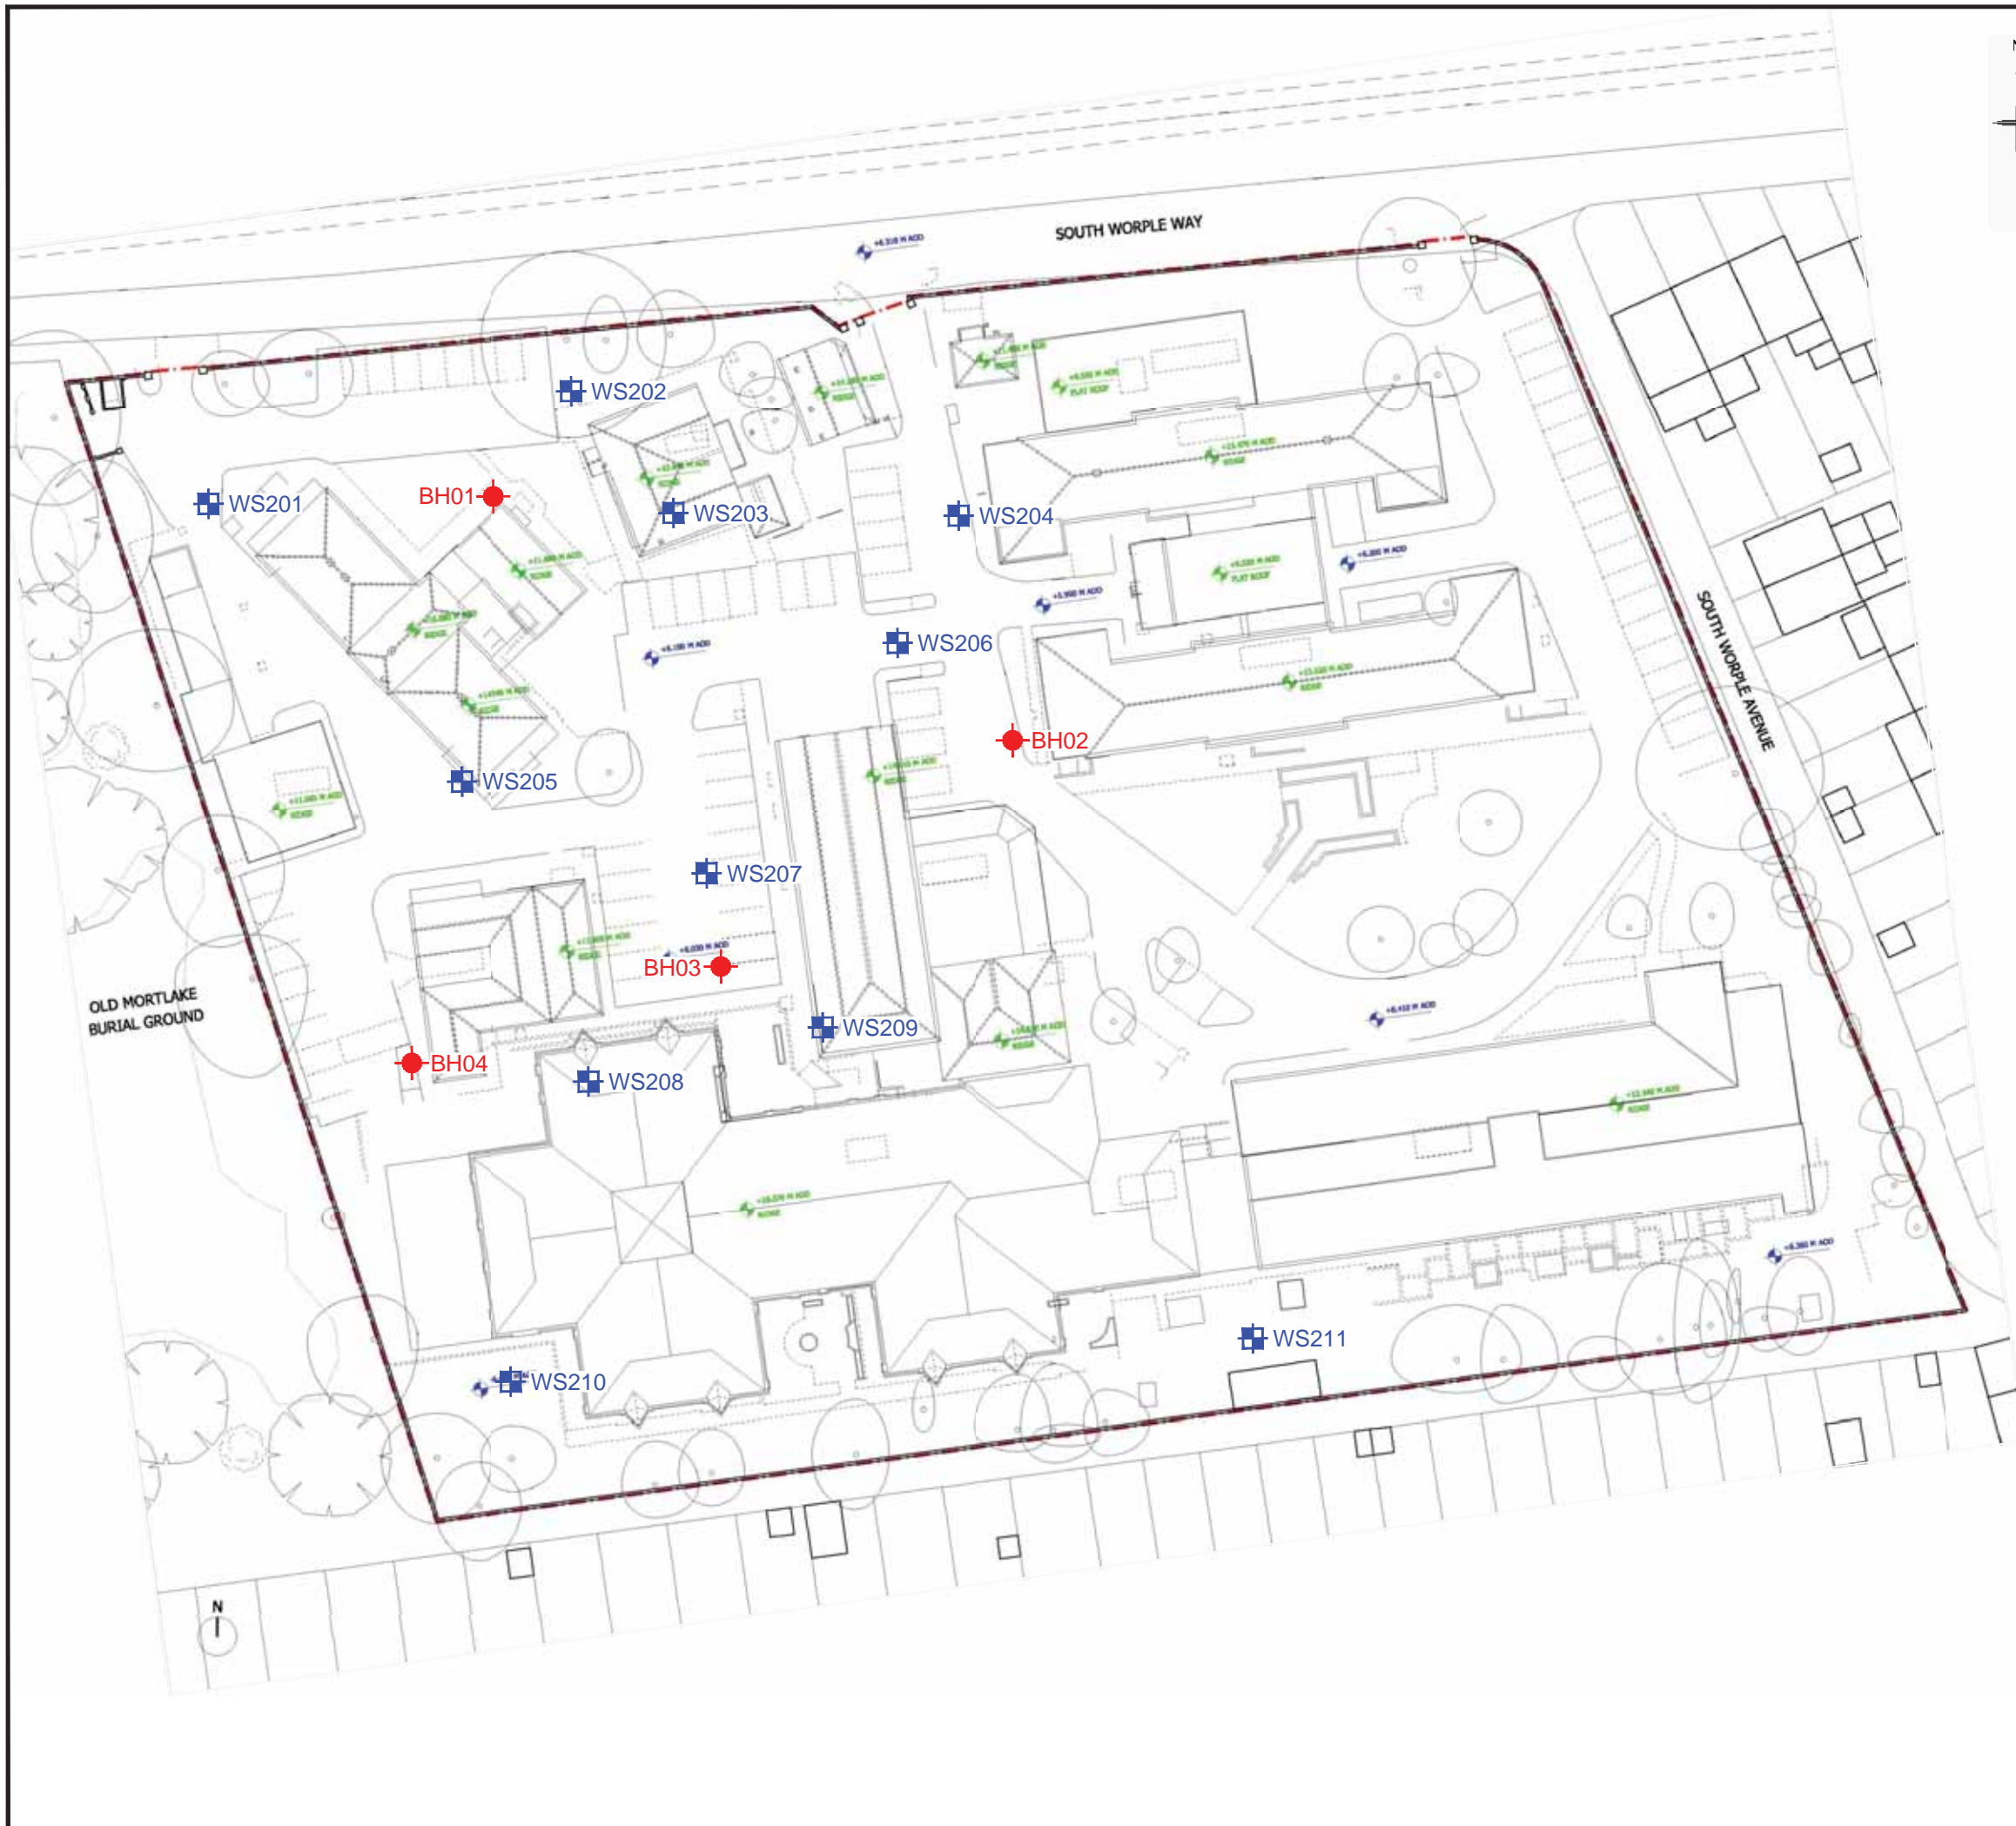
- - - Site Boundary
- Borehole Location
- Window Sample Location

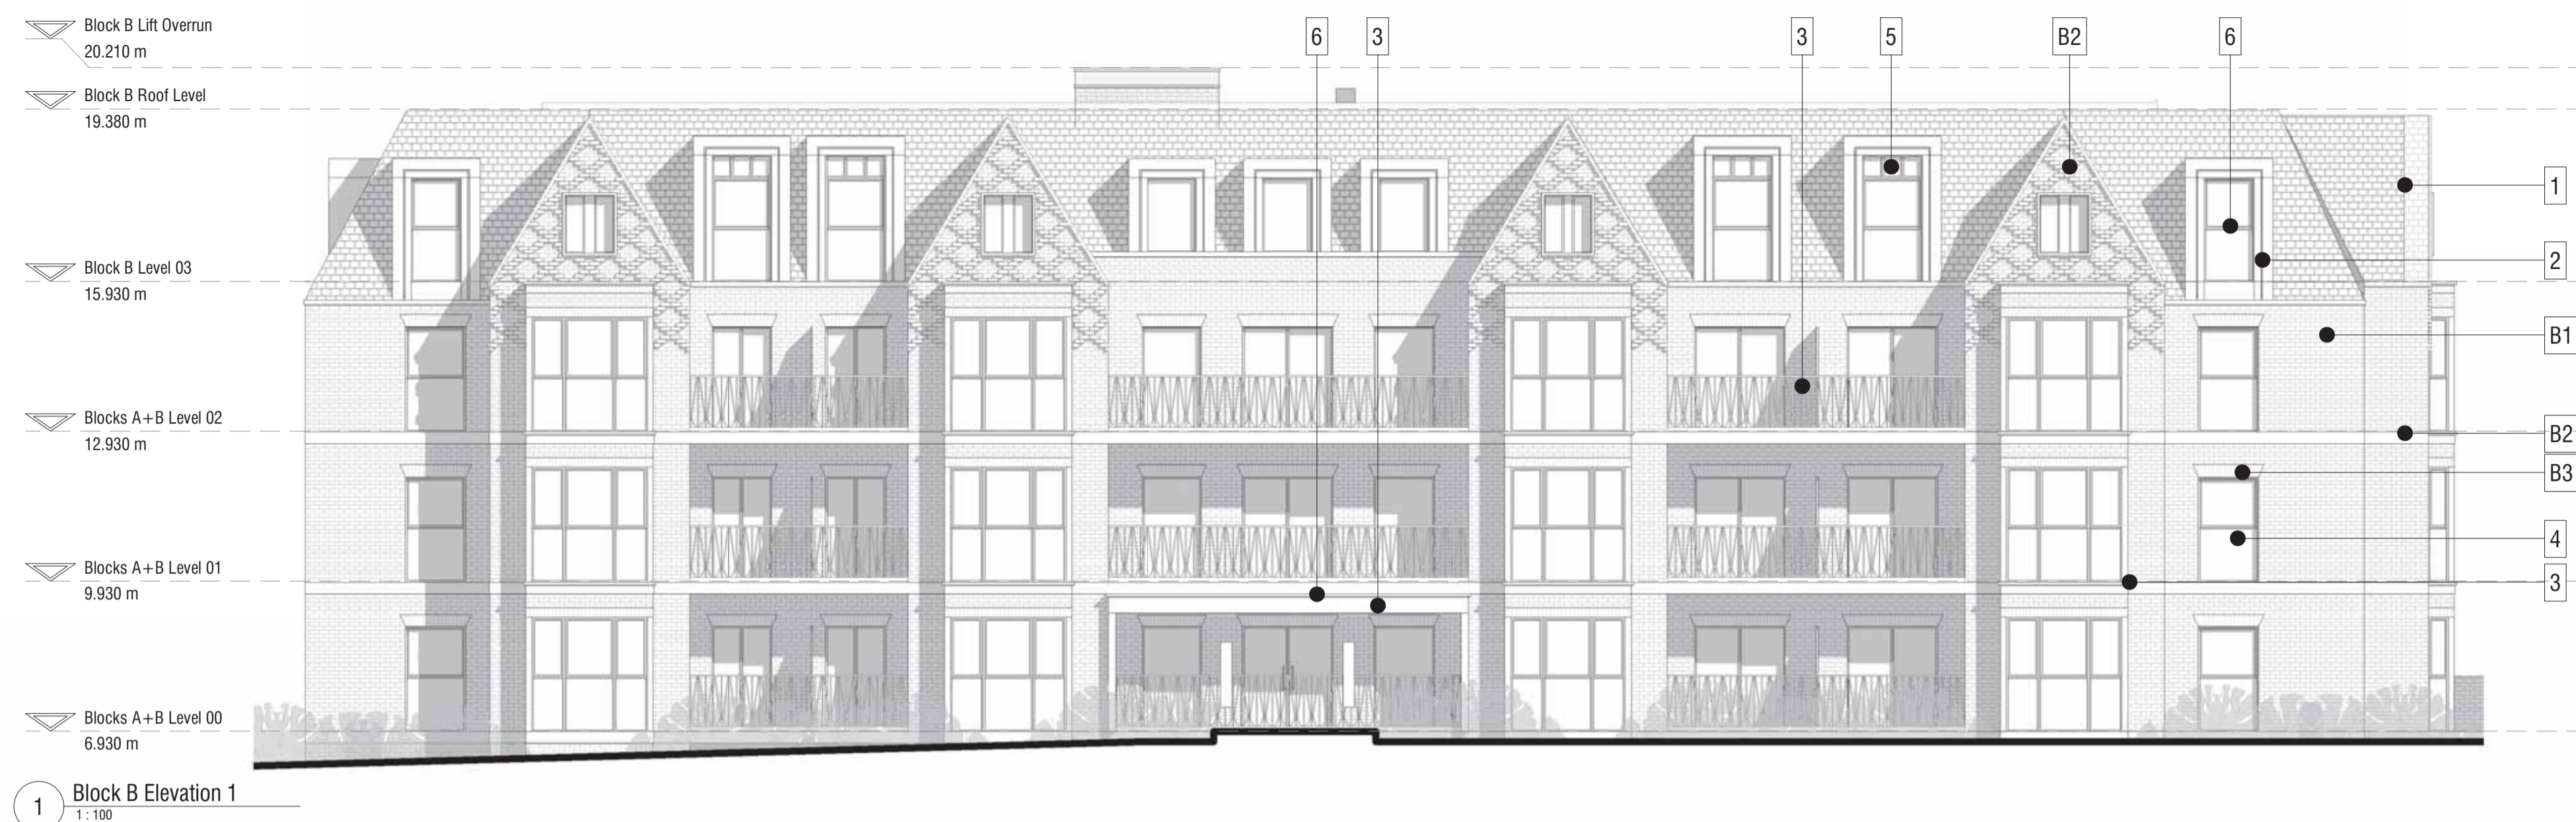
- Common Materials
- 1. Natural slate roof tiles
 - 2. Zinc cladding
 - 3. Brown-toned metalwork
 - 4. Clear laminated glass
 - 5. Grey backpainted glass panels
 - 6. Black grey window frames

- Block B Brickwork
- B1. Main brick
 - B2. Lighter Accent Brick
 - B3. Darker Accent Brick
