Barnes Hospital

Basement Impact Assessment Report

RBG Project No.:
4427

Document No.:
4427-RBG-ZZ-XX-RP-ST-00002

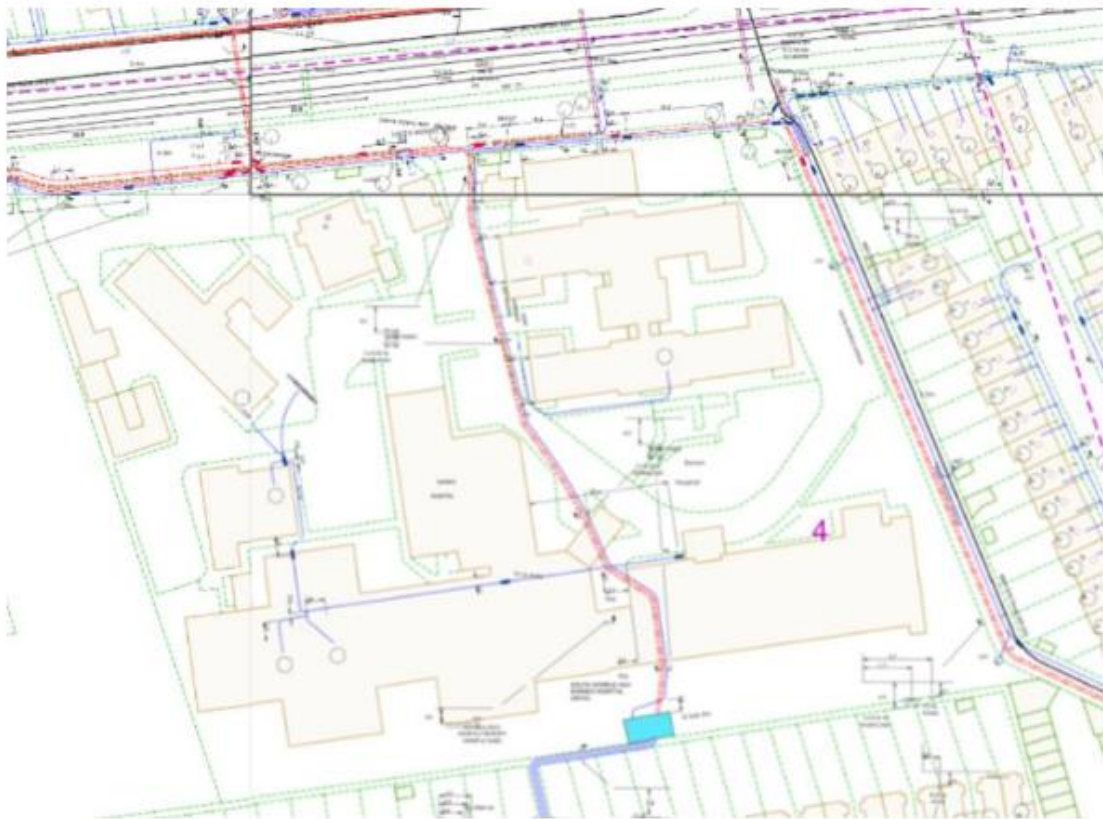
Figure 2-2: UKPN Utilities around the site

Services, including electric, gas, telecom and water, are present beneath the site according to various utility surveys. An electrical substation is located south of the site, as shown in Figure 2-2. Gas and Openreach utilities are presented in Figure 2-3 and Figure 2-4, respectively. The existing drainage on site is depicted in Figure 2-5.

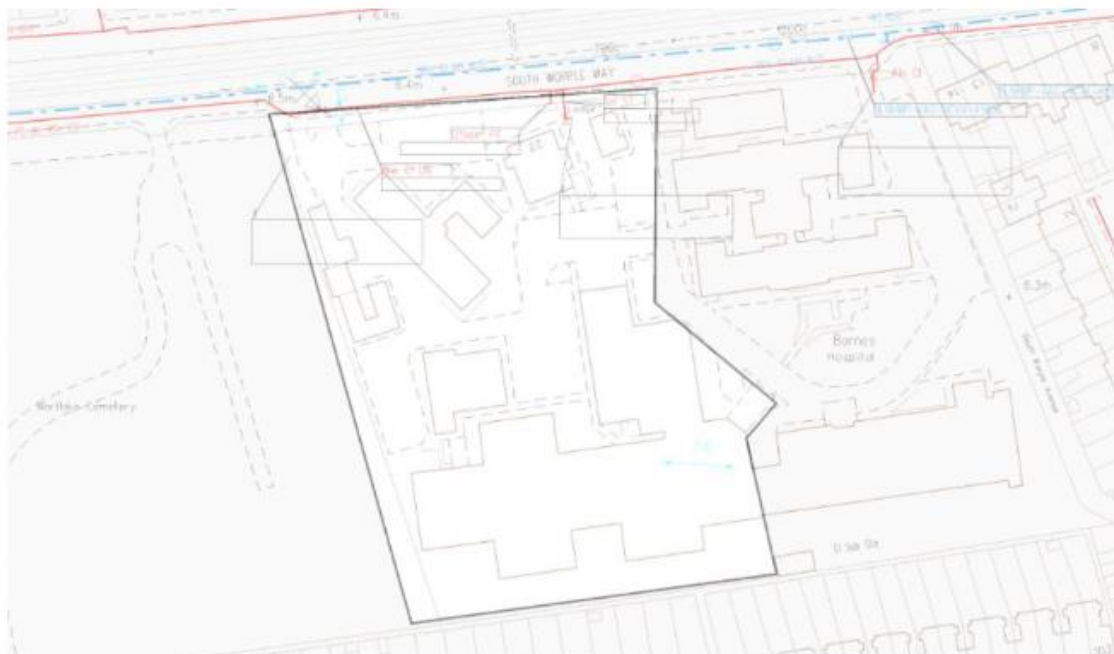
Figure 2-3: Gas main utilities around the site (in dotted gray lines)

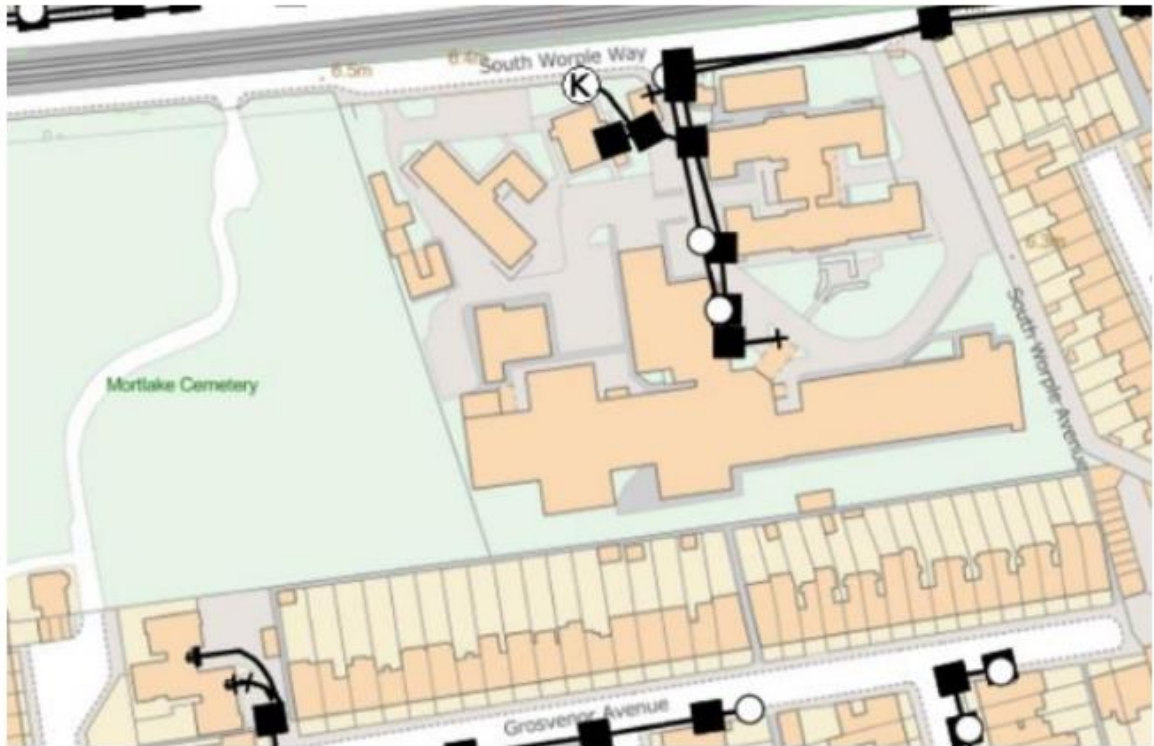
Figure 2-4: Openreach utilities on site (in black)

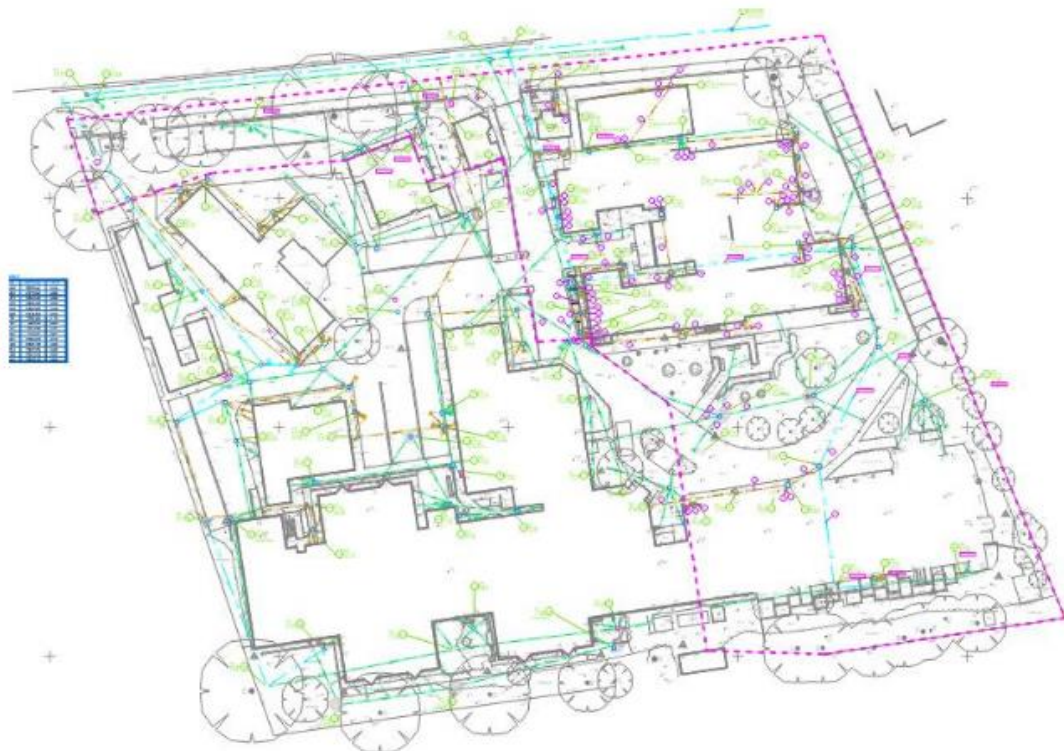
Figure 2-5: Existing drainage on site (in purple)

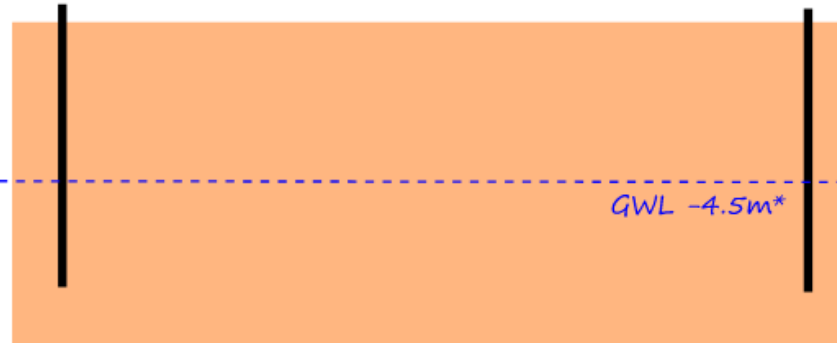
Stage 1: Install wells and dewater construction site

*i.e. 4.5m bgl - level taken as >0.5m below foundation level (TBC)

1. Install groundwater wells around the perimeter of the excavation footprint;
2. Reduce the groundwater level below foundation level;
3. Install temporary sheet piles where applicable;
4. Excavate to foundation level at the basement footprint by use of an open cut excavation method with a battered wall or sheet pile wall depending on the site constraints;
5. Construct the pad and strip footings onto the soil;
6. Construct the entire basement which includes the basement slab spanning onto the pad and strip footings, the RC retaining walls and the RC transfer slab at ground floor level;
7. Backfill of the soil to the proposed ground level;
8. Construct the superstructure;
9. Remove the wells, the groundwater will rise to its initial level.

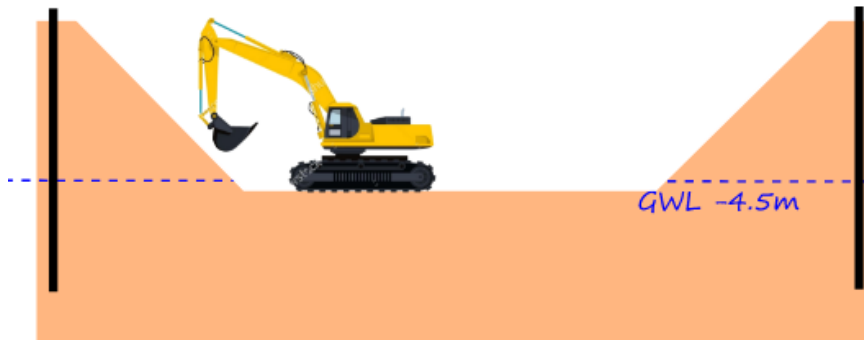
Stage 2: Open cut excavation with batter
