Hammersmith Bridge–Listed Building Consent for Pedestal Stabilisation

Design, Access and Heritage Statement

6 January 2022

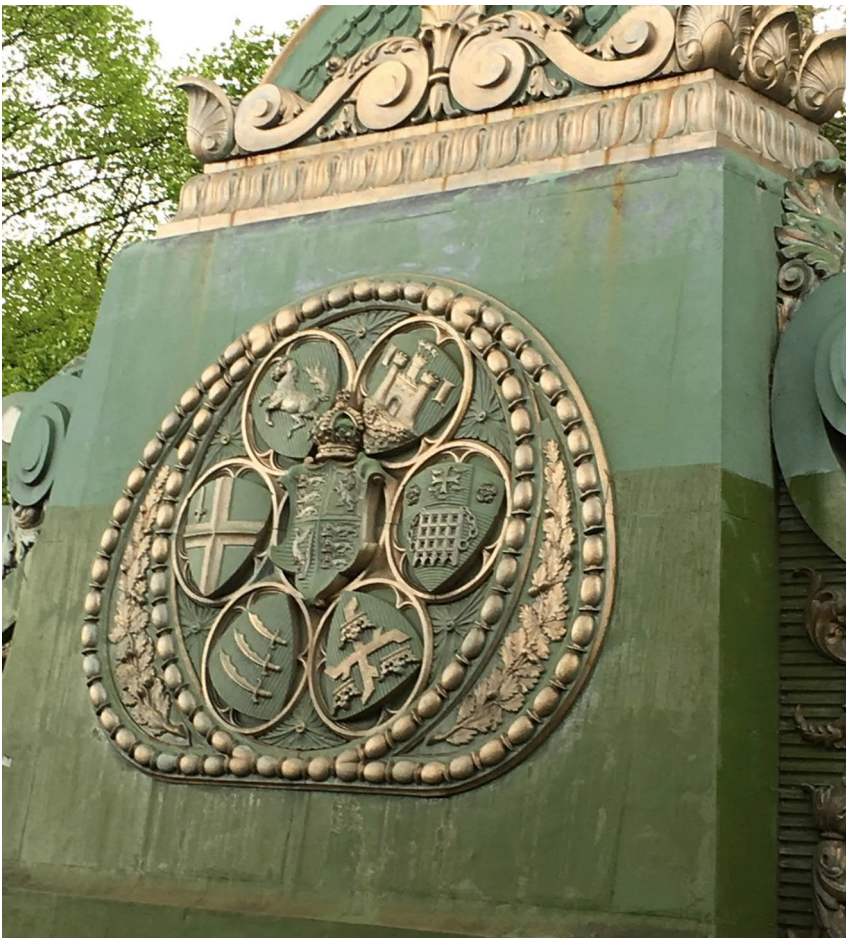
Figure 2.3: Image of the coats of arms

The bridge is recorded as currently being painted in the original colour envisaged by Bazalgette. Each of the saddle casings display the seal of the Metropolitan Board of Works which is made up from the following coats of arms: the Royal House, Kent, Guildford, Westminster, Colchester, Middlesex, the City of London, details of which are included within Drawing No: HC/209/C/40 in Section 6. (Hailstone, 1987)

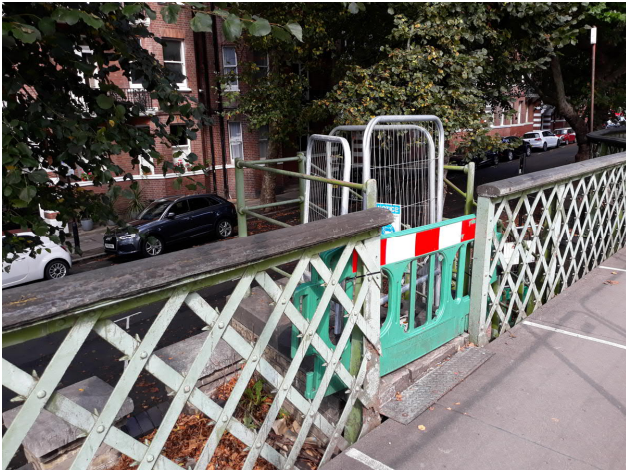
There is already an opening in the parapet at the north-west end to allow pedestrians to access the bridge from the road below via a staircase. Although this would allow a diversion route past the north-west pedestal works without having to remove any of the parapet members, it would not be accessible to cyclists or people with mobility impairments, and is thus not a viable option.

Photo 3.1: Existing opening in parapet for access staircase at the north-west end

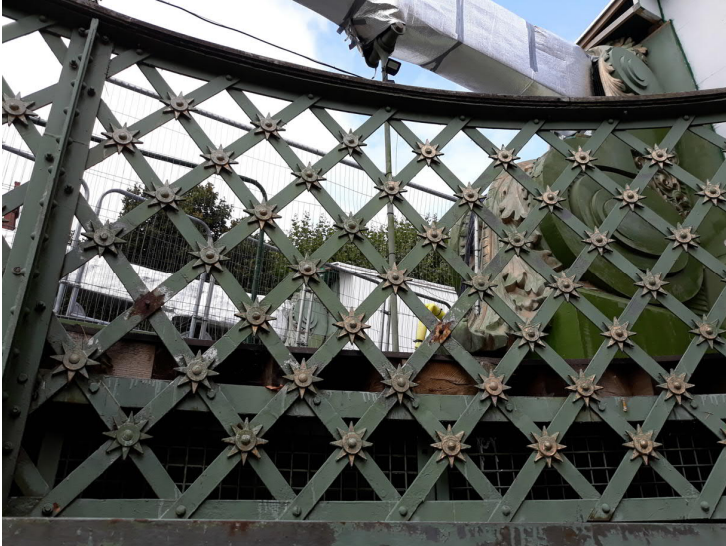
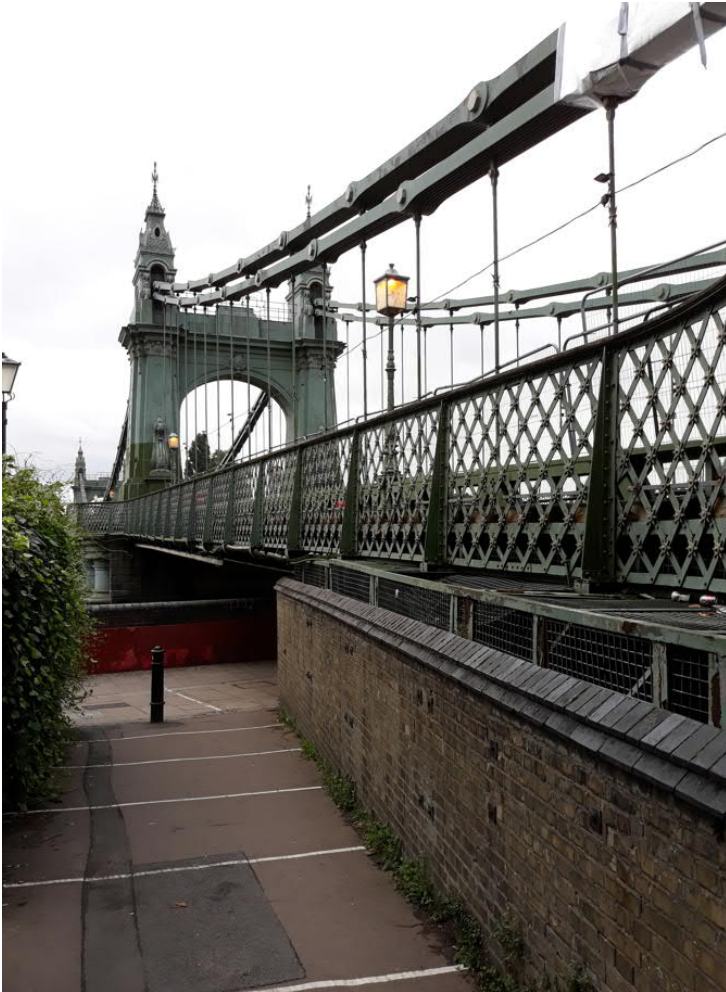
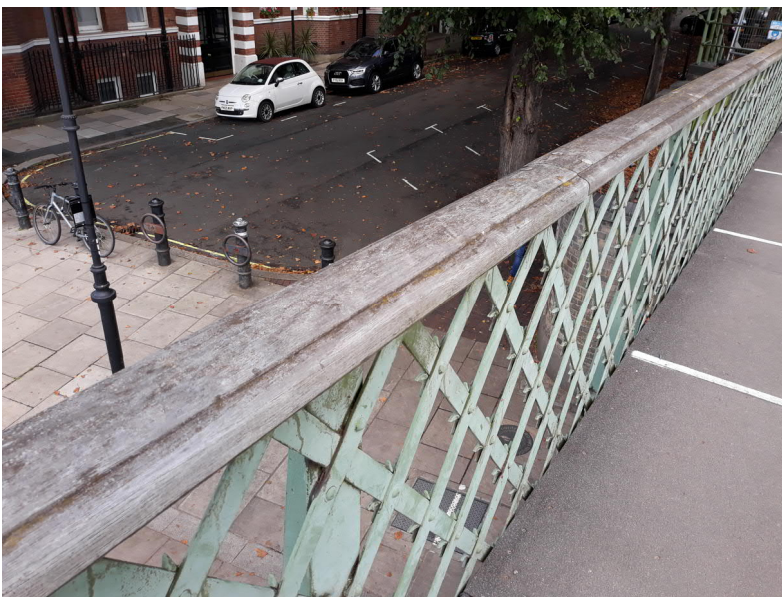
Some photographs and record drawings of the existing parapets are shown below. As can be seen on these images, the original parapet consists of metal flat bars joined together by riveting. The handrail consists of teak; the joints in this handrail generally do not coincide with the vertical cast iron members on the parapet.

Photo 3.2: Typical parapet near north-east pedestal, viewed from adjacent ramp

Photo 3.3: Typical parapet adjacent to ramp at north-east end

Photo 3.4: Typical parapet near north-west pedestal, viewed from bridge footway

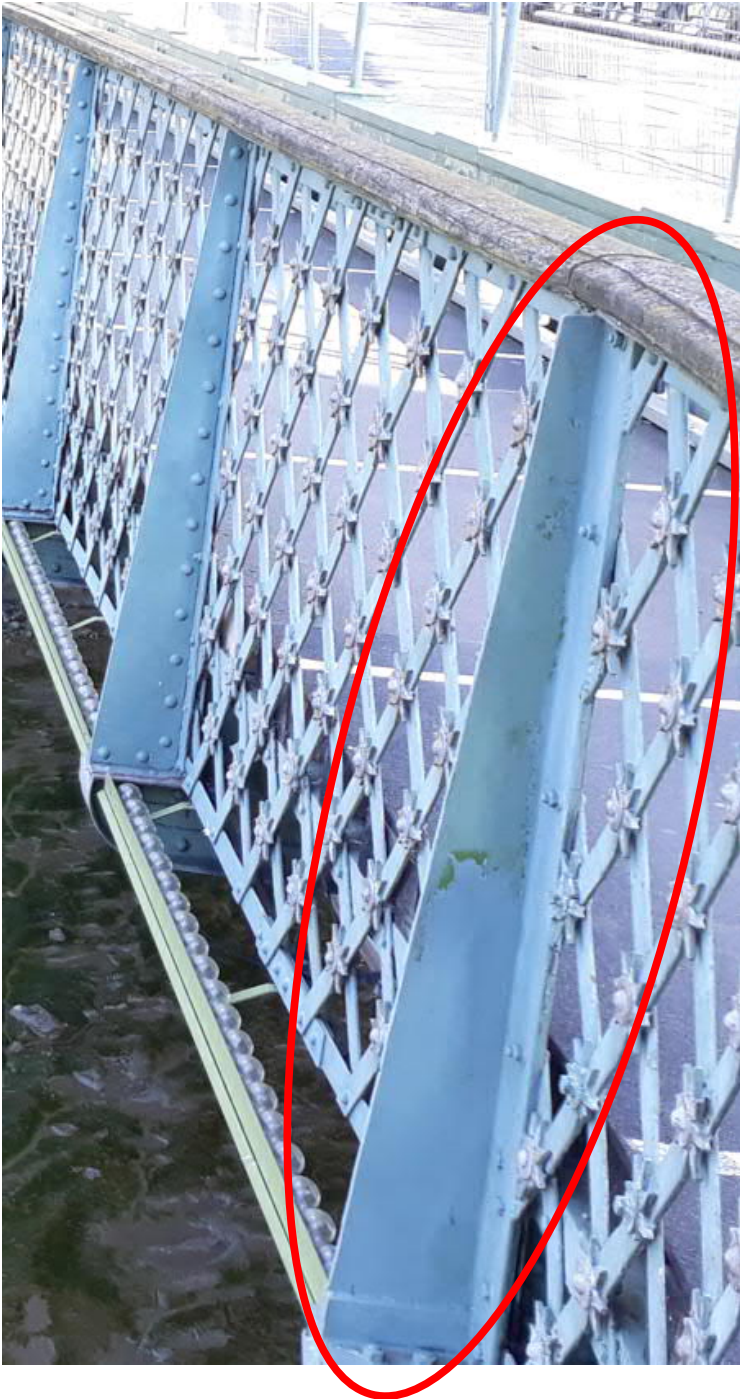
However, closer to the towers, there are signs that sections of the original parapet have been removed in the past, possibly as part of the temporary footway interventions carried out in 1977. Photo 3.5 shows the original riveted vertical members on the left, and a newer, bolted T-section vertical member on the right; the newer member makes use of dome-headed bolts instead of rivets, and some of the diagonal members have been butt-welded to this vertical member as well.

Photo 3.5: Replacement parapet vertical member from previous interventions (west side of the bridge, near the Hammersmith end tower)

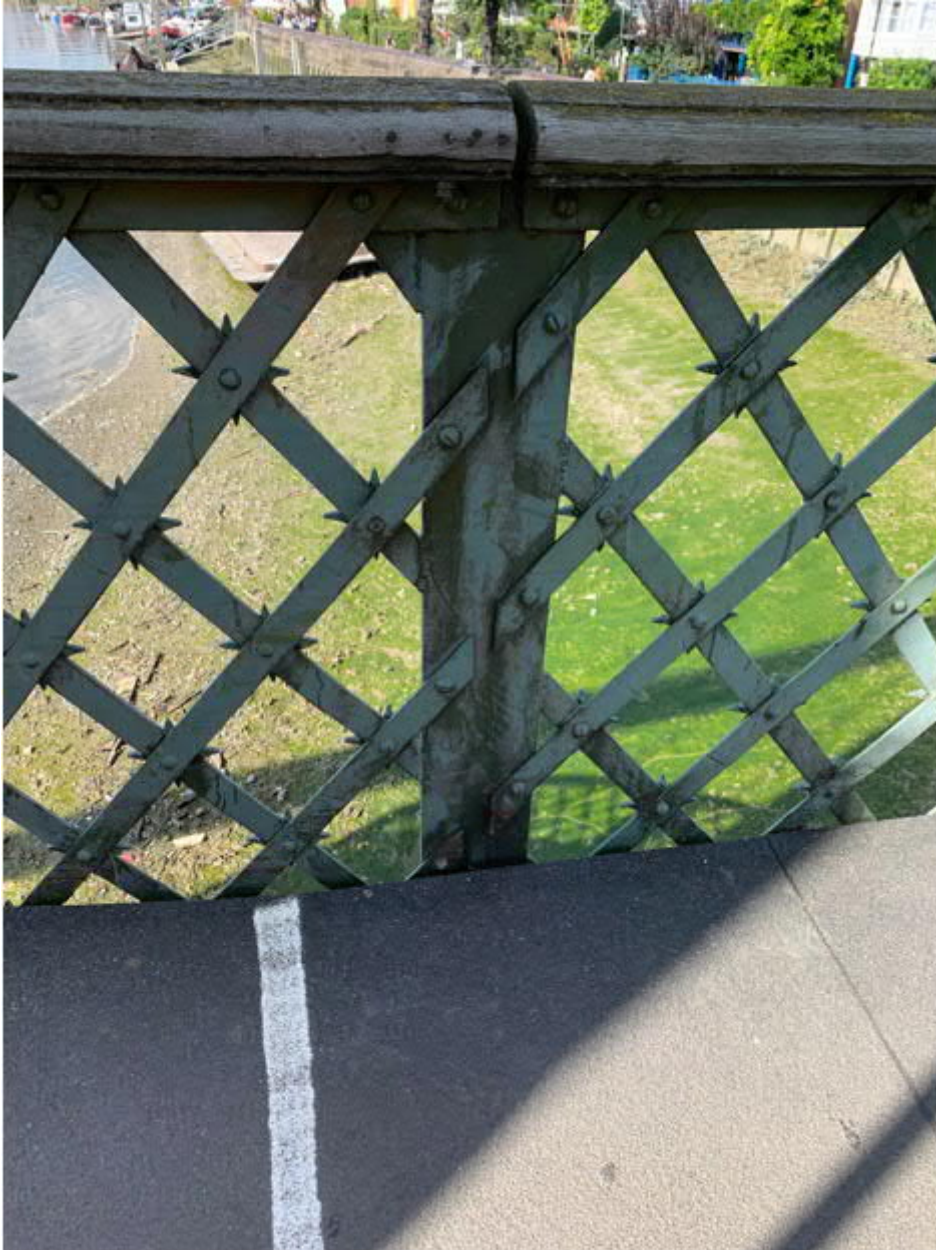
Photo 3.6 shows the footway side of the length of parapet shown in Photo 3.5 – the diagonal members were cut at the location of the original vertical member and then reinstated by bolting them onto the replacement vertical member.

Photo 3.6: Evidence of previous cutting of parapet diagonal members

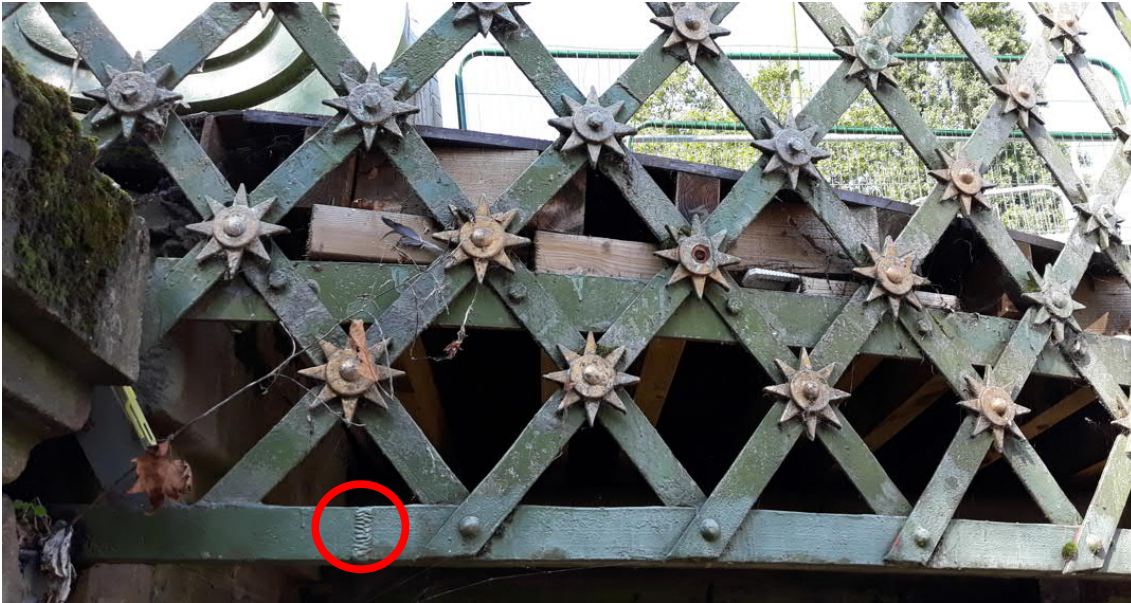
There are also signs of the bottom horizontal member on the east side of the bridge near the Barnes end abutment having previously been cut and welded back together, as shown on Photo 3.7.

Photo 3.7: Signs of previous cutting and welding of parapet bottom horizontal member (east side of the bridge, near Barnes end abutment)

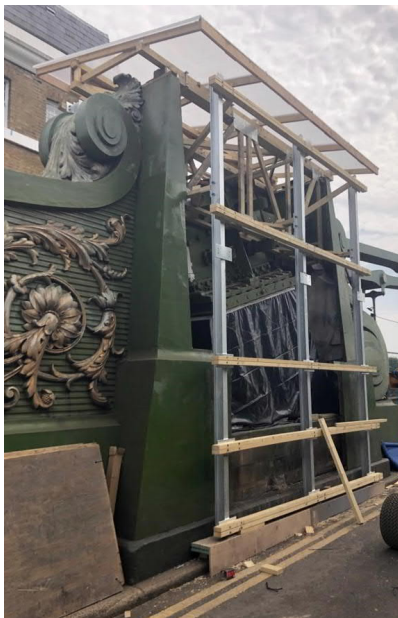
Figure 3.13: Panels removed as described in the 2019 Listed Building Consent application

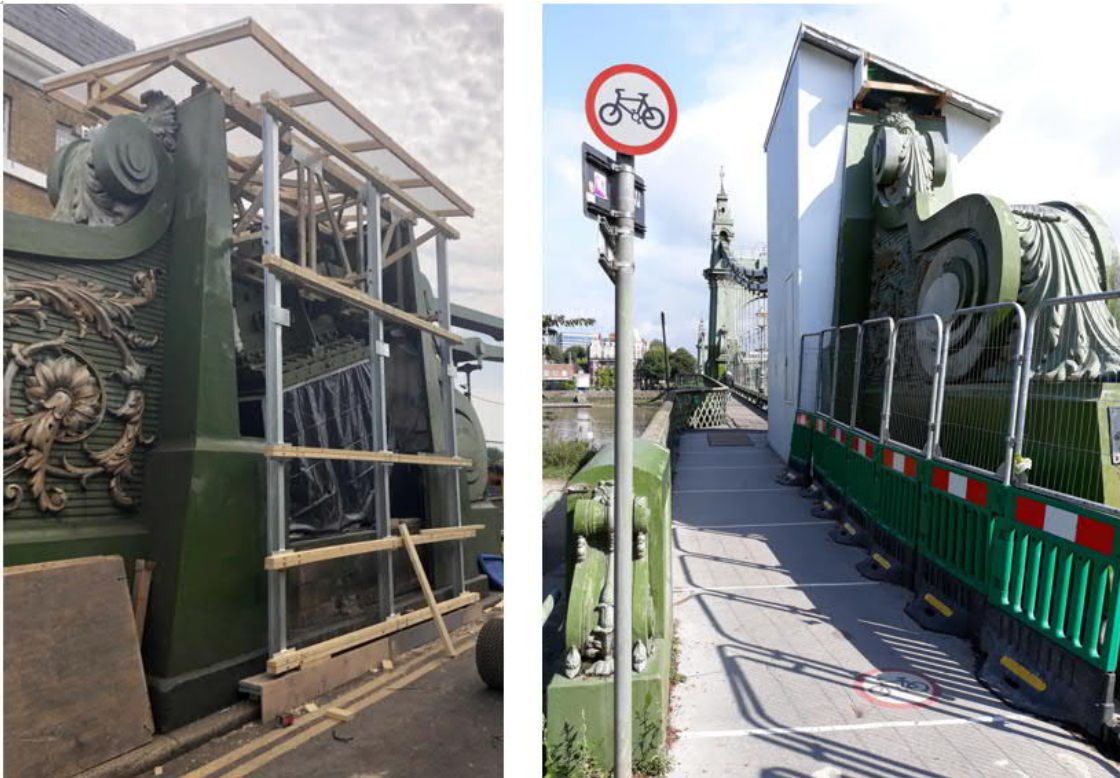
Photo 3.9: Current hoarding around pedestals

The proposed new temporary hoarding will be no taller than the current hoarding. The hoarding will be weatherproof, and will remain in place to provide protection to the historic fabric until the original deviation chamber panels are reinstated as part of the future planned major refurbishment works.

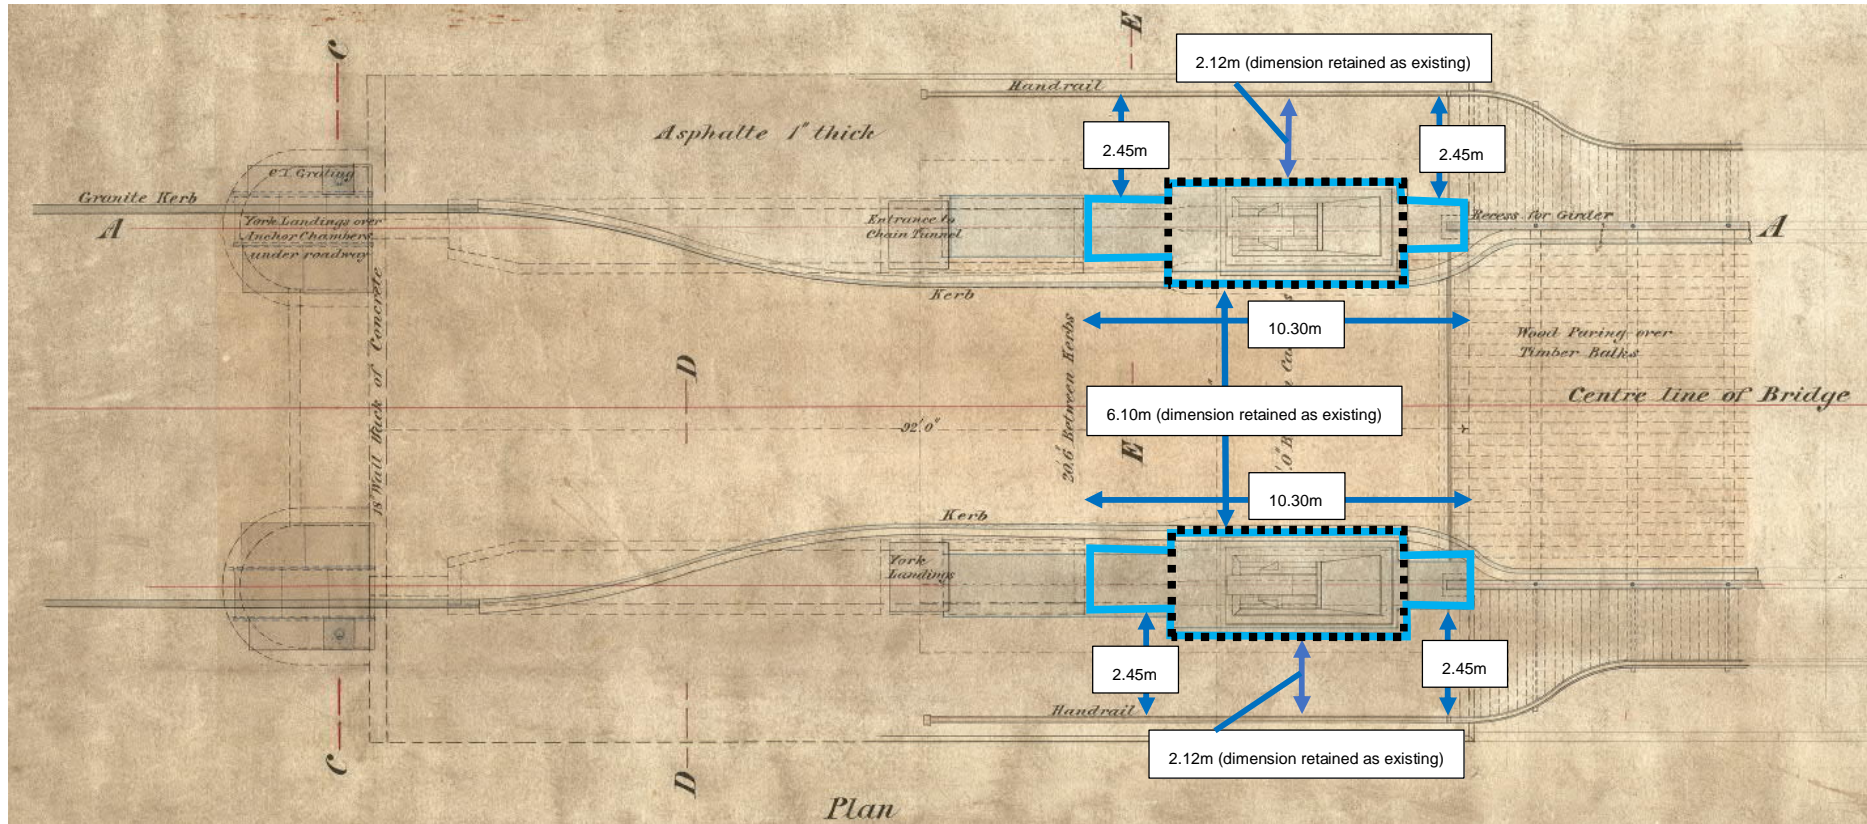
Figure 3.15: Indicative plan view of current temporary hoarding (shown in black, dashed) and proposed temporary hoarding after permanent intervention works are complete (shown in blue), with key outline dimensions highlighted [Barnes end shown; Hammersmith end same but handed]
