DESK STUDY, GROUND INVESTIGATION & BASEMENT IMPACT ASSESSMENT REPORT

ELLERAY HALL & NORTH LANE DEPOT/EAST CAR PARK
TEDDINGTON, TW11

Report Title: Desk Study, Ground Investigation & Basement Impact Assessment for Elleray Hall & North Lane Depot/East Car Park, Teddington

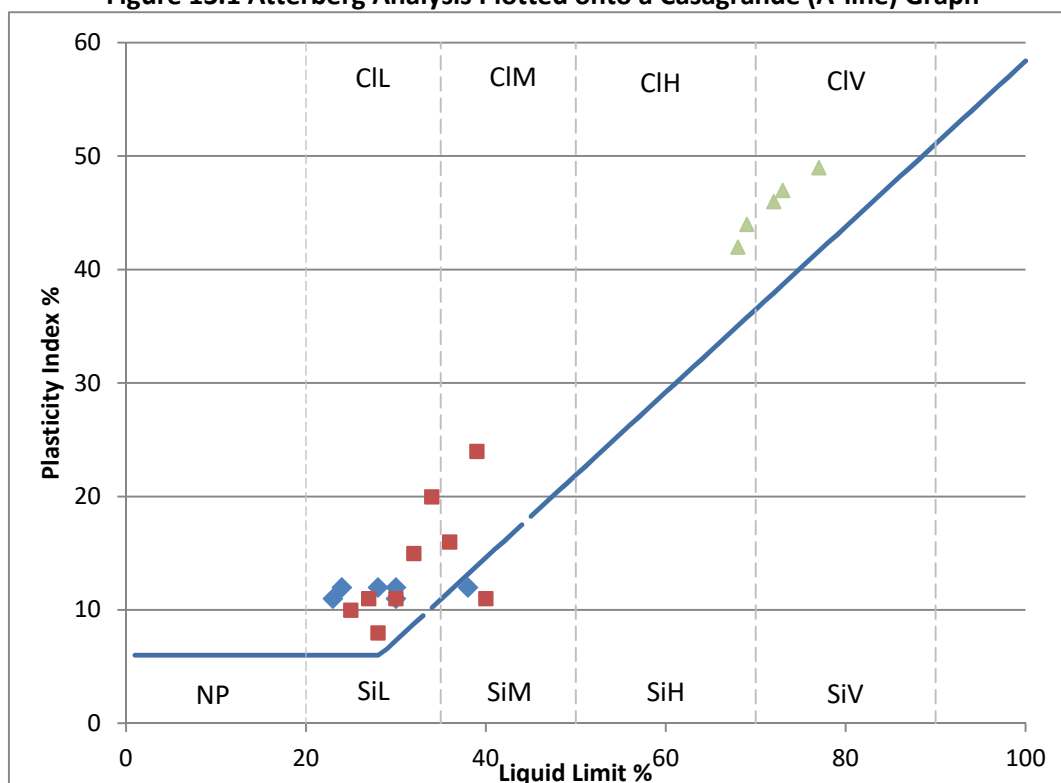
Figure 13.1 Atterberg Analysis Plotted onto a Casagrande (A-line) Graph

13.5.4 Due to the range of values determined for the Atterberg limit results they have been plotted onto a Casagrande A-Line graph.

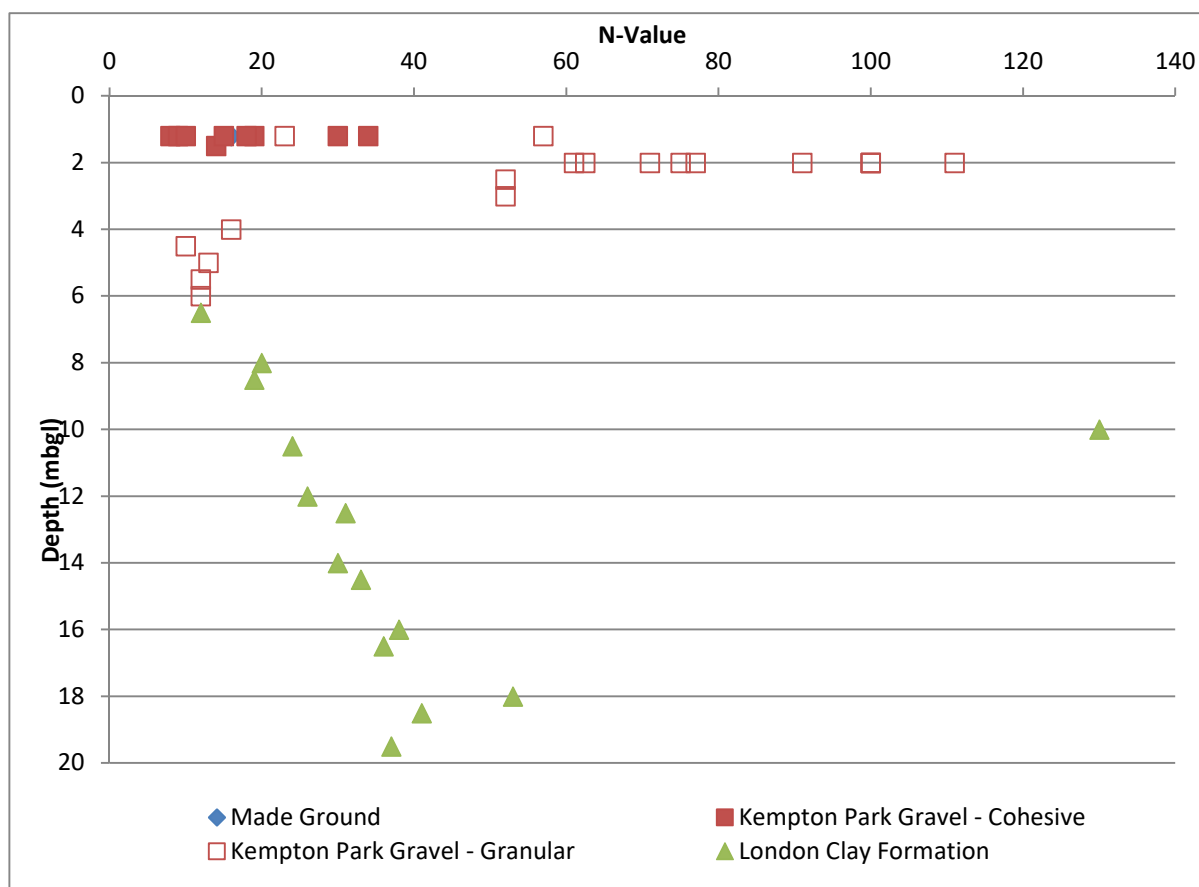
Figure 13.2: SPT ‘N’ Value v Depth

13.6.1 Standard Penetration Tests were undertaken at regular intervals throughout the window sampler holes and cable percussive boreholes. The results of the SPTs are plotted against depth in Figure 13.2 below.

13.6.3 N_{equi} results have been calculated where the full 300mm of penetration could not be achieved for 50 or more blows.

13.6.4 The results are broadly consistent between the two sites, as would be expected between two plots in close proximity with very similar geology. The N-values increase sharply within the granular superficial deposits, before dropping within the London Clay Formation where they start to increase with depth.

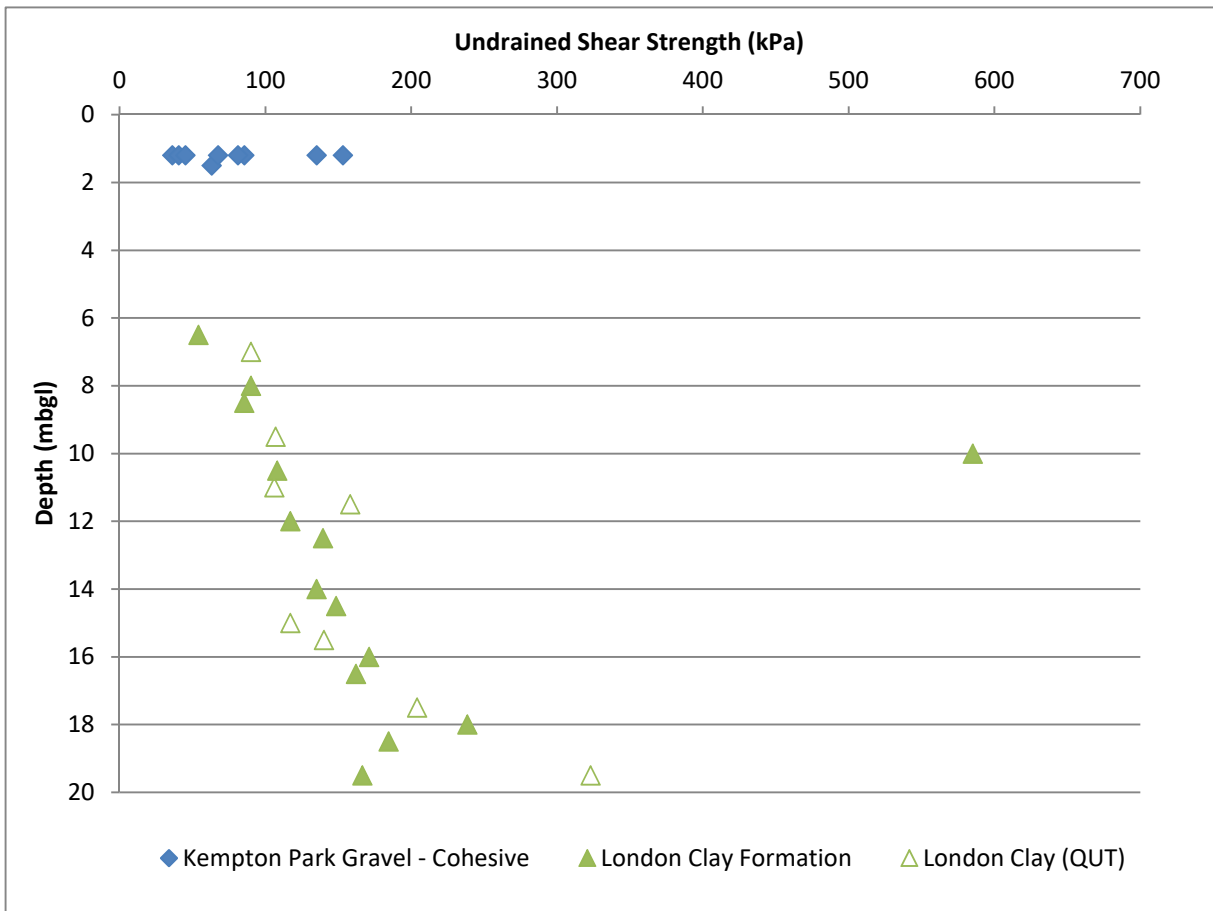
Figure 13.3: Undrained Shear Strength v Depth

13.7.3 The graph below shows the shear strength profile of the London Clay Formation encountered at the site, based on the SPT to shear strength correlation described above, as well as the results of undrained triaxial tests on undisturbed samples taken from the boreholes.

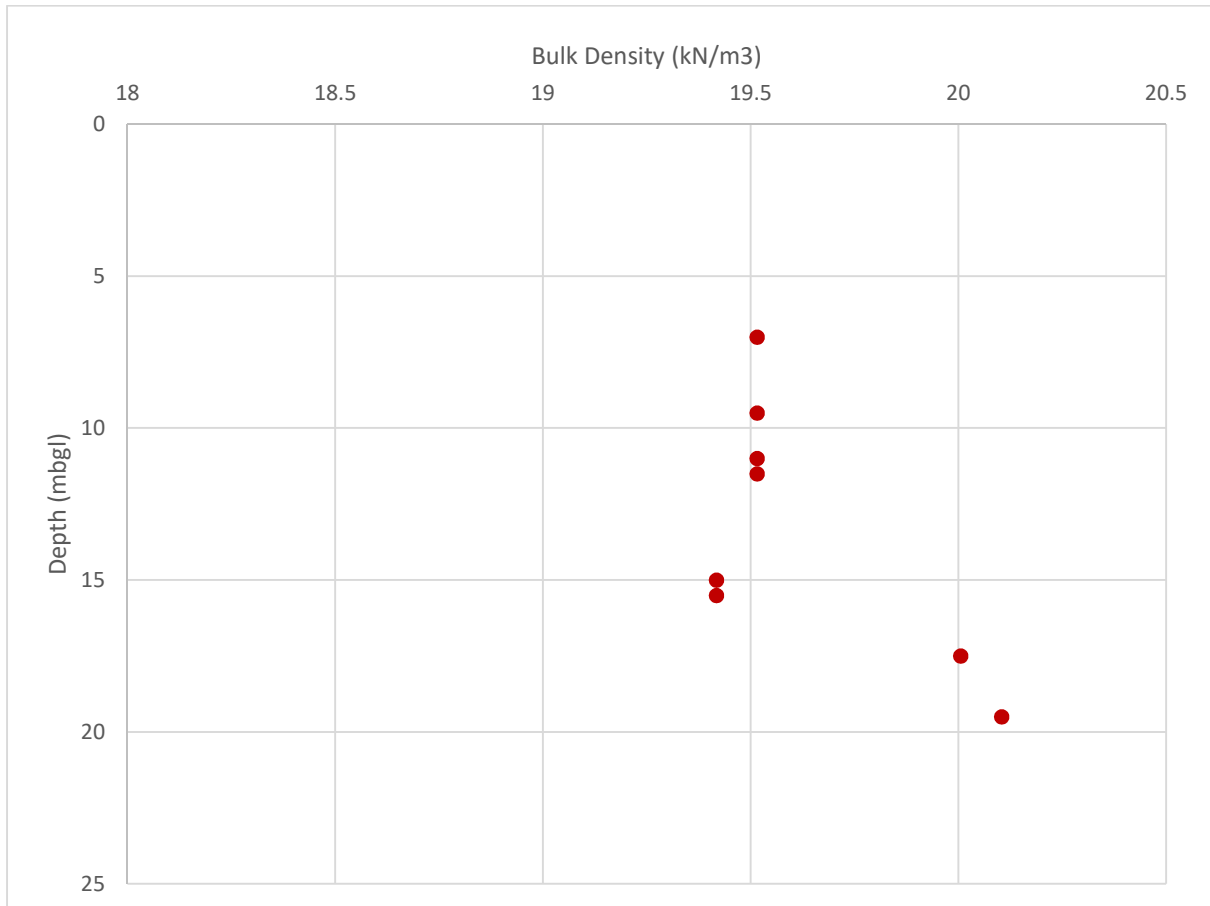
Figure 13.4: Bulk Density of London Clay v Depth

13.8.1 In order to calculate the undrained shear strength of undisturbed sample of London Clay, using the quick undrained triaxial methodology, the bulk density of the materials has to be calculated. These values are provided on the quick undrained triaxial testing certificates in the Concept Factual Report. These results are summarised in the figure below.

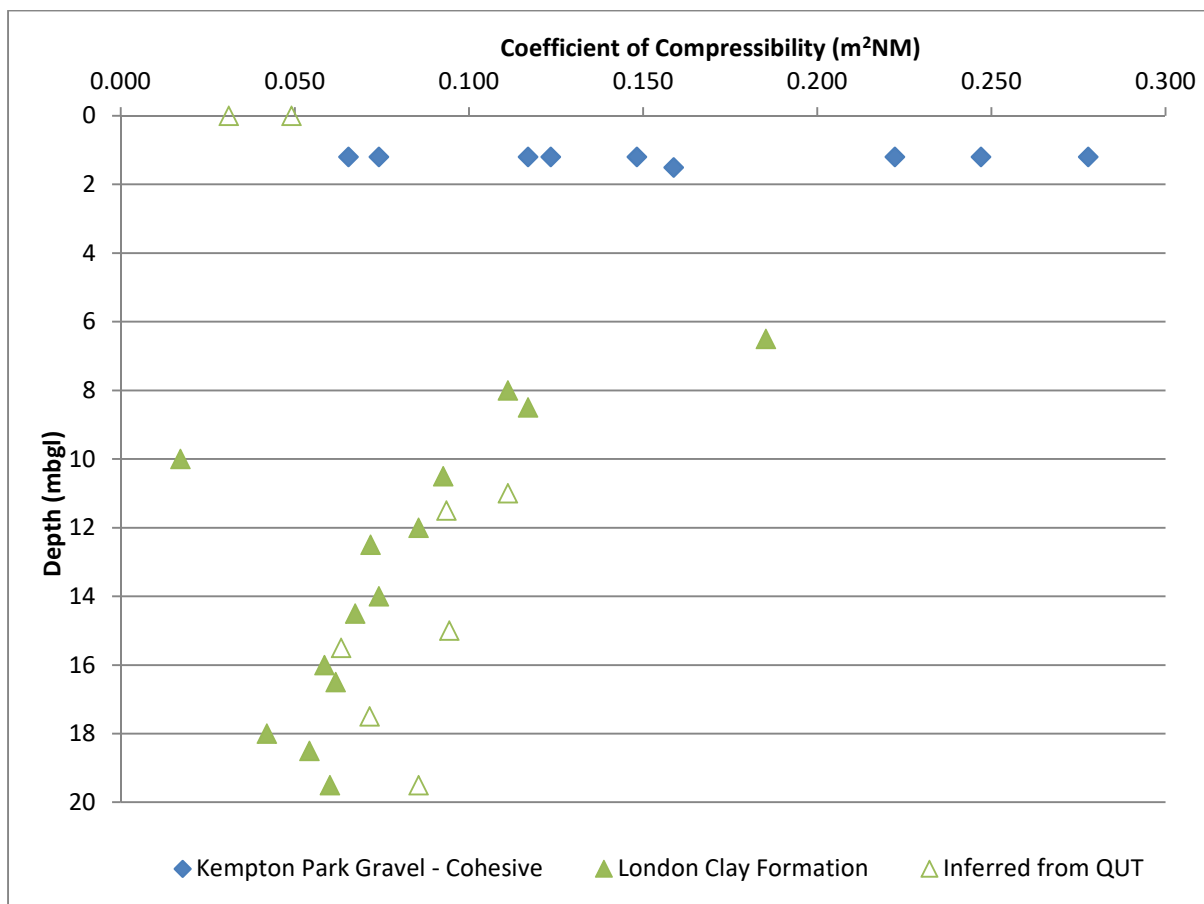
Figure 13.5: Coefficient of Volume Compressibility (m_v) v Depth

13.9.3 Where the undrained shear strength of the clays was obtained using the quick undrained triaxial methodology, the m_v value has been obtained by rearranging the equations for f_1 and f_2 and substituting in the measured undrained shear strength. These are plotted against depth below in Figure 13.5.

13.9.4 As would be expected, the results reduce with depth as the clay increases in strength and the over burden increases, reducing the potential for compressibility.

13.9.5 The results from of the London Clay are generally of “low compressibility” with some near surface clays of “medium compressibility”. This is due to the lack of overburden pressure at shallow depth allowing the clays to relax and so compress slightly when loaded.
