APPENDIX 6 – UXO ASSESSMENT

DETAILED UNEXPLODED ORDNANCE (UXO) RISK ASSESSMENT

Elleray Hall & North Lane Depot, Teddington TW11
And
East Car Park, Teddington TW11

This report has been produced by Primely on behalf of JOMAS

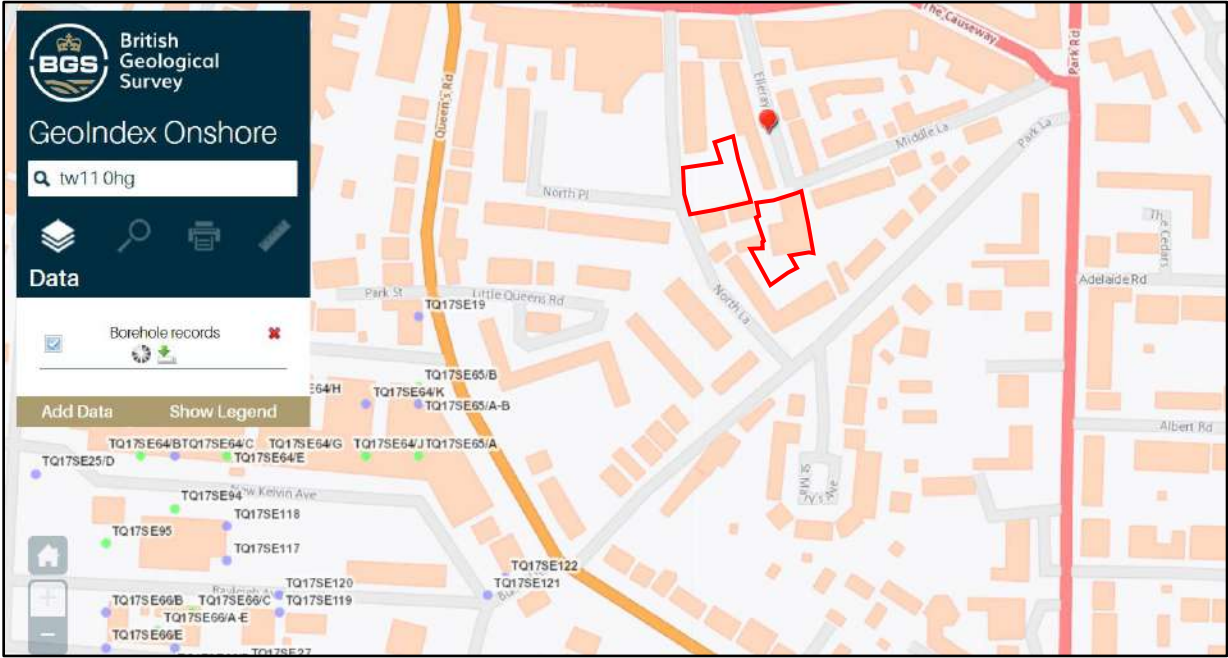
Figure 2.4: Historical borehole records (Source: BGS Web Service)

The British Geological Survey Geology of Britain web map services provides access to the geographic locations and logs of historical borehole investigations and well installations located nearby, to the north and east of the site (See figure 2.4 below).

Table 2.4.1 below displays the strata succession encountered in the boreholes (See appendix for full log). No boreholes were found closer to the site.

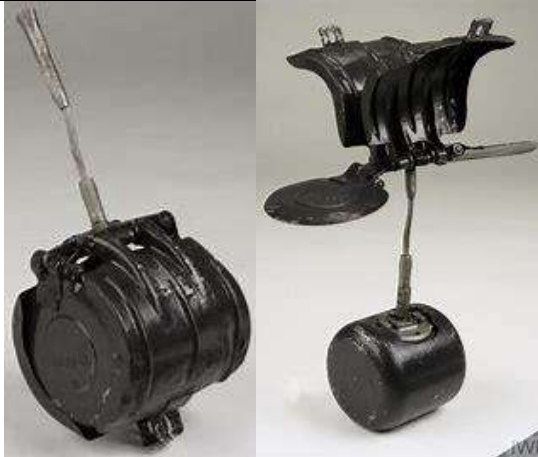
SD-2 Butterfly bomb

Weight	2Kg
Length	200mm
Body diameter	80mm
explosive	Fp 60/40
NEQ	0.225Kg (0.496lb)
Fuse	Mechanical Clockwork/ Mechanical time or B1/B2 Harassment
German 2 kg anti-personnel submunition used by the Luftwaffe during ww2. They were packed into containers holding between 6 and 108 submunitions.

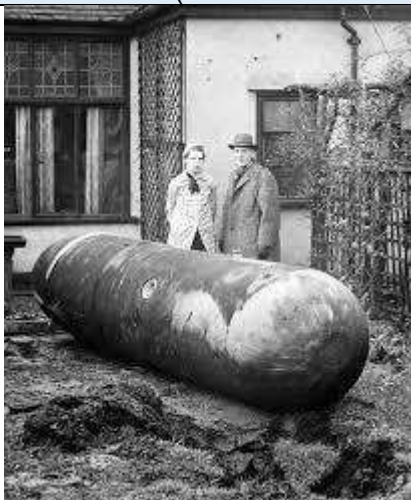
Parachute Mine (Luftmine B / LMB)

Bomb Weight	987.017kg (2176lb)
ExplosiveWeight	125-130kg (276-287lb)
Fuze Type	Impact/ Time delay / hydrostatic pressure fuze
Bomb Dimensions	1640 x 512mm (64.57 x 20.16in)
Body Diameter	368mm (14.5in)
Remarks	Parachute Mines were normally carried by HE115 (Naval operations), HE 111 and JU 88 aircraft types. Deployed a parachute when dropped in order to control its descent.

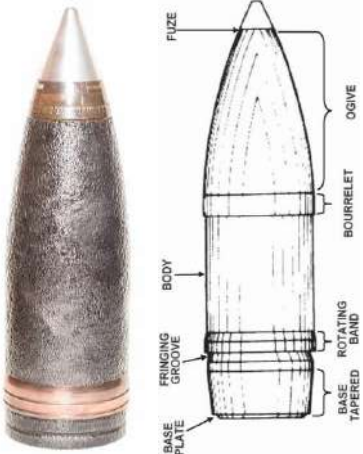
3.7" British Anti Aircraft Artillery Projectile (AAA)

Body	forward centring bands and a wider driving band. Square-based Brass cartridge shell with tapered nose
	Dimensions	94mm x 360mm (3.7 x 14.7")
	Weight	12.7kg (28lb)
	Fuze	Mechanical time fuze
	Composition	Cast steel
	Explosive	Amatol, TNT or RDX/TNT. MK6 had

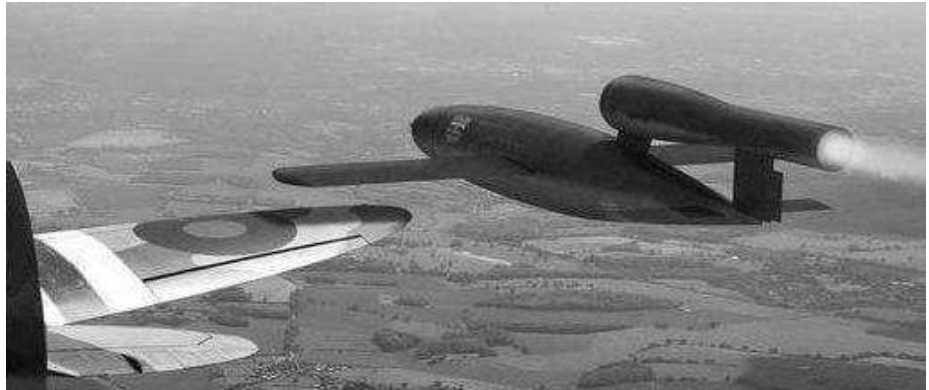
Annex D1 The V1 Flying Bomb

The V1 Flying bomb was the world's first cruise missile, they were also known as Doodle bugs or Vengeance weapon. The V1 was an unmanned plane that delivered a ton of high explosive. Between June 1944 and March 1945, 2419 of them exploded in London. The V1 was capable of inflicting huge damage to buildings, homes, and personnel. In the inner London suburbs where terrace houses were packed together, sometimes up to 20 houses would totally collapse, just at one hit. The blast area of a V1 extended across a radius of 400 -600 yards in each direction. <https://youtu.be/ro4ApX7EhJw>
