ENVIRONMENTAL RISK ASSESSMENT (DEVELOPMENT AREA 1)

Environmental Risk Assessment

The Former Stag Brewery East Site, Mortlake, London

February 2018

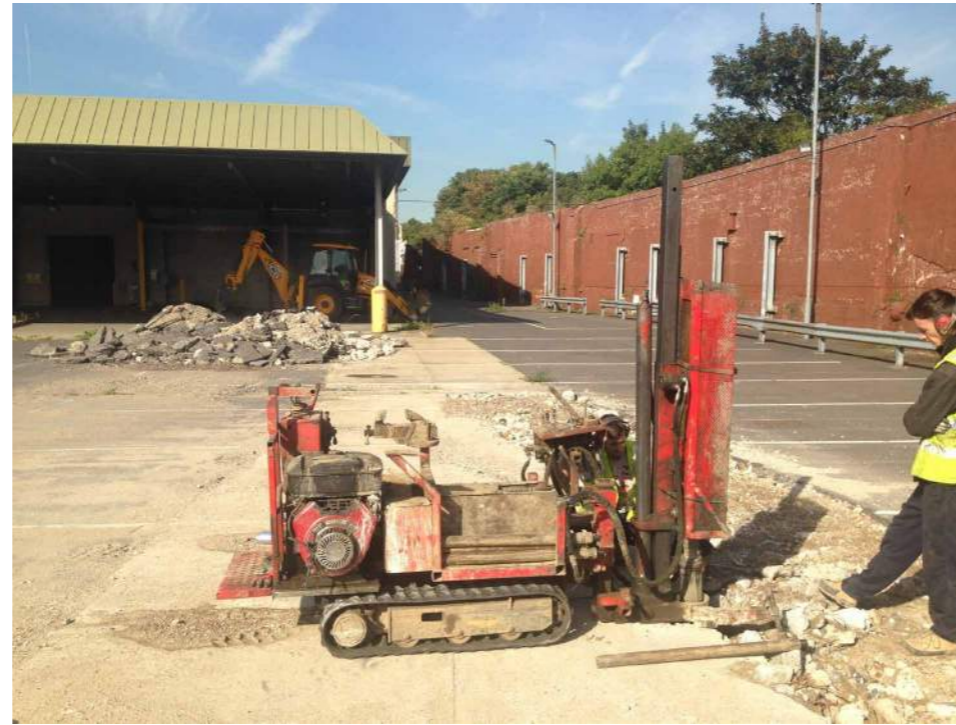
Photograph 7. Ground investigation works in progress

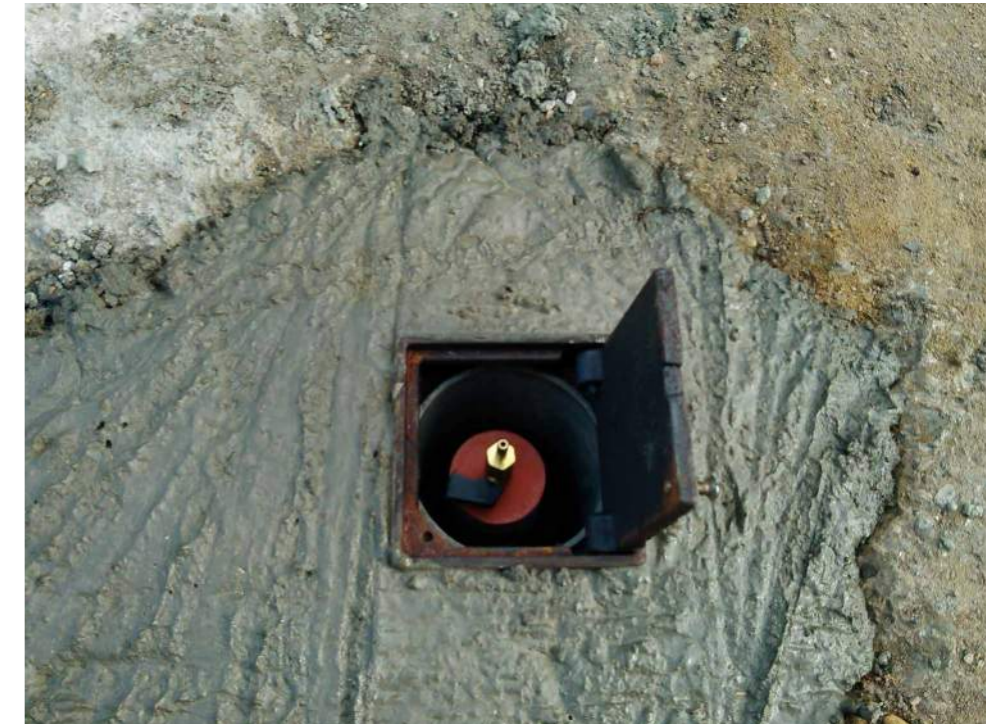
Photograph 8. Typical completed borehole

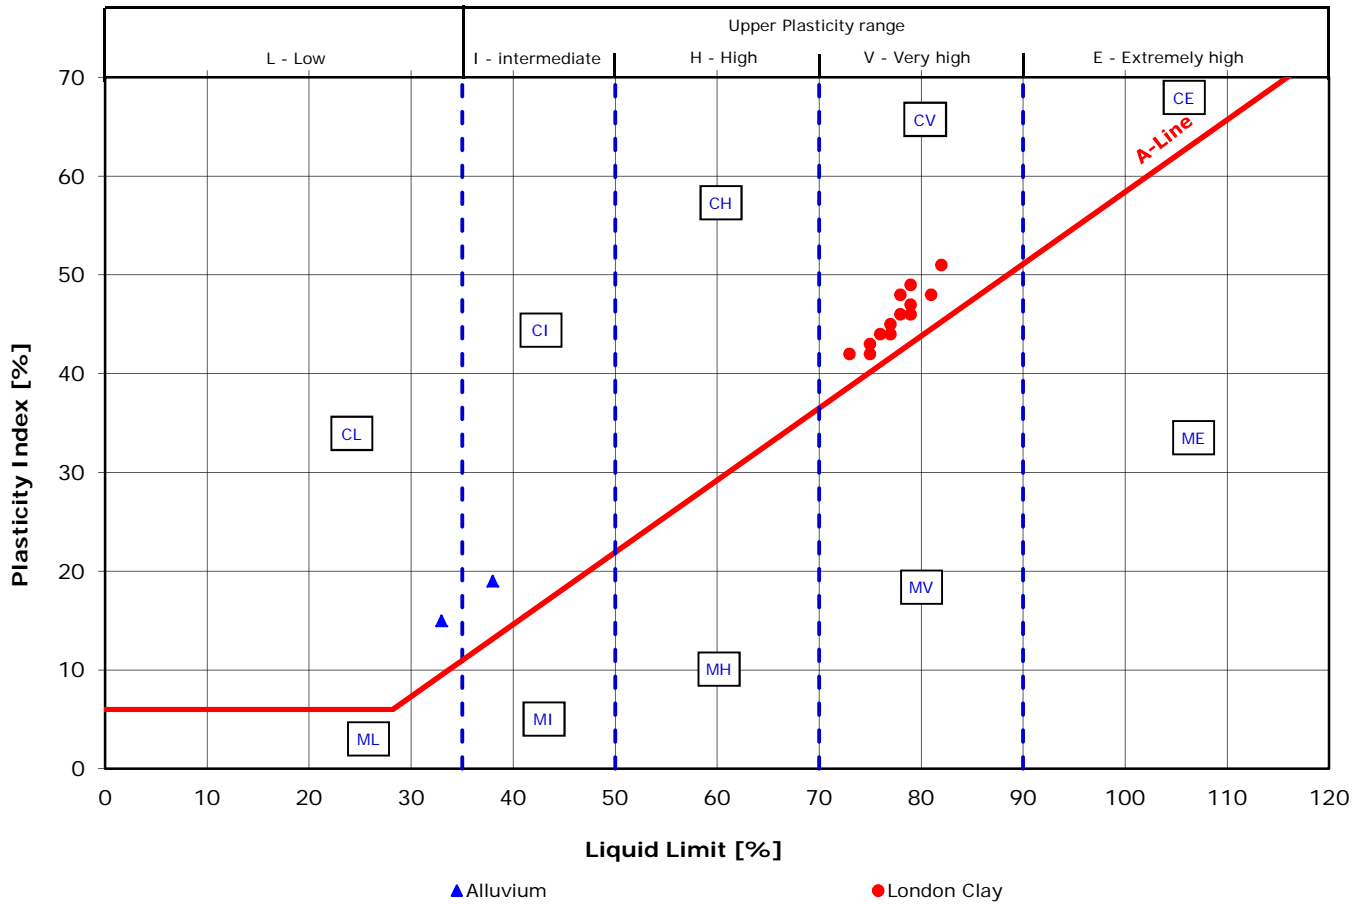
Plasticity Chart

M - SILT [plots below the A-Line]
C - CLAY [plots above the A-Line]

Classification in accordance with BS5930:1999+A2:2010 "Code of practice for site investigations"
