# BS 5837 Arboricultural Report

Impact Assessment & Method Statement

**Barnes Hospital  
South Worple Way  
Barnes  
SW14 8SU**

**Dated  
8<sup>th</sup> March 2022**

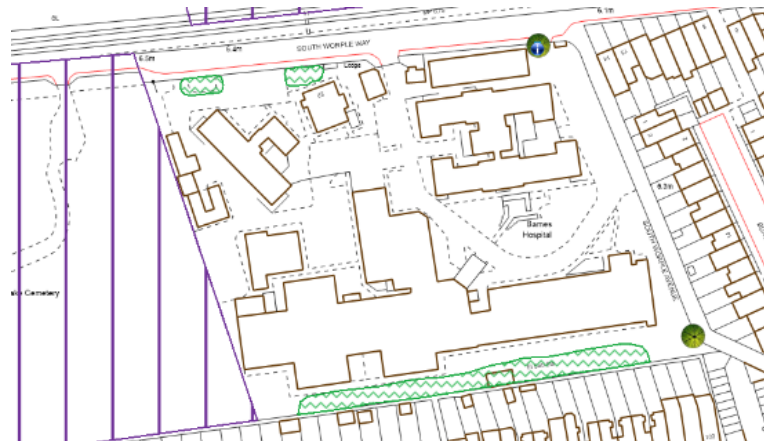
- The site lies immediately adjacent to a conservation area (see purple hatched area on the screenshot overleaf). Trees included within our survey that are affected by this conservation area are T9, T10, T11, T13, T14, T15 and T16.
- There are tree preservation orders affecting trees within the site as indicated in green on the screenshot overleaf. Trees included within our survey we believed to be protected are T4, T5, T6, T7, T8 and trees T19 to T26.

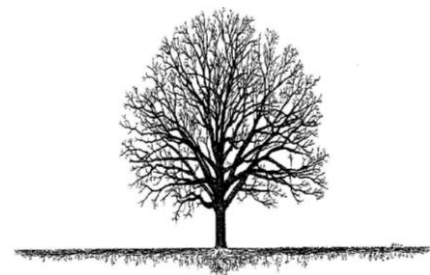
4.6.15. The majority of tree roots lie within the upper soil horizons. This is because the availability of oxygen decreases with depth and roots need to breathe to stay alive. In addition, nutrients are more readily available in the form of organic matter close to the soil surface.

4.6.16. Healthy soils contain about 25% air space between solid particles. Increased loading of the soils caused by construction activity causes air to be squeezed out as the soil becomes compacted preventing roots from breathing. Even an increase in pedestrian activity may cause some soil compaction.

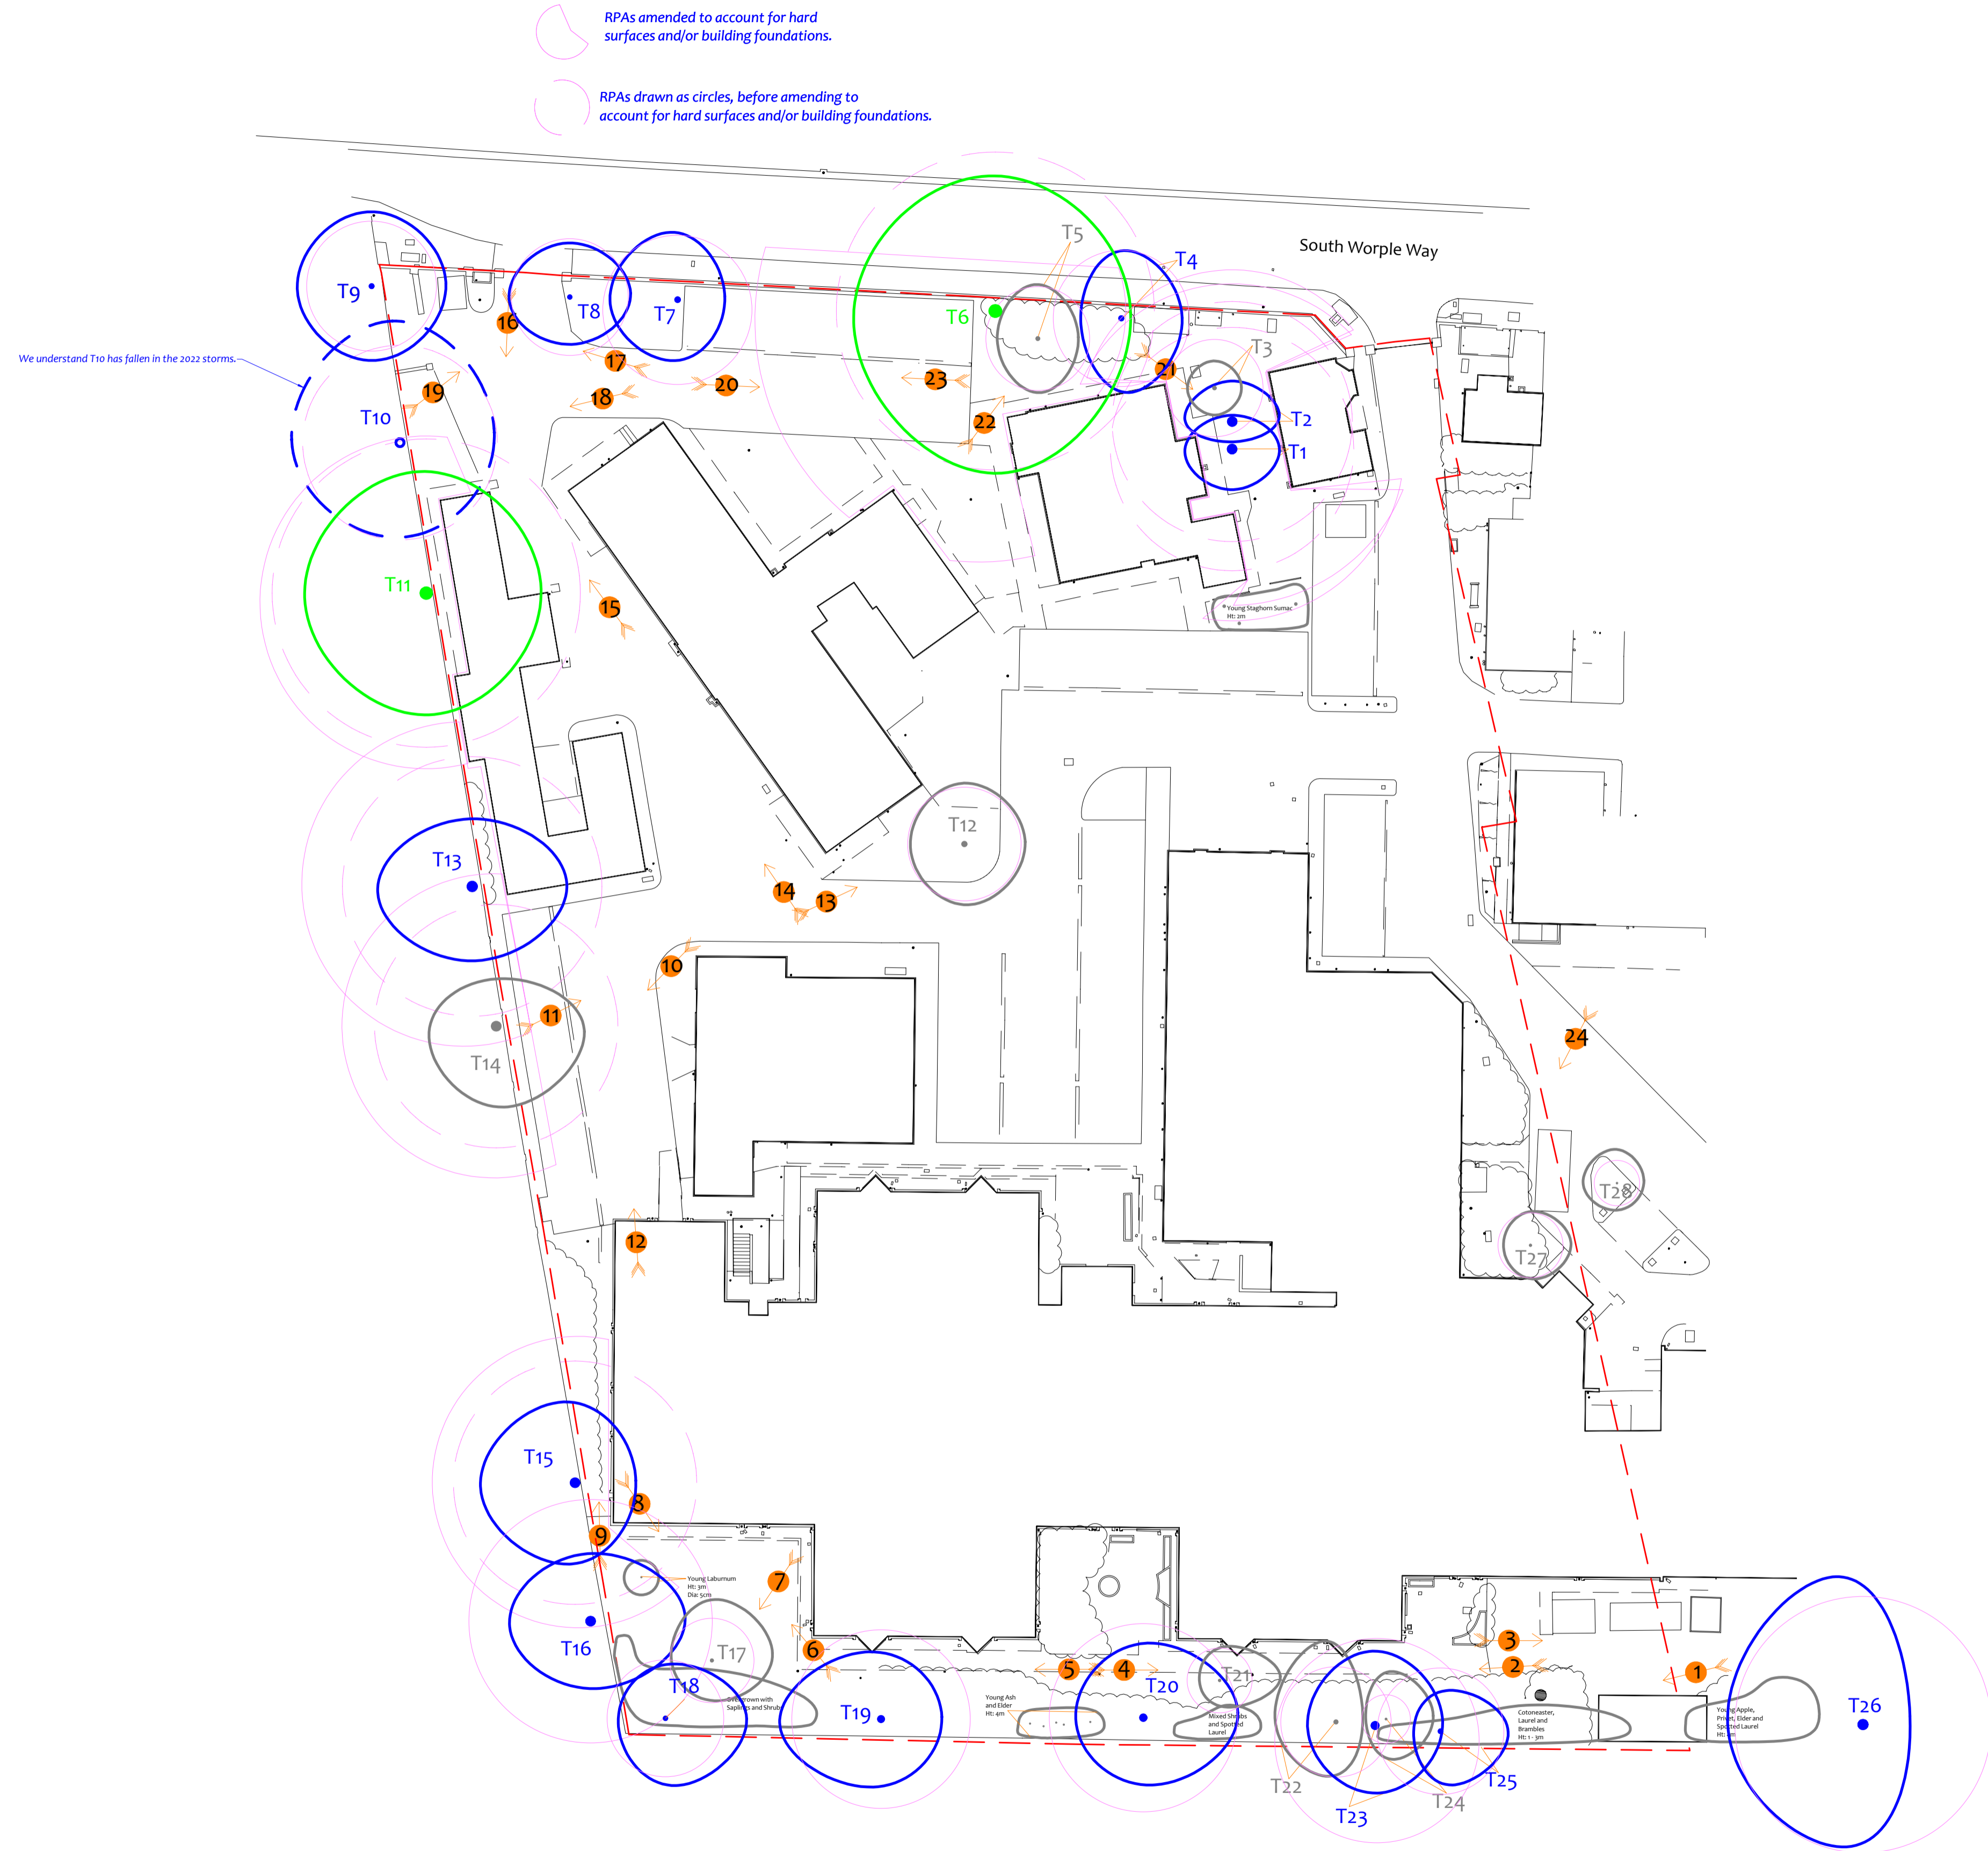
**Tree Constraints Plan**  
(Existing Layout)

Drawing No: CCL 10770 / TCP Rev 3  
 Title: Tree Constraints Plan (Existing Layout)  
 Site: Barnes Hospital SW14 8SU  
 Scale: 1:300 Paper Size: A1

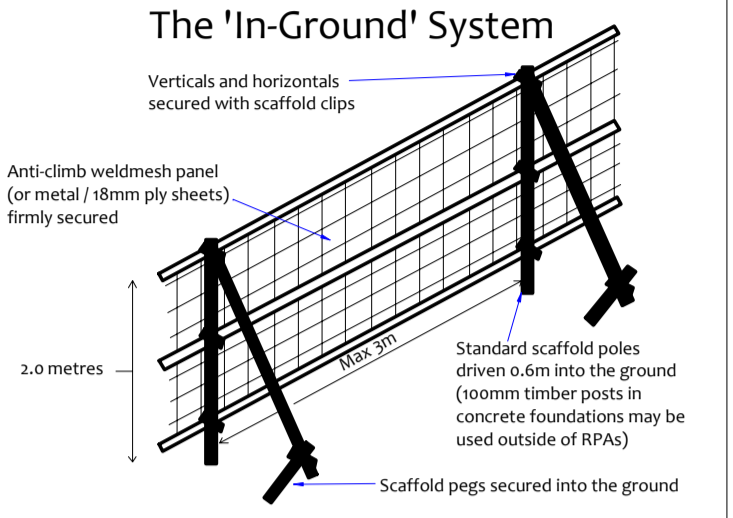
This system may be installed where indicated by a solid purple line on the Tree Protection Plan. It should be robust enough to withstand occasional knocks by plant machinery and, once installed, shall remain in place throughout the entire construction phase.

Vertical scaffold poles are driven into the ground, onto which are affixed horizontal scaffold poles and diagonal bracing struts. Wedmesh panels (or similar – e.g. Heras type fencing panels, or 18mm plywood boards) are secured to this scaffold framework using sturdy clips (e.g. standard scaffold clips). The system is illustrated in the diagram to the right and is based on BS 5373 guidelines.

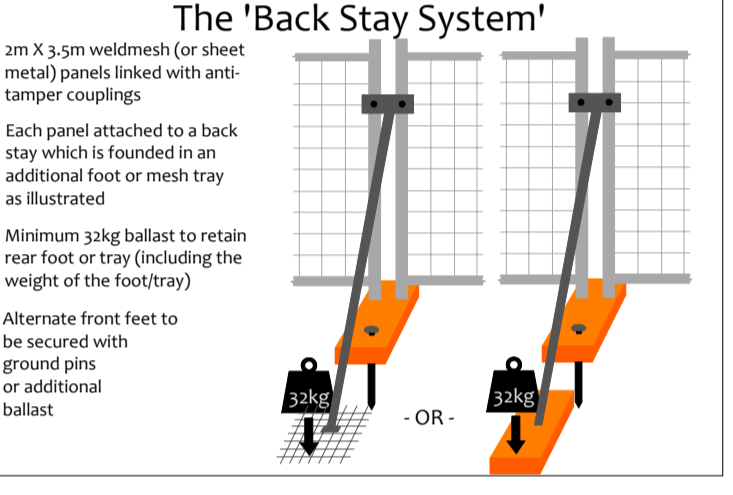
### The Back-Stay System

This system may be installed where indicated by a solid or dashed purple line on the Tree Protection Plan. It is more practical over existing hard surfaces or where the fencing needs to be moved to enable permitted activities within a Restricted Activity Zone. This system should be able to withstand occasional knocks by machinery and should not be relocated except with the consent of the site manager and the approval of the local authority.
