UNEXPLODED ORDNANCE DESK STUDY

Ham Close Redevelopment Richmond upon Thames TW10

Geo-Environmental Report

Ashburnham Rd, Richmond, TW10 7PB
for:

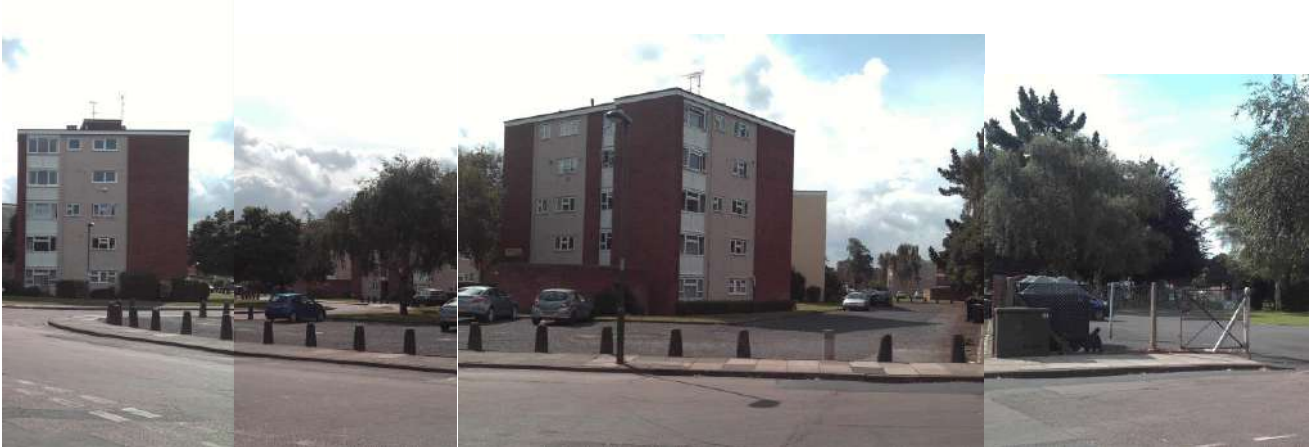
View across site from northwest corner

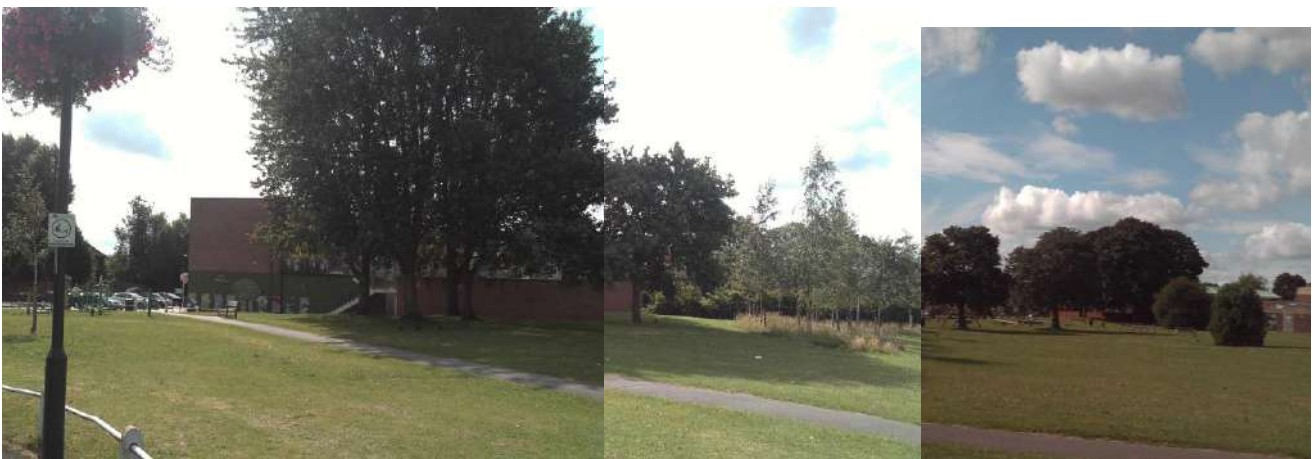
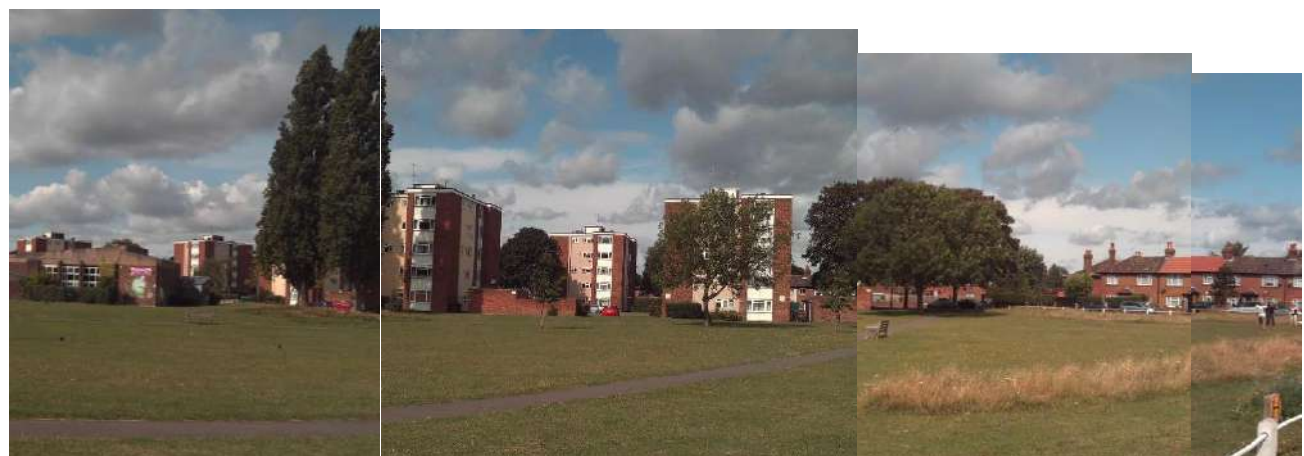
View across site from the east

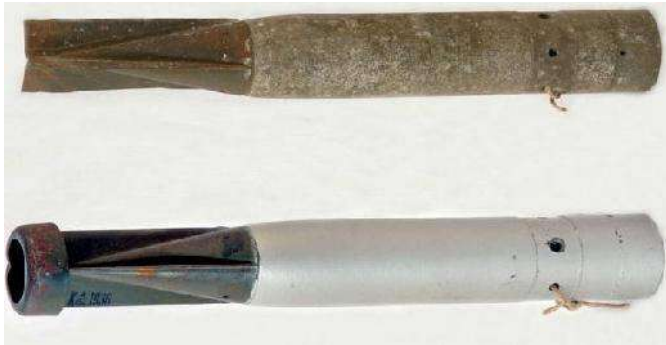
1kg incendiary Bomblet (Top as found today)

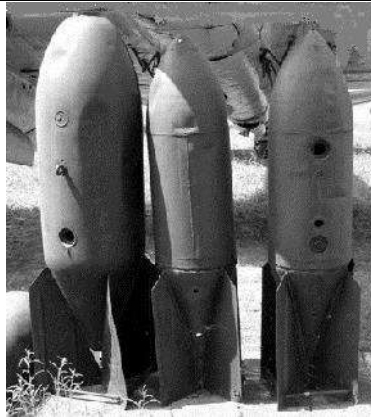
Flam c500, c250 & c50 Oil Bombs

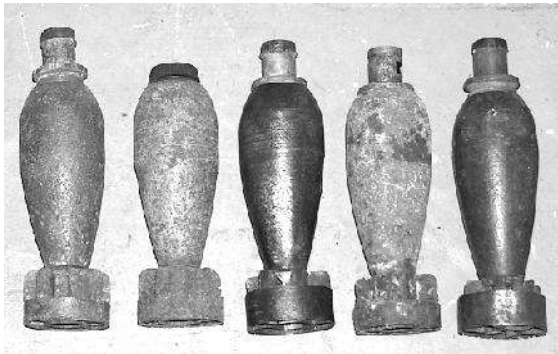
SD1 Anti-Personnel Bomblets

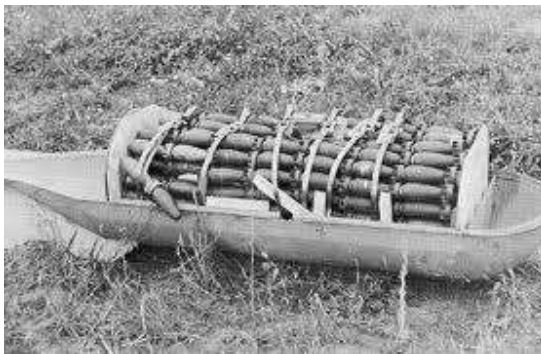
SD1 Container Bomb

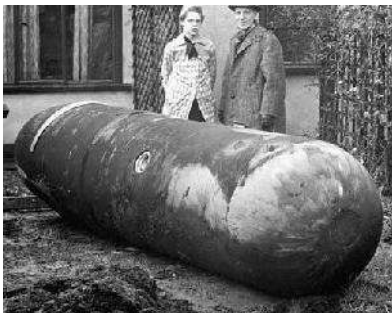
Parachute Mines
