Site	Ham Close Richmond Upon Thames London TW10 7PG
Client	Richmond Housing Partnership
Date	11 th August 2017
Our Ref	DTS/9324

PHASE 1 ENVIRONMENTAL REPORT
of a site at
HAM CLOSE, RICHMOND UPON THAMES, LONDON,
TW10 7PG
for
RICHMOND HOUSING PARTNERSHIP

Project No 9324
Report ref: 9324-P1E-1
Issued: 11 August 2017
Revision:

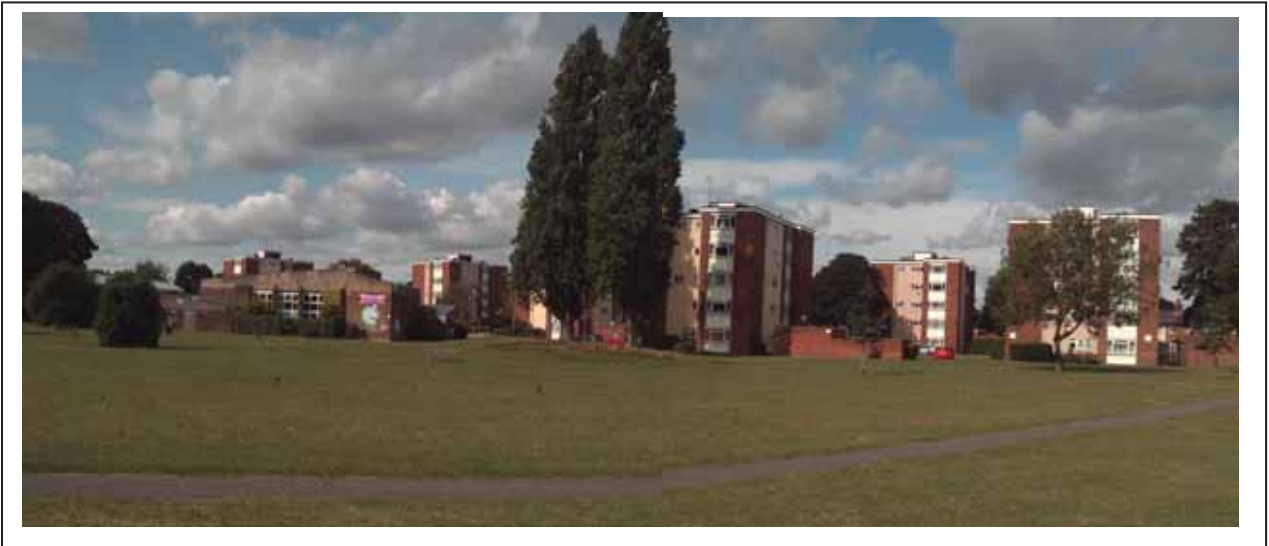
Photograph 1: View of the site from the east

The east end of the site is grassed communal open space with an asphalt surfaced car park in the southeast corner. There is an electricity sub-station in the service yard, immediately next to the southeast corner of the site.

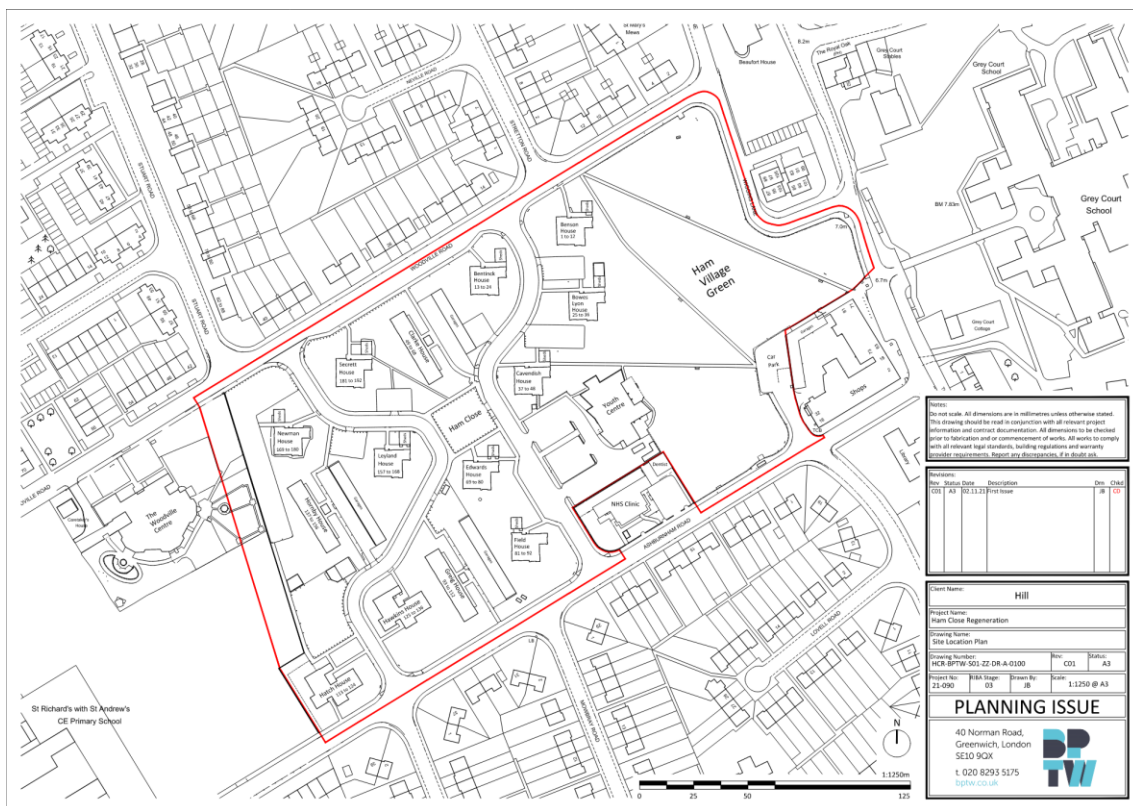
Figure 1: Indicative Site Masterplan

- 3.1.1 The Application Site area is 4.69 Hectares. The site is located on Ham Close, between St Richard's CE Primary School and Ham Street/Wiggins Lane, in a predominantly residential setting. The site is centred at National Grid Reference TQ 0030585, OS co-ordinates 550309 158566.
- 3.1.2 The application site currently houses 192 homes, a community centre and a Maker Labs use as part of the existing Ham Close Estate, existing site layout can be seen in Figure 1.
- 3.1.3 Access is provided from Ham Close which forms two parallel minor roads that generally run north-west to south-east, connecting to Ashburnham Road in the south and Woodville Road in the north.

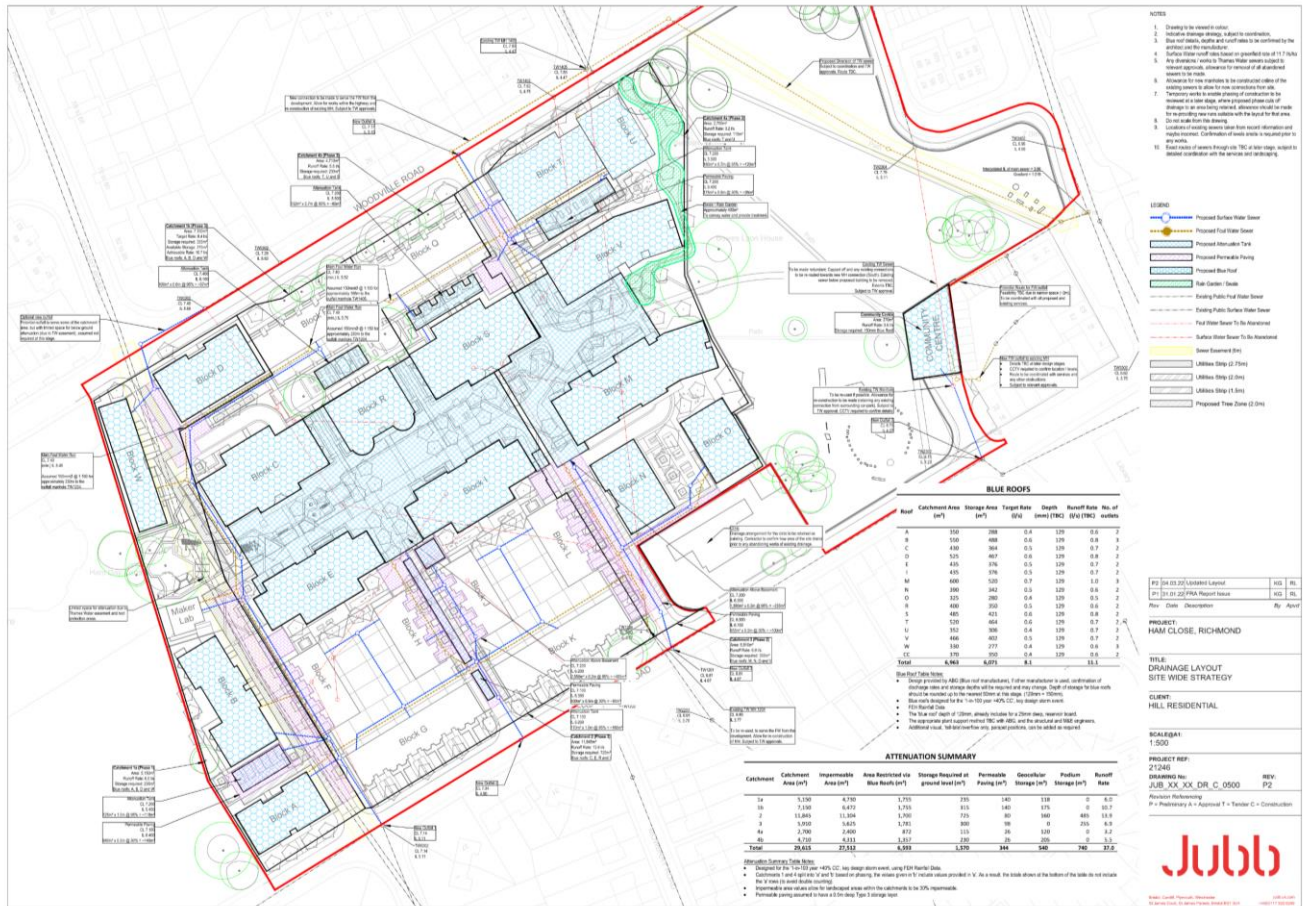
Figure 5 Proposed Drainage Layout

6.3.2 As highlighted above, the site will discharge towards the neighbouring surface water sewer. The site can accommodate green and blue roofs, raingardens, permeable paving and below ground attenuation tanks to treat and attenuate runoff. A drainage strategy included in Appendix E shows the possible sizes and locations of these SuDS features, extract can be seen in Figure 5.
