Client Name:		Hill Residential	
Project Name:		Ham Close Regeneration	
Drawing Name:		Proposed Phase 2 Masterplan	
Drawing Number:	HCR-BPTW-501-00-DR-A-0115	Rev:	CO1
Project No:	21-090	Status:	A3
RIBA Stage:	03	Drawn By:	JB
Scale:	1:500 @ A1

Client Name:		Hill Residential	
Project Name:		Ham Close Regeneration	
Drawing Name:		Proposed Phase 3 Masterplan	
Drawing Number:	HCR-BPTW-501-00-DR-A-0116	Rev:	CO1
Project No:	21-090	Status:	A3
RIBA Stage:	03	Drawn By:	JB
Scale:	1:500 @ A1

Geo-Environmental Report

Ashburnham Rd, Richmond, TW10 7PB
for:

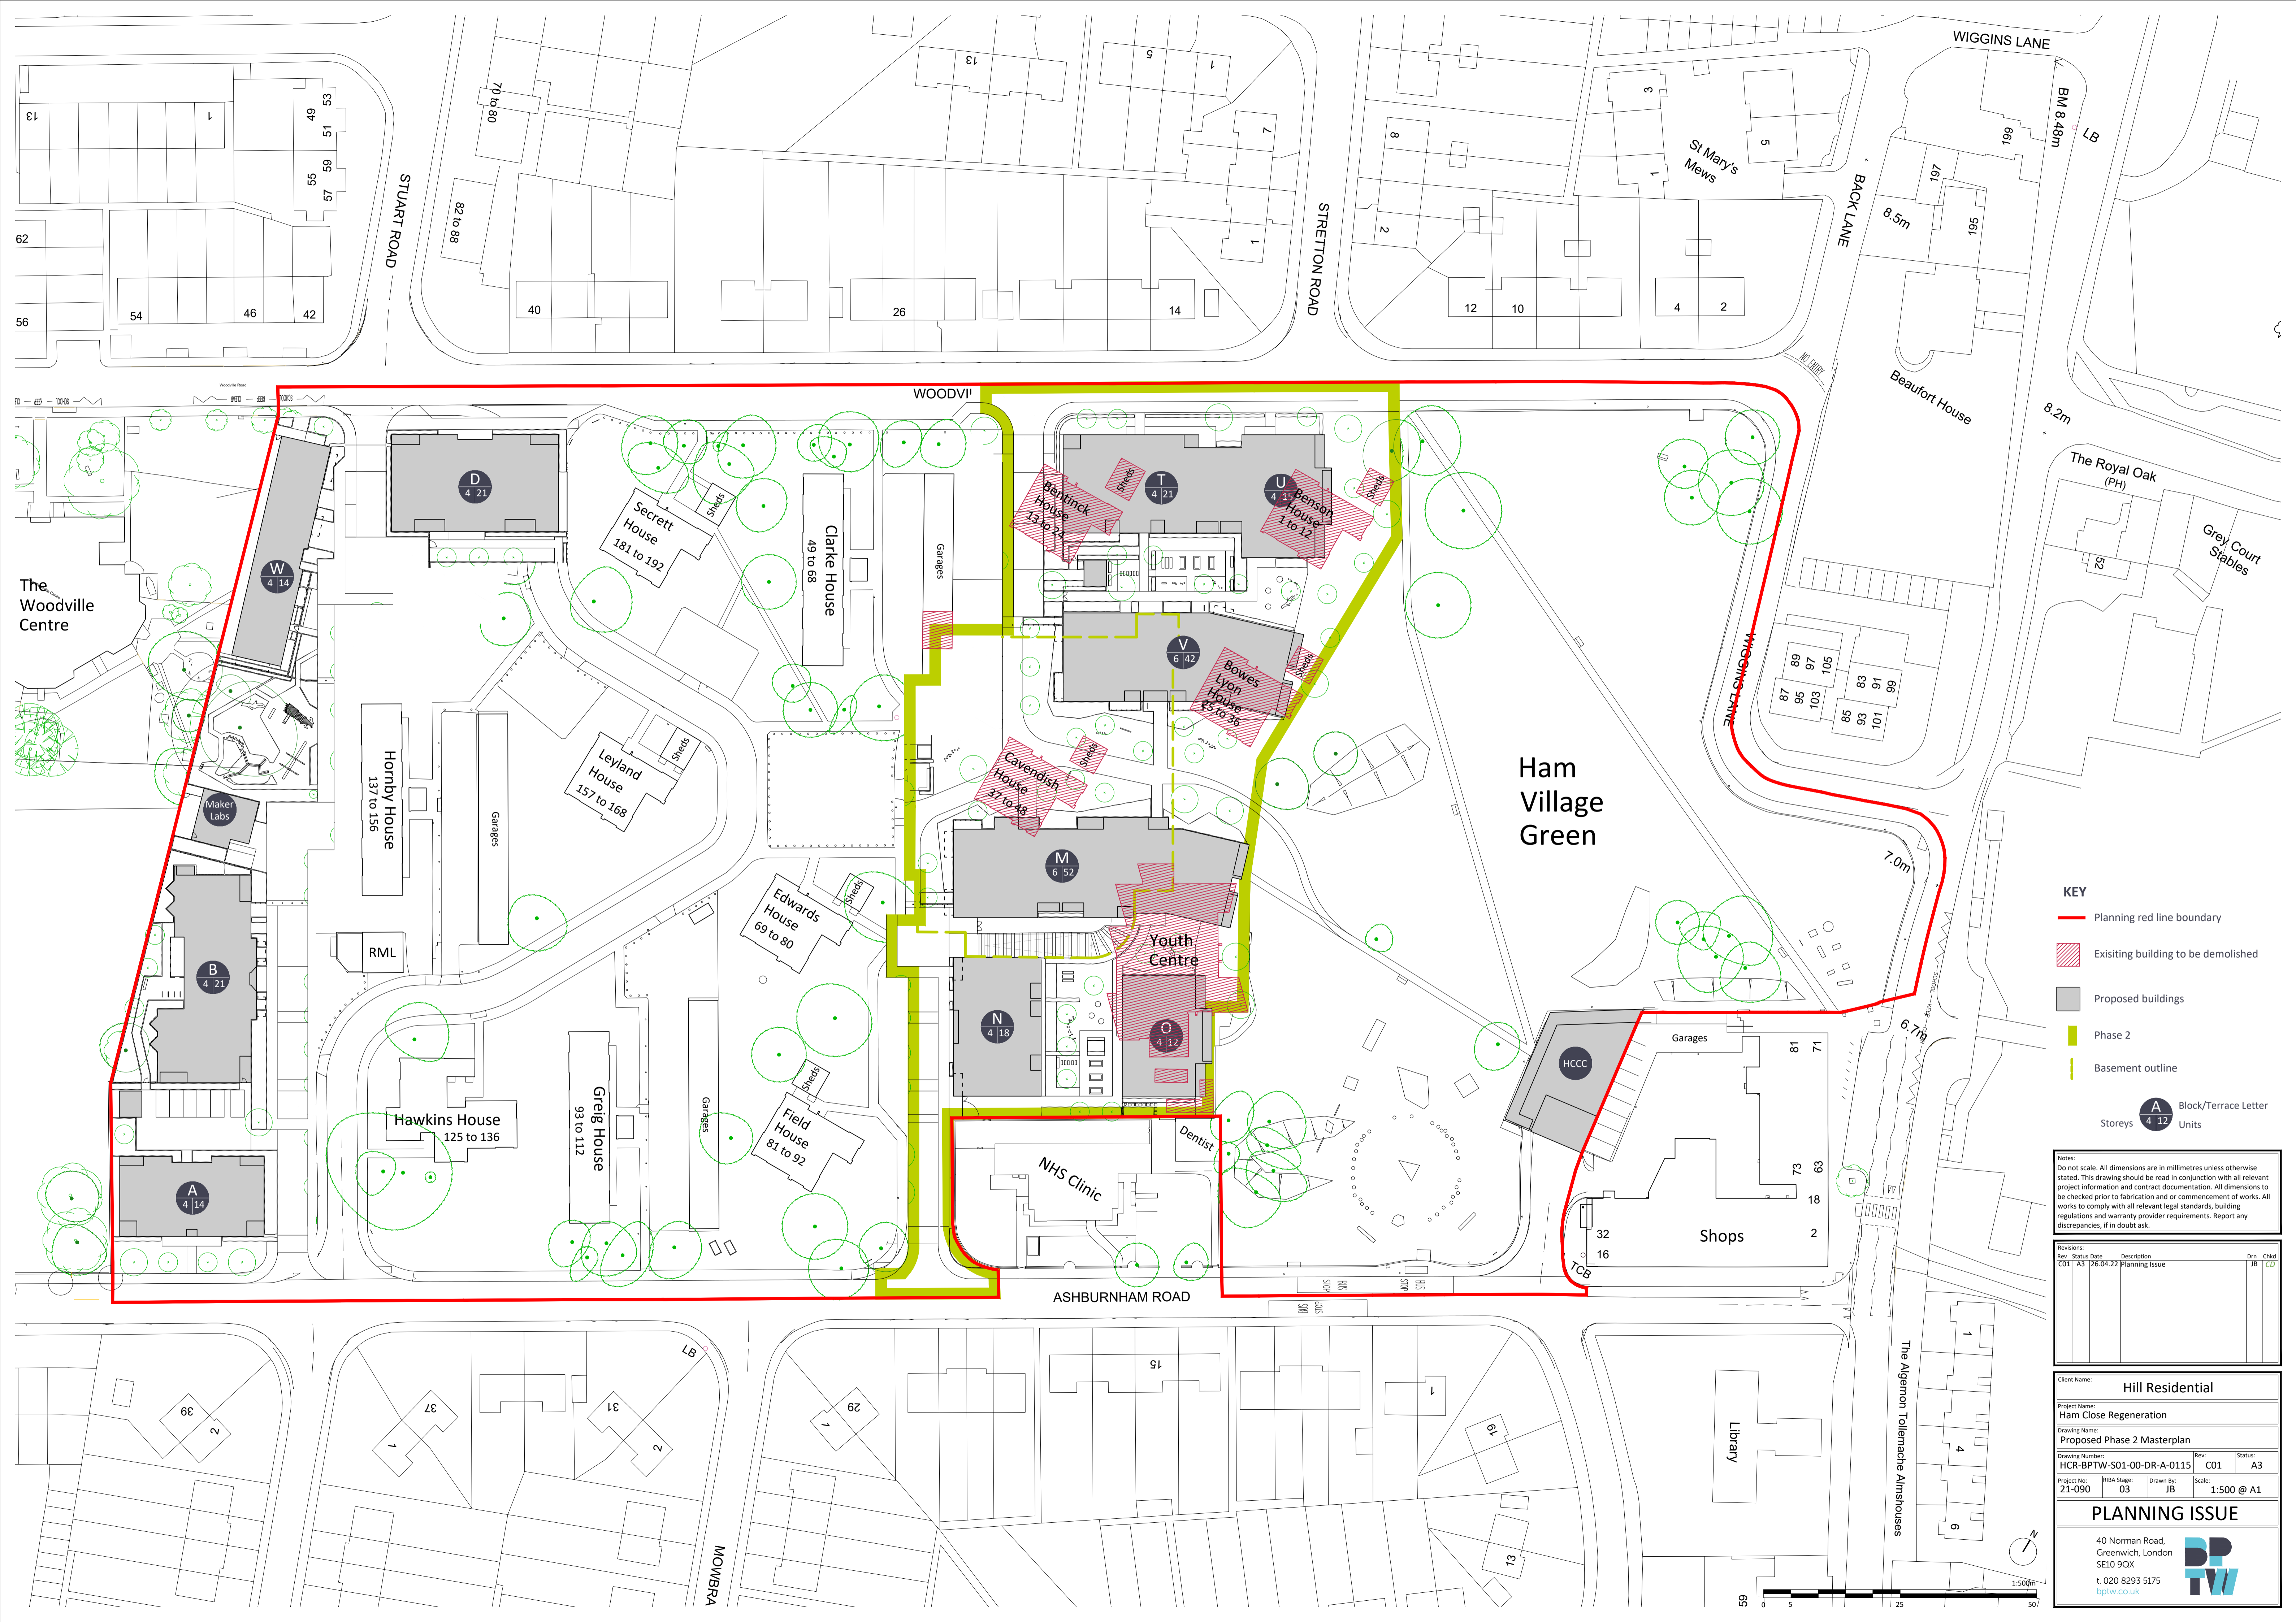
- Planning red line boundary
- Existing building to be demolished
- Proposed buildings
- Phase 2
- Basement outline
- Block/Terrace Letter
- Stores
- Units

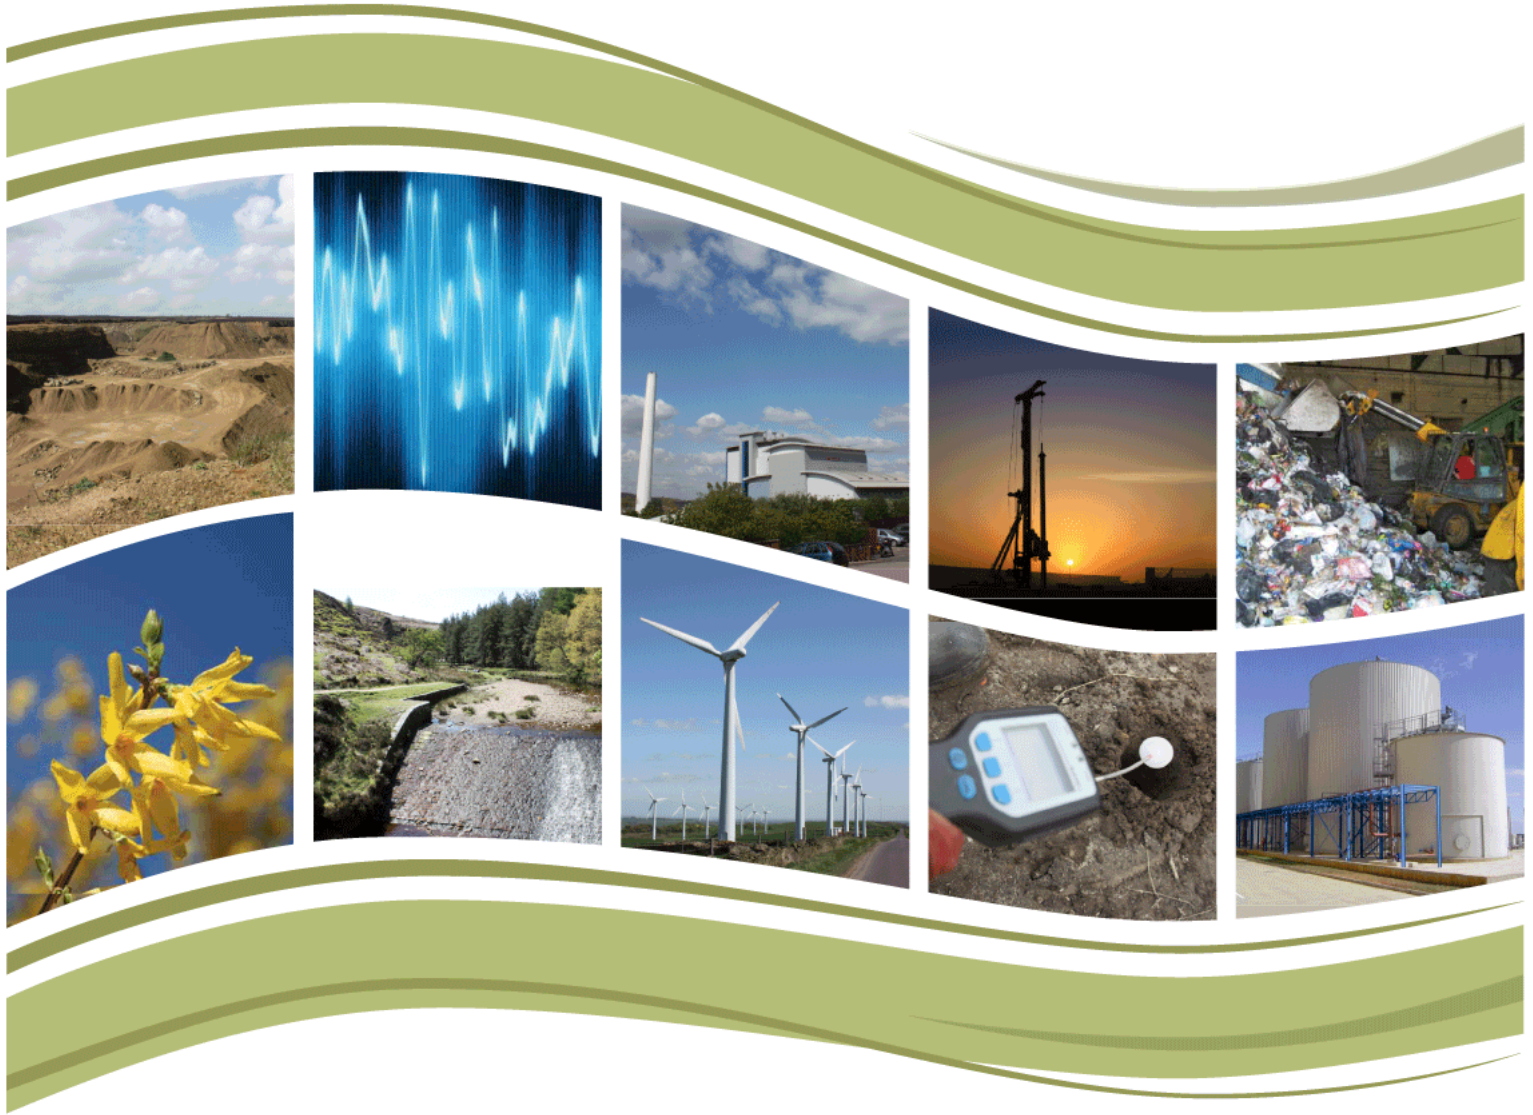
APPENDIX B – GROUND INVESTIGATION DATA

Ground Conditions comprise Made Ground over firm clay and loose becoming dense with depth sand and gravel. Shallow groundwater was not encountered.

Spread foundations should be suitable for domestic houses but piled foundations are likely to be required for apartments.
