# HERITAGE ANALYSIS

# HERITAGE ANALYSIS INTRODUCTION

RICHMOND INN

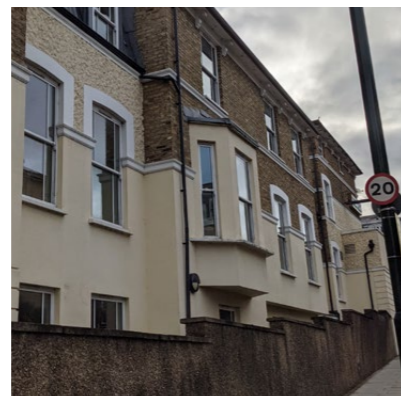
Floating bay on 90s extension

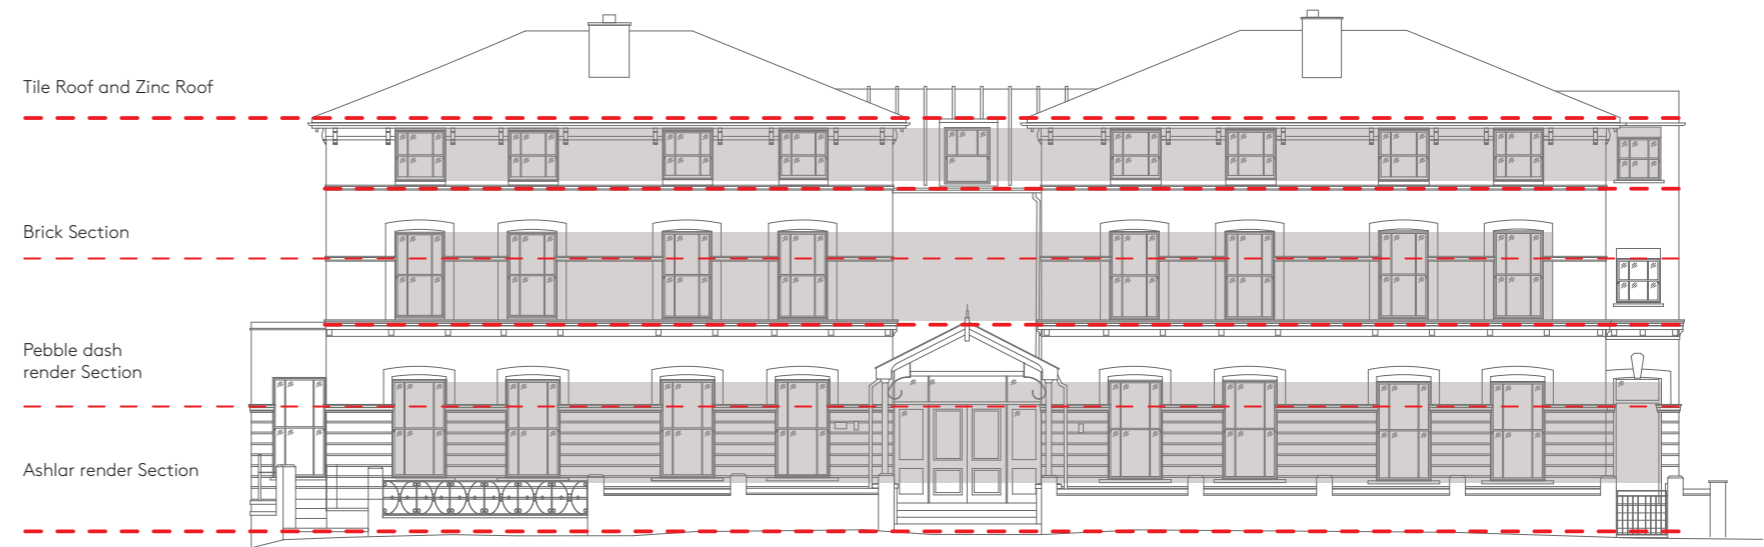
The building has a clear horizontal arrangement, establishing a hierarchy by its floors and windows proportions.

Windows are horizontally aligned with each other all around the building.

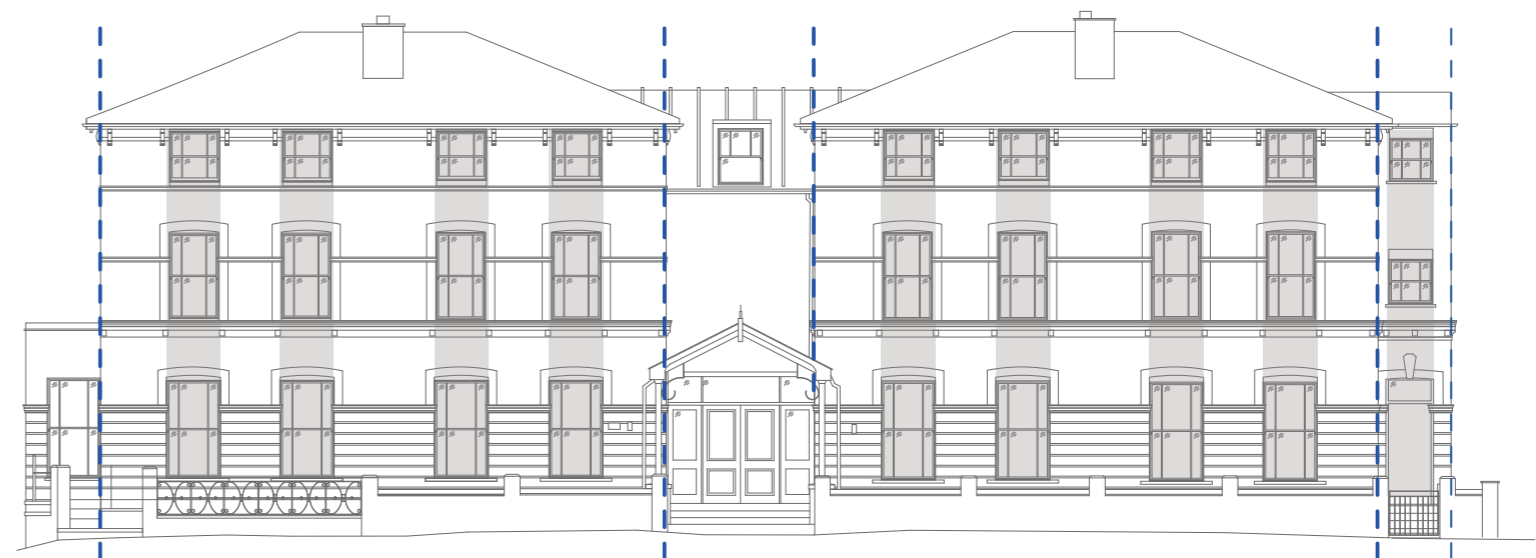
There is a well-defined vertical rhythm of the building's window arrangement, the ratio of separation remains the same.

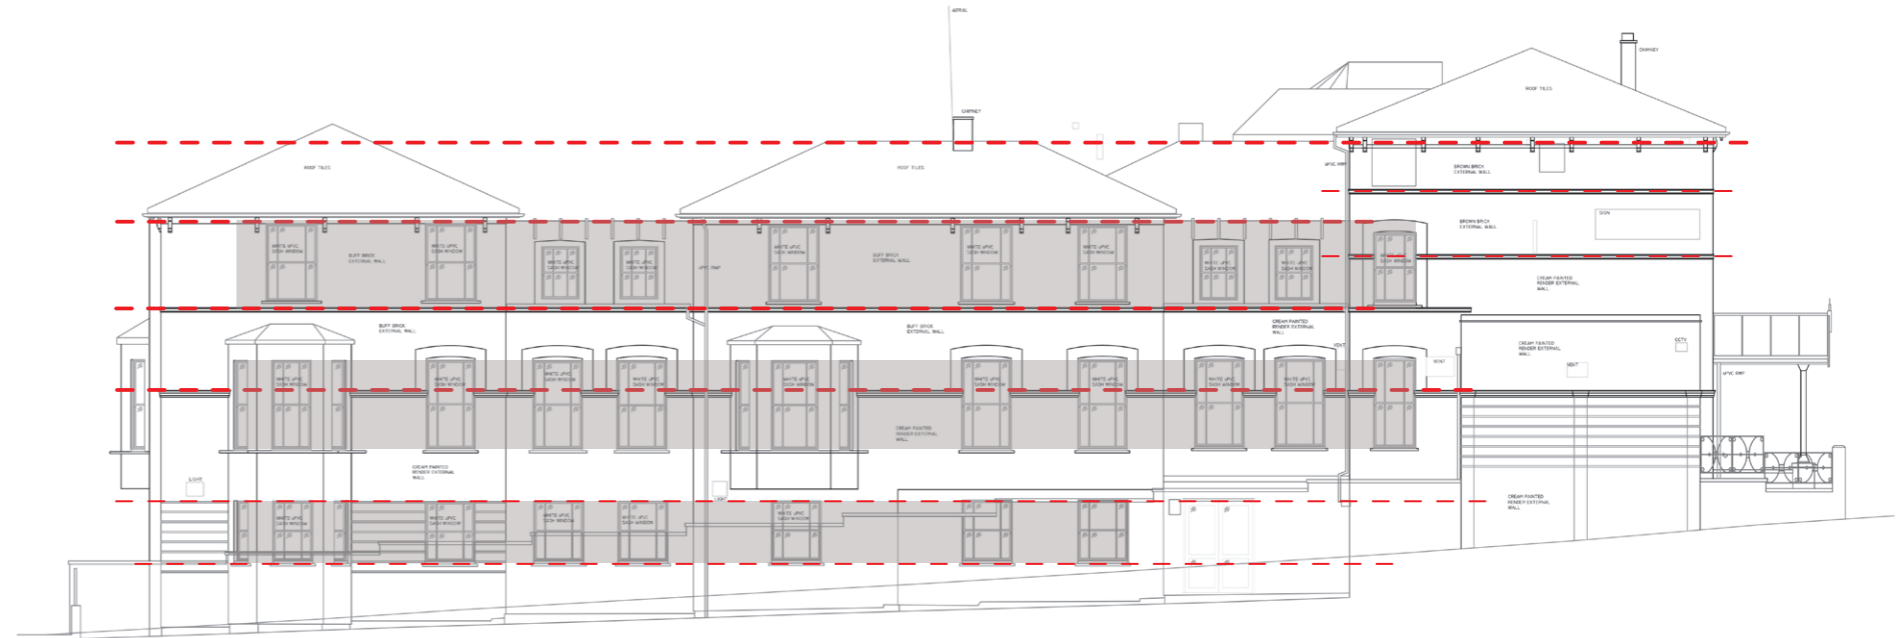
The building has a clear horizontal arrangement, establishing a hierarchy by its floors and windows proportions.

Windows are horizontally aligned with each other all around the building.

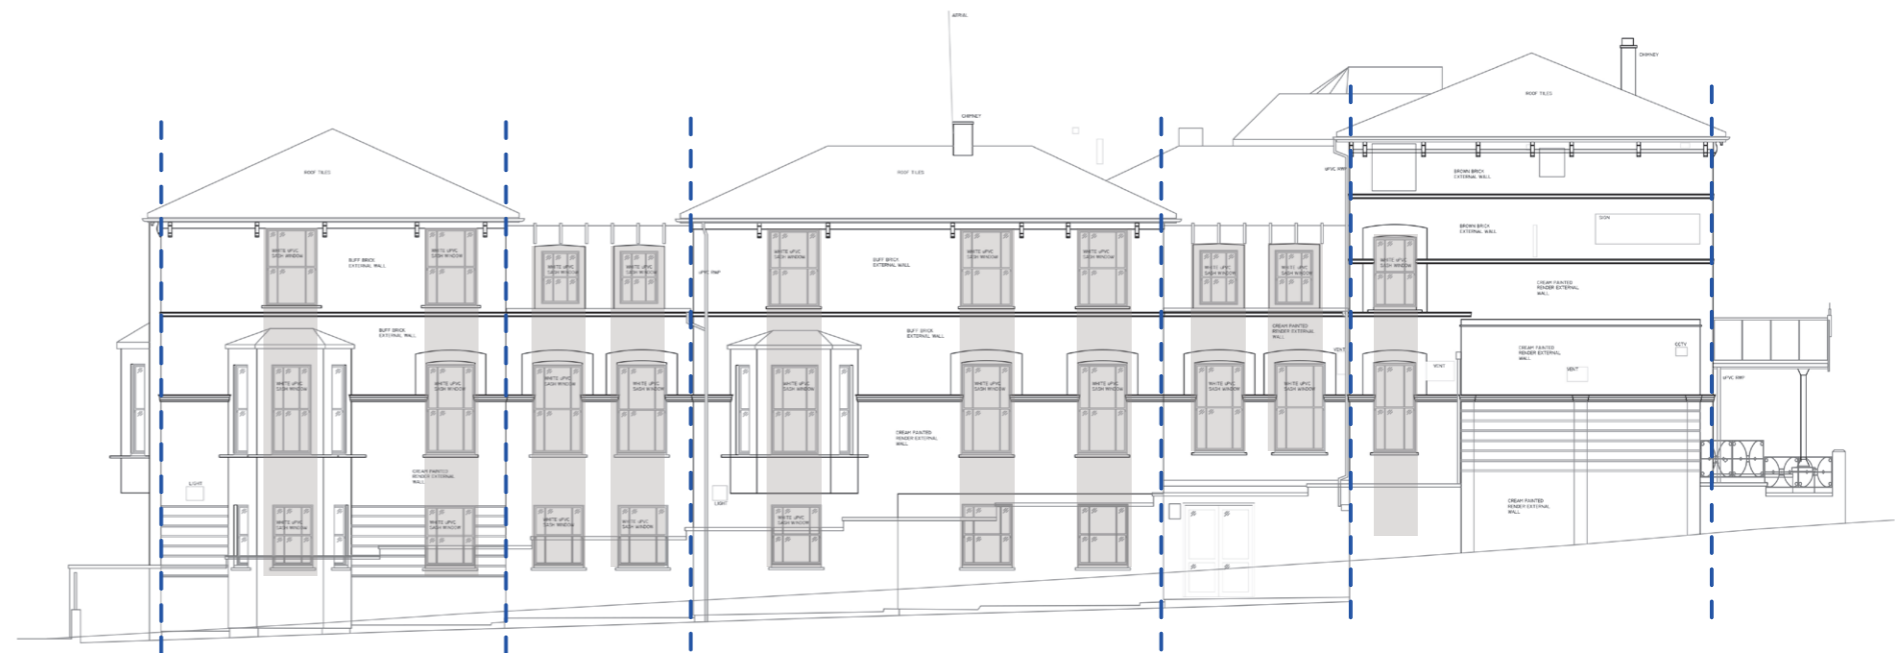
There is a well-defined vertical rhythm of the building split in 3 pavilions along Church Road.

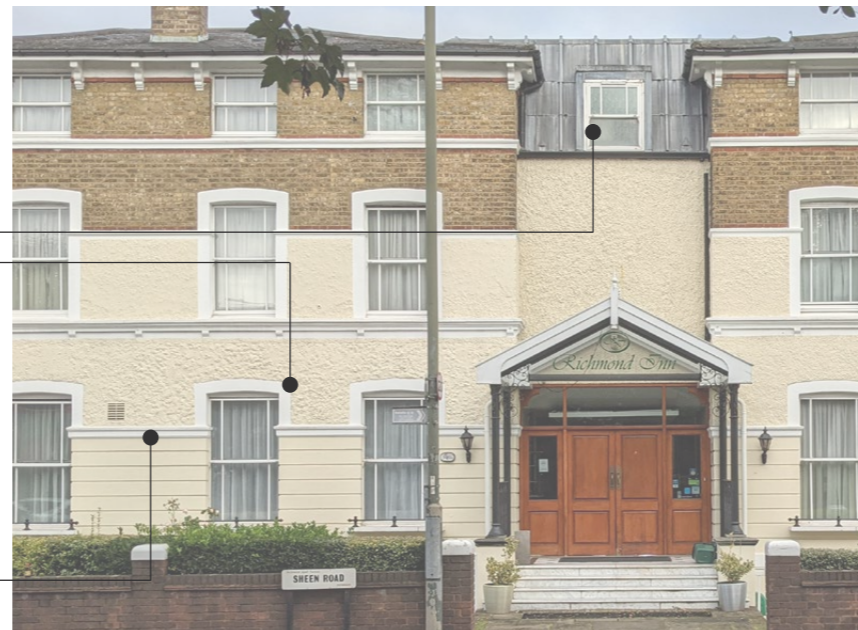
The existing façades showcase some decorative elements such as cornices, mouldings and different materials which together reinforce this horizontal hierarchy.

Traditional dormer

Traditional cornice

Traditional white sash Window with frame

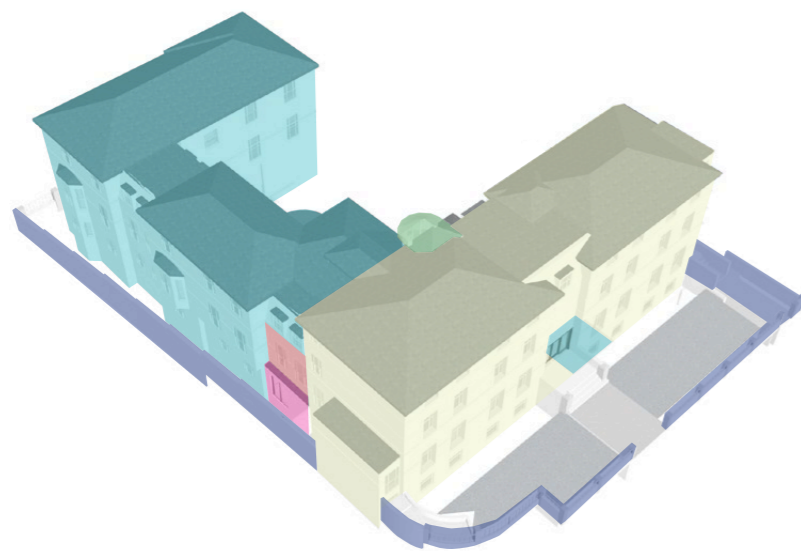
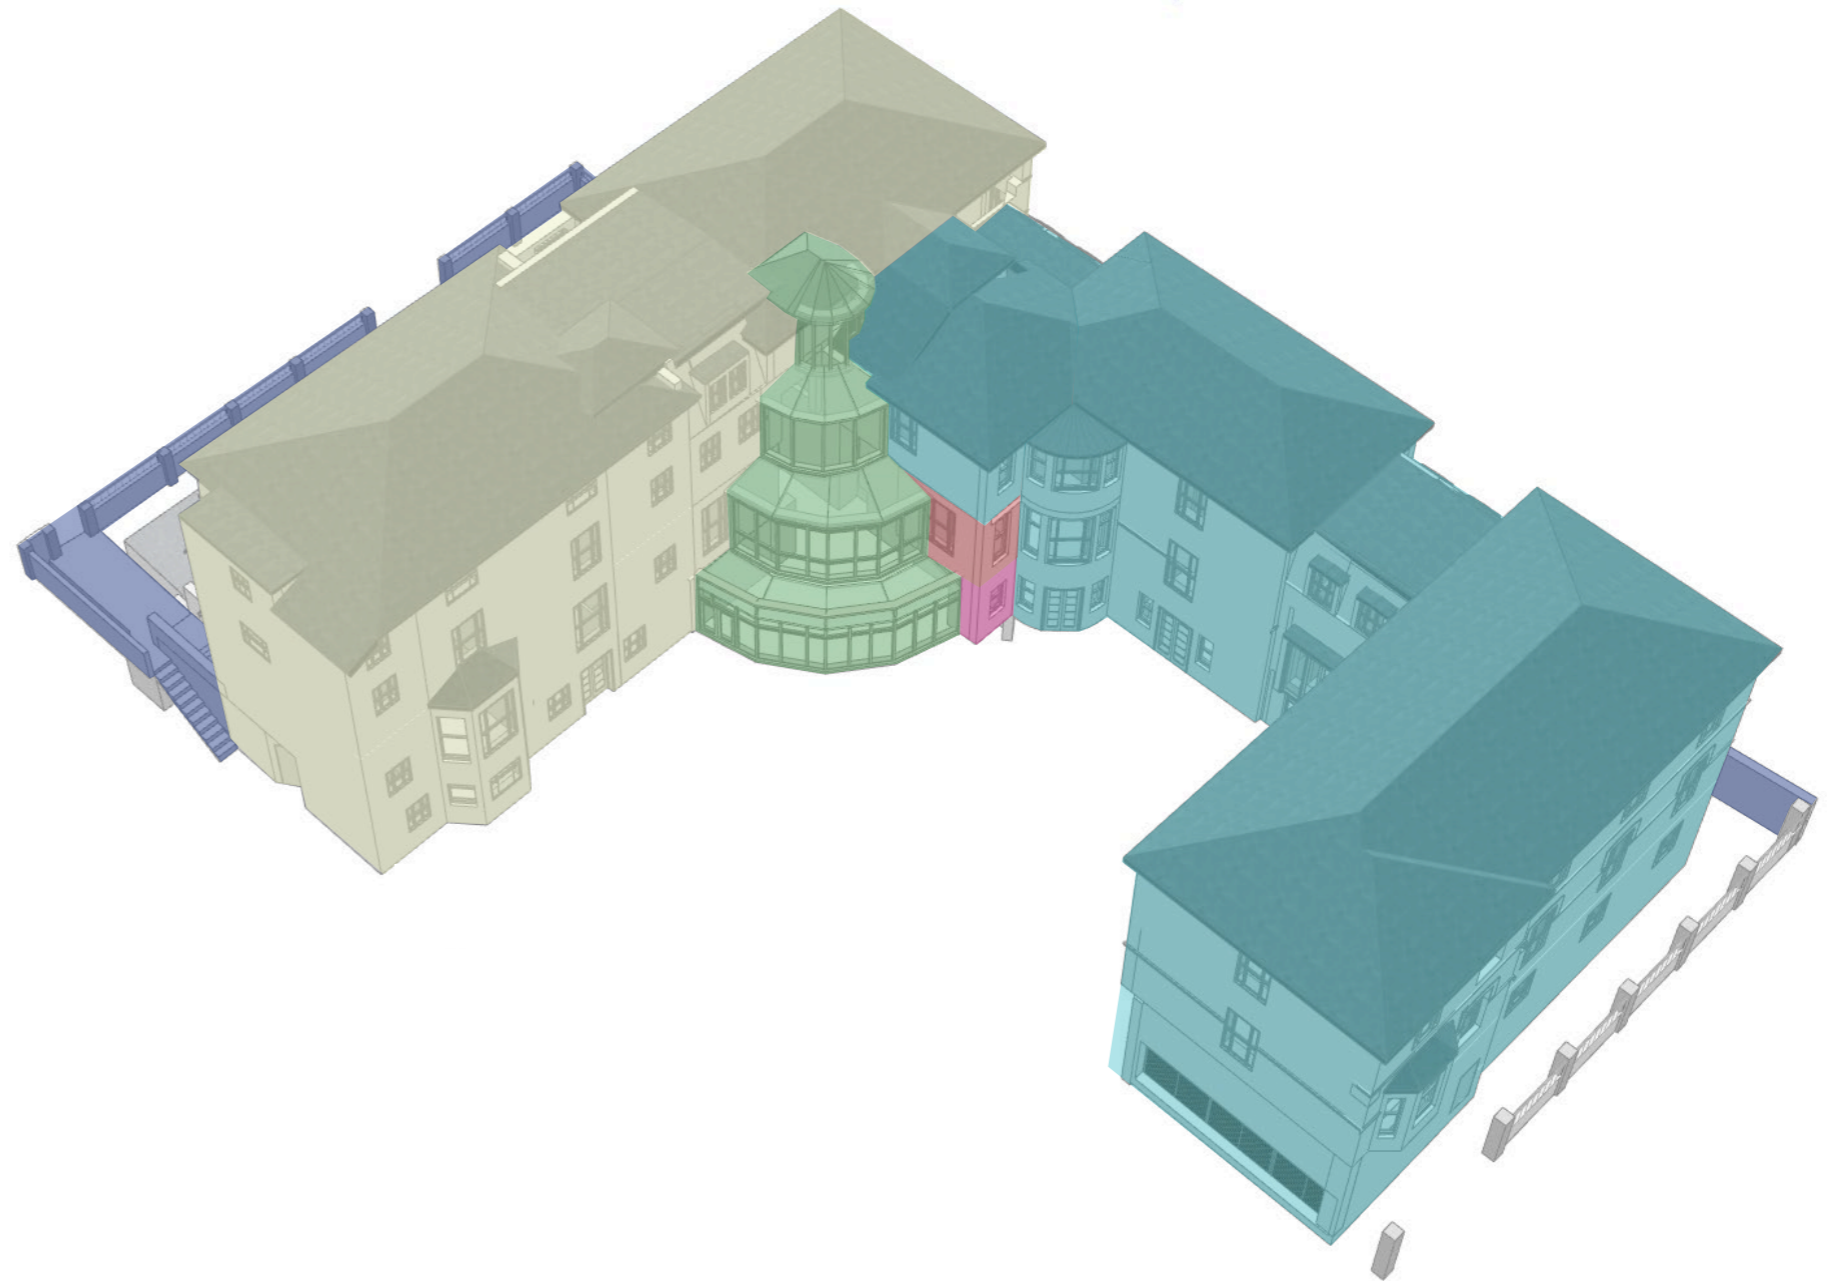
South West Axo

North East Axo

- Extent of the building prior 80/90s alterations
- 1981 - Single storey infill
- 1989 - Additional Storey infill
- 1996 - Part 3 and Part 4 Storey Extension
- 1999 - New Conservatory design (Planning amendment)
- 2014 - New front and side boundary, new external stairs
