Adelaide House, 16 Park Road, Teddington TW11 0AG

Schedule of Repairs & Construction Method Statement for works to a Listed Building

30 June 2022

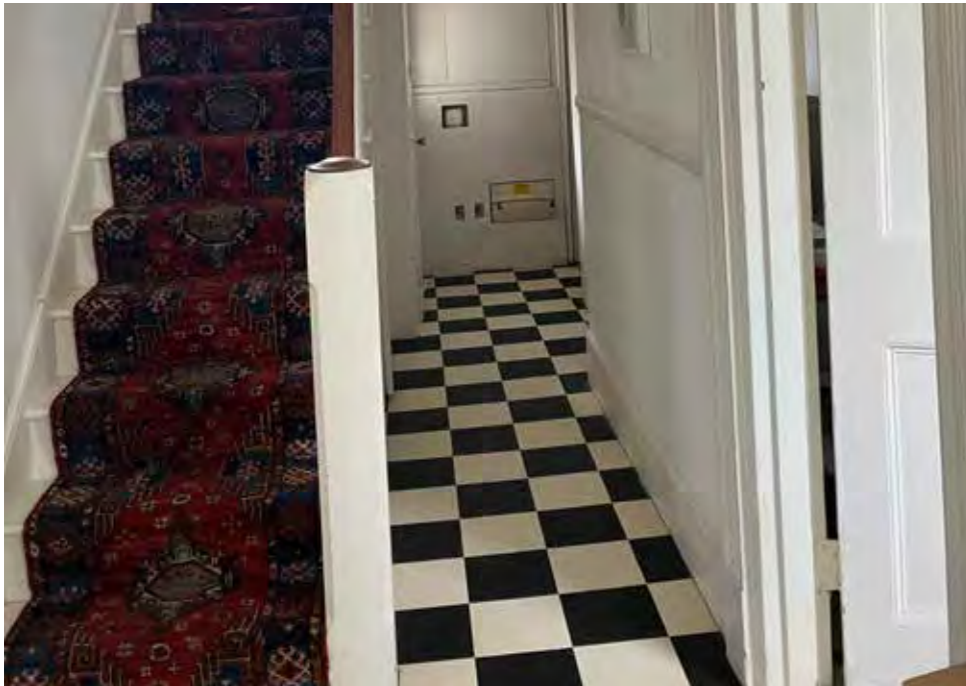
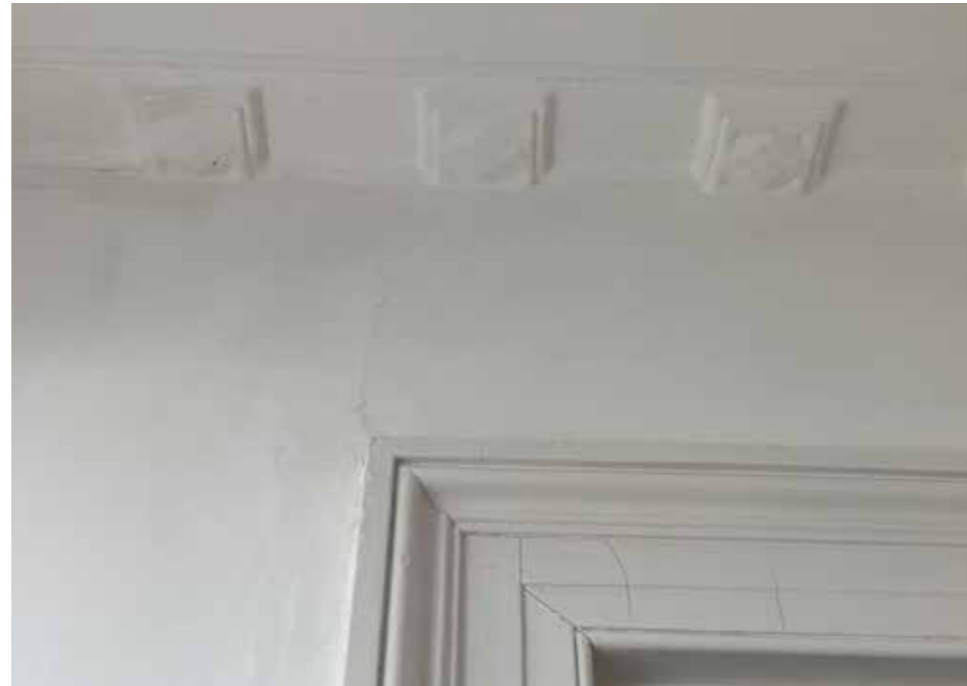
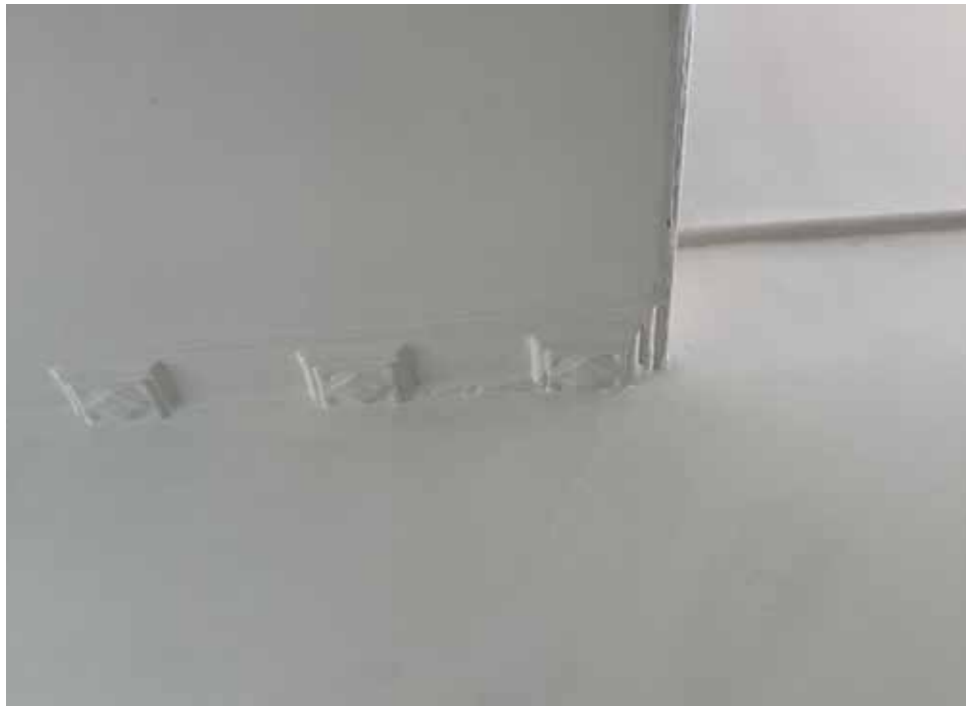
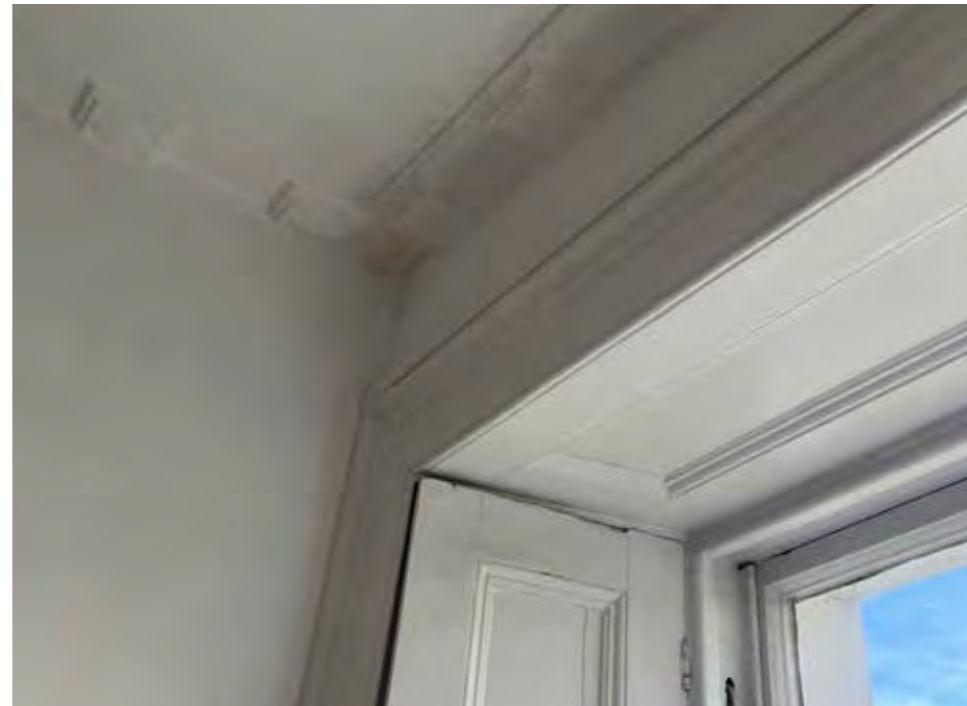
1. Hallway

1. Existing linoleum floor covering to be carefully removed and replace with Georgian style tiles.

2. Specialist cornice expert will carefully remove existing layers of paint on cornicing to reveal existing moulding and decorate.

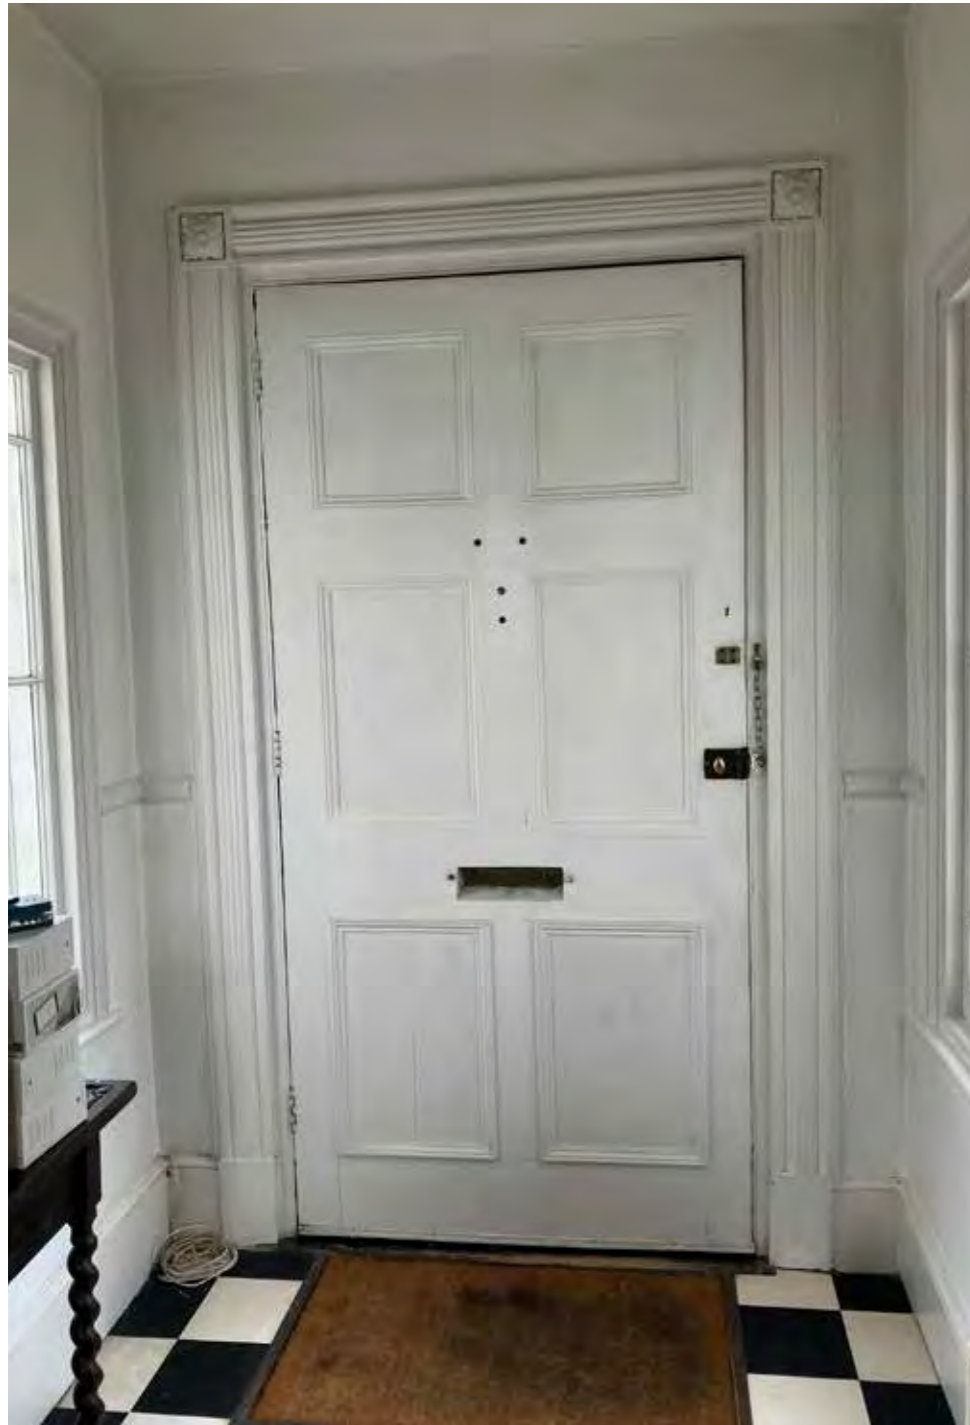
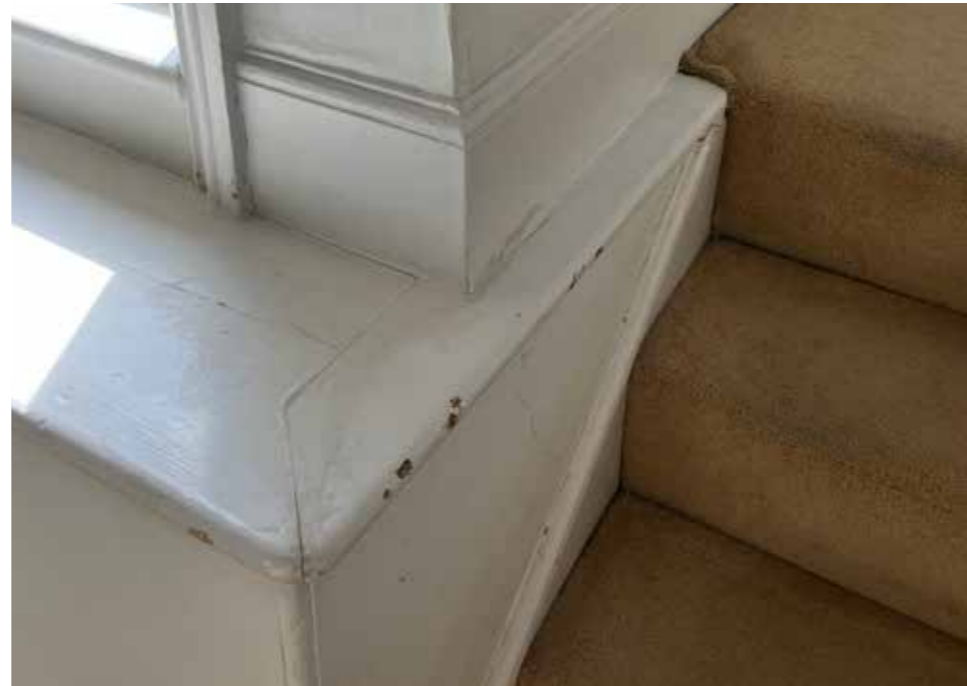
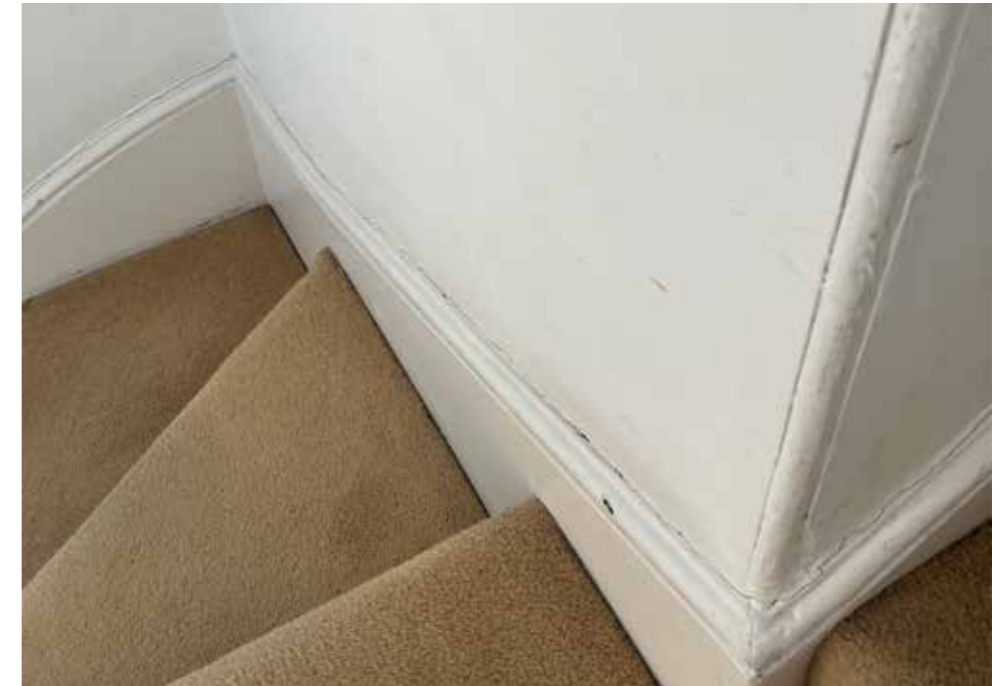
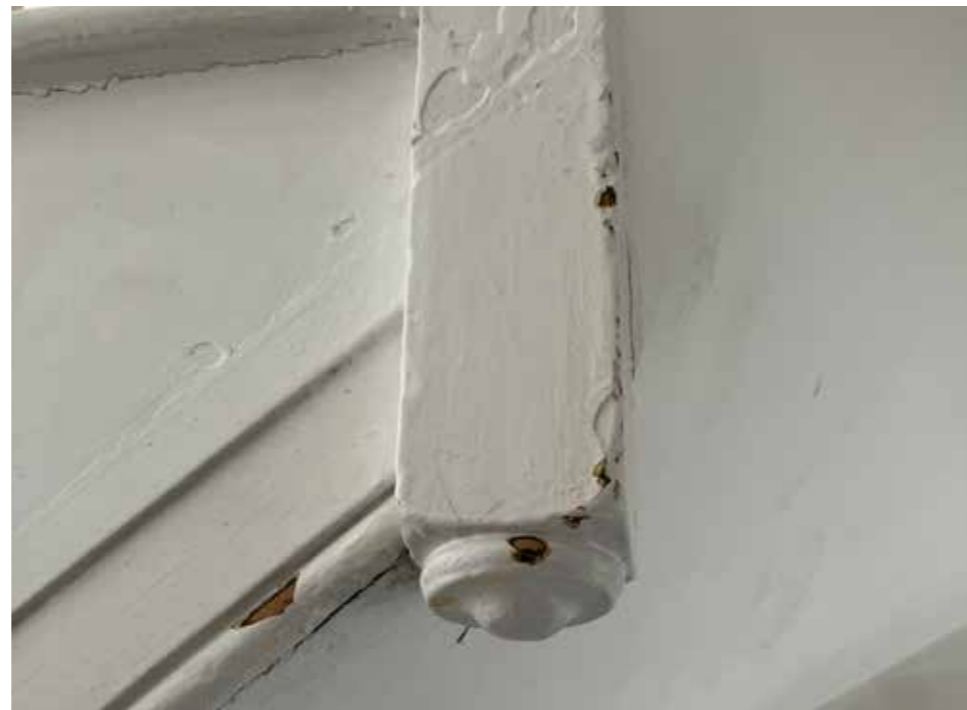
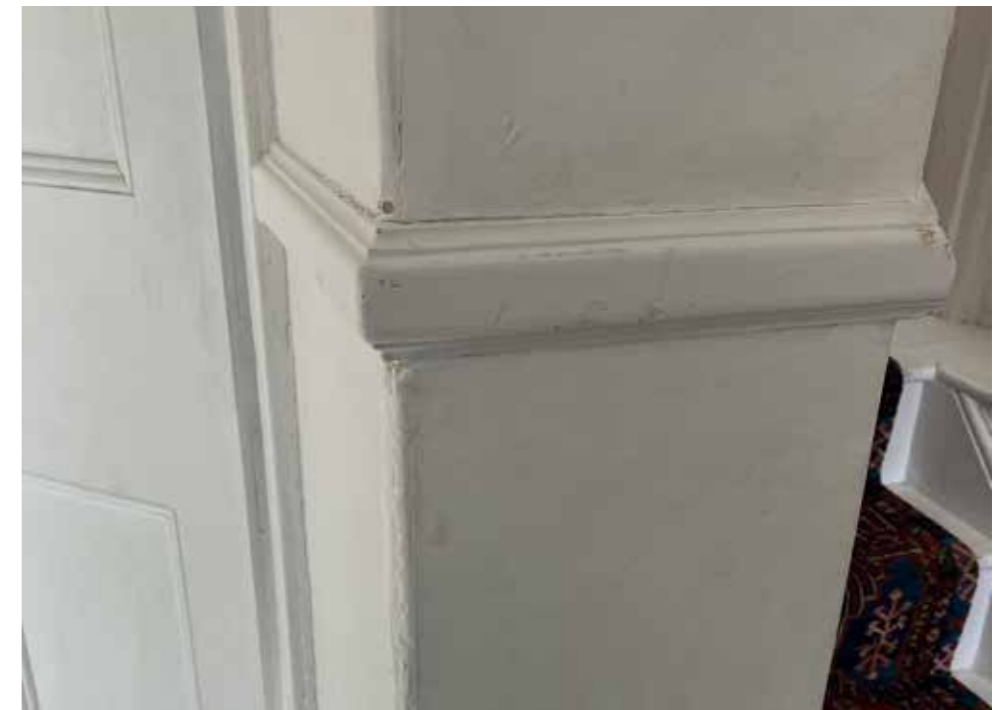
1. Hallway

3. Existing front door and architrave retained, cleaned and cracks repaired where possible.

4. Existing skirting, architraves, window cills and woodwork filled, cleaned and made good.

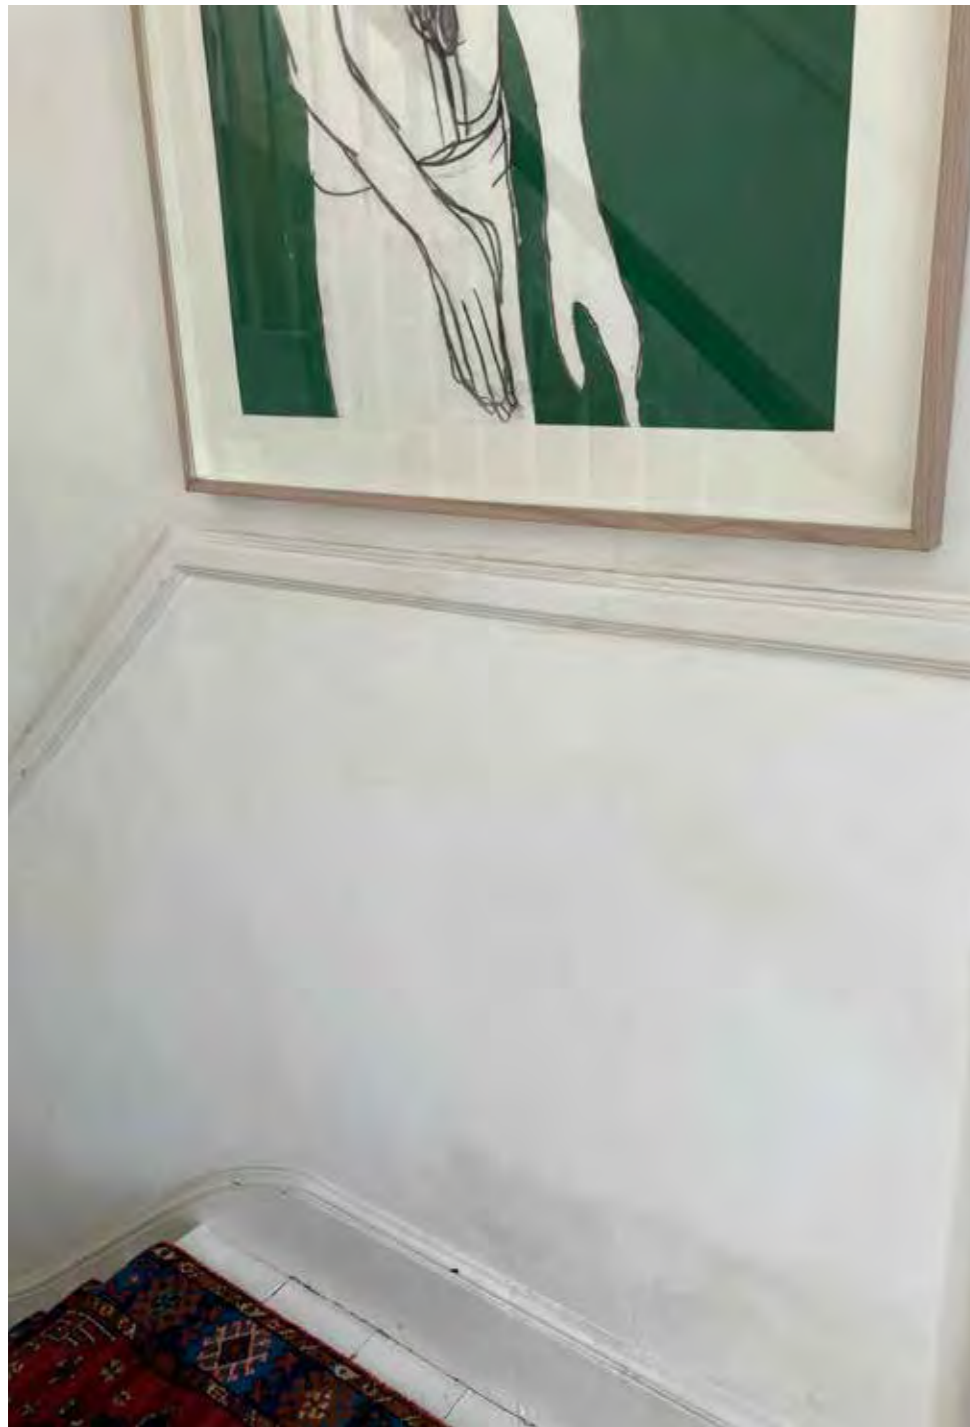
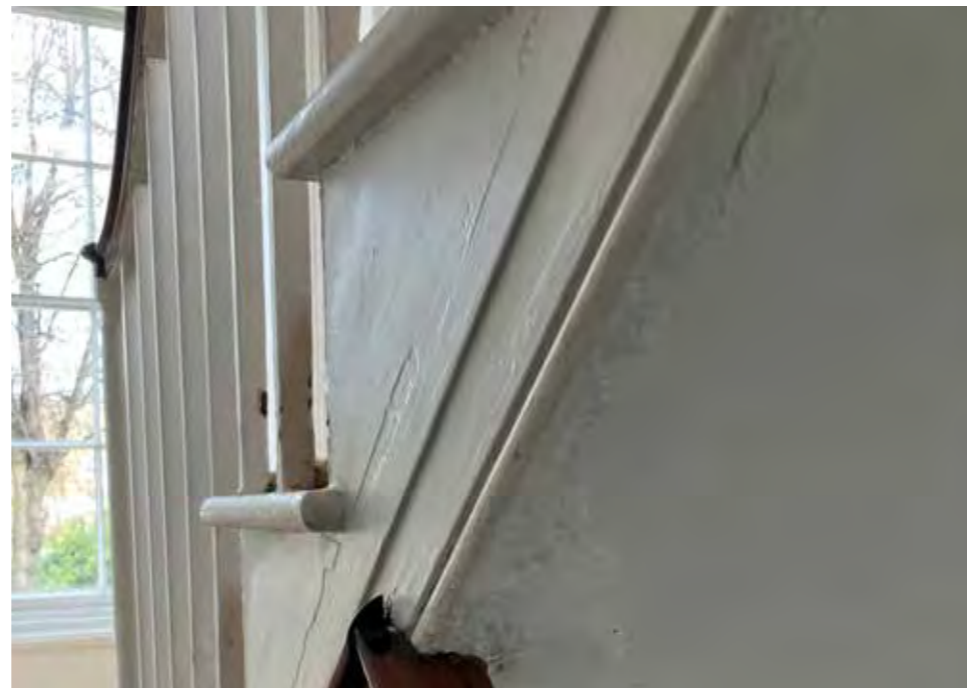
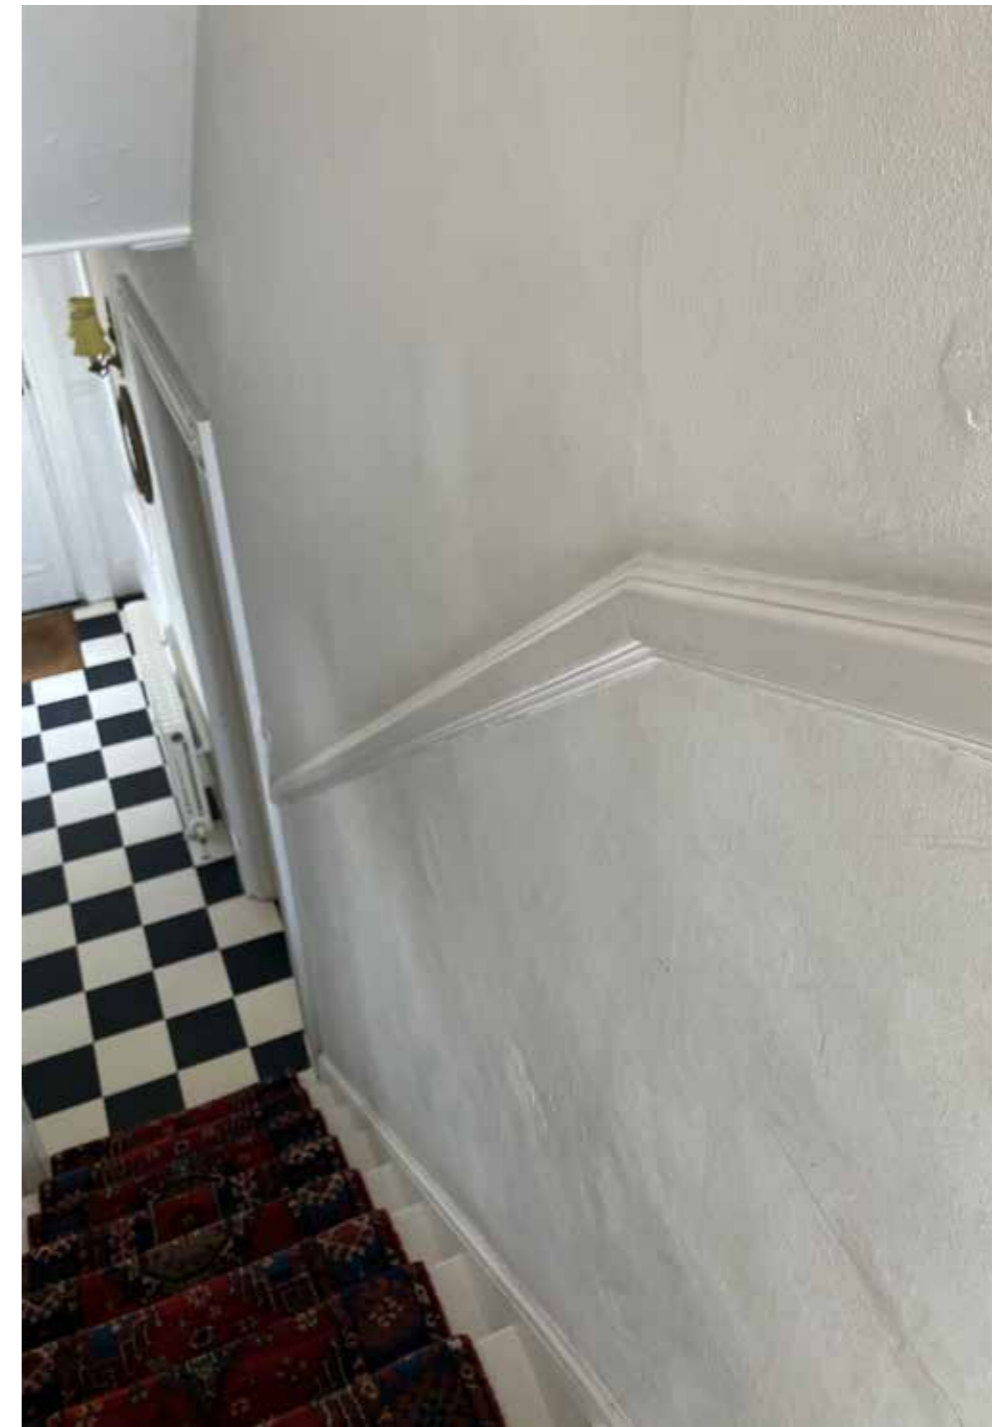
1. Hallway

5. Damaged wall and ceiling linings removed and replaced.

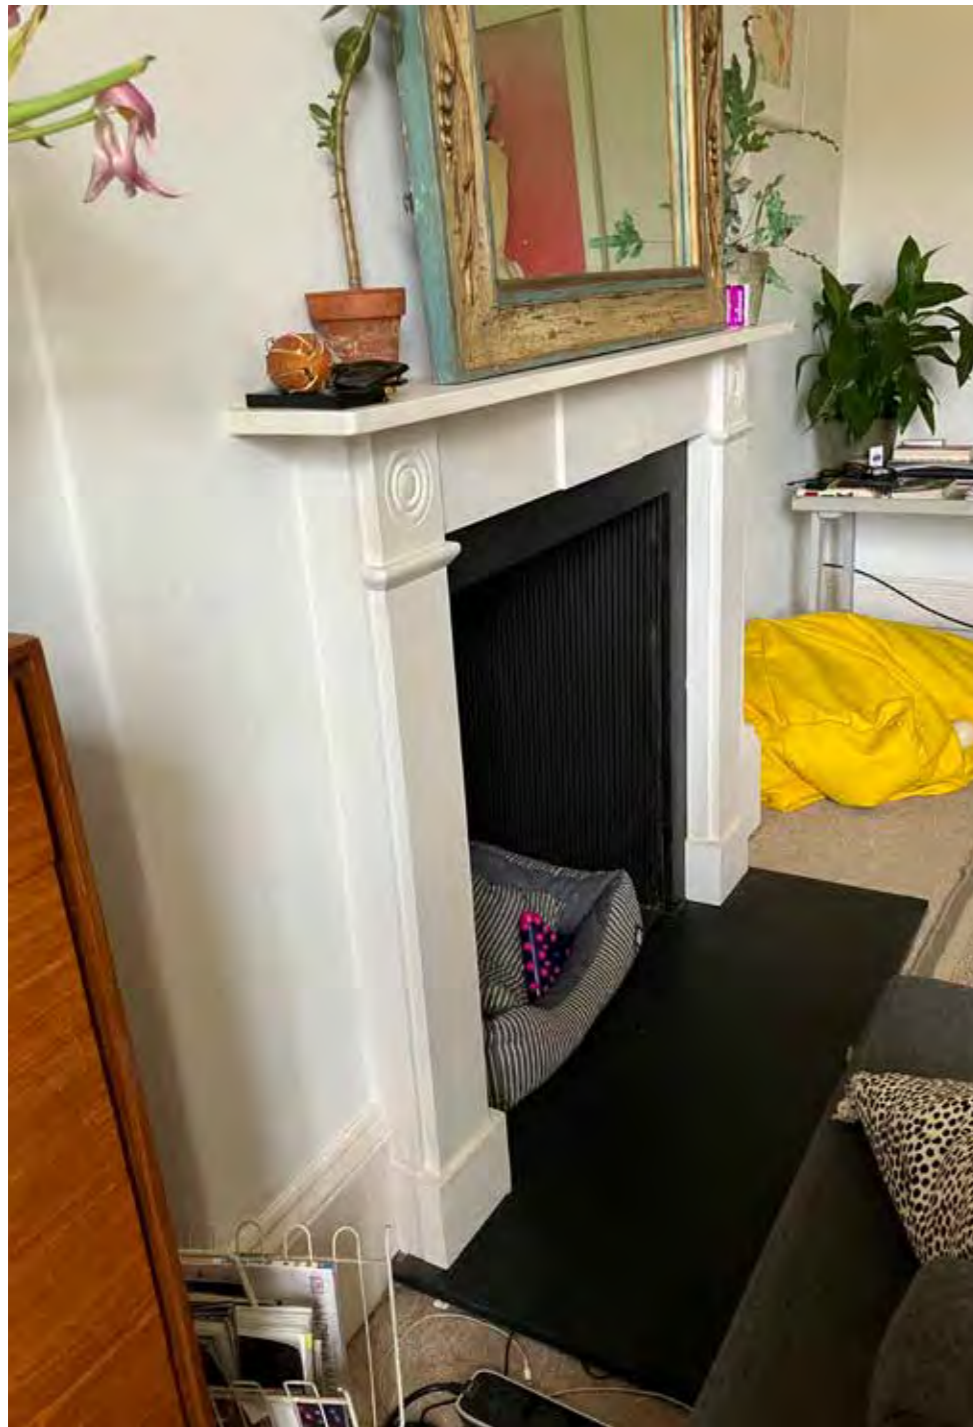
2. Sitting Room

1. Existing fireplace retained and painted to make good.

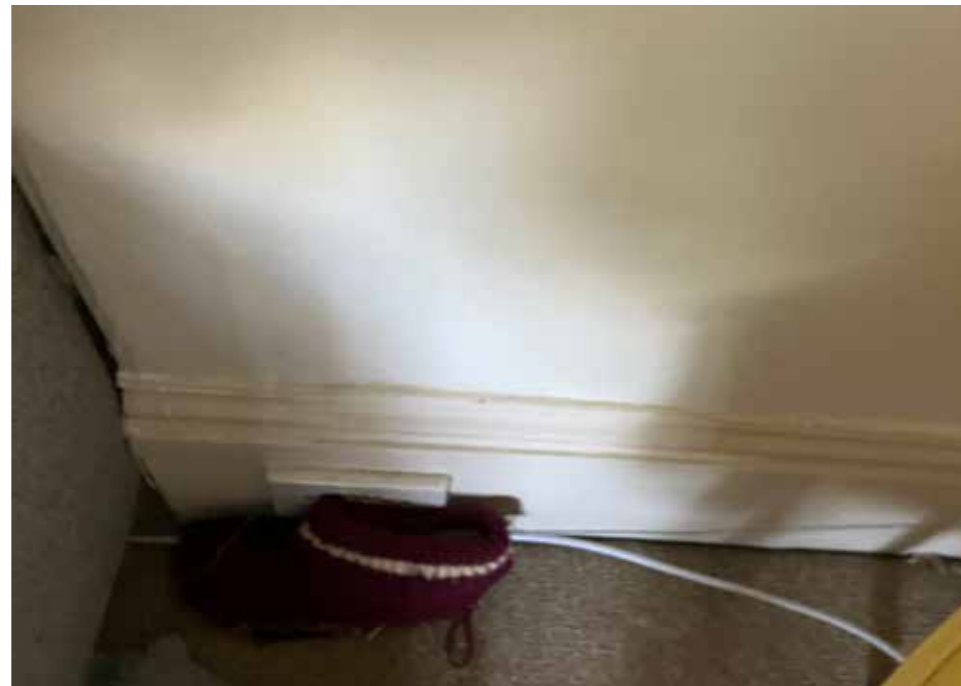
2. Existing skirting repaired where required and redecorated to make good.

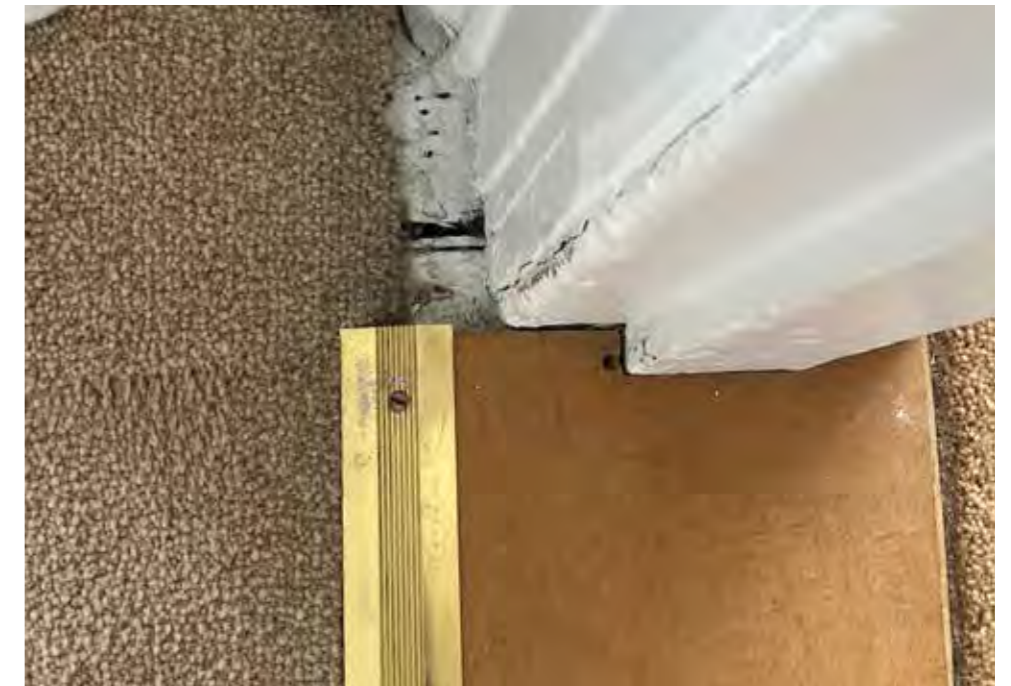
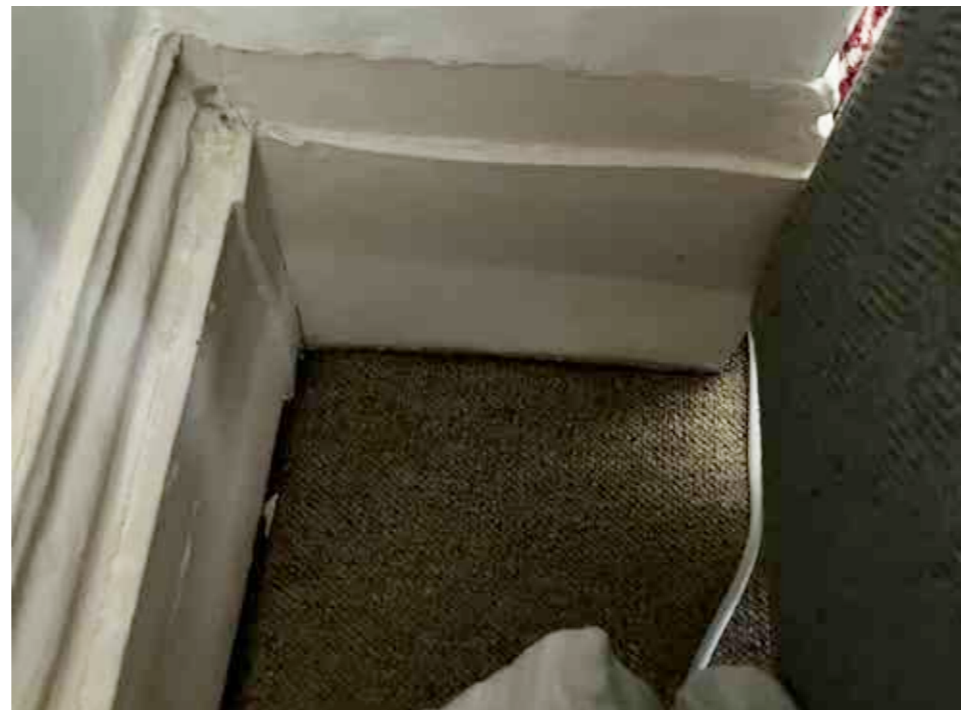
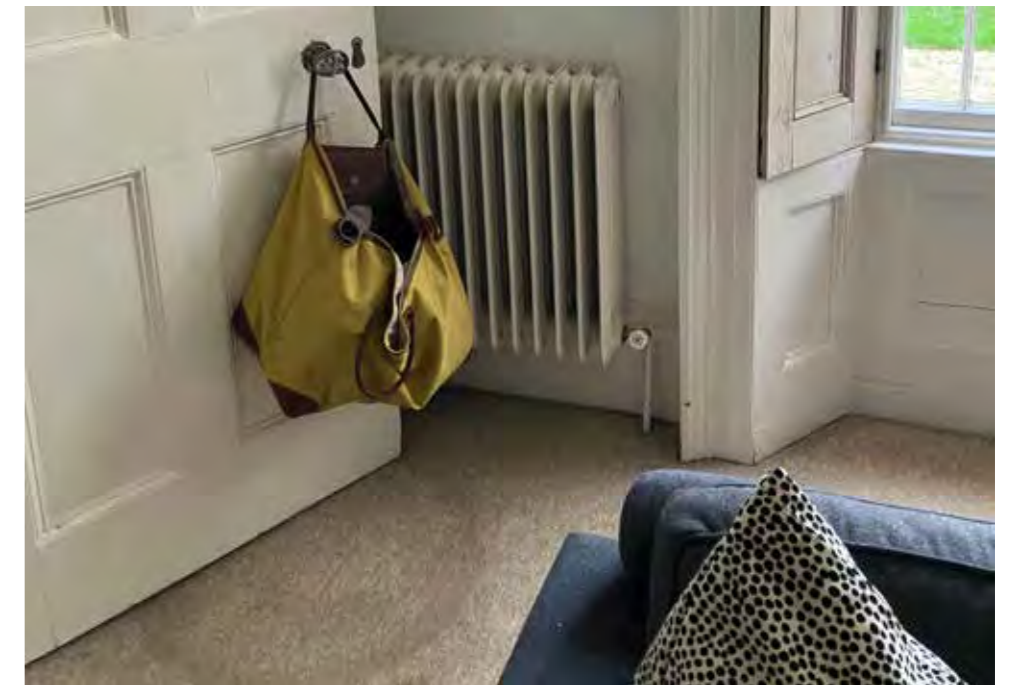
3. Existing damaged carpet flooring carefully removed to reveal original floorboards.

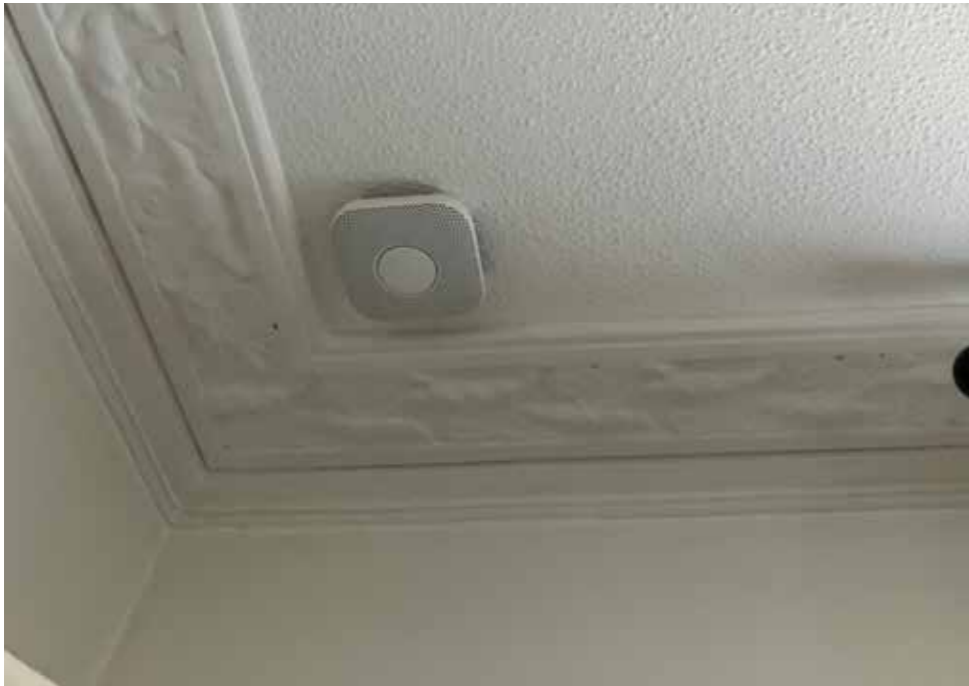
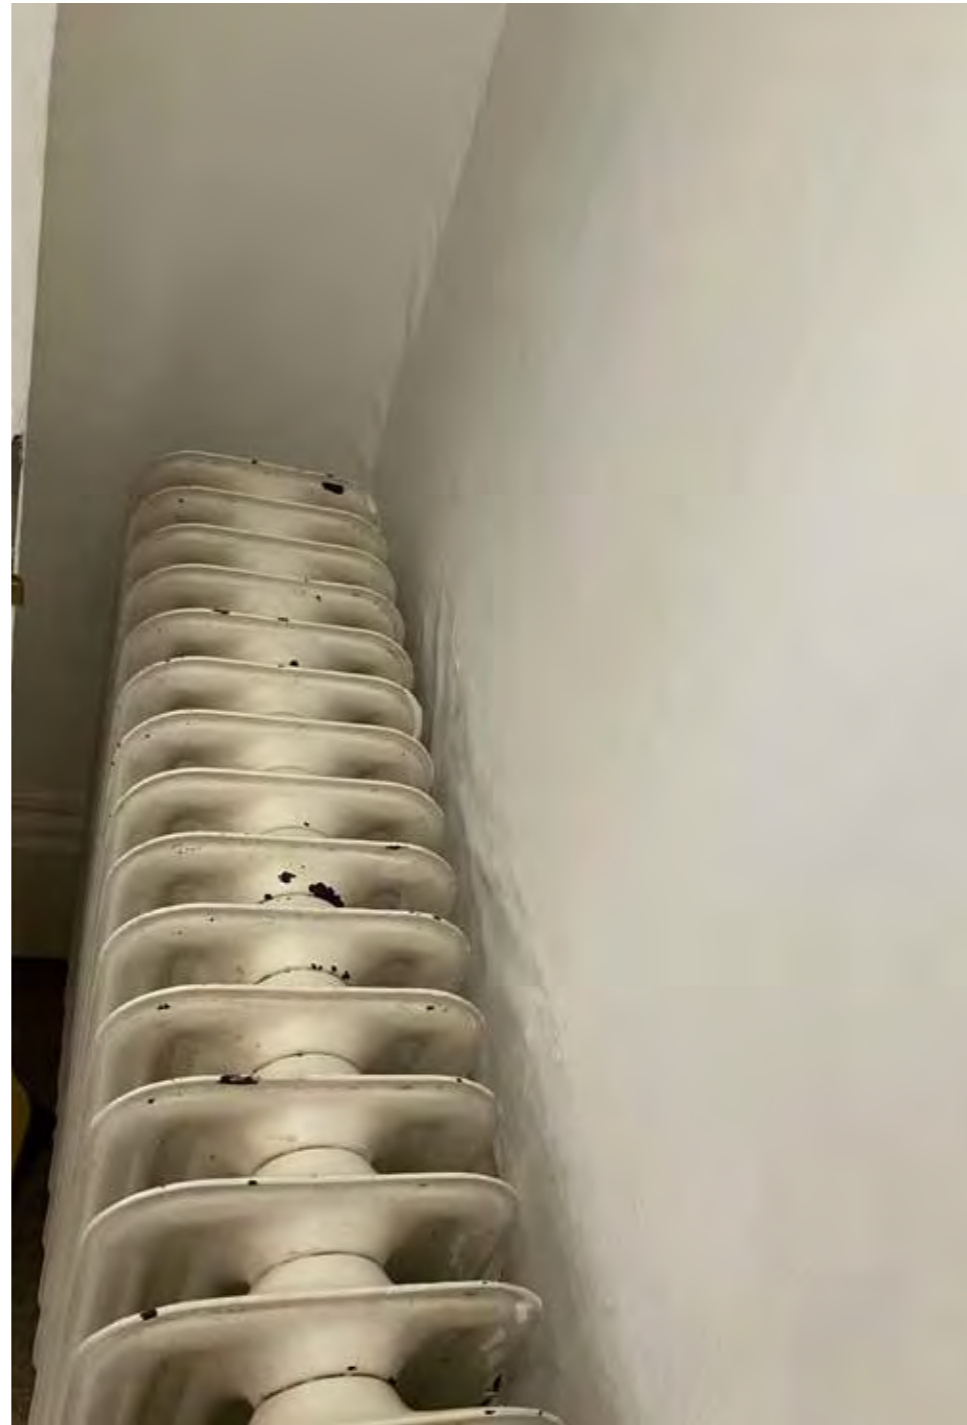
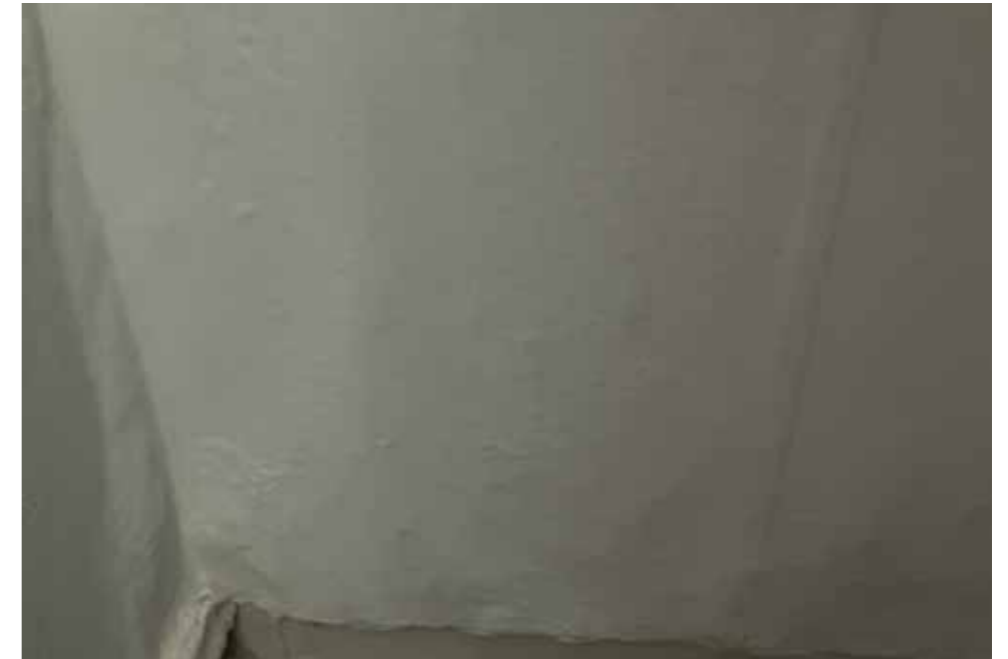
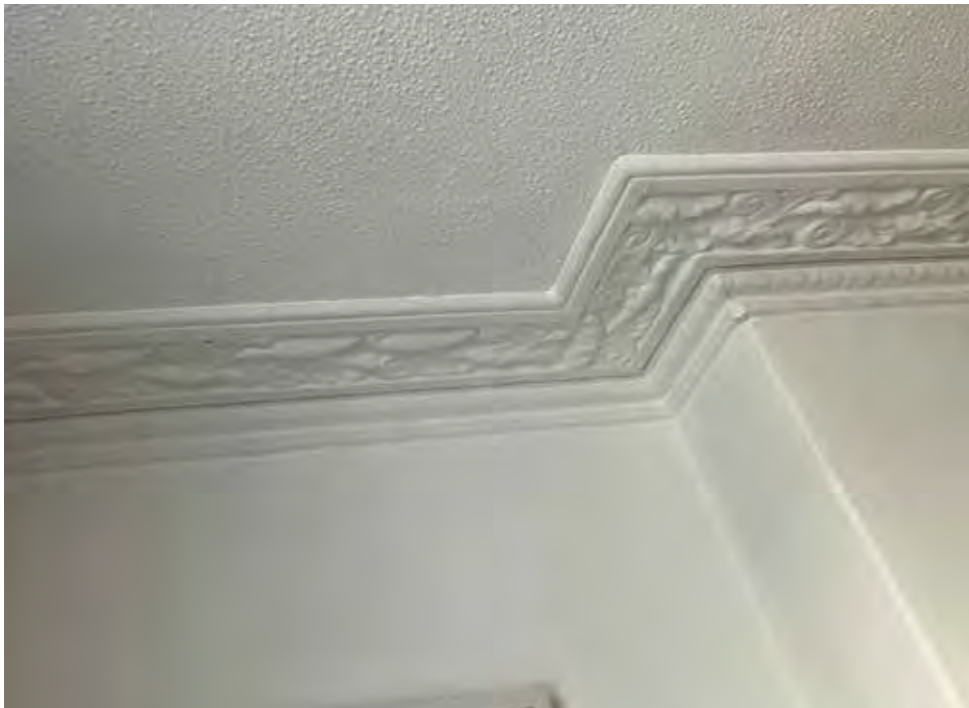
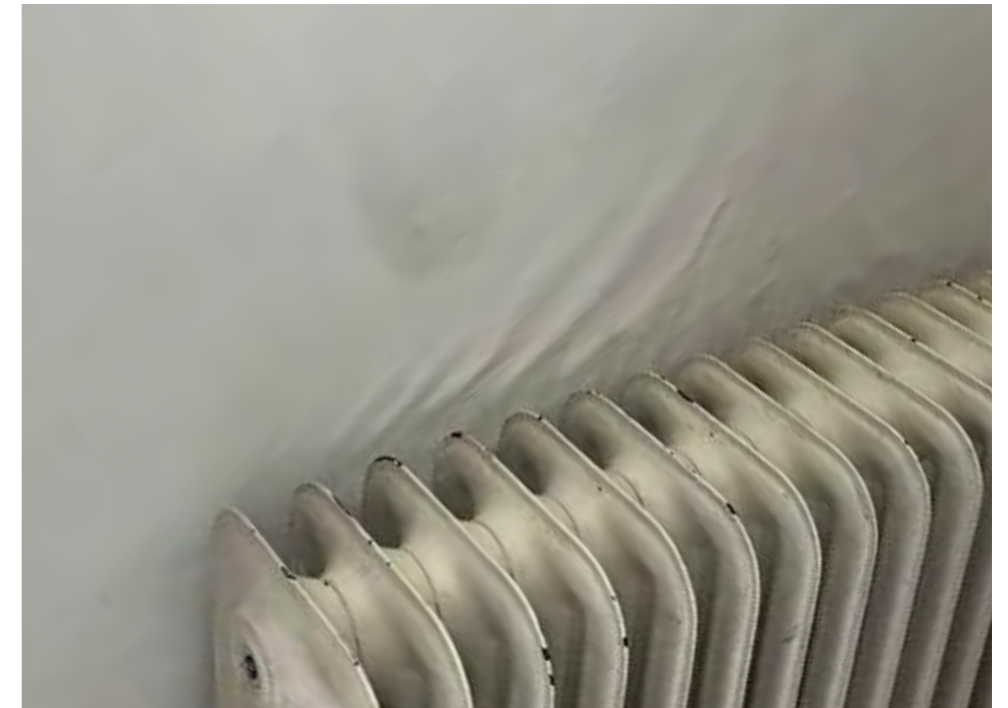
2. Sitting Room

4. Specialist cornice expert will carefully remove existing layers of paint on corncing to reveal existing moulding and decorate.

5. Damaged wall and ceiling linings removed and replaced.

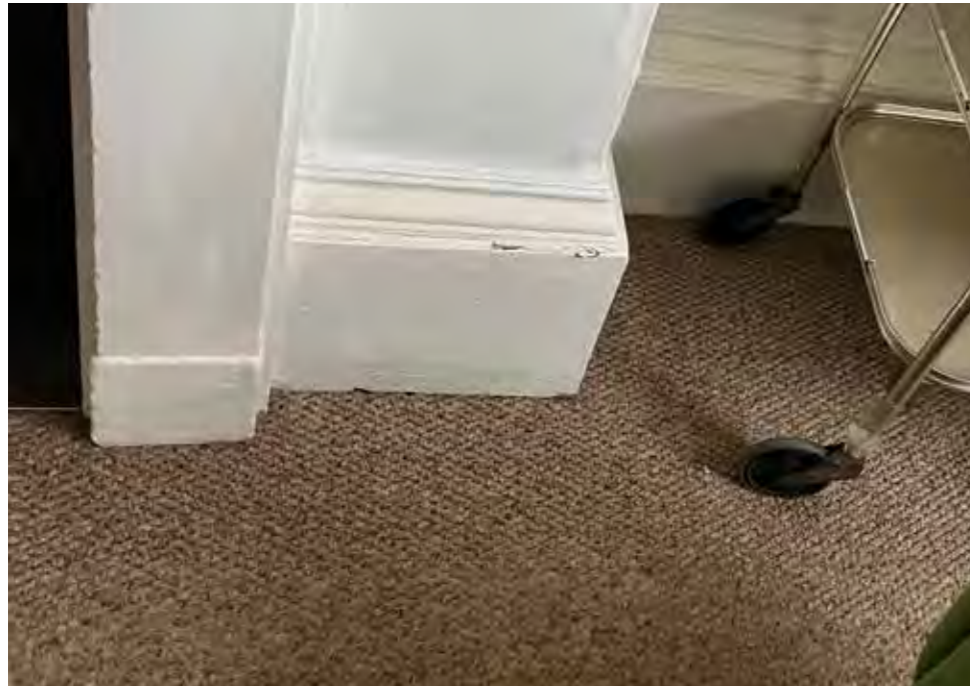
3. Study

1. Existing skirting repaired where required and redecorated to make good.

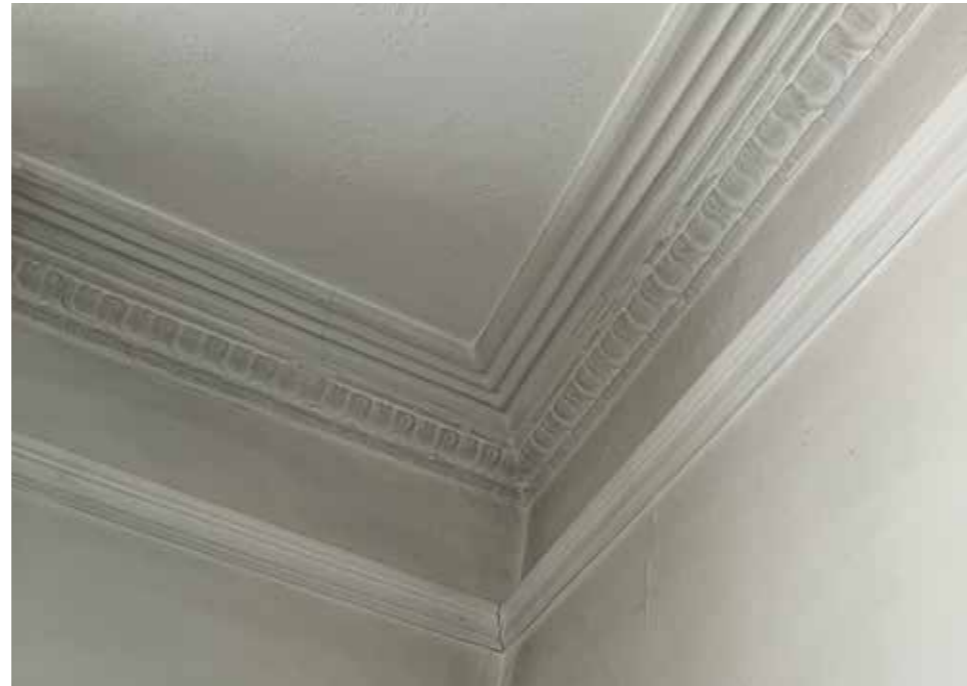
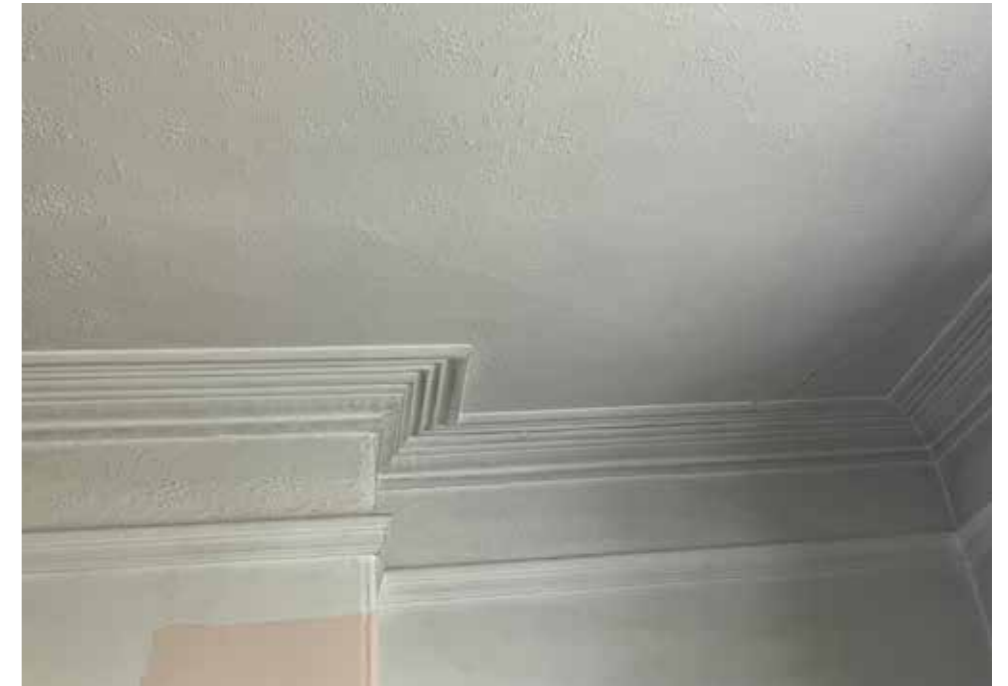
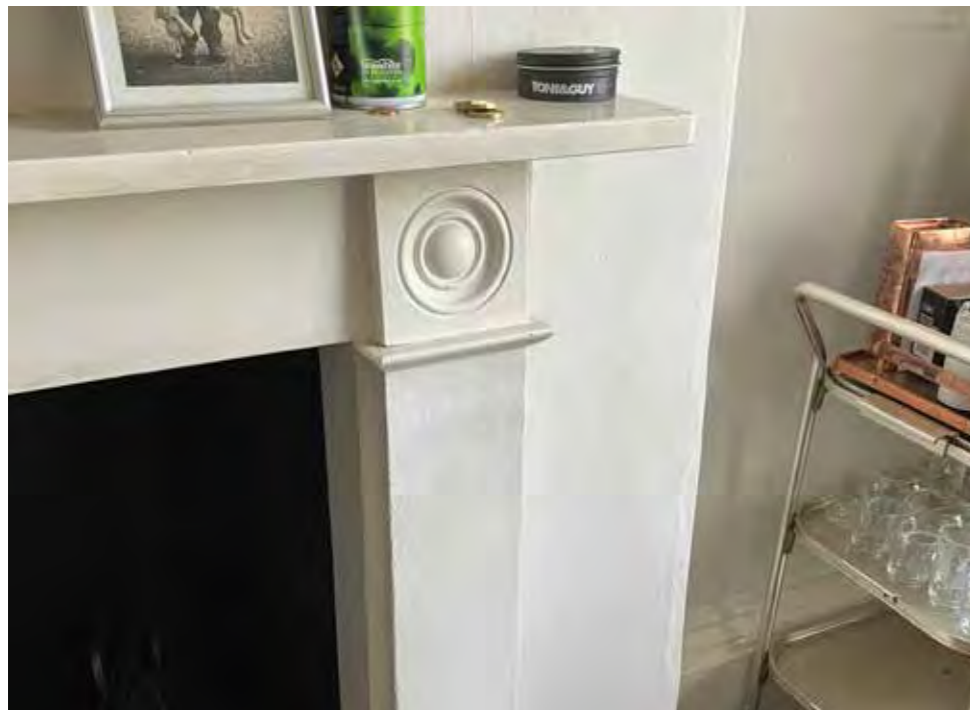
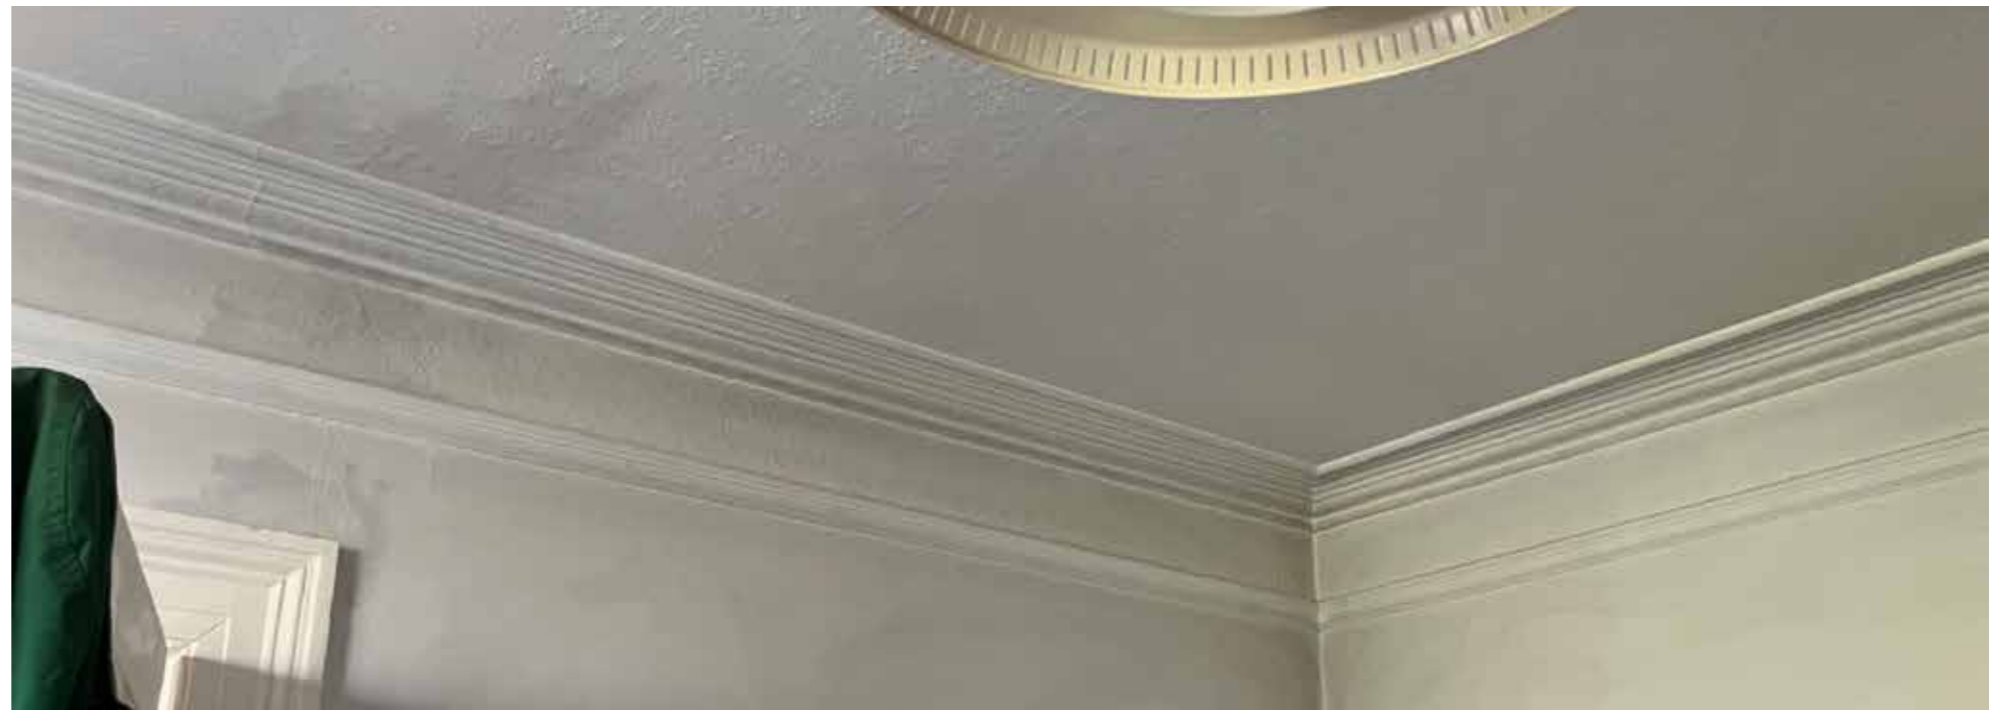
2. Specialist cornice expert will carefully remove existing layers of paint on cornicing to reveal existing moulding and decorate.
