Adelaide House, 16 Park Road, Teddington TW11 0AG

Schedule of Repairs & Construction Method Statement for works to a Listed Building

30 June 2022

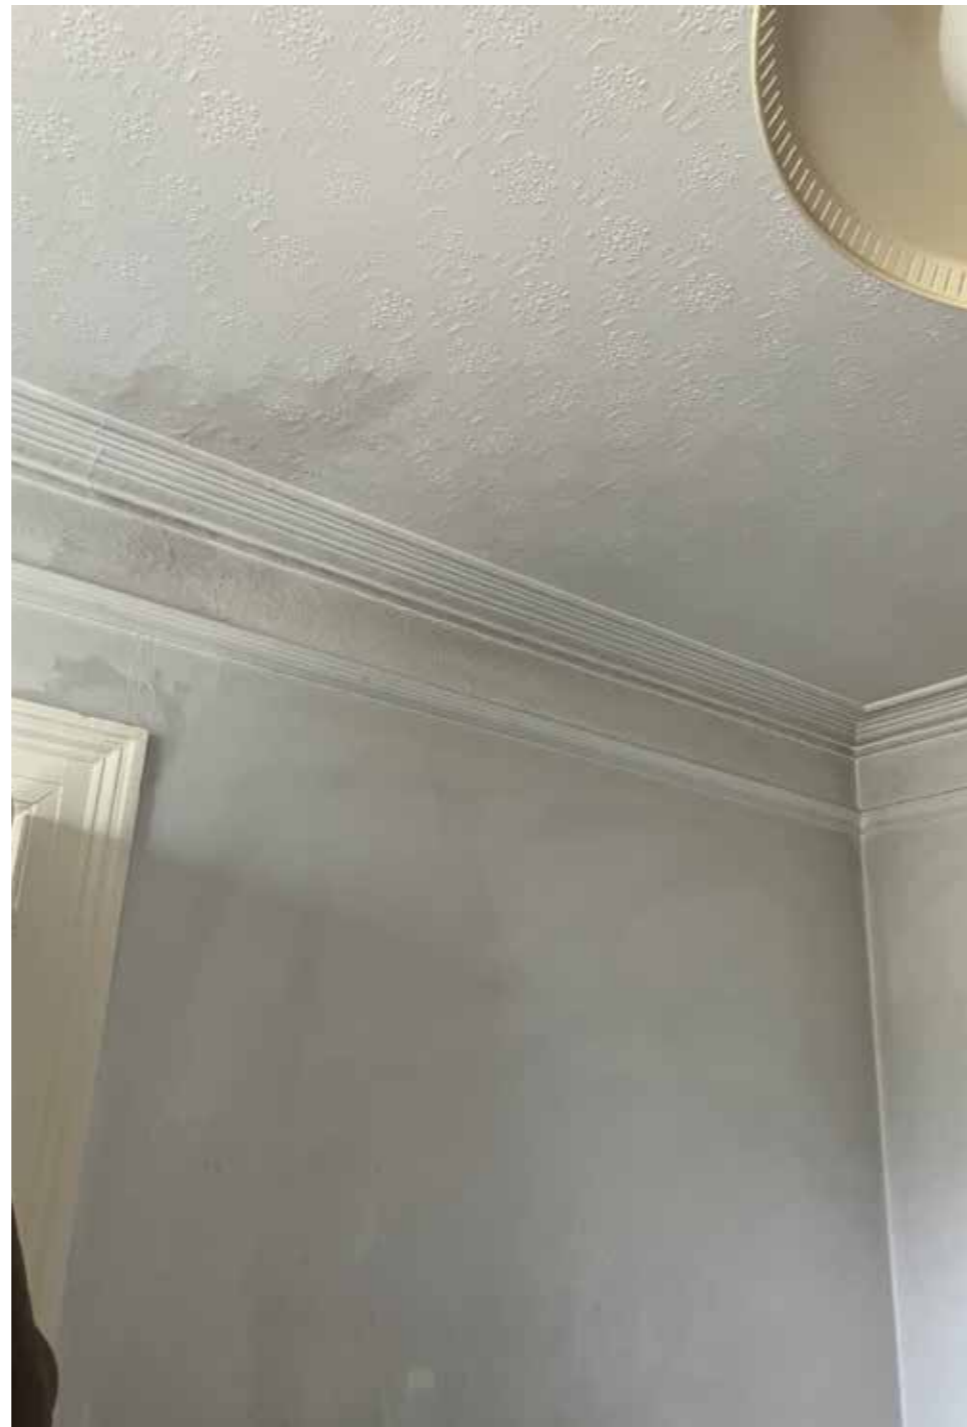
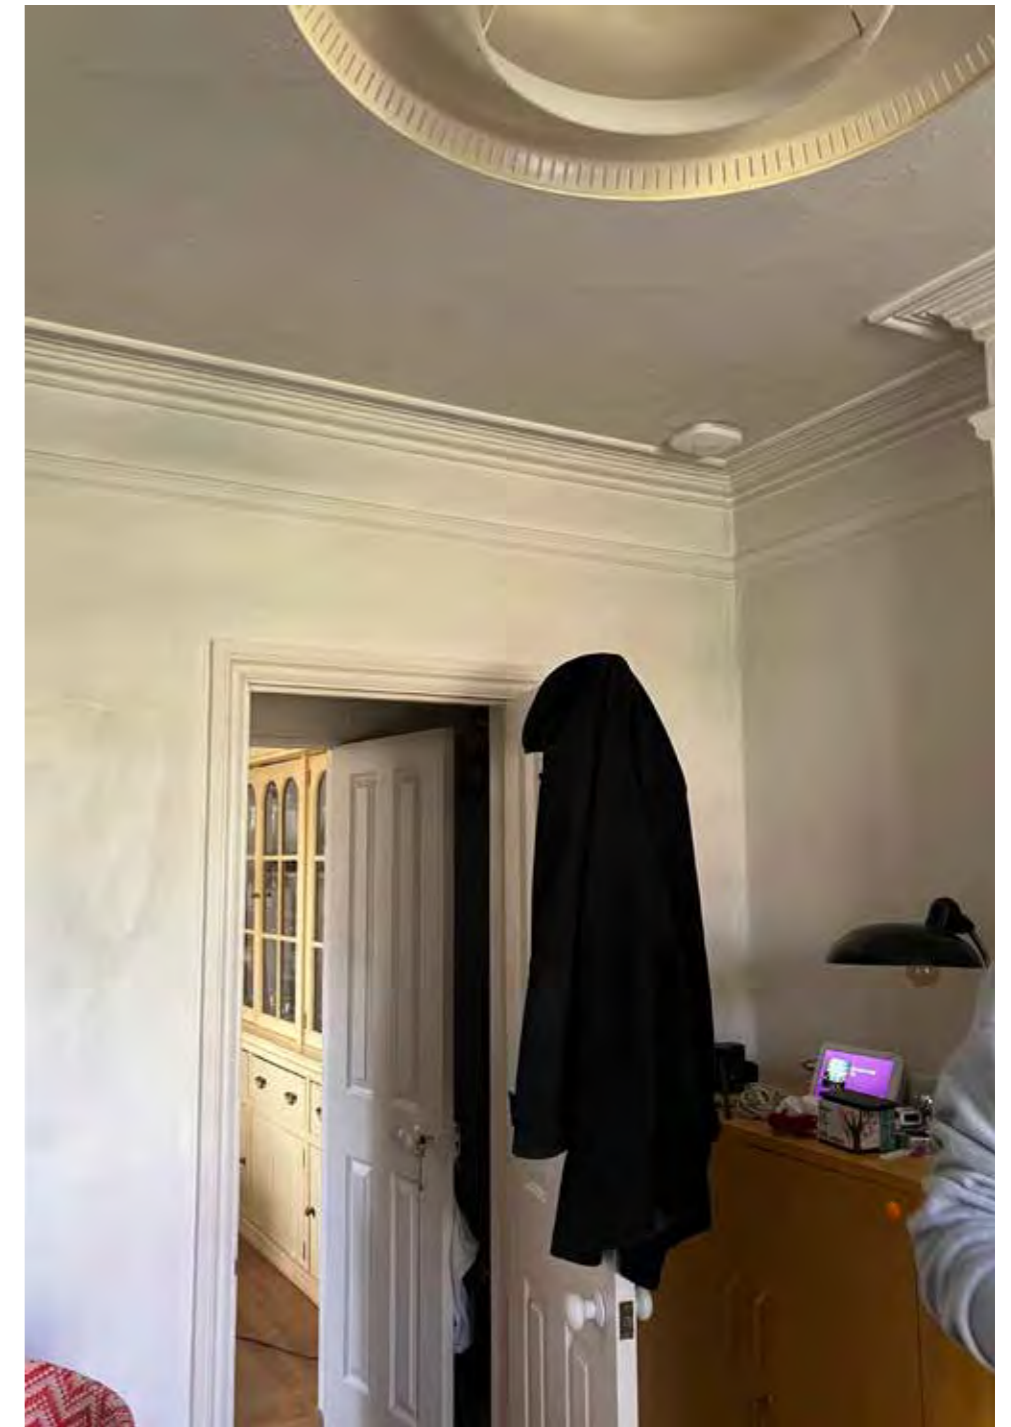
5. Damaged wall and ceiling linings removed and replaced.

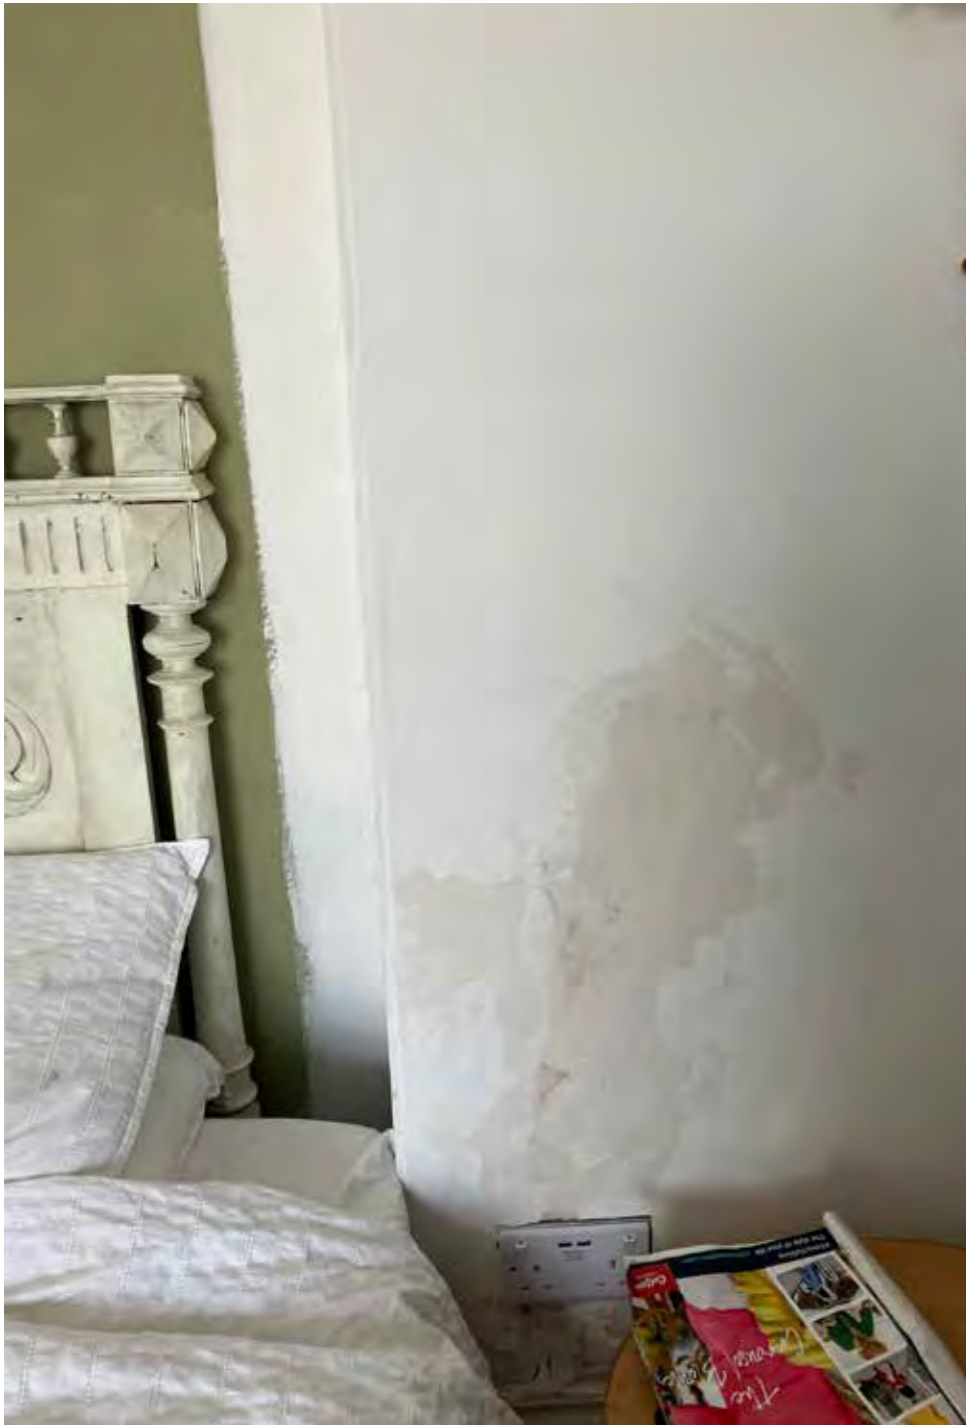
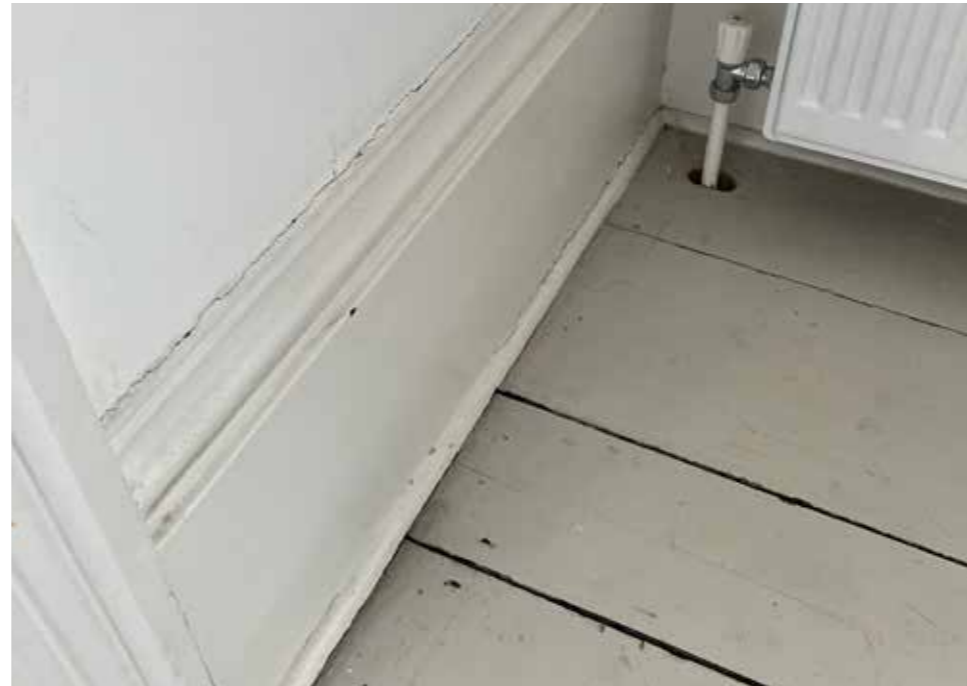
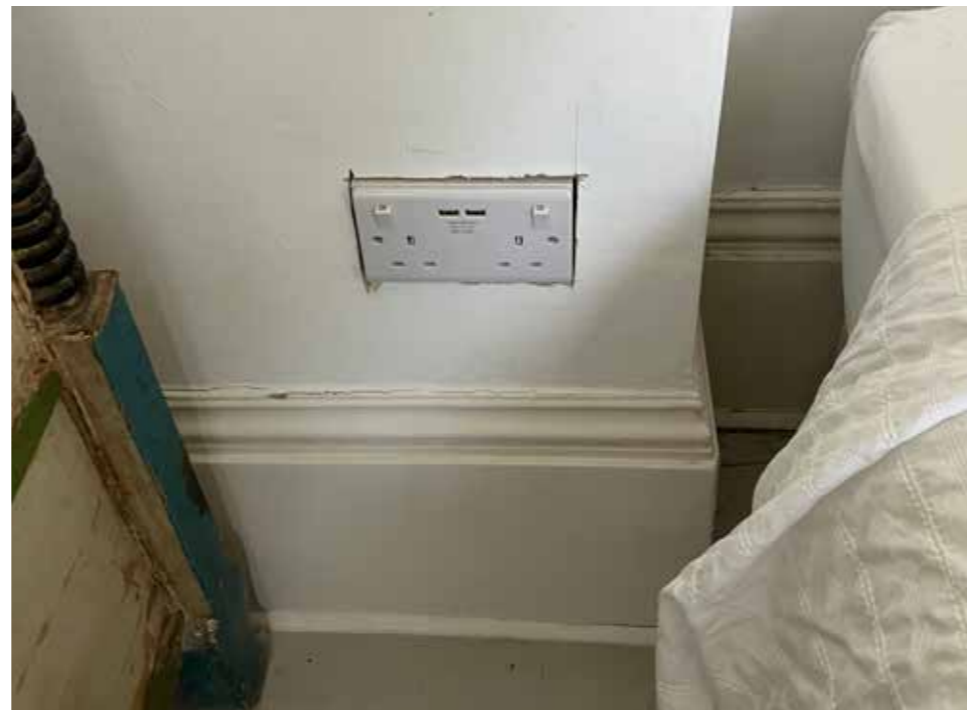
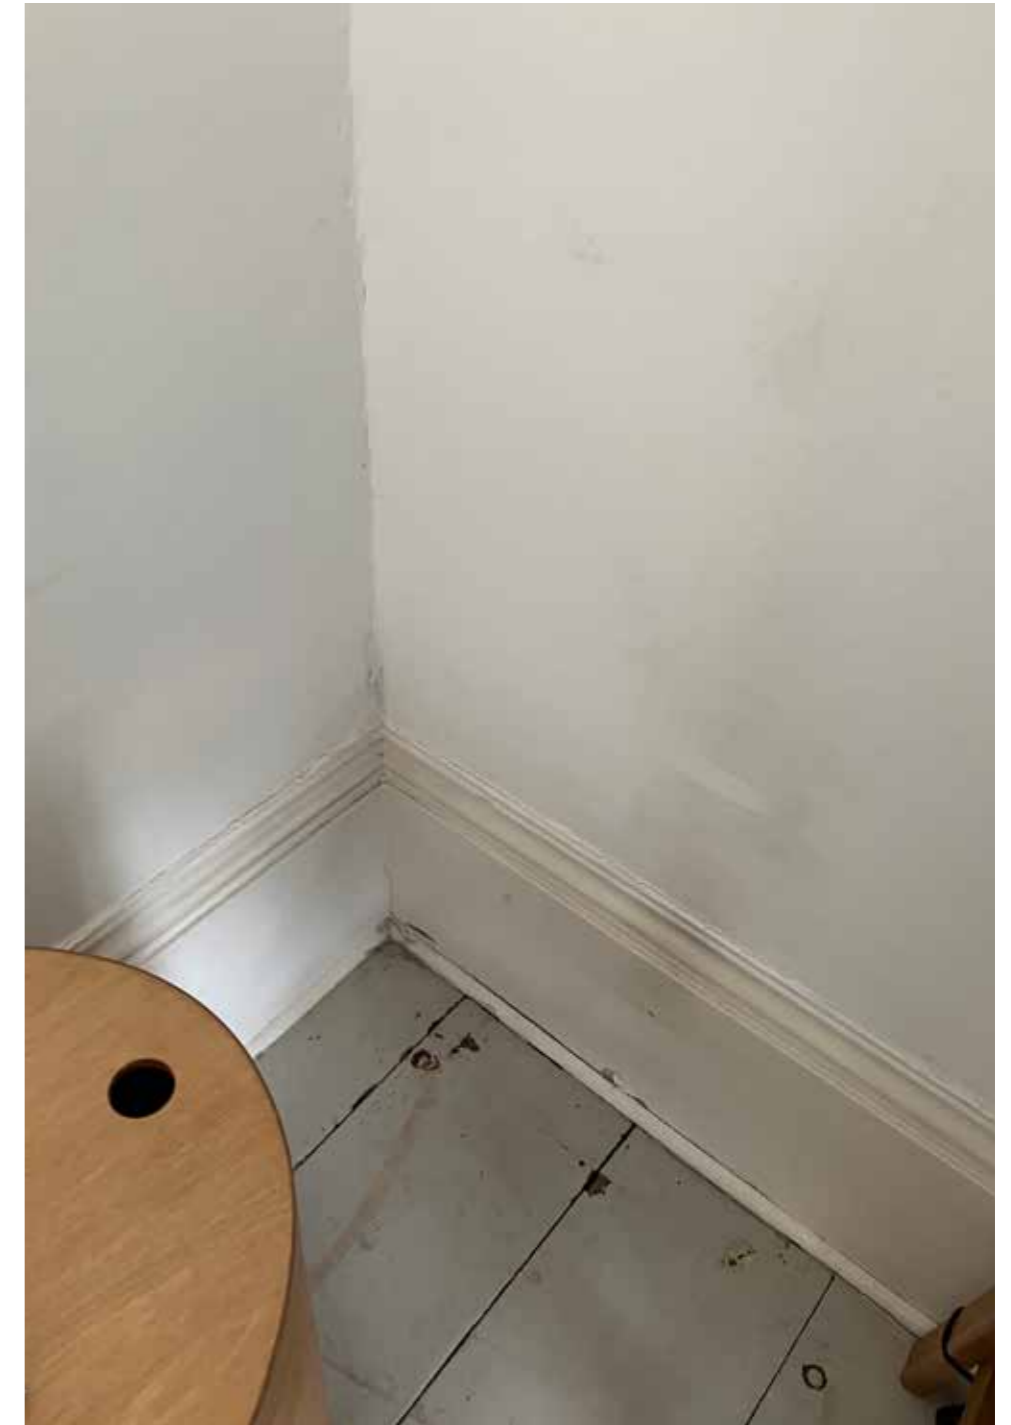
4. Master Bedroom

1. Cracks and disrepair of walls and skirting to be filled and decorated.

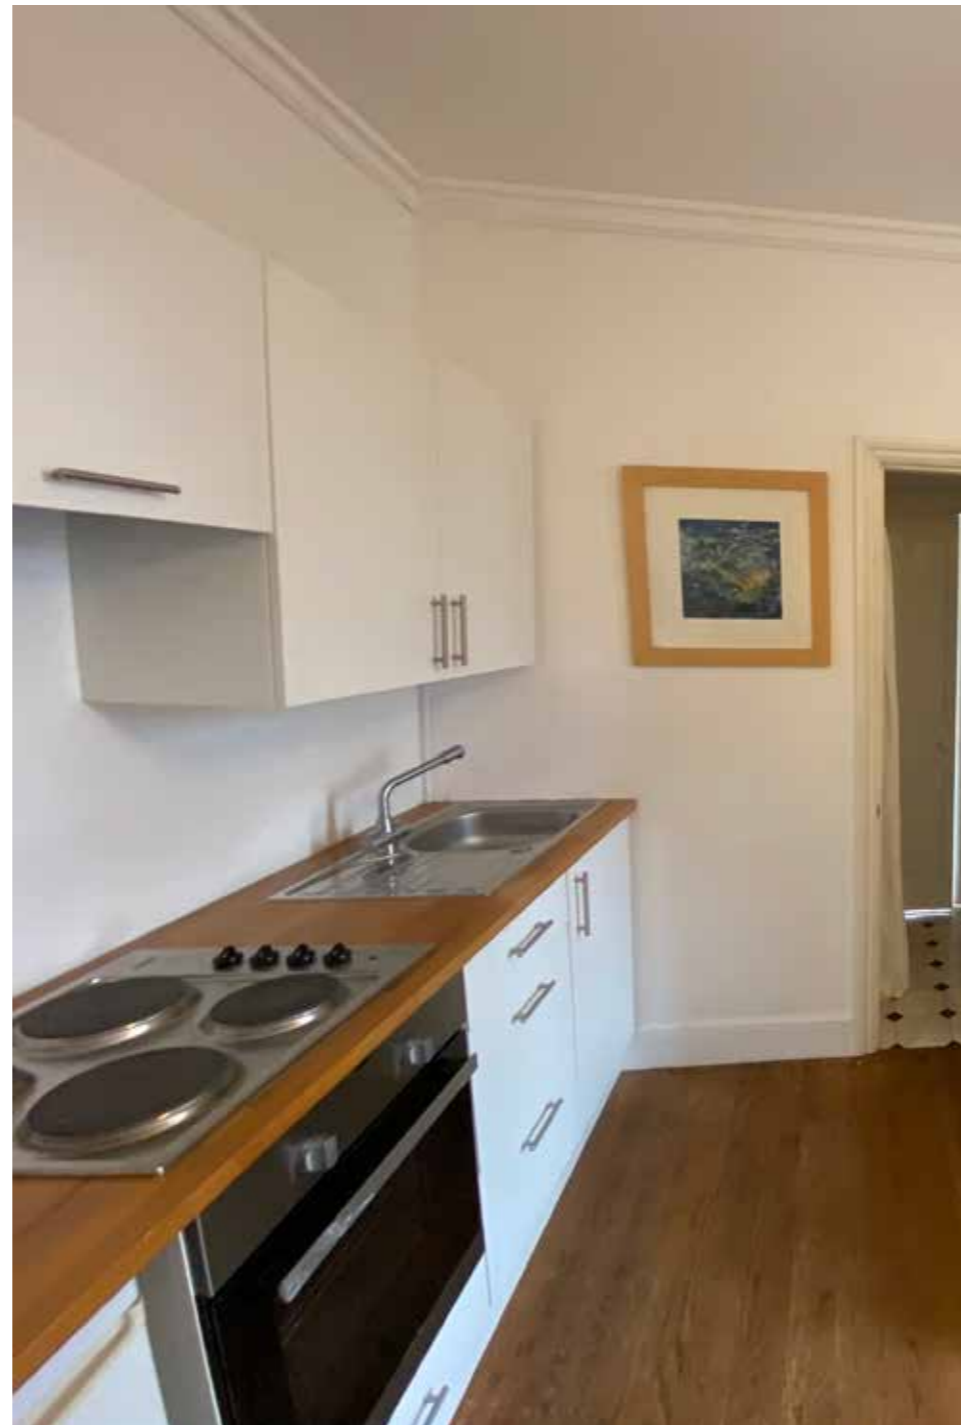
5. Existing First Floor Day Room

1. Existing modern kitchen to be removed

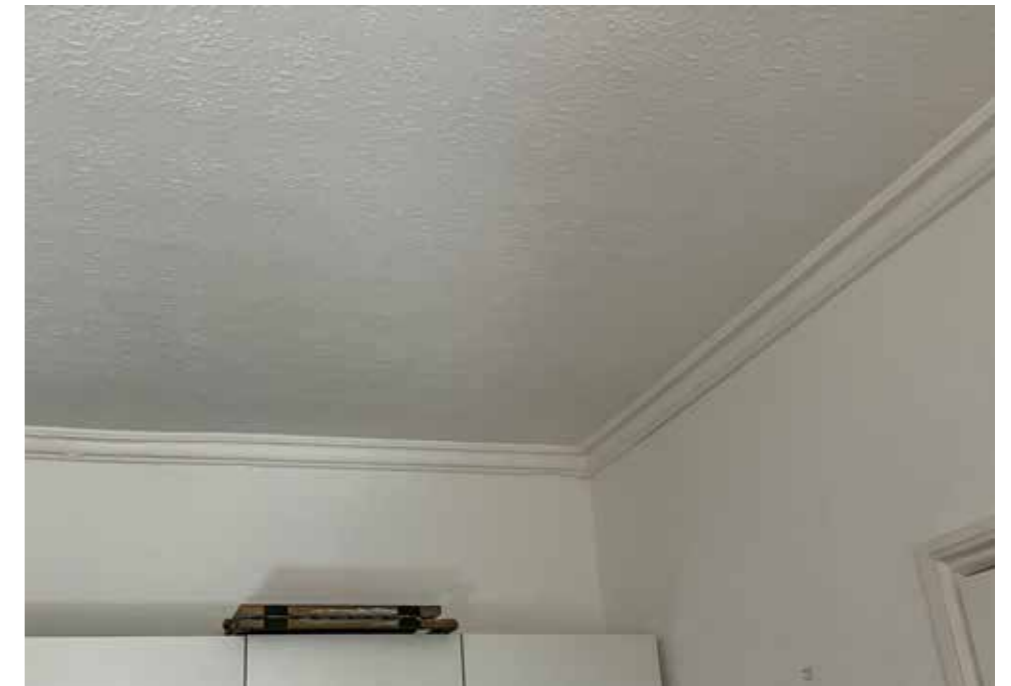
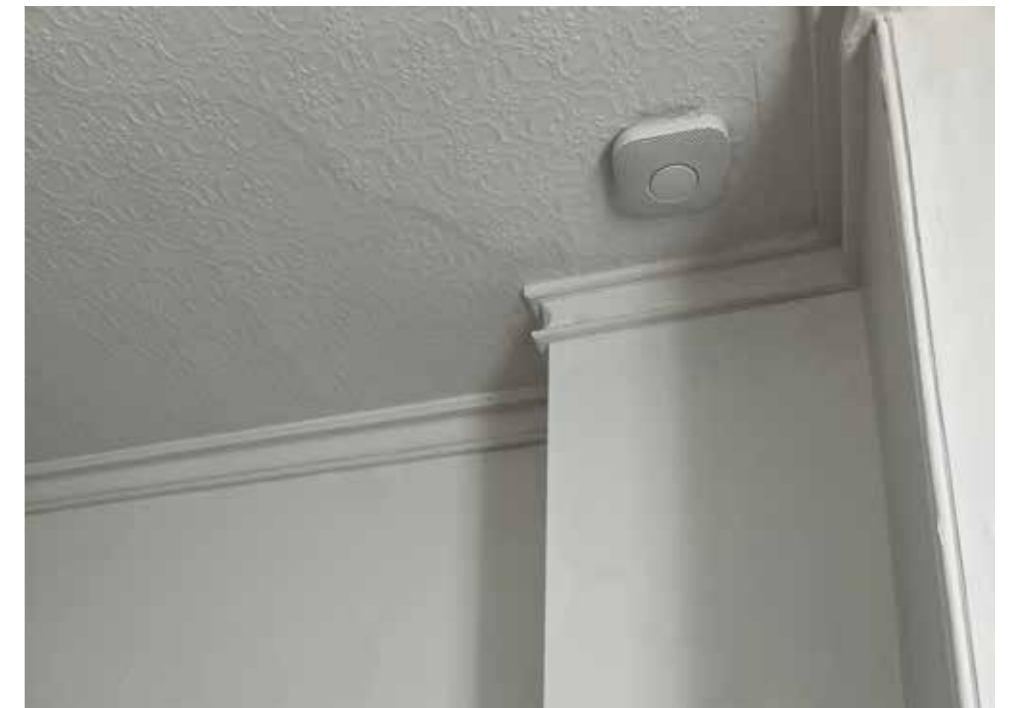
2. Damaged wall and ceilings to be repairs and made good.

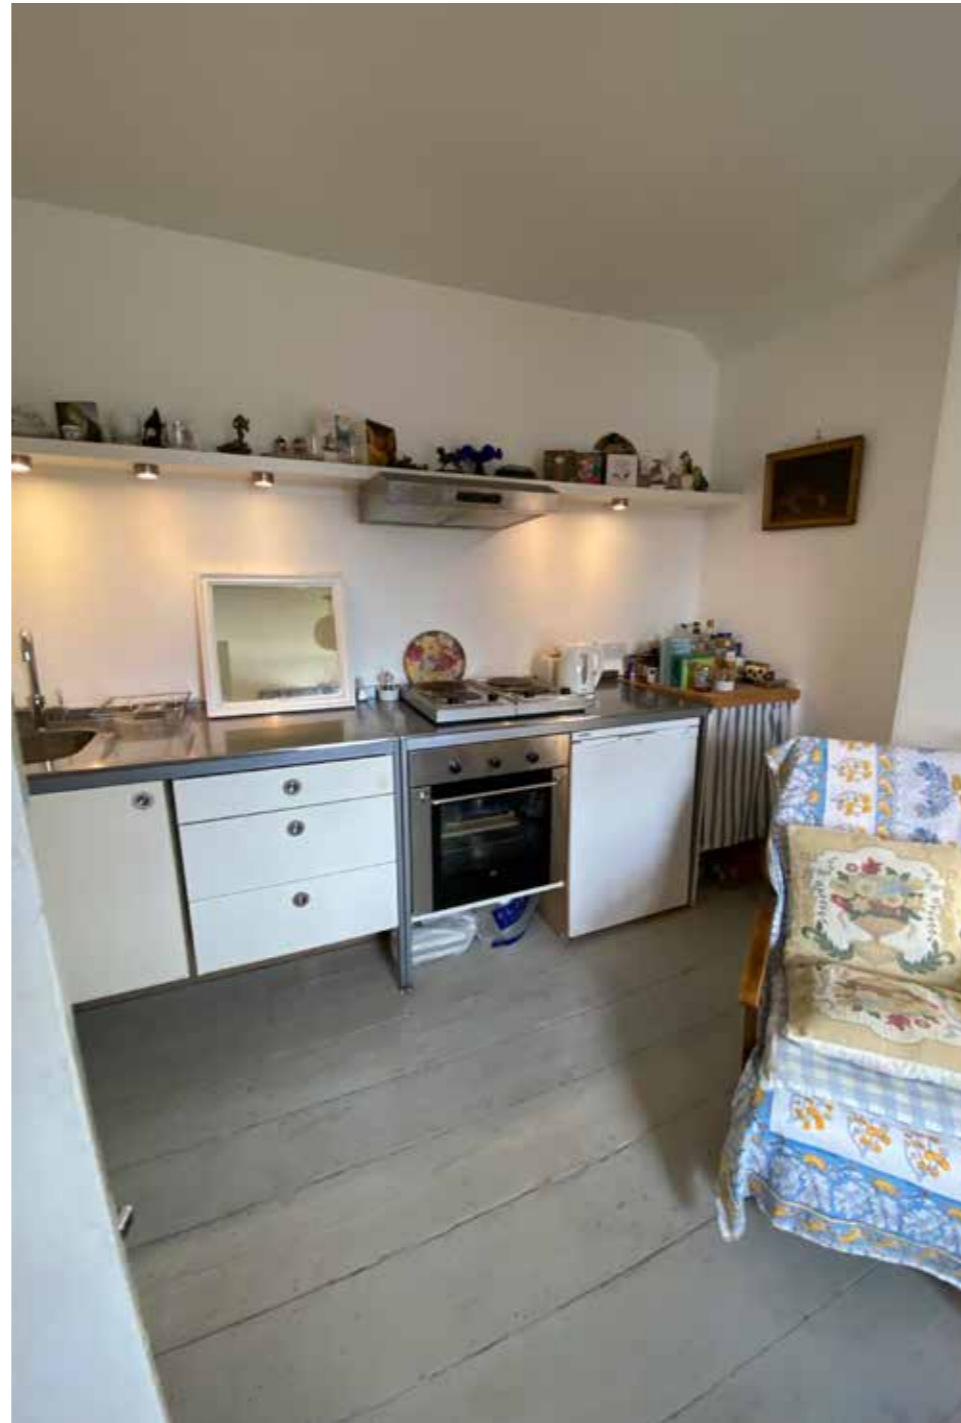
Before (photo taken 04.02.21) :

1. Existing modern kitchen has been removed

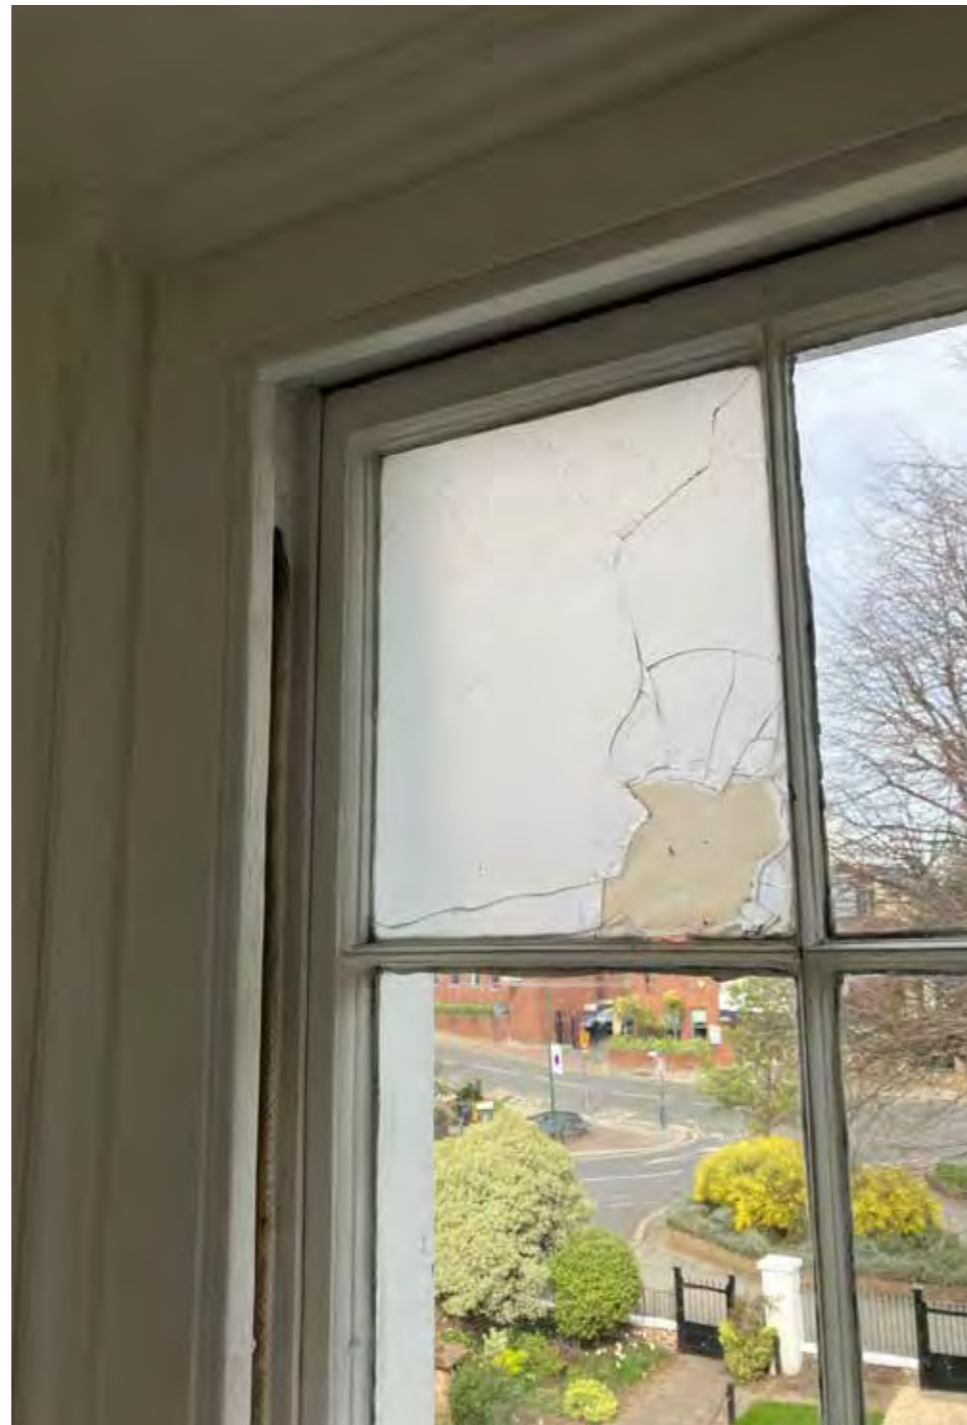
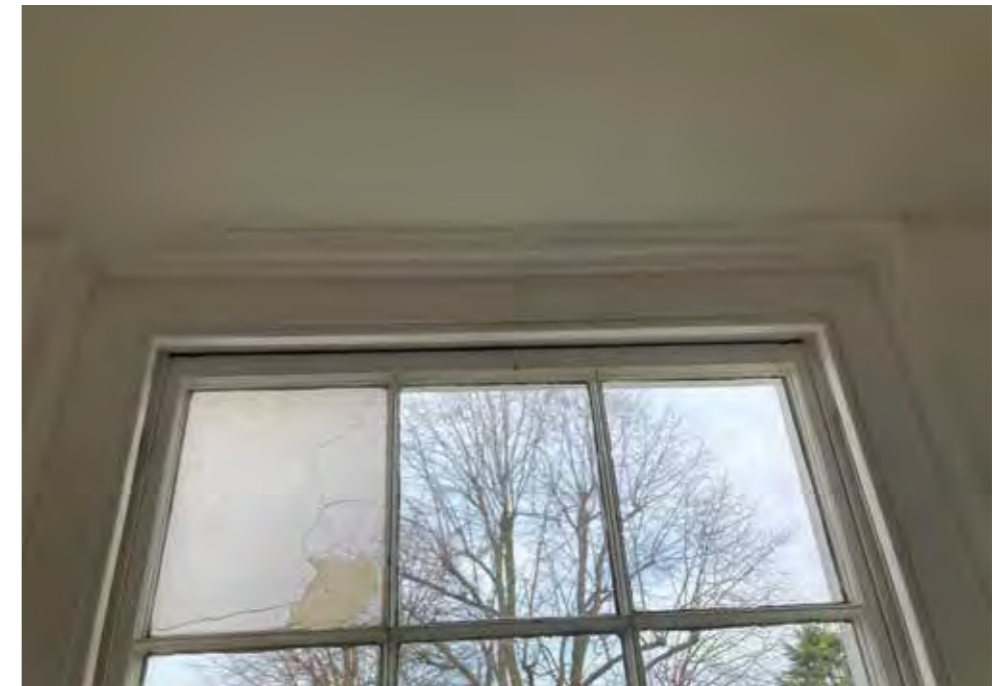
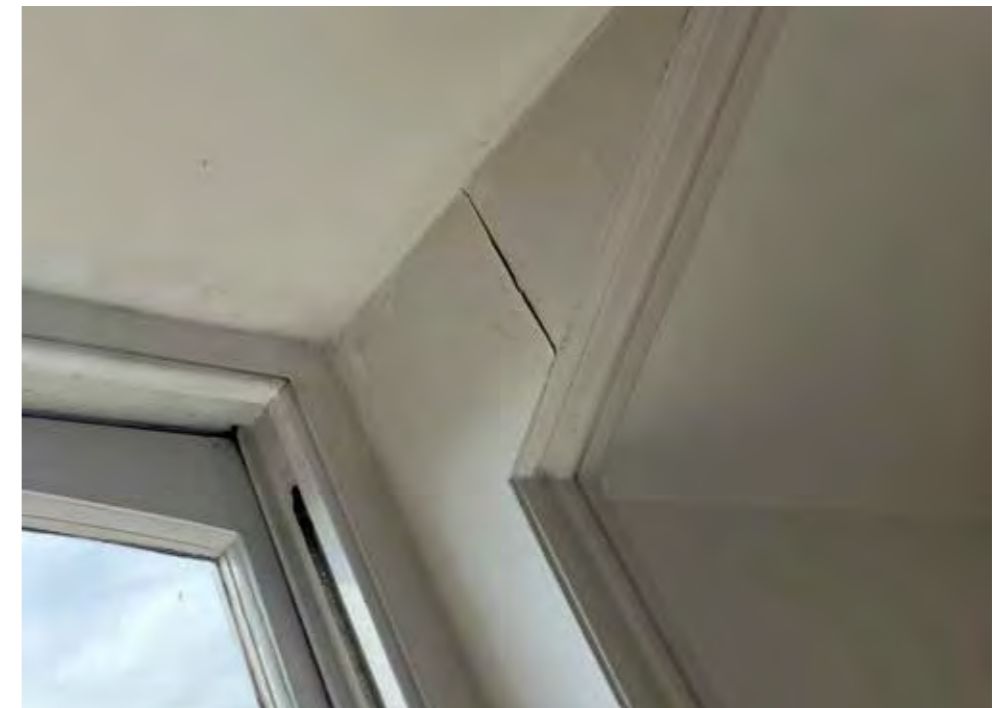
1. Existing broken window repaired and frame made good.

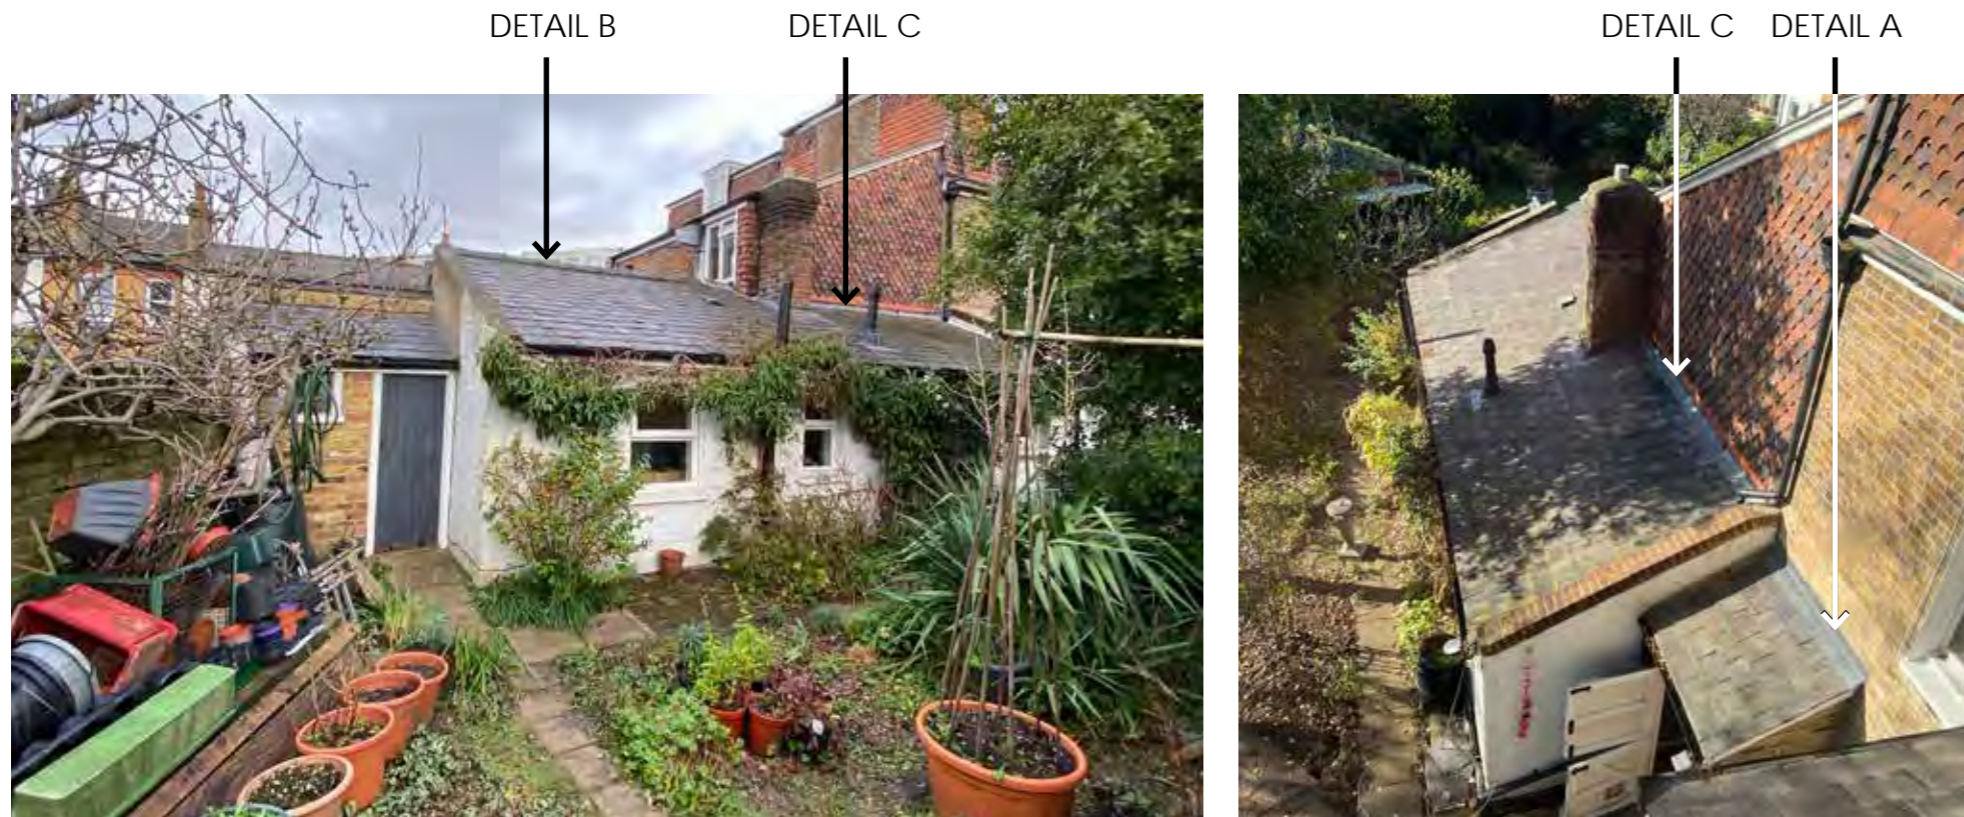
Photos of Existing Rear extension

The existing outbuilding extension is constructed from a single skin of in brickwork, with timber roof joists, slate tiles.

Apart from the small lean to entrance on the right hand side, this structure abuts the solid brick Party Wall of No.14.

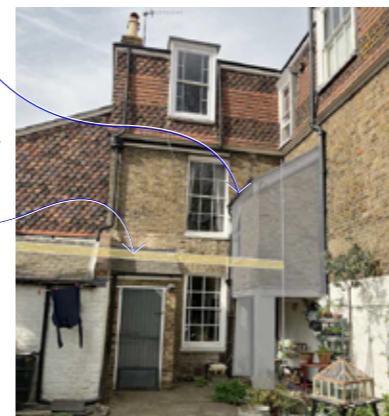
Illustration of Timber Wall Plate

Timber Wall Plate resin bolted to existing blockwork. Minimal connection to existing building.
