3.1.3 Holly Road, South

3.2 Previous reports

3.3 Ground conditions

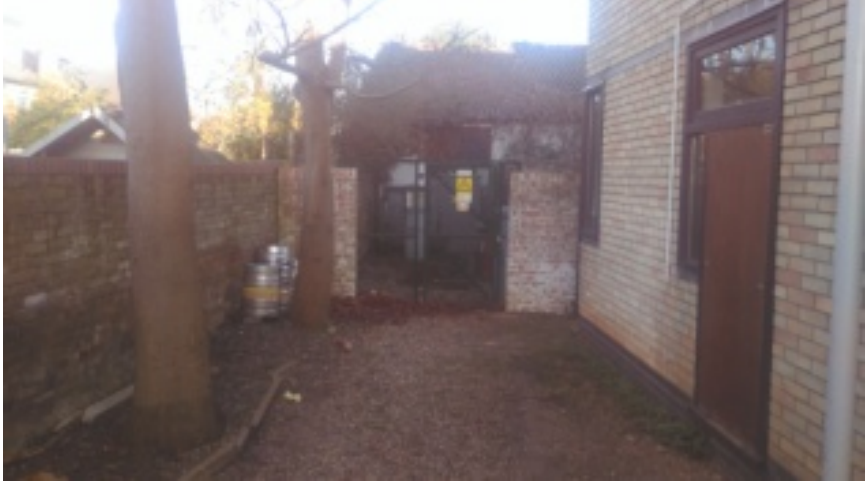
| Photo No. 7 | Date: 26.03.2018 | |

| Description: Business Park – Electrical substation located in south-eastern extents | | |

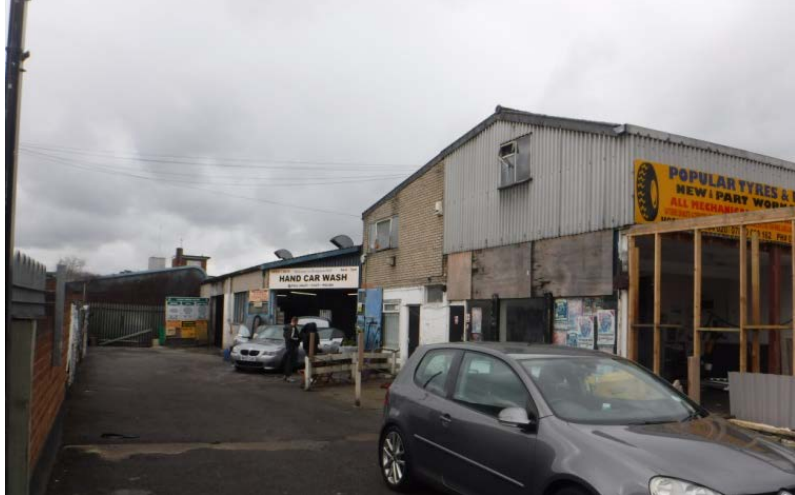
| Photo No. 8 | Date: 26.03.2018 | |

| Description: Car wash present land use – active car wash | | |

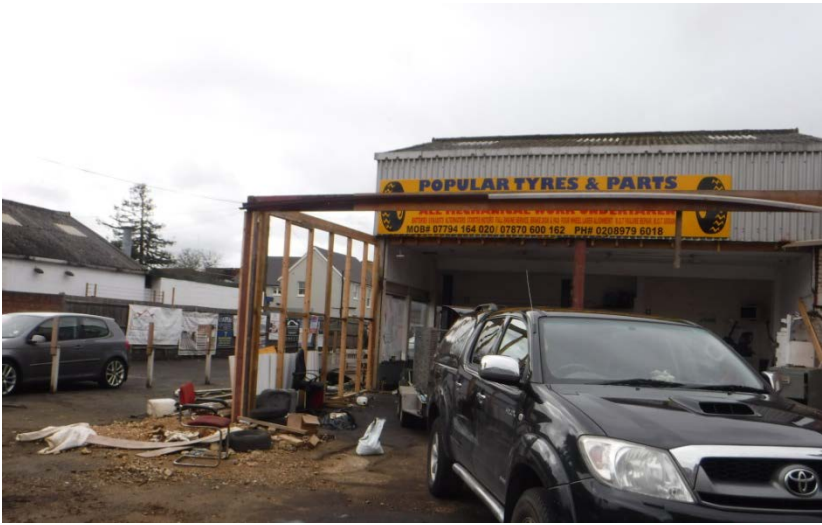
| Photo No. 9 | Date: 26.03.2018 | |

| Description: Car wash present land use – garage | | |
