## Detailed Unexploded Ordnance (UXO) Risk Assessment

<b>Project Name</b>	St Clare Business Park
<b>Client</b>	RSK
<b>Site Address</b>	Hampton Hill, Hampton, TW12 1QF
<b>Report Reference</b>	DA6247-00
<b>Date</b>	13th April 2018
<b>Originator</b>	JM

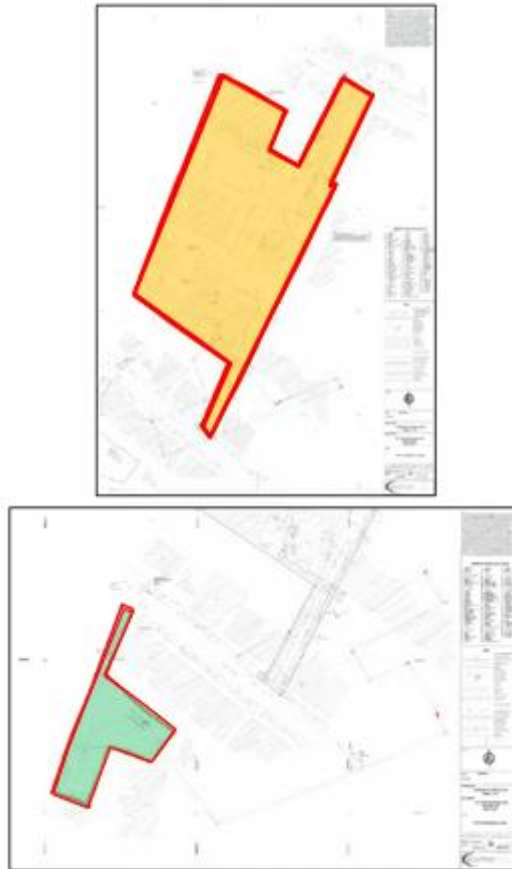
Risk Map

For indicative purposes – not to scale.  
Please note that this assessed risk map may not take into account all post-war redevelopment/excavations on site.

- Due to these factors, as well as the ‘j-curve effect’, by which an item of UXO can come to rest at a lateral offset from its point of entry, a medium risk from items of UXO has been identified at the larger northern site area. The risk at the small southern area has been identified as low.
- There is no evidence that the site formerly had any military occupation or usage that could have led to contamination with items of Allied ordnance, such as LSA and SAA. The conditions in which HAA or LAA projectiles may have fallen unnoticed within the site boundary are however analogous to those regarding aerial delivered ordnance.
- Post-war redevelopment has involved the removal of the nurseys and the creation of the current business park premises. The risk of UXO remaining is considered to have been mitigated at the location of and down to the depth of post-war foundations and excavations.

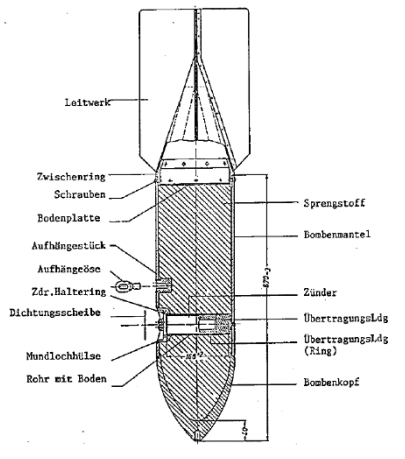
SC 50kg High Explosive Bomb	
Bomb Weight	40-54kg (88-119lb)
Explosive Weight	c25kg (55lb)
Fuze Type	Impact fuze/electro-mechanical time delay fuze
Bomb Dimensions	1,090 x 280mm (42.9 x 11.0in)
Body Diameter	200mm (7.87in)
Use	Against lightly damageable materials, hangars, railway rolling stock, ammunition depots, light bridges and buildings up to three stories.
Remarks	The smallest and most common conventional German bomb. Nearly 70% of bombs dropped on the UK were 50kg.

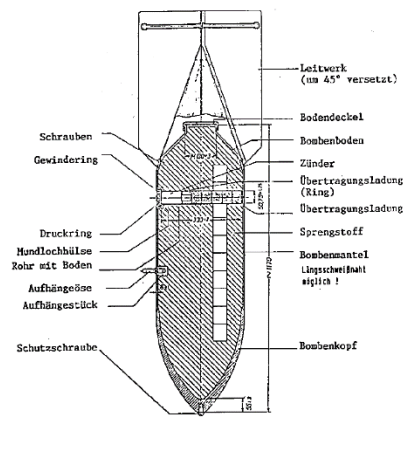
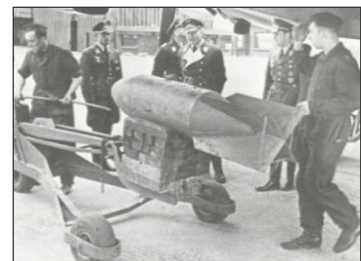
SC 250kg High Explosive Bomb	
Bomb Weight	245-256kg (540-564lb)
Explosive Weight	125-130kg (276-287lb)
Fuze Type	Electrical impact/mechanical time delay fuze.
Bomb Dimensions	1640 x 512mm (64.57 x 20.16in)
Body Diameter	368mm (14.5in)
Use	Against railway installations, embankments, flyovers, underpasses, large buildings and below-ground installations.
Remarks	It could be carried by almost all German bomber aircraft, and was used to notable effect by the Junkers Ju-87 Stuka (Sturzkampfflugzeug or dive-bomber).

SC250 bomb being loaded onto German bomber

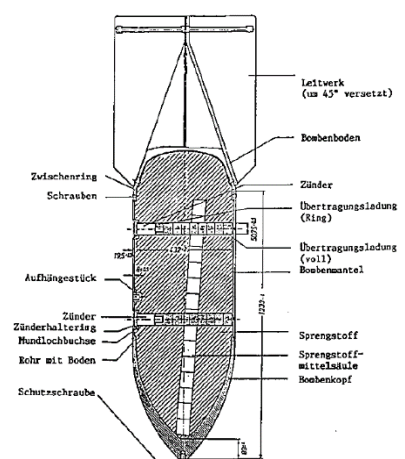
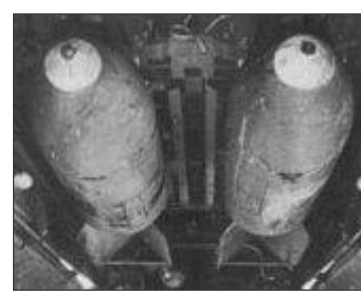
SC 500kg High Explosive Bomb	
Bomb Weight	480-520kg (1,058-1,146lb)
Explosive Weight	250-260kg (551-573lb)
Fuze Type	Electrical impact/mechanical time delay fuze.
Bomb Dimensions	1957 x 640mm (77 x 25.2in)
Body Diameter	470mm (18.5in)
Use	Against fixed airfield installations, hangars, assembly halls, flyovers, underpasses, high-rise buildings and below-ground installations.
Remarks	40/60 or 50/50 Amatol TNT, trialene. Bombs recovered with Trialene filling have cylindrical paper wrapped pellets 1-15/16 in. in length and diameter forming

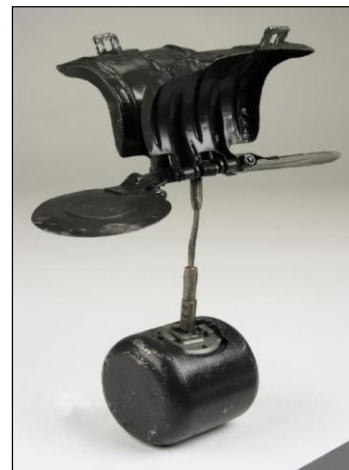
## Parachute Mine (Luftmine B / LMB)

Bomb Weight	Approx. 990kg (2176lb)
Explosive Weight	Approx. 705kg (1,554lb)
Fuze Type	Impact/ Time delay / hydrostatic pressure fuze
Dimensions	2.64m x 0.64m (3.04m with parachute housing)
Use	Against civilian, military and industrial targets. Used as blast bombs and designed to detonate above ground level to maximise damage to a wider area.
Remarks	Deployed a parachute when dropped in order to control its descent. Had the potential to destroy a whole street of housing in a 100m radius.

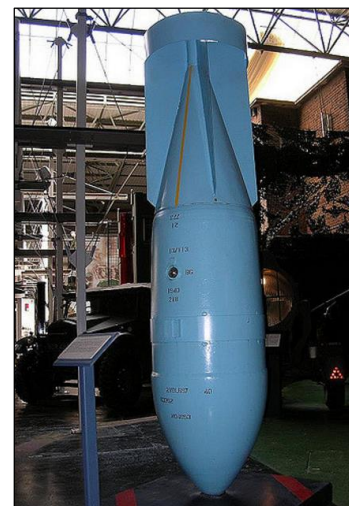
## SC 1000kg

Bomb Weight	993-1027kg (2,189-2,264lb)
Explosive Weight	530-620kg (1168-1367lb)
Fuze Type	Electrical impact/mechanical time delay fuze.
Filling	Mixture of 40% amatol and 60% TNT, but when used as an anti-shipping bomb it was filled with Trialen 105, a mixture of 15% RDX, 70% TNT and 15% aluminium powder.
Bomb Dimensions	2800 x 654mm (110 x 25.8in)
Body Diameter	654mm (18.5in)
Use	SC type bombs are General Purpose Bombs used primarily for general demolition work. Constructed of parallel walls with comparatively heavy noses. They are usually of three piece welded construction

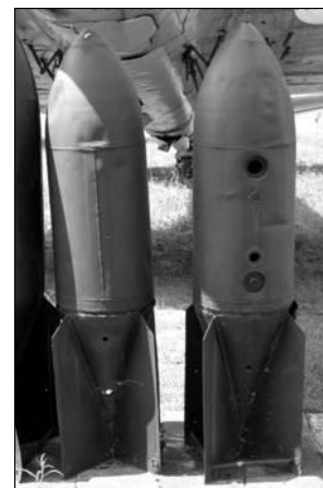
## Flam C-250 Oil Bomb

Bomb Weight	125kg (276lb)
Explosive Weight	1kg (2.2lb)
Fuze Type	Super-fast electrical impact fuze
Filling	Mixture of 30% petrol and 70% crude oil
Bomb Dimensions	1,650 x 512.2mm (65 x 20.2in)
Body Diameter	368mm (14.5in)
Use	Often used for surprise attacks on ground troops, against troop barracks and industrial installations. Thin casing – not designed for ground penetration

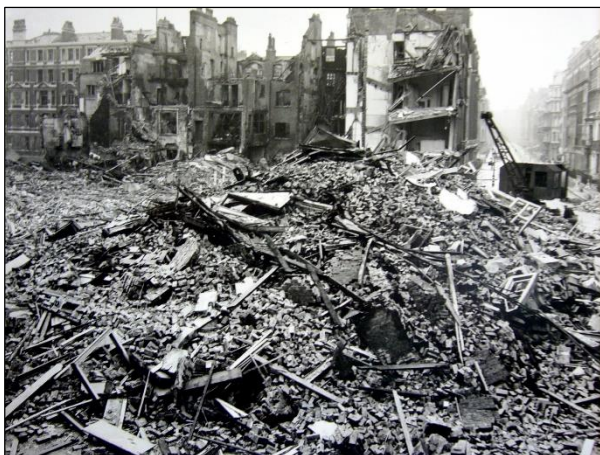
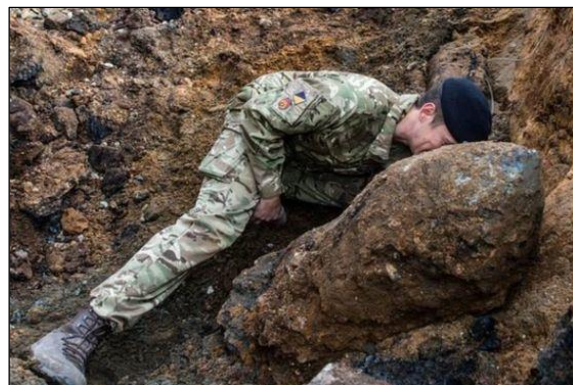
## 'J-Curve' Effect

**Top:** J-curve Effect - Due to angle of entry, unexploded bombs would often end their trajectory at a lateral offset from point of entry, often ending up beneath adjacent extant structures/sites.

One of the most common scenarios for the above occurring was where a UXB fell into a 'bomb site' (such as the area shown **Top Left**), the entry hole of the bomb obscured by debris and rubble present. Note that the entry hole of a 50kg UXB could be as little as 20cm in diameter (**Left**).

Photograph **above** shows 250kg bomb found in Bermondsey pointing upwards, demonstrating 'J-curve'

J-curve is the term used to describe the characteristic curve commonly followed by an aerial delivered bomb dropped from height after it penetrates the ground. Typically, as the bomb is slowed by its passage through underlying soils, its trajectory curves towards the surface. Many UXBs are found with their nose cone pointing upwards as a result of this effect. More importantly however is the resulting horizontal offset from the point of entry. This is typically a distance of about one third of the bomb's penetration depth, but can be up to 15m. This is illustrated in **Annex G**.

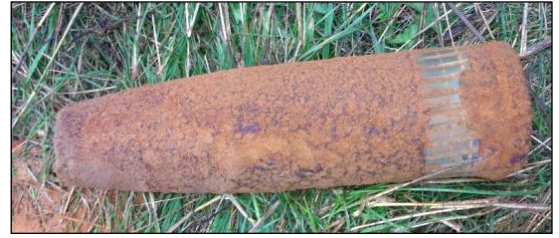
## 3.7 Inch QF Anti-Aircraft Projectile

Projectile Weight	28lb (12.6 kg)
Explosive Weight	2.52lbs
Fuze Type	Mechanical Time Fuze
Dimensions	3.7in x 14.7in (94mm x 360mm)
Rate of Fire	10 to 20 rounds per minute
Use	The 3.7in AA Mk 1-3 were the standard Heavy Anti-Aircraft guns of the British Army.
Ceiling	30,000ft to 59,000ft

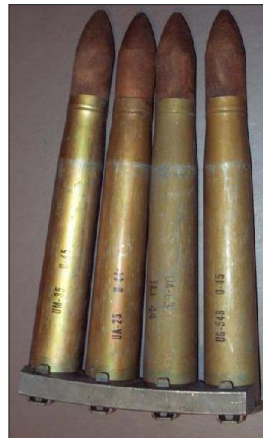
## 40mm Bofors Projectile

Projectile Weight	1.96lb (0.86kg)
Explosive Weight	300g (0.6lb)
Fuze Type	Impact Fuze
Rate of Fire	120 rounds per minute
Projectile Dimensions	40 x 180mm
Ceiling	23,000ft (7000m )
Remarks	Light quick fire high explosive anti-aircraft projectile. Each projectile fitted with small tracer element. If no target hit, shell would explode when tracer burnt out. Designed to engage aircraft flying below 2,000ft

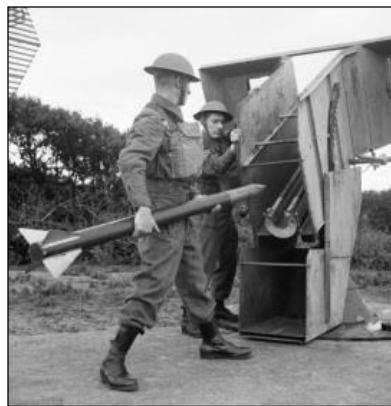
## 3in Unrotated Projectile (UP) Anti-Aircraft Rocket ("Z" Battery)

HE Projectile Weight	3.4kg (7.6lb)
Explosive Weight	0.96kg (2.13lb)
Filling	High Explosive – TNT. Fitted with aerial burst fuzeing
Dimensions of projectile	236 x 83mm (9.29 x 3.25in)
Remarks	As a short range rocket-firing anti-aircraft weapon developed for the Royal Navy. It was used extensively by British ships during the early days of World War II. The UP was also used in ground-based single and 128-round launchers known as Z Batteries. Shell consists of a steel cylinder reduced in diameter at the base and threaded externally to screw into the shell ring of the rocket motor

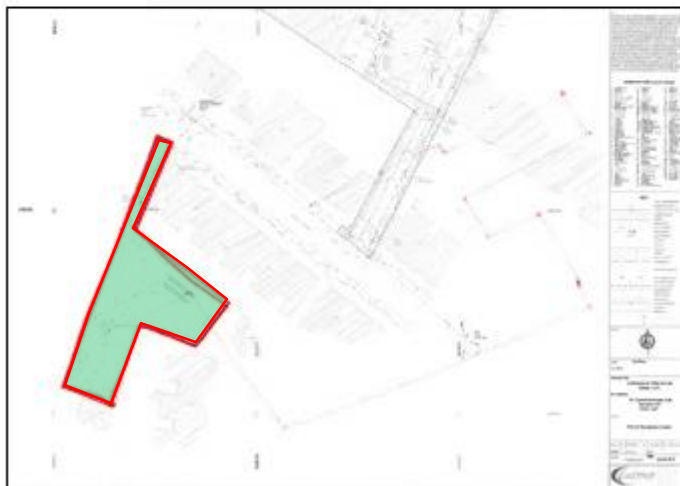
- Low Risk
- Medium Risk

**Low and Medium Risk Areas:**
