Section Inspection - 04/04/2022 - BRANCH 1X

Town or Village:	Richmond	Inspection Direction:	2	Upstream Node:	BRANCH 1
Road:	50-56 Sheen Road	Inspected Length:	0.62 m	Upstream Pipe Depth:	0.000 m
Location:	Property or buildings	Total Length:	1.00 m	Downstream Node:	MH.11
Surface Type:	Concrete Footway	Joint Length:	0.90 m	Downstream Pipe Depth:	0.530 m
Use:	Foul	Pipe Shape:	Circular		
Type of Pipe:	Gravity drain/sewer	Dia/Height:	100 mm		
Flow Control:	No flow control	Material:	Vitrified clay		
Year Constructed:	1960	Lining Type:	No Lining		
Inspection Purpose:	Sample condition survey	Lining Material:	No Lining

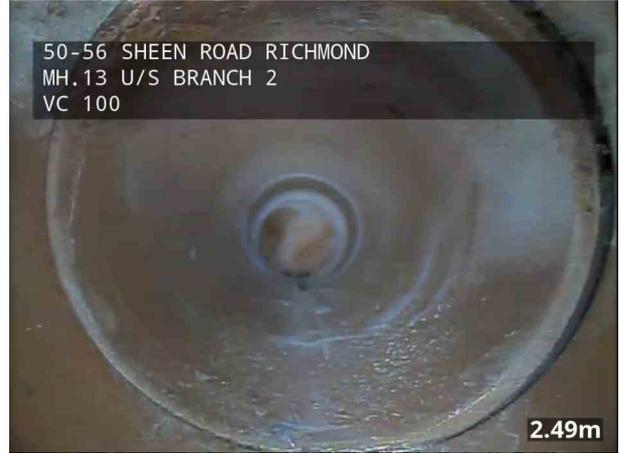
50-56 SHEEN ROAD RICHMOND
 MH.13 U/S BRANCH 2
 VC 100
 2.49m
 _50-56 SHEEN ROAD_RICHMOND_33_047.jpg, 00:00:10,
 2.49 m
 Joint displaced, medium

Comments:
Recommendations: PATCH REPAIR REQUIRED

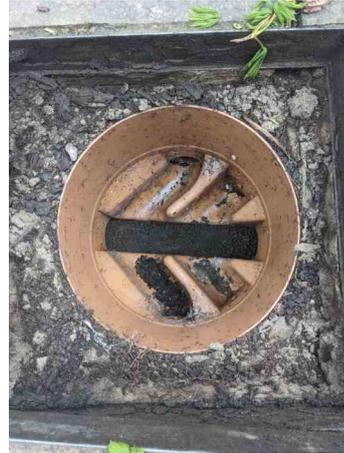
_50-56 SHEEN ROAD_RICHMOND_34_049.jpg, 00:00:15,
 3.25 m
 Finish node, manhole, reference: MH.16, CHAMBER SILTED

Comments:
Recommendations: JETTING AND RESURVEY REQUIRED

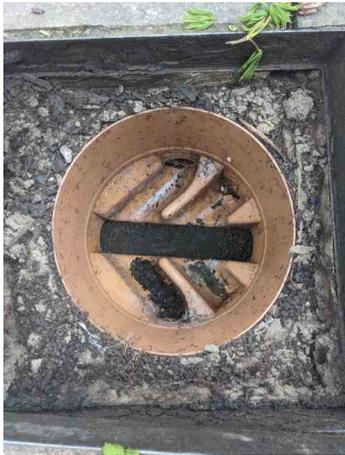
_50-56 SHEEN ROAD_RICHMOND_35_050.jpg, 00:00:00,
 0.00 m
 Start node, manhole, reference: MH.16

Construction Features					Miscellaneous Features				
Structural Defects					Service & Operational Observations				
STR No. Def	STR Peak	STR Mean	STR Total	STR Grade	SER No. Def	SER Peak	SER Mean	SER Total	SER Grade
0	0.0	0.0	0.0	1.0	1	8.0	20.0	8.0	5.0

Comments:
Recommendations: JETTING AND RESURVEY REQUIRED

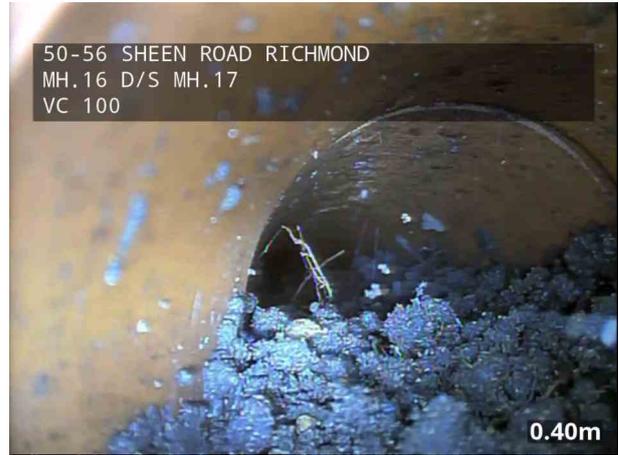
_50-56 SHEEN ROAD_RICHMOND_35_051.jpg, 00:00:00,
 0.40 m
 Survey abandoned, DUE TO HEAVY SILTS

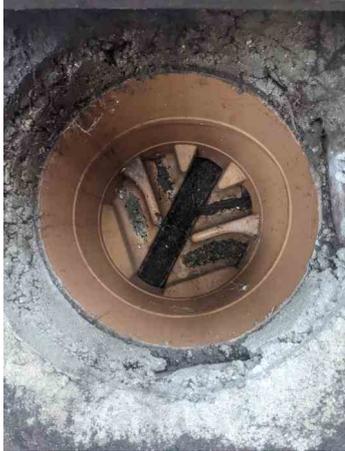
_50-56 SHEEN ROAD_RICHMOND_37_053.jpg, 00:00:00,
 0.00 m
 Start node, manhole, reference: MH.17

Construction Features					Miscellaneous Features				
Structural Defects					Service & Operational Observations				
STR No. Def	STR Peak	STR Mean	STR Total	STR Grade	SER No. Def	SER Peak	SER Mean	SER Total	SER Grade
0	0.0	0.0	0.0	1.0	1	8.0	12.9	8.0	5.0

Comments:
Recommendations: JETTING AND RESURVEY REQUIRED

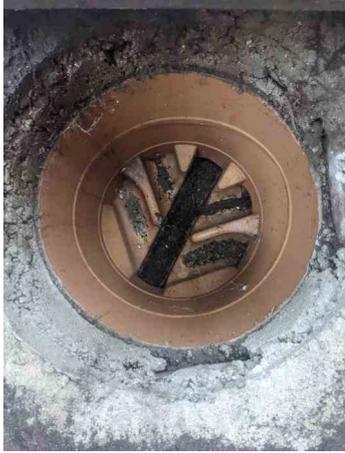
_50-56 SHEEN ROAD_RICHMOND_38_055.jpg, 00:00:00,
 0.00 m
 Start node, manhole, reference: MH.17

Construction Features					Miscellaneous Features				
Structural Defects					Service & Operational Observations				
STR No. Def	STR Peak	STR Mean	STR Total	STR Grade	SER No. Def	SER Peak	SER Mean	SER Total	SER Grade
0	0.0	0.0	0.0	1.0	2	7.0	3.8	9.0	4.0

Comments:
Recommendations: JETTING AND RESURVEY REQUIRED

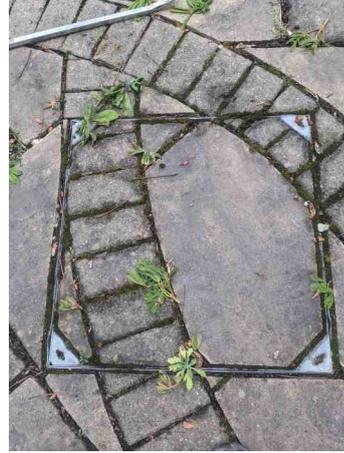
_50-56 SHEEN ROAD_RICHMOND_38_056.jpg, 00:00:13,
 2.38 m
 Finish node, manhole, reference: MH.18, U.T.R SEIZED

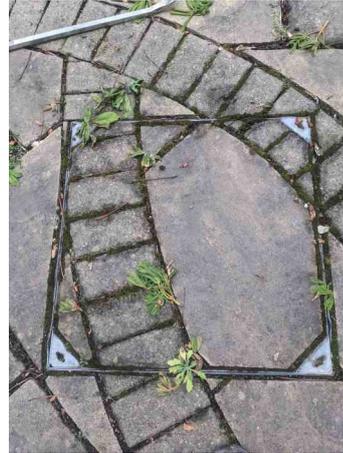
_50-56 SHEEN ROAD_RICHMOND_43_063.jpg, 00:00:31,
 6.77 m
 Finish node, manhole, reference: MH.18, U.T.R SEIZED

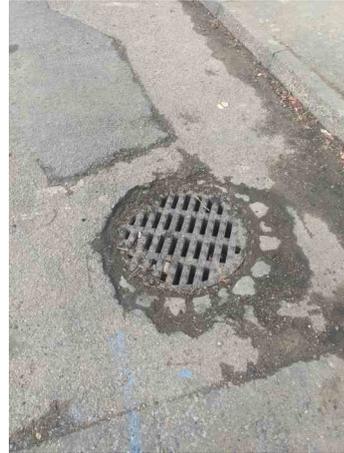
_50-56 SHEEN ROAD_RICHMOND_51_075.jpg, 00:01:42,
 23.50 m
 Finish node, manhole, reference: MH.25, MAIN SEWER U.T.R

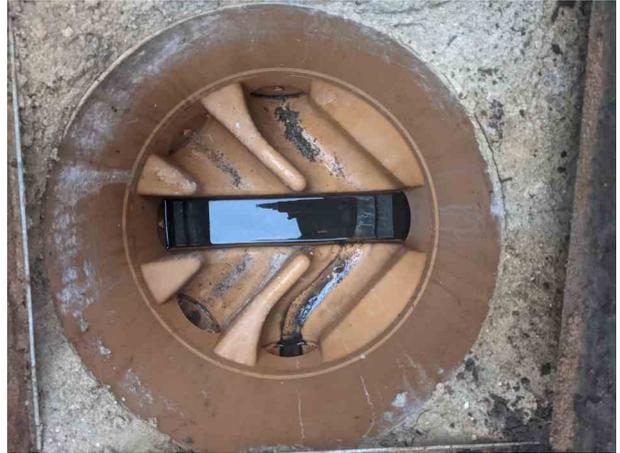
_50-56 SHEEN ROAD_RICHMOND_55_081.jpg, 00:00:55,
 13.09 m
 Finish node, manhole, reference: MH.27, SILT IN CHAMBER

Comments:
Recommendations: JETTING AND RESURVEY REQUIRED

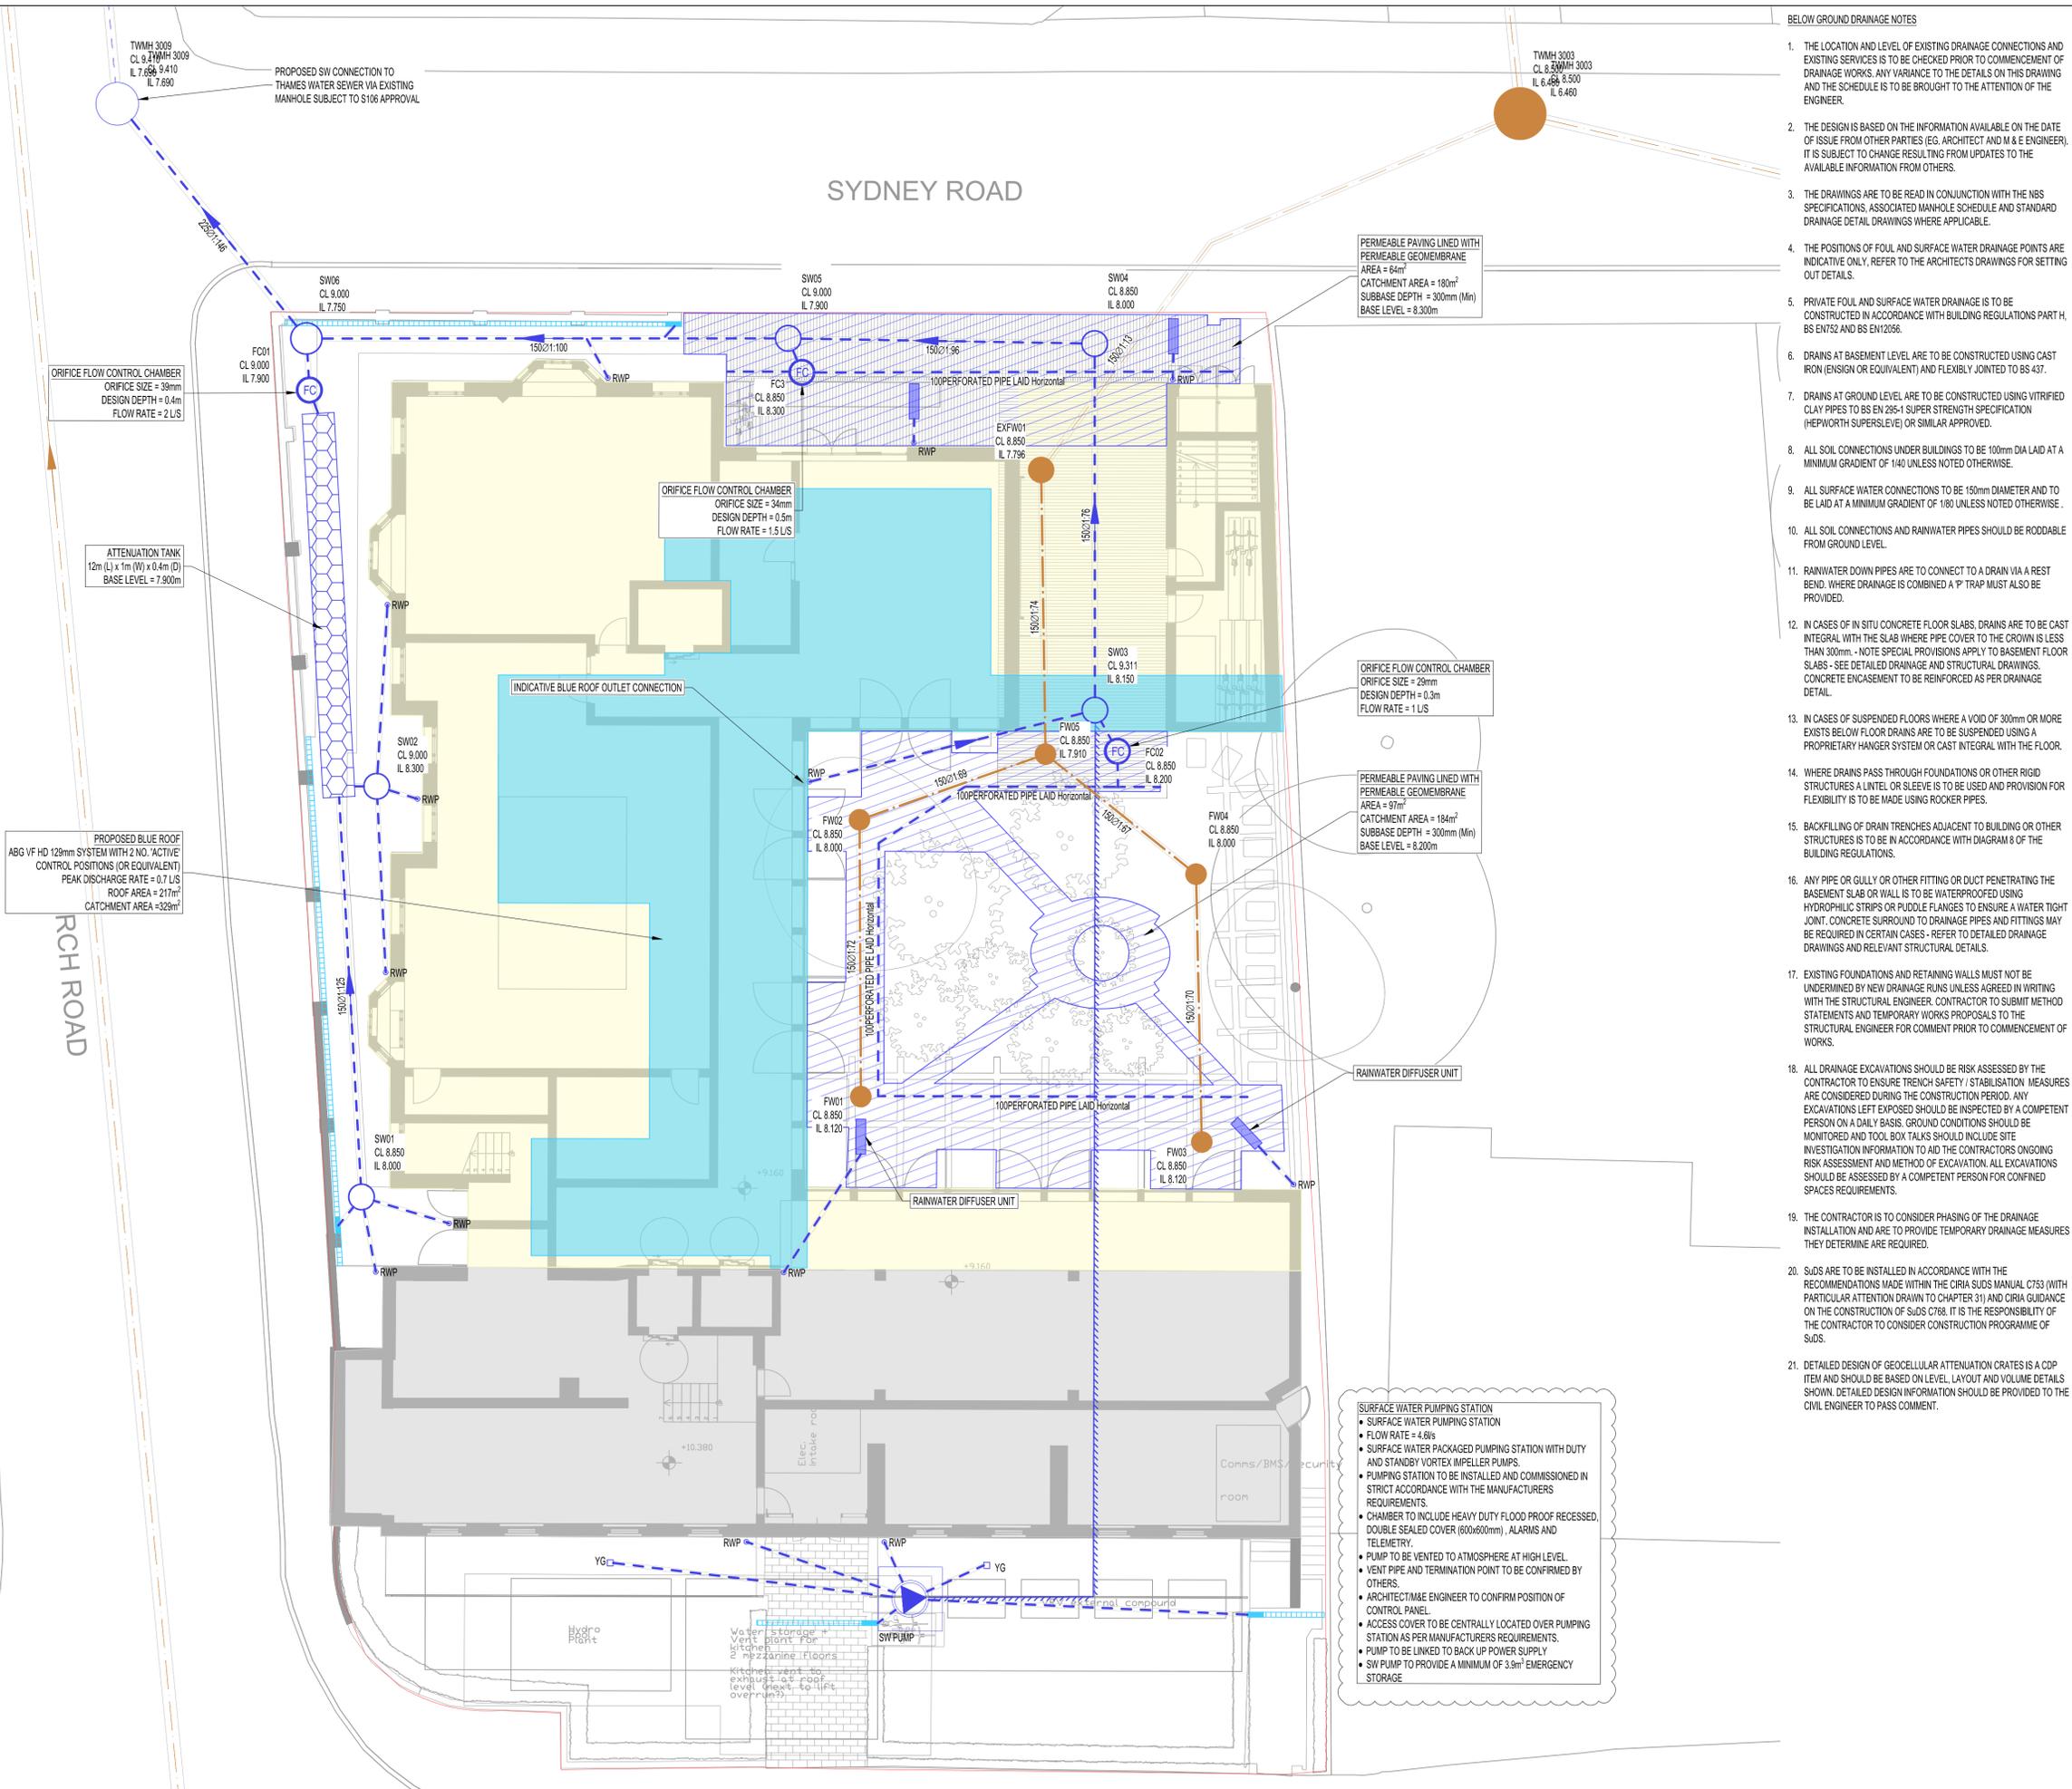
ORIFICE FLOW CONTROL CHAMBER
ORIFICE SIZE = 39mm
DESIGN DEPTH = 0.4m
FLOW RATE = 2 L/S
