# Greggs Bakery / Twickenham

## Phase I Environmental Assessment

# GREGGS BAKERY SITE & No. 2 GOULD ROAD TWICKENHAM TW2 6RT

Report No. 4609-1 v2 Ind

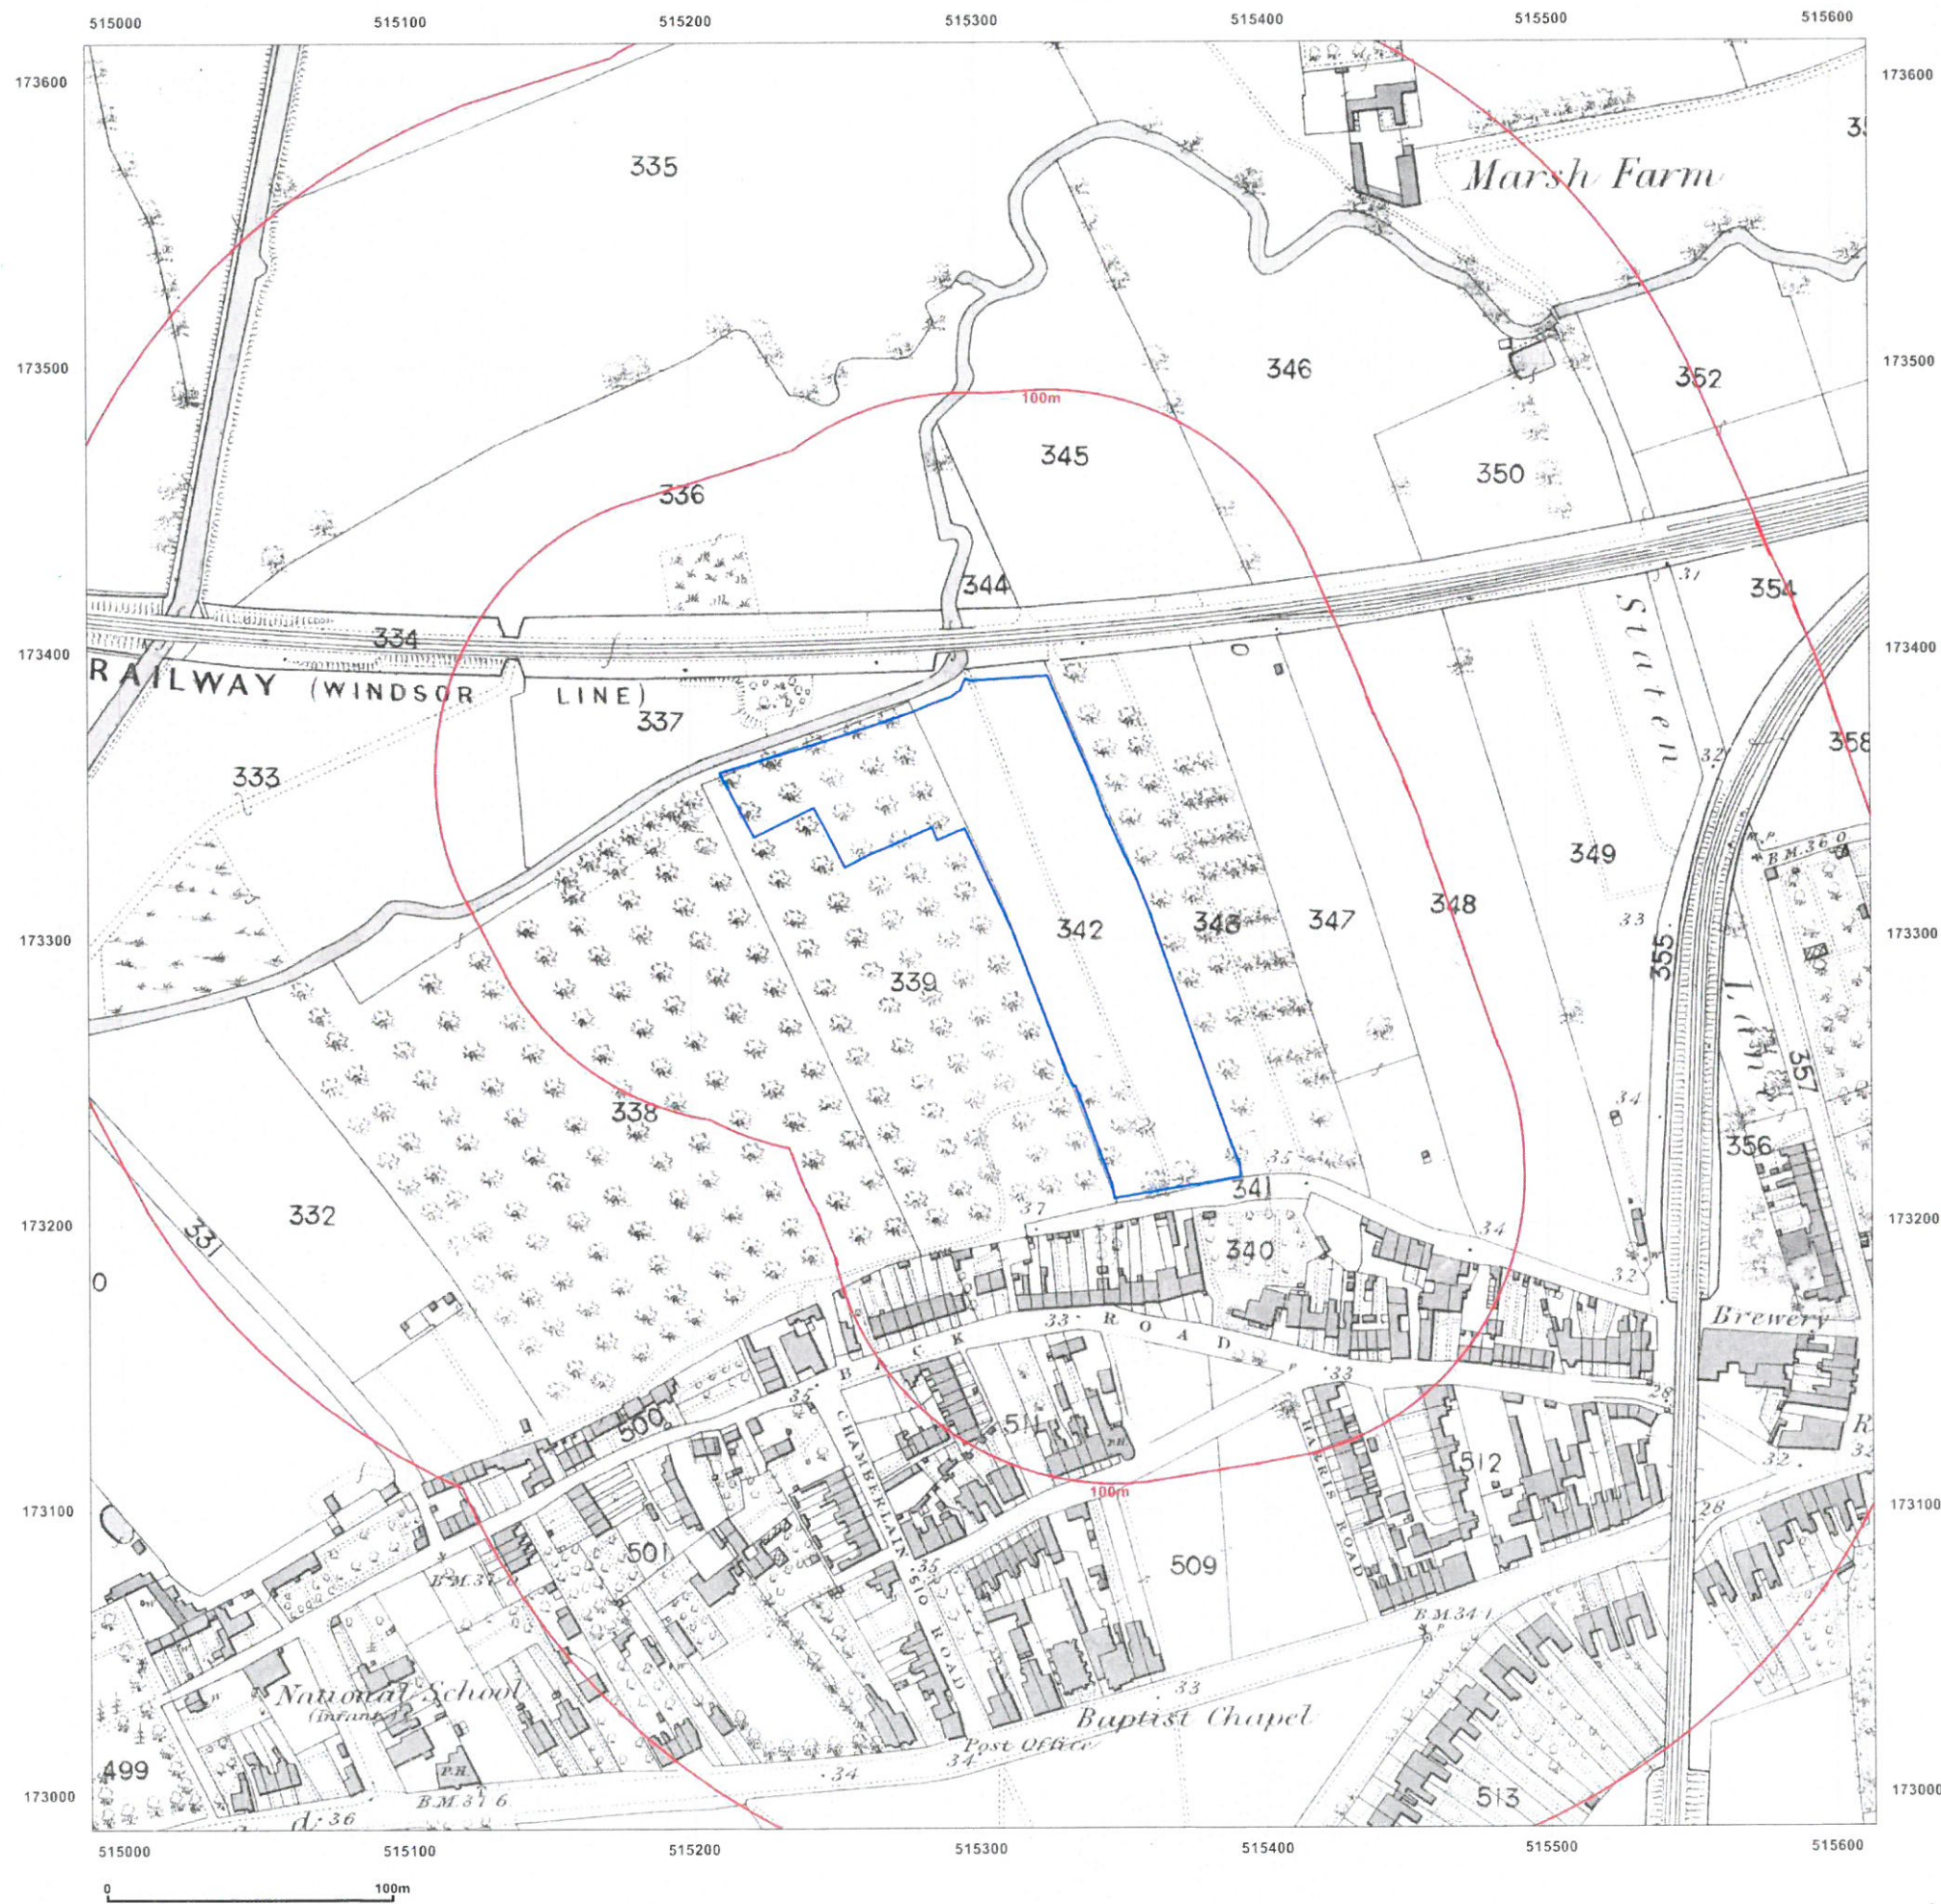
The earliest available mapping is given at Figure 2 and shows the site to be undeveloped. The main portion of the site has a path across it, up to the River Crane whilst the north west is

part of an orchard. The orchard continues some way to the west and one is also present immediately east of the site. A railway line runs east - west just to the north of the site and another railway line lies to the south east. Land to the north of the railway line is undeveloped save for Marsh Farm, some 200 m to the north east. The Duke of Northumberland's River is noted in the far north west of the mapped area. Land south of the site is fairly well developed and includes numerous residential properties, a School, Chapel, Post Office and Brewery.

Extract from Ordnance Survey Map  
County Series: 1865
