SITE INVESTIGATION REPORT

KNELLER HALL, 65 KNELLER ROAD, TWICKENHAM, LONDON TW2 7DN

Report ref: **10728/SG**

Date: **5th July 2022**

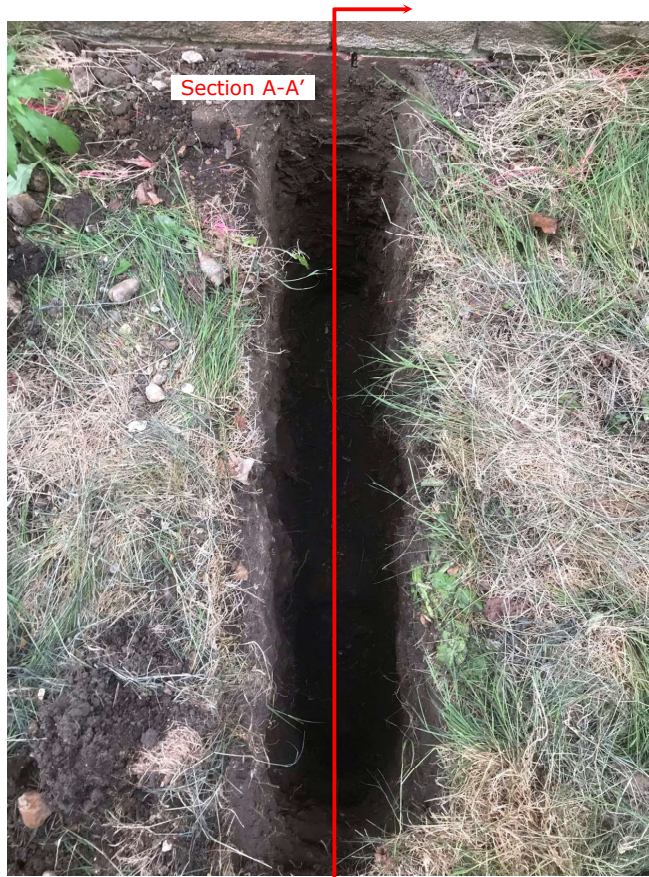
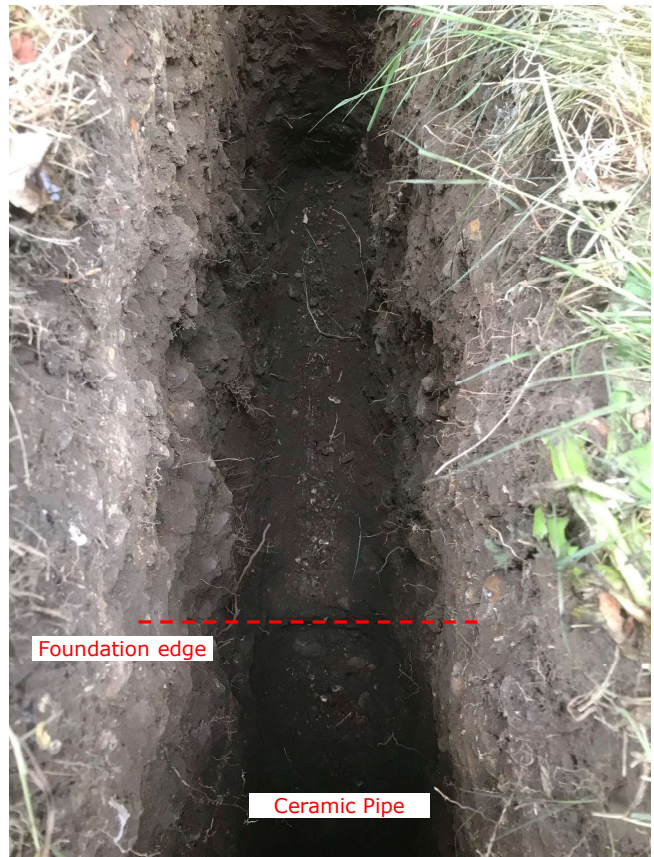
PHOTOGRAPHS

Date:	09/05/22	Groundwater details	Samples
Equipment:	Hand excavated	• Dry	
Stability:	Stable		
Remarks:	Base of foundation not identified due to presence of services		Logged by: JW

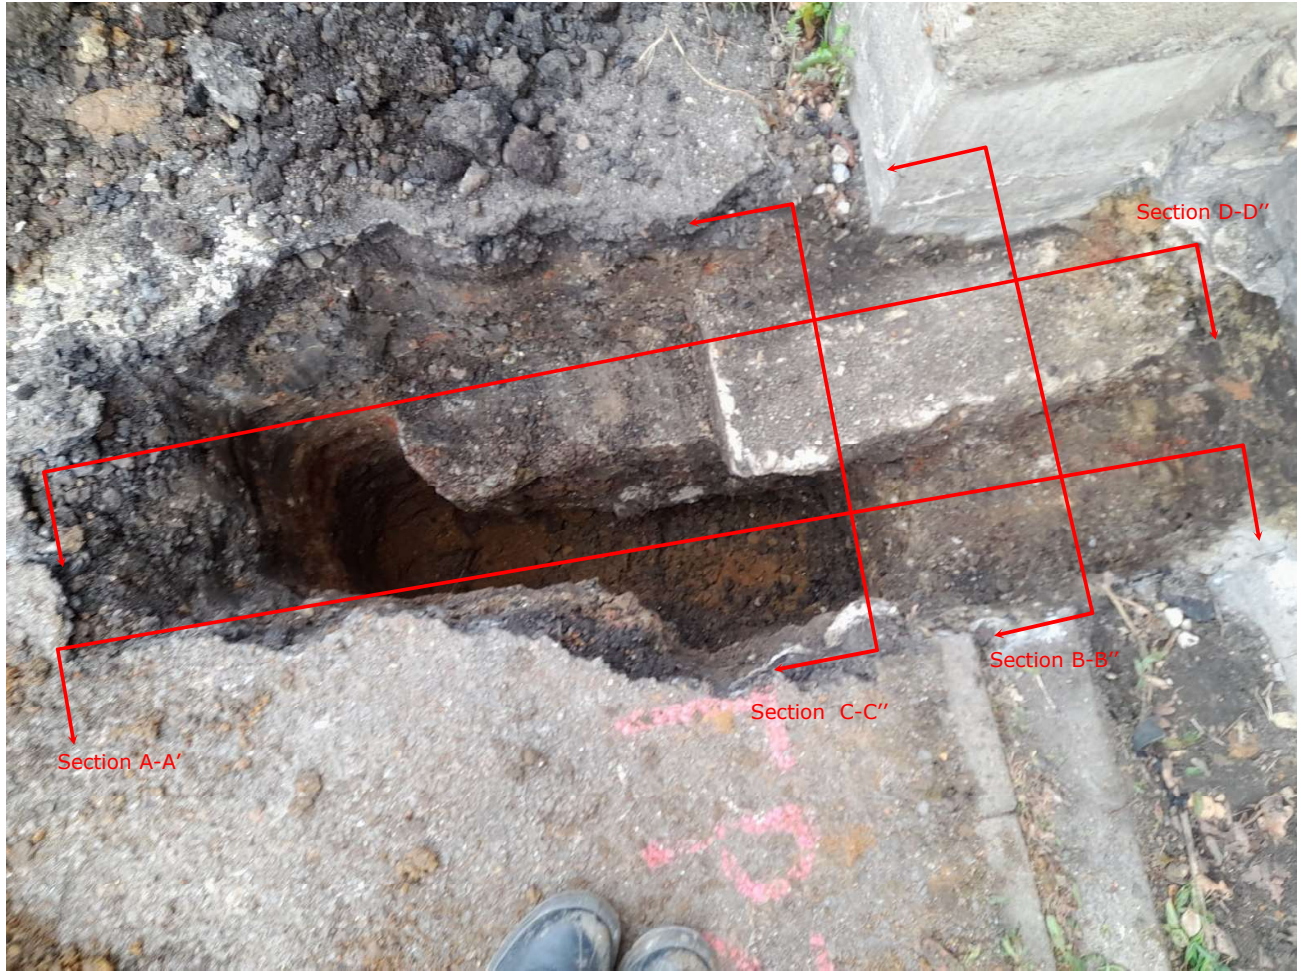
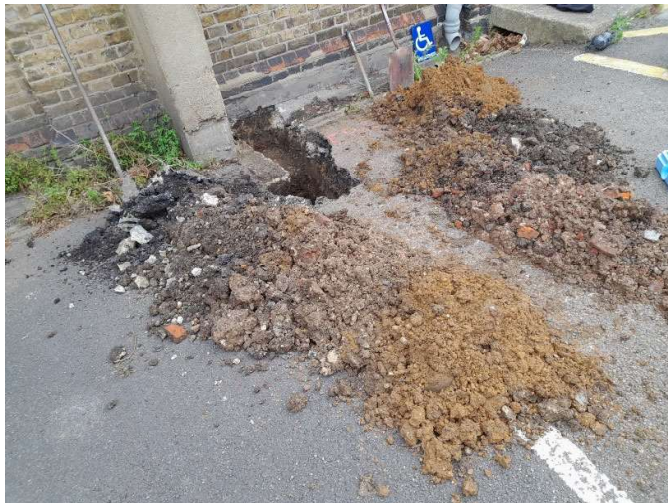
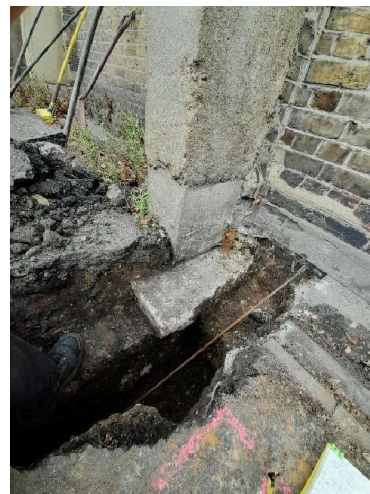
Site & Location	Kneller Hall, 65 Kneller Road, Twickenham, London TW2 7DN	Trial Pit No: TP2 (2 of 6)
Client:	Radnor House School Ltd	Report No: 10728/SG
Engineer:	AKS Ward Ltd

Date:	13/05/22	Groundwater details	Samples
Equipment:	Hand excavated		
Stability:	Stable	• Dry	E @ 0.3m D @ 0.4m D @ 0.6m D @ 0.9m
Remarks:	Additional supports and foundation added to structure over time.		Logged by: SG

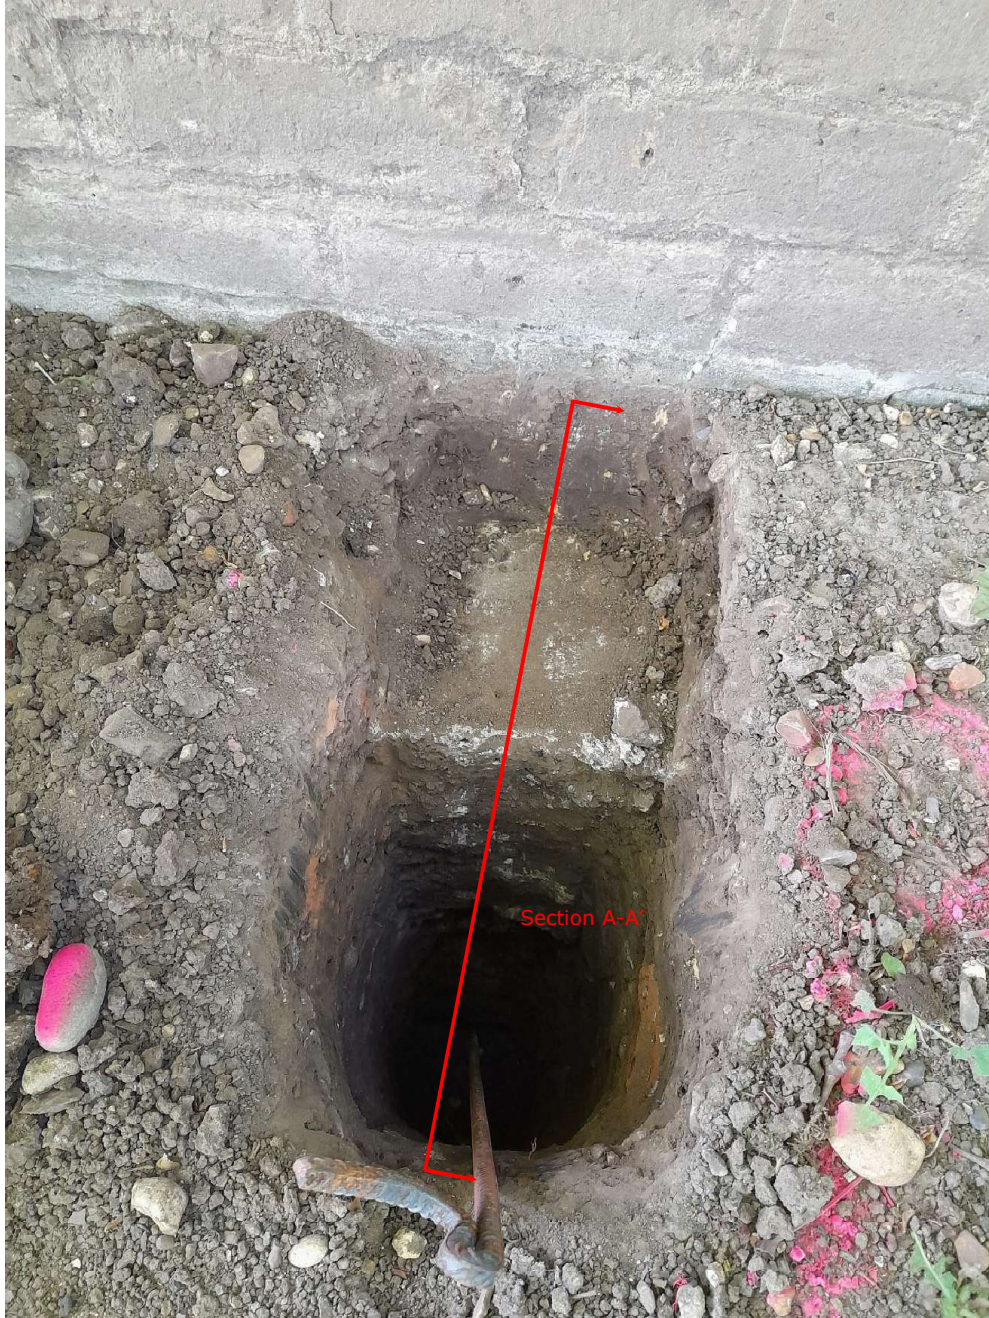
PHOTOGRAPHS

Date:	09/05/22	Groundwater details	Samples
Equipment:	Hand excavated	Dry, becoming moist from 1.05m.	D @ 0.30m E @ 0.50m
Stability:	Stable		D @ 0.60m D @ 1.10m
Remarks:			Logged by: SG

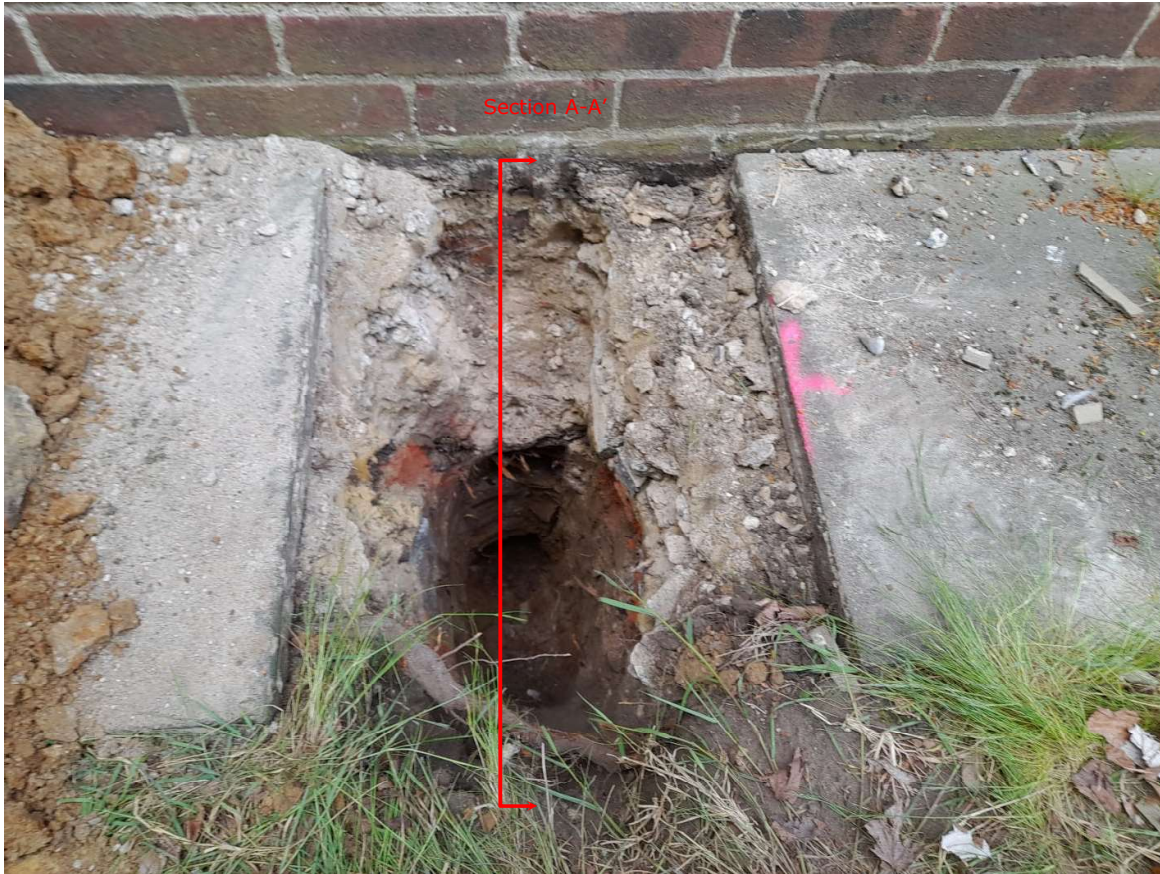
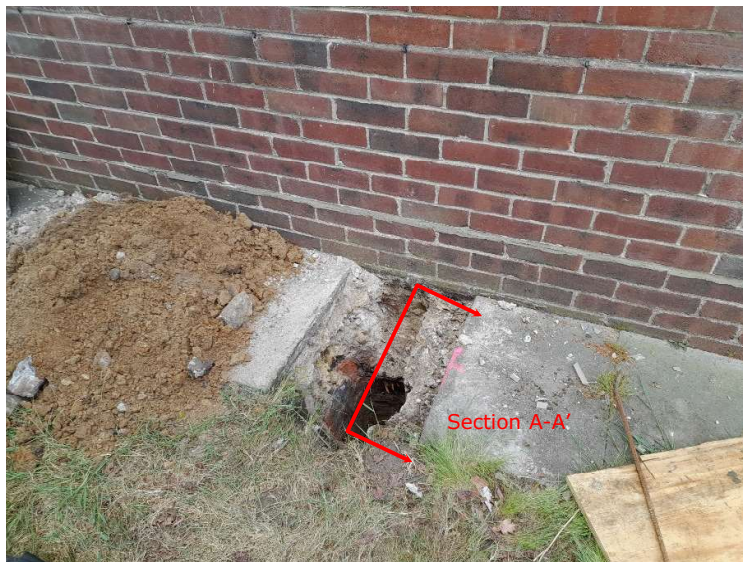
PHOTOGRAPHS

Date:	09/05/22	Groundwater details	Samples
Equipment:	Hand excavated	• Dry	D @ 0.40m
Stability:	Stable		E @ 0.60m
Remarks:			D @ 0.70m
			D @ 1.00m
			Logged by: SG

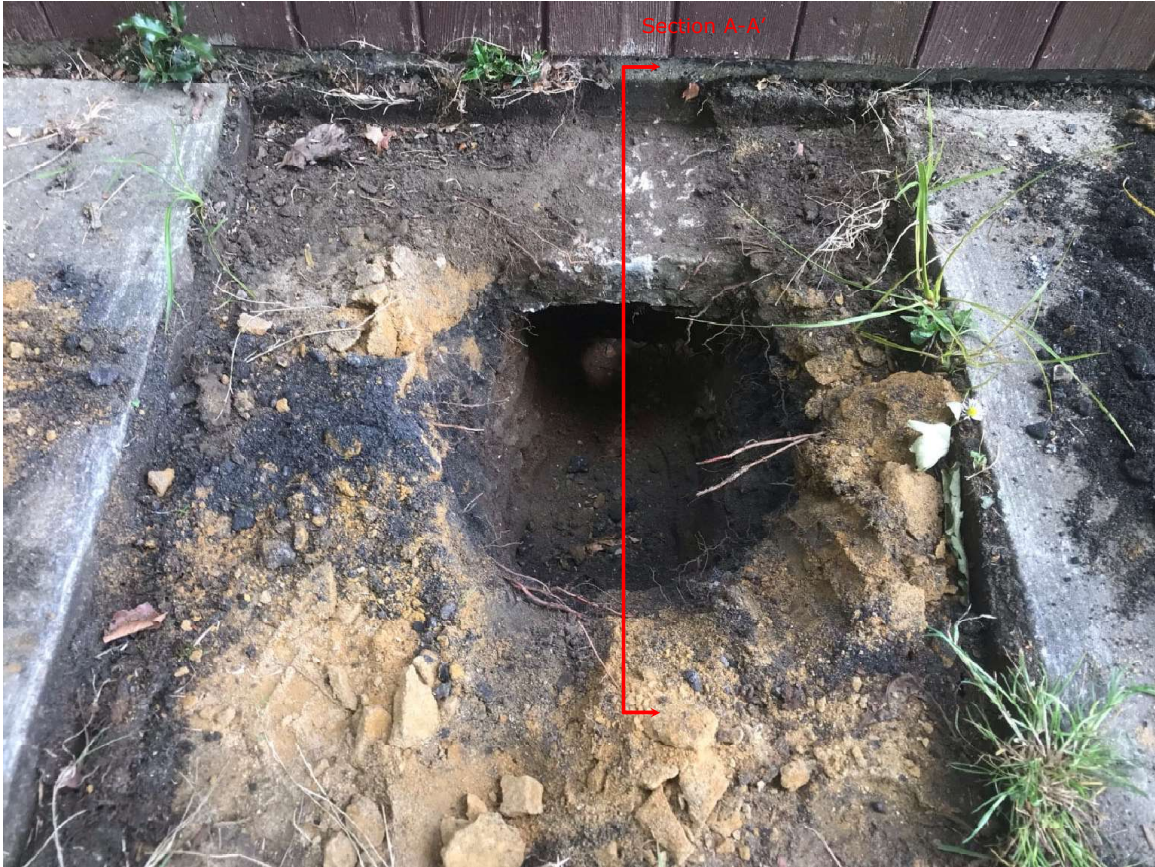
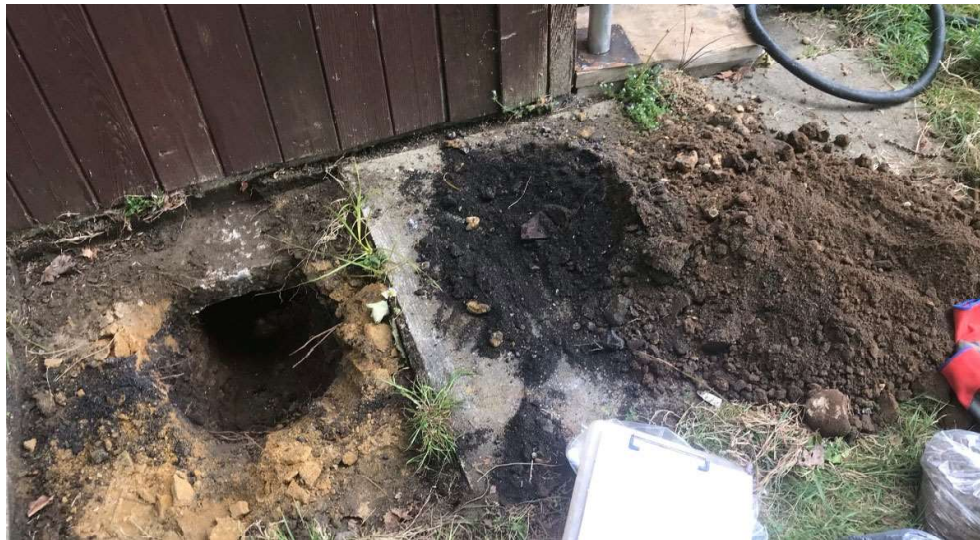
PHOTOGRAPHS

Date:	12/05/22	Groundwater details	Samples
Equipment:	Hand excavated	• Dry	D @ 0.15m D @ 0.30m
Stability:	Stable		
Remarks:			Logged by: JW
