**Land Contamination Phase 2 &
Geotechnical Investigation
YEX2487 – Meadows Hall, Richmond
February 2022**

The development comprises erection of 1no. mansion block of 8no. residential units and 5no. residential mew units with associated hardstanding and soft landscaping.

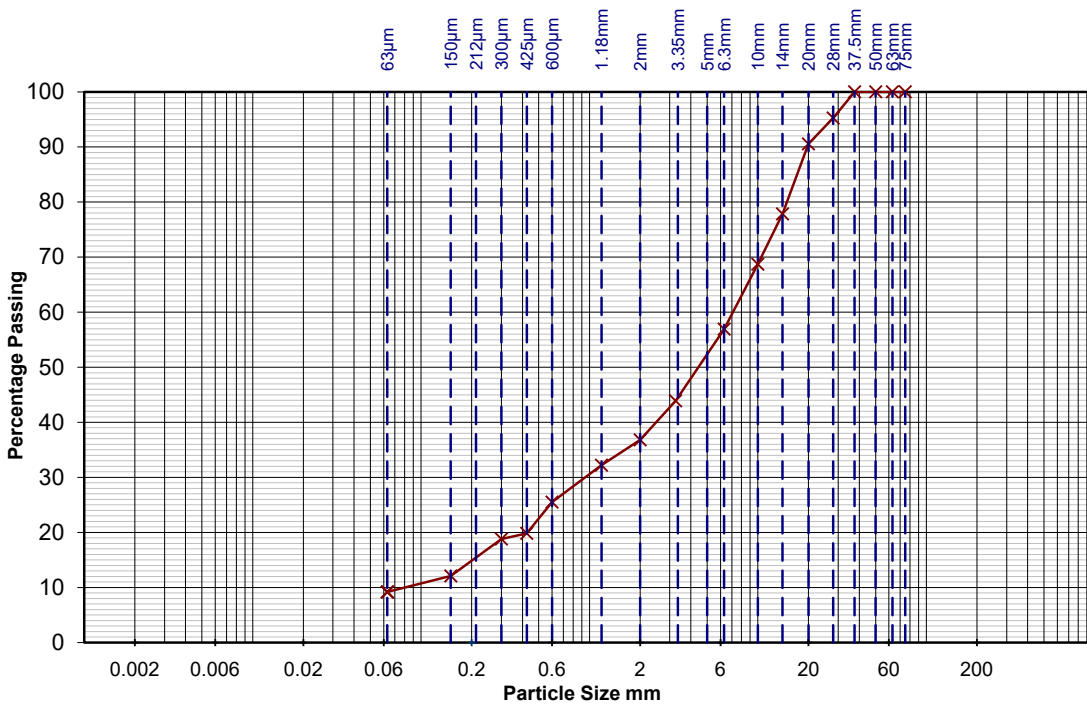
Sieve Size	75	63	50	37.5	28	20	14	10	6.3	
Percentage Passing	100.0	100.0	100.0	100.0	95.3	90.5	77.8	68.7	56.9	
Sieve Size	5	3.35	2	1.18	0.6	0.425	0.3	0.212	0.15	0.063
Percentage Passing	-	43.9	36.8	32.2	25.5	18.8	19.9	-	12.1	9.2

DESCRIPTION: Slightly clayey/silty very sandy fine to coarse GRAVEL
