**THAMES YOUNG MARINERS,
RIVERSIDE DRIVE, RICHMOND,
GREATER LONDON**

**ARBORICULTURAL METHOD
STATEMENT**

Report No: RT-MME-158839-01

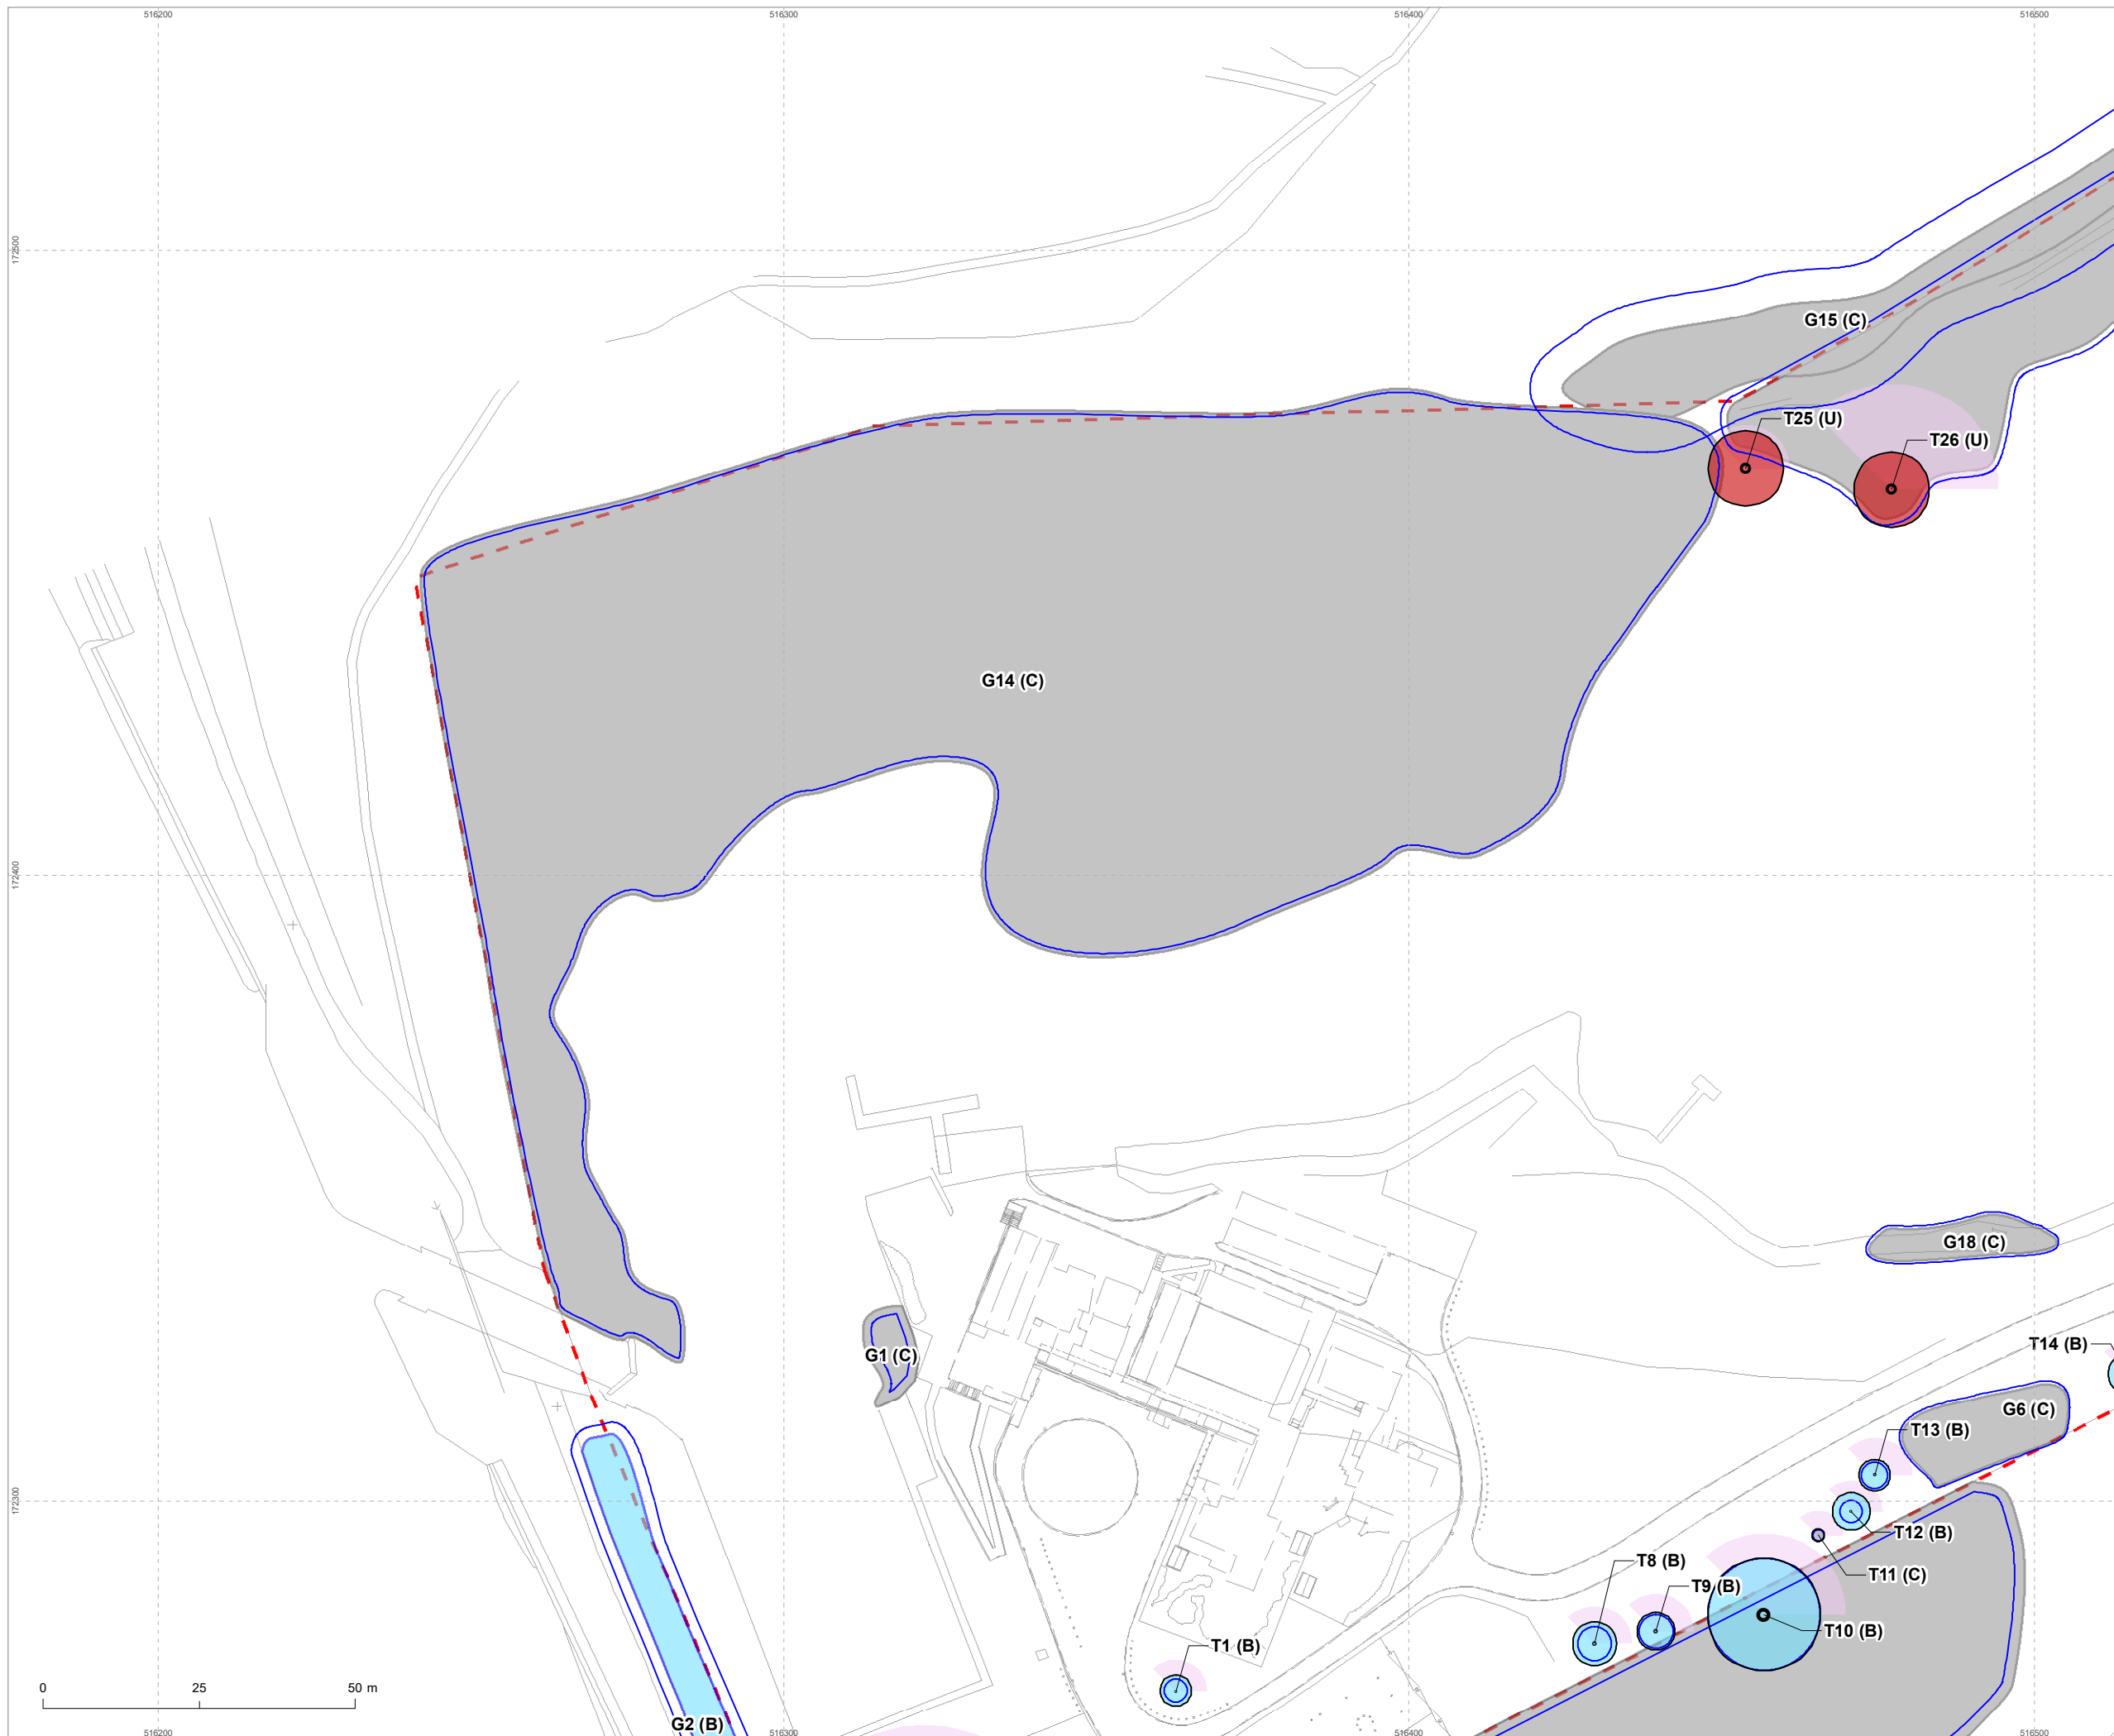
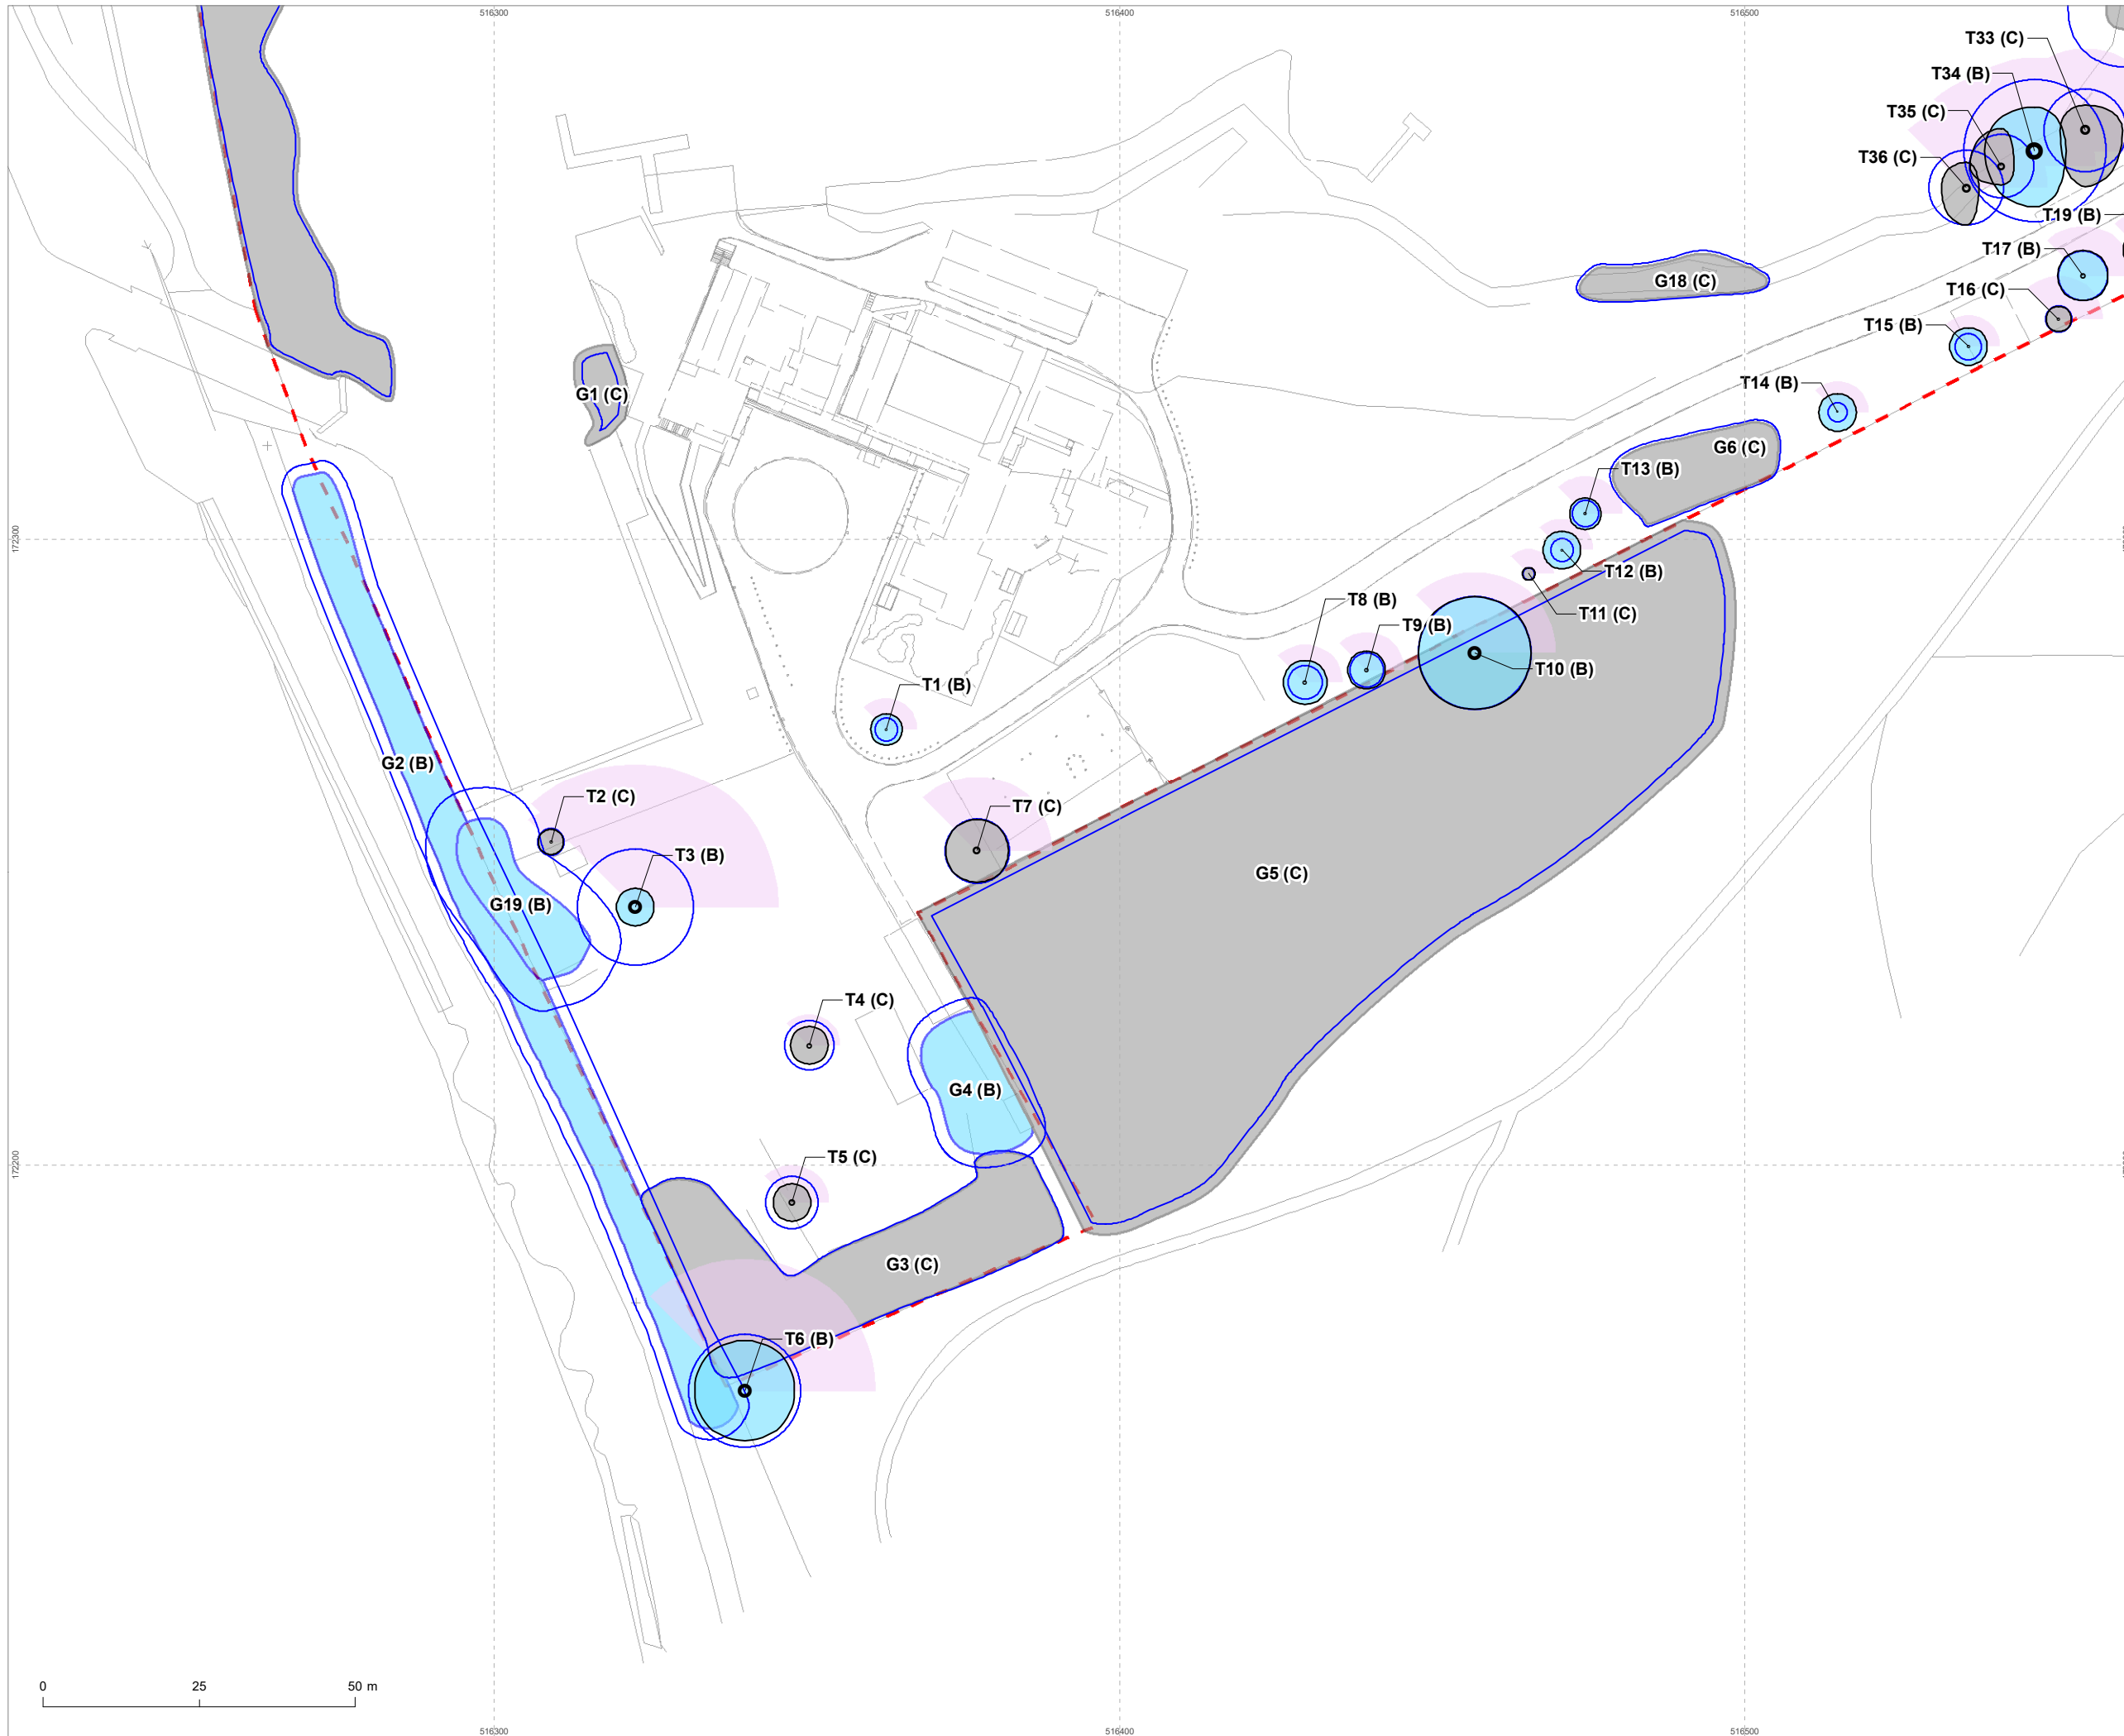
C157100-01-01

The location of the trees surveyed can be found on Tree Survey Plan (C157100-01-01). The Tree Retention Plan (C157100-02-01), provided in Section 7 of this report, shows those trees proposed to be removed as part of an approved planning application. Confirmation of the proposed tree removal should be sought from the Project Arboriculturist or Local Authority prior to undertaking any tree felling or tree work.

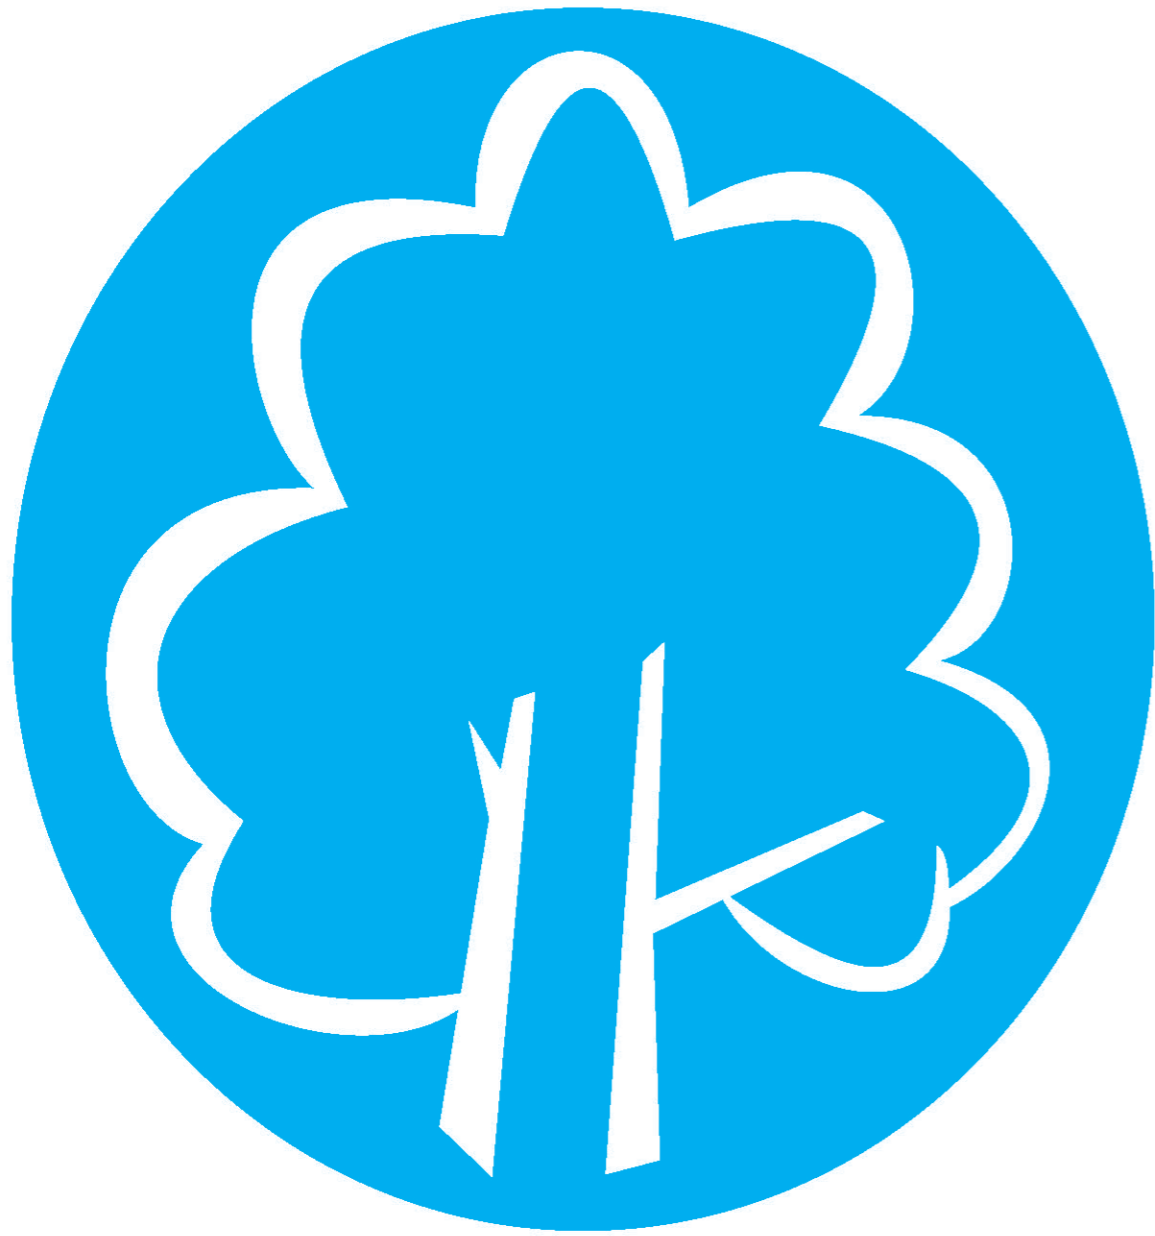
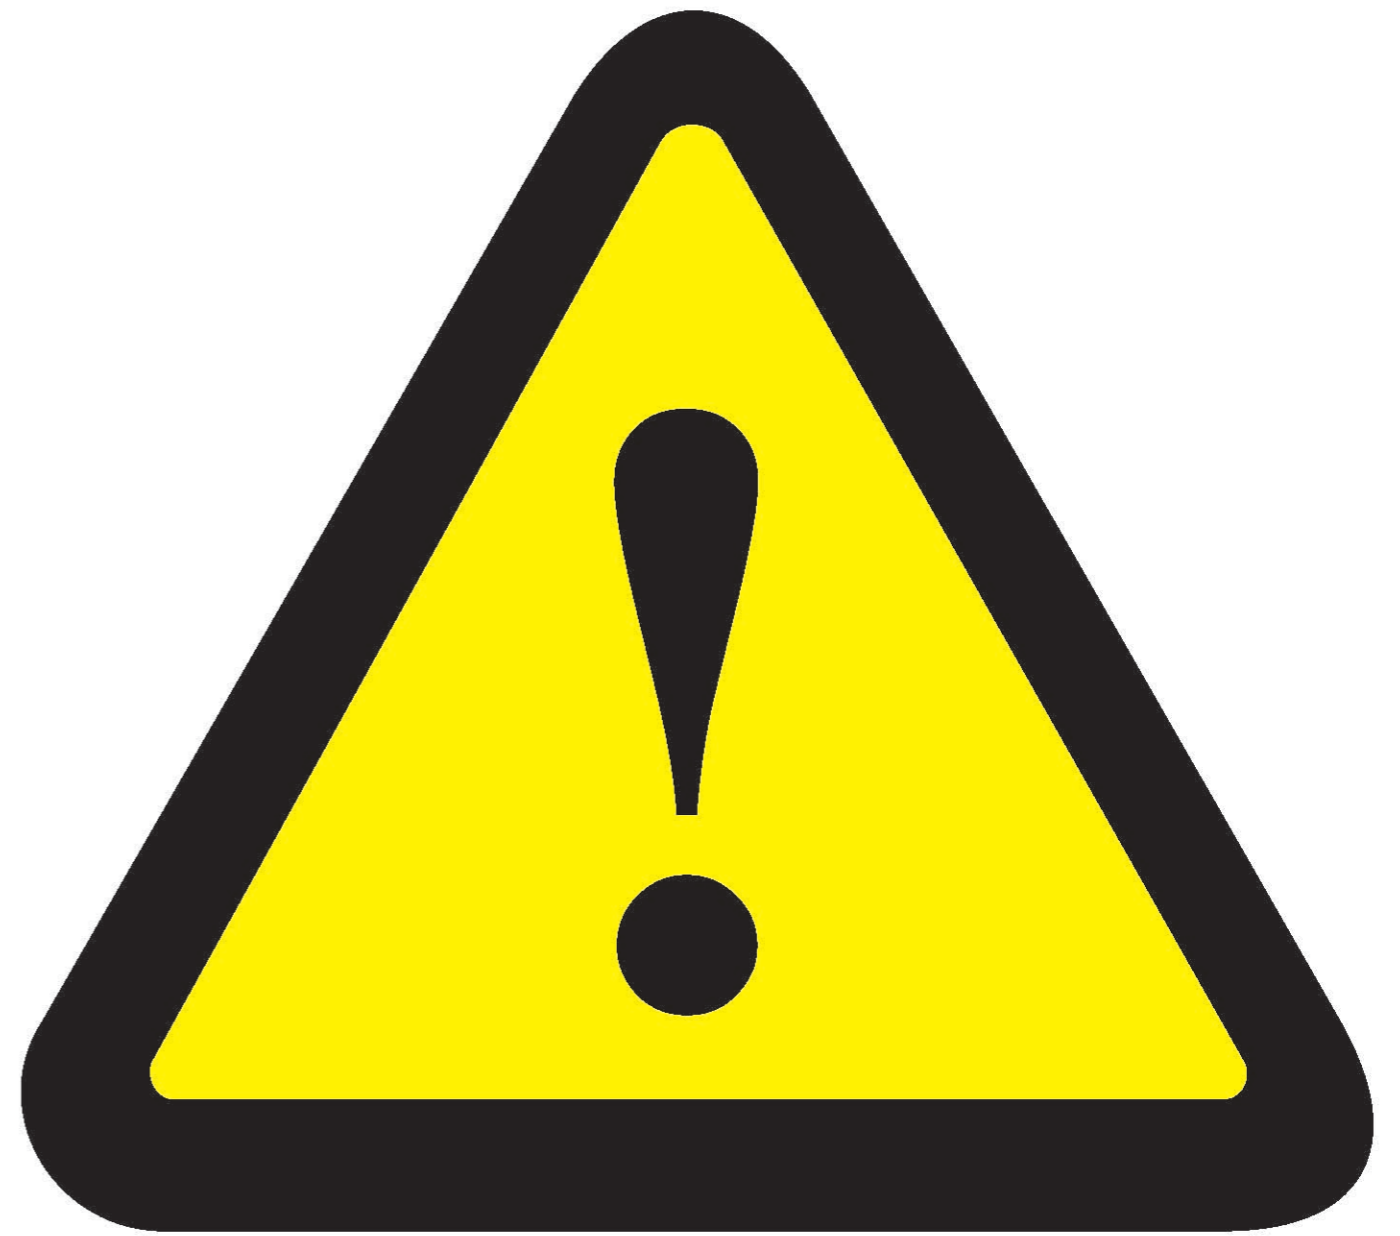
**PROTECTIVE FENCING. THIS
FENCING MUST BE
MAINTAINED IN ACCORDANCE
WITH THE APPROVED PLANS
AND DRAWINGS FOR THIS
DEVELOPMENT.**

**TREE PROTECTION AREA
KEEP OUT !**

Protective barriers will be erected prior to the commencement of any site works (e.g., before any materials or machinery are brought on site, or the stripping of topsoil commences) and signs will be installed on the protective barriers to inform site contractors of the importance of the tree protection measures in accordance with the Conditions agreed as part of the planning consent for the site (Town and Country Planning Act 1990).

The protective barriers are to be constructed in accordance with the specification detailed in BS5837:2012 '*Trees in relation to design, demolition and construction – Recommendations*'. Fencing should be erected prior to site occupation and inspected by the Project Arboriculturist to ensure they are complete, robust, and sufficiently protect the CEZ for the retained trees present on site. Any variation to the specification of the protective barrier will be agreed with the Local Planning Authority Arboricultural Officer.
