Detailed Unexploded Ordnance (UXO) Risk Assessment

Project Name	Thames Young Mariners, Richmond
Client	Soils Limited
Site Address	Thames Young Mariners, Riverside Dr, Richmond TW10 7RX
Report Reference	DA15987-00
Date	16/09/22
Originator	DB

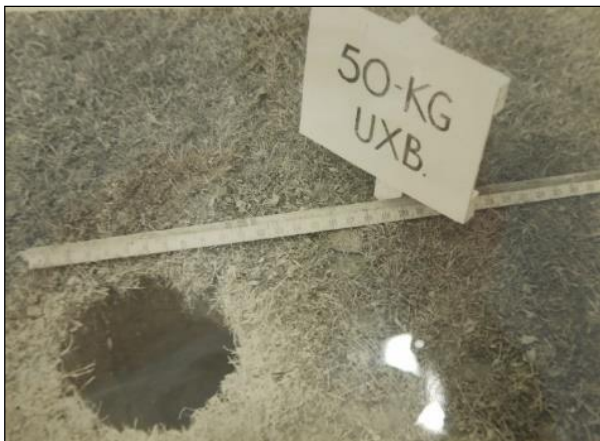
One of the most common scenarios for UXO going unnoticed was when a UXB fell into a 'bomb site' (such as the area shown **Top Left**), the entry hole of the bomb obscured by any debris and rubble present. Note that the entry hole of a 50kg UXB could be as little as 20cm in diameter (**Left**).

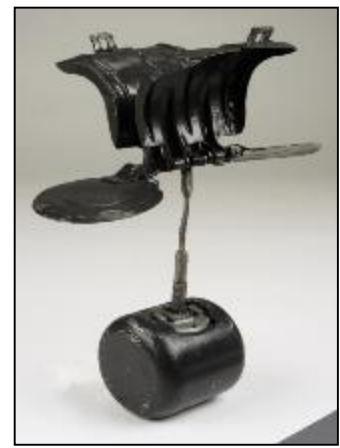
SD2 Butterfly Bomb	
Bomb Weight	2kg (4.41lb)
Explosive Weight	7.5oz (212.6 grams) of TNT surrounded by a layer of bituminous composition.
Fuze Type	41 fuze (time) , 67 fuze (clockwork time delay) or 70 fuze (anti-handling device)
Bomb Dimensions	Length 240 mm Width 140 mm Height 310 mm
Body Diameter	3in (7.62 cm) diameter, 3.1in (7.874) long
Use	It was designed as an anti-personnel/fragmentation weapon. They were delivered by air, being dropped in containers that opened at a predetermined height, thus scattering the bombs.
Remarks	The smallest and most common conventional German bomb. Nearly 70% of bombs dropped on the UK were 50kg.

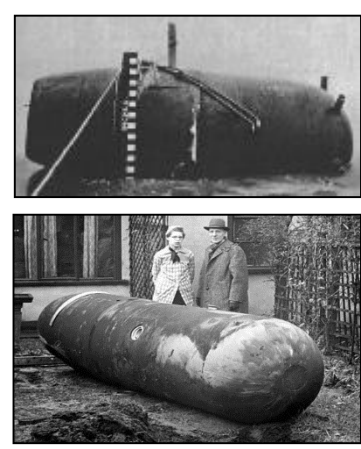
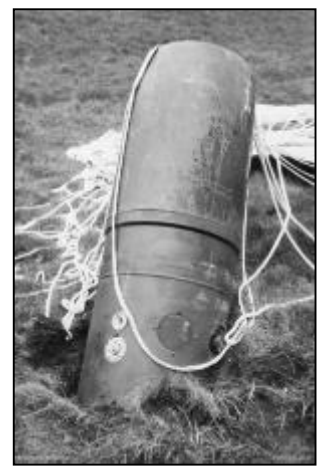
Parachute Mine (Luftmine B / LMB)

Bomb Weight	987.017kg (2176lb)
Explosive Weight	125-130kg (276-287lb)
Fuze Type	Impact/ Time delay / hydrostatic pressure fuze
Bomb Dimensions	1640 x 512mm (64.57 x 20.16in)
Body Diameter	368mm (14.5in)
Use	Against civilian, military and industrial targets. Designed to detonate above ground level to maximise damage to a wider area.
Remarks	Parachute Mines were normally carried by HE 115 (Naval operations), HE 111 and JU 88 aircraft types. Deployed a parachute when dropped in order to control its descent.

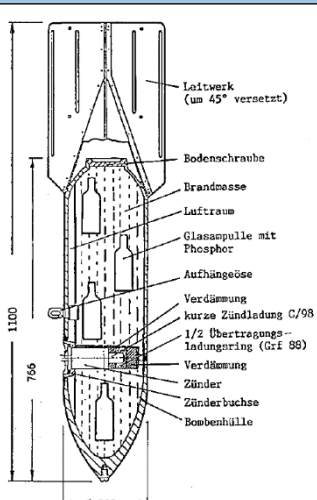
C50 A Incendiary Bomb	
Bomb Weight	c41kg (90.4lb)
Explosive Weight	0.03kg (0.066lb)
Incendiary Filling	12kg (25.5lb) liquid filling with phosphor igniters in glass phials. Benzine 85%; Phosphorus 4%; Pure Rubber 10%
Fuze Type	Electrical impact fuze
Bomb Dimensions	1,100 x 280mm (43.2 x 8in)
Use	Against all targets where an incendiary effect is to be expected
Remarks	Early fill was a phosphorous/carbon disulphide incendiary mixture

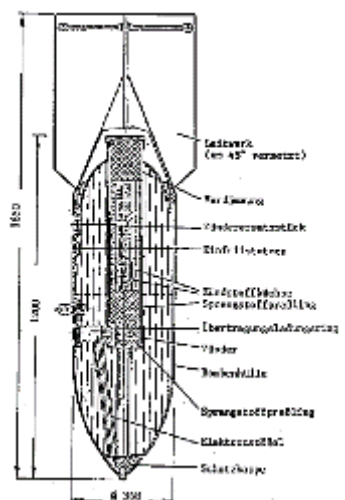
Flam C-250 Oil Bomb	
Bomb Weight	125kg (276lb)
Explosive Weight	1kg (2.2lb)
Fuze Type	Super-fast electrical impact fuze
Filling	Mixture of 30% petrol and 70% crude oil
Bomb Dimensions	1,650 x 512.2mm (65 x 20.2in)
Body Diameter	368mm (14.5in)
Use	Often used for surprise attacks on living targets, against troop barracks and industrial installations. Thin casing – not designed for ground penetration

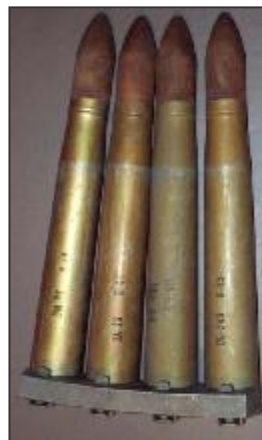
40mm Bofors Projectile

Projectile Weight	1.96lb (0.86kg)
Explosive Weight	300g (0.6lb)
Fuze Type	Proximity and Mechanical Time Fuze
Rate of Fire	120 rounds per minute
Projectile Dimensions	40mm x 310mm (1.6in x 12.2in)
Ceiling	23,000ft (7000m)

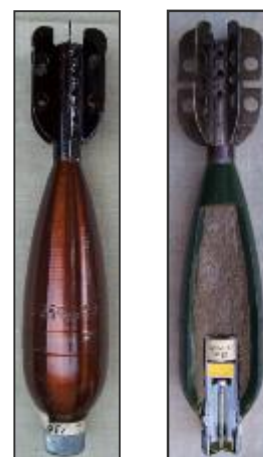
Typical 3 inch Smoke Mortar

Weight	4.5kg (9lb 14oz)
Maximum Range	2515m (2,750 yards)
Filling	White phosphorus & smoke fill (also came in Explosive & Illuminating models)
Bomb Dimensions	490 x 76mm (19.3in x 3in)
Fuze Type	An impact fuze which initiates a bursting charge. This ruptures the mortar bomb 's body and disperses the phosphorus filler
Use	As a screening devices for unit movement or to impair enemy field of vision.
Remarks	This mortars long cylindrical body and tail sometimes causes it to be misrecognised as a German incendiary bomb.

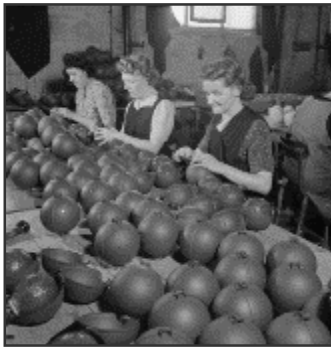
Filling	Approx. 600g Nobel's No.283 (Nitro-glycerine)		
Design	A glass ball on the end of a Bakelite (plastic) handle. The inside of the ball would contain the explosive filling and the outside a very sticky adhesive coating.

Use	An anti-tank grenade primarily issued to the home guard. It required the user to come in very close proximity with the target and smash the glass explosive container against it.		
Remarks	One of a number of weapons developed for use as an <i>ad hoc</i> solution to the lack of sufficient anti-tank guns in the aftermath of the Dunkirk evacuation amid fear of German invasion.

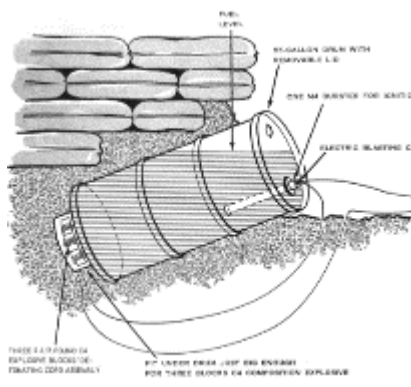
Filling	Initially a mixture of 40% petrol and 60% gas. Ammonal provided the propellant charge.		
Design	Usually constructed from a 40-gallon drum dug into a roadside and camouflaged.

Use	As an improvised anti-tank bomb. When triggered the Fougasse could project a beam of burning sticky fuel in a fixed direction from up to 3m (10ft) wide and 27m (30yards) long.		
Remarks	A highly unorthodox weapon designed by the Petroleum warfare department to address a critical lack of weapons in 1940. 50,000 are estimated to have been distributed around the UK.
