Scoping Investigation Report

Thames Young Mariners, Riverside Drive, Richmond TW10 7RX

Surrey County Council

Reference: 20295/SIR Rev I.0

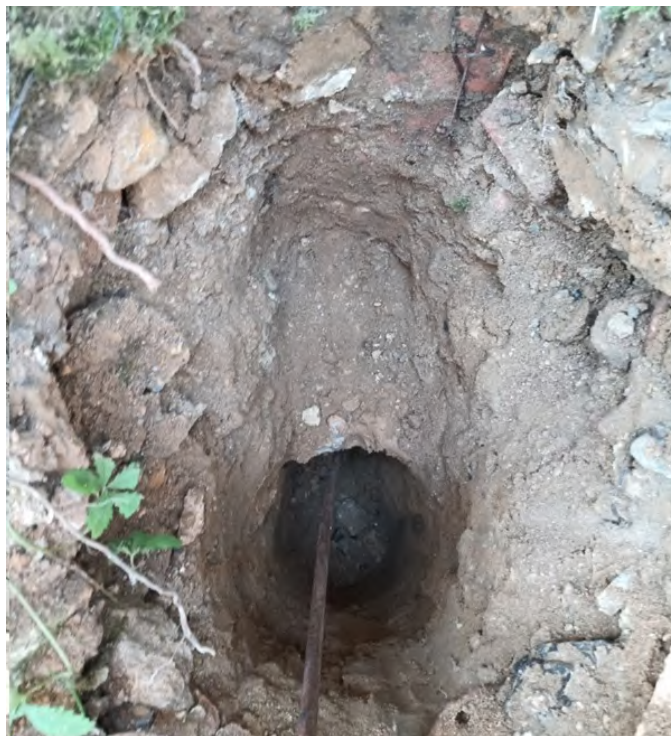
Appendix B.2 Foundation Exposures

- One foundation exposure was undertaken at the request of the Clients engineers to determine the foundation depth of the existing main building. The foundation exposure was undertaken at a location where access could be gain along the northern side of the existing main building.

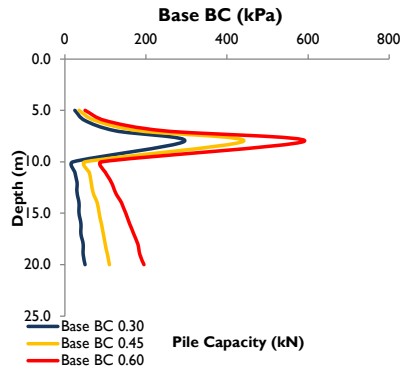
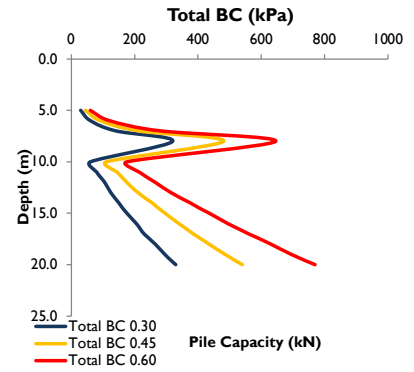
Parameters:	FOS:	Shaft	Base	Alpha Value (α):	0.45	Maximum no. of layers	2
Name: TYM	Clay:	3	3	GW Level: 4m BGL	NC Value:	9	
Job No: 20295	Gravel:	3	3				
Date: 28.9.22

Notes: Piles founded in the KPGR but in close proximity to the LC boundary must consider the reduced allowable load within the underlying LC, within the final design, to prevent overstressing.

Material	Pile Depths (m bgl)	Pile Diameter (m):									Layer
		0.3			0.45			0.6			
		Shaft	Base	Total	Shaft	Base	Total	Shaft	Base	Total	
Gravel	5.0	5	25	30	10	35	45	10	50	60	1
Gravel	6.0	10	50	60	15	75	90	20	100	120	1
Gravel	7.0	15	125	140	25	185	210	35	245	280	1
Gravel	8.0	25	295	320	40	440	480	55	590	645	1
Clay	10.0	40	20	60	60	50	110	85	90	175	2
Clay	11.0	55	25	80	85	60	145	115	100	215	2
Clay	12.0	75	30	105	110	65	175	150	115	265	2
Clay	13.0	95	30	125	140	70	210	190	125	315	2
Clay	14.0	115	35	150	175	80	255	235	140	375	2
Clay	15.0	140	35	175	210	85	295	285	150	435	2
Clay	16.0	165	40	205	250	90	340	335	160	495	2
Clay	17.0	190	40	230	290	95	385	390	170	560	2
Clay	18.0	220	45	265	335	100	435	450	180	630	2
Clay	19.0	250	45	295	380	105	485	510	185	695	2
Clay	20.0	280	50	330	430	110	540	575	195	770	2
Clay	20.0	280	50	330	430	110	540	575	195	770	2

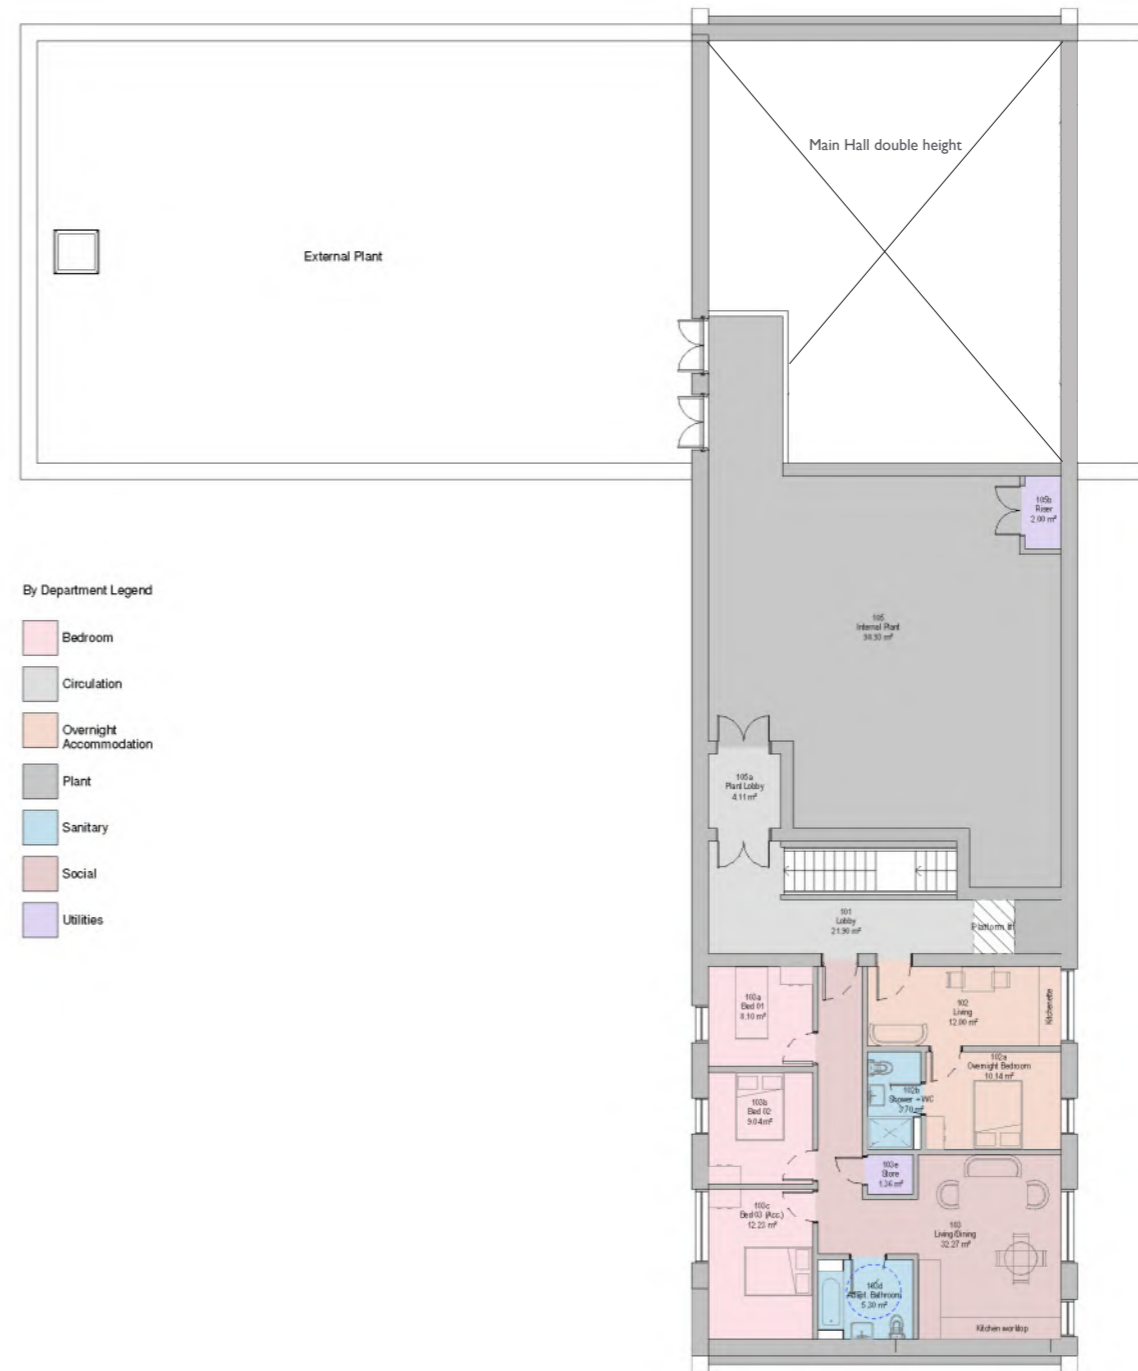
3.2.3 Main Building - First Floor Plan

These proposals show the relocated staff residential accommodation at first floor level. The scale of provision has been reviewed with SOLD to optimise the amount of accommodation and include overnight surveillance of the site, which is an important security measure necessary due to the equipment stored within the site. Access to this accommodation is distinct from the general use at upper ground floor level.

To achieve the energy efficiency targets for this scheme, a plantroom is included at this level for the primary energy generation plant that serves this building and the adjacent Guest Residential Blocks. Air source heat pumps (ASHPs) will be located here, with heat rejection equipment positioned externally on the flat roof above the kitchen and changing areas.

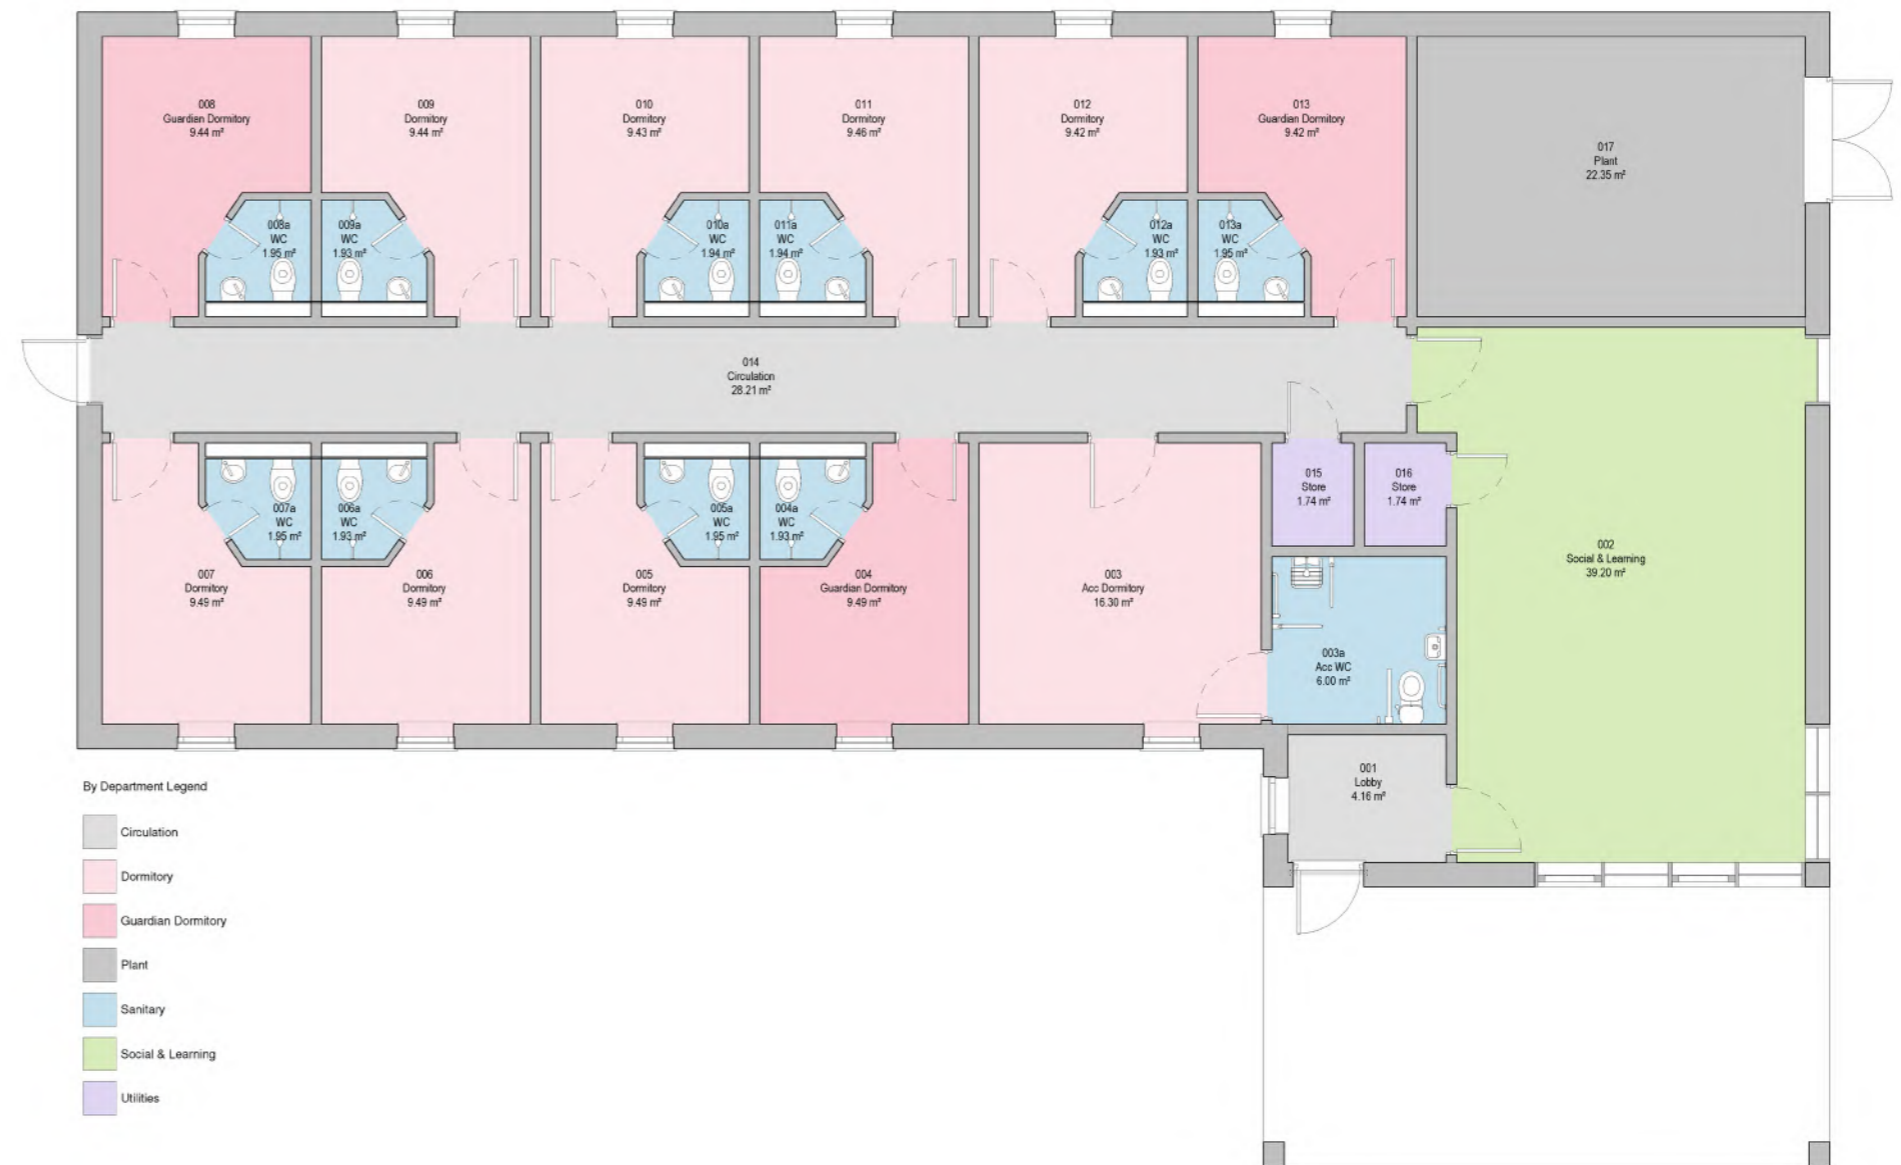
3.2.4 Guest Residential Blocks

The layout is organised around a central corridor with four bed dormitories sharing ensuite shower facilities. Additional guardian bedrooms are necessary for appropriate safeguarding of each group of children. The number of bedrooms is based on school group size.

As for the changing facilities, our approach has been to integrate accessible sleeping provision alongside standard bedrooms so that groups can be fully inclusive. A small flexible room is included in each building for the school group to socialize and gather before and after activities.
