Kingston
Bridge House,
Church Grove,
Hampton Wick,
KT1 4AG

Endoscope and eDNA Survey Report

October 2022

Ref: 22-9417

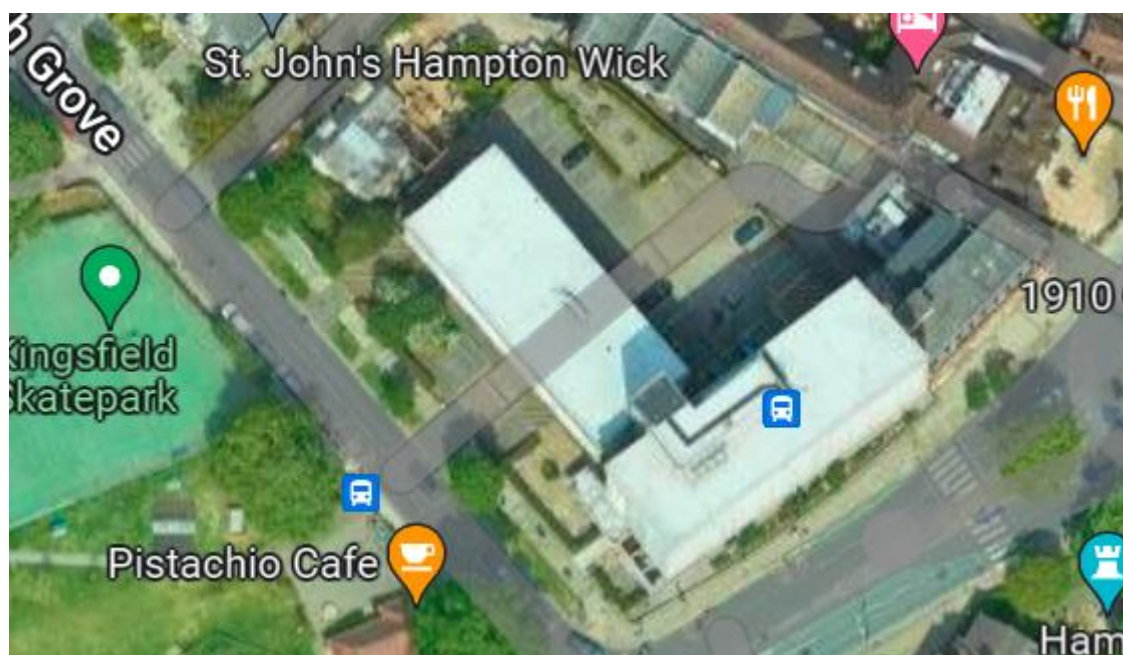
Figure 1: Building surveyed. Source: Google Maps.

4.1.1. The endoscope survey was carried out on the 23rd of September 2022, commencing at noon. Conditions were suitable with 7mph winds, no rain, overcast, and 18°C. Figure 1 below shows the building surveyed.

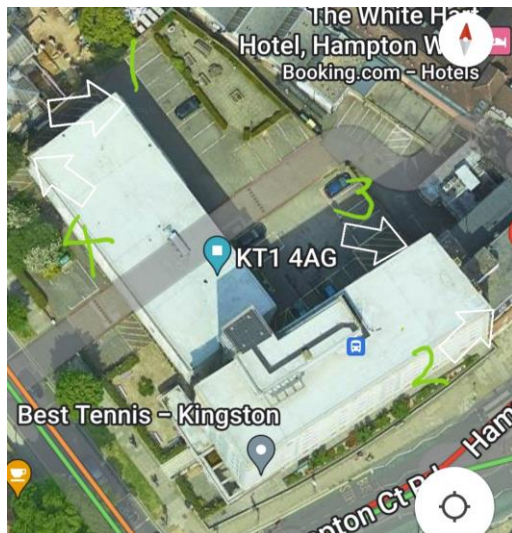
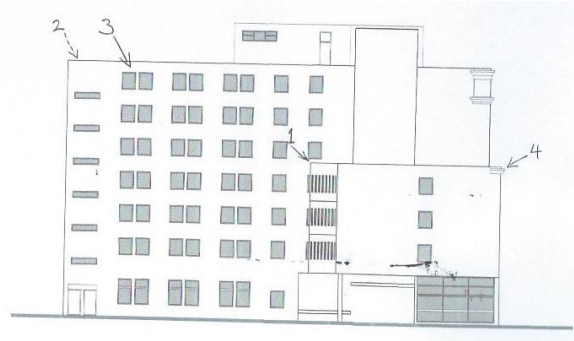
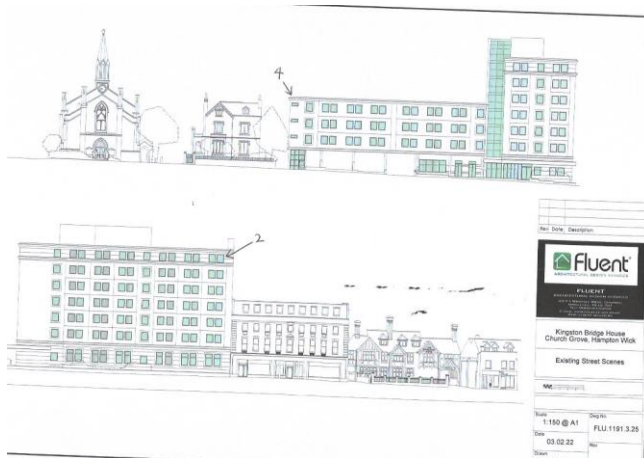
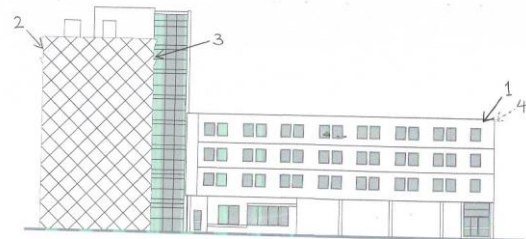
Figure 2: Confirmed Location of Roosting Bats Found During Endoscope Survey Source: Google Maps and Agent

4.1.2. The surveyor noted three locations with confirmed presence of bats in the form of droppings (referred to Point 1, 2 and 3 in this report). Point 4 could not be fully surveyed due to its location, the surveyor did note its overall potential to have previously supported roosting bats. Figure 2 below details the location (in both google ariel view and elevation plans) of the confirmed presence of roosting bats in the form of droppings and or overall potential for use by roosting bats.

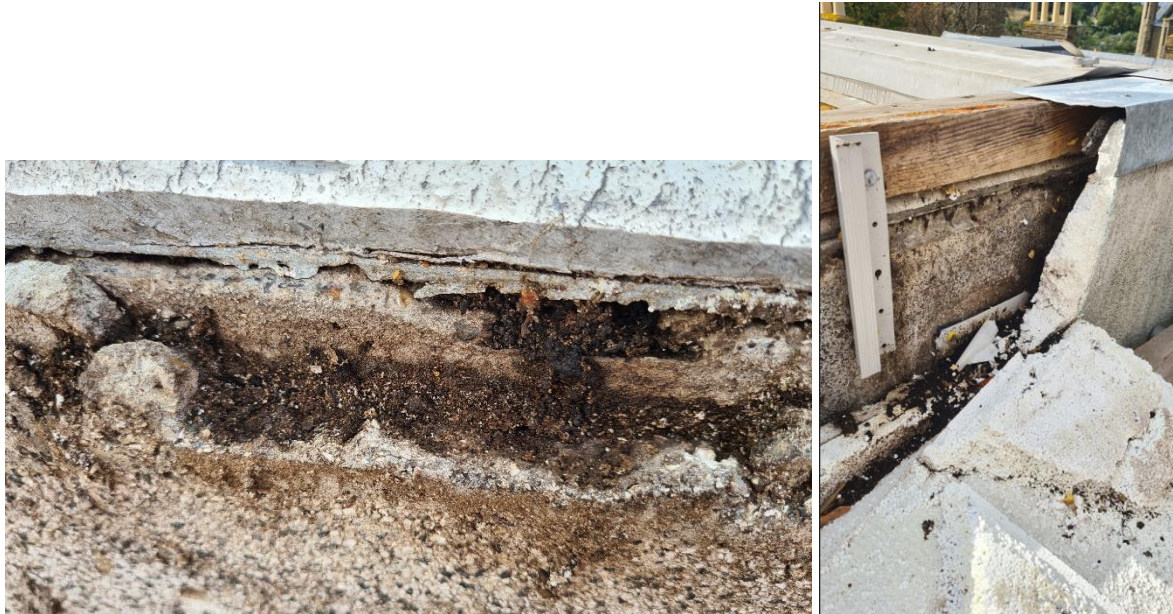
Figure 3: Point 1 Roost Location and Droppings

4.1.3. Point 1 is located in the Northeast corner of the building north wing. Droppings were found from a location above a window that Alison Fure has previously described as having a roost entry point. The droppings had a notable age range and cascading from the crevice roost location. The original roost space appears to run along the cladding, the cladding that has been pulled away during previous works shows the extent of the roosting space shown by the number of droppings. It is likely that the roosting space could have run along the whole of the upper wall space especially if no restriction of movement was in place for the individual bats. The number of droppings found is consistent with use as a maternity roost as documented previously by Alison Fure. Figure 3 below shows a close up of the droppings and also the location with the cladding removed.

- Point 1 had confirmed the species as common pipistrelle (*Pipistrellus pipistrellus*).
- Point 2 had confirmed the species as soprano pipistrelle (*Pipistrellus pygmaeus*).
- Point 3 had confirmed the species as common pipistrelle (*Pipistrellus pipistrellus*).

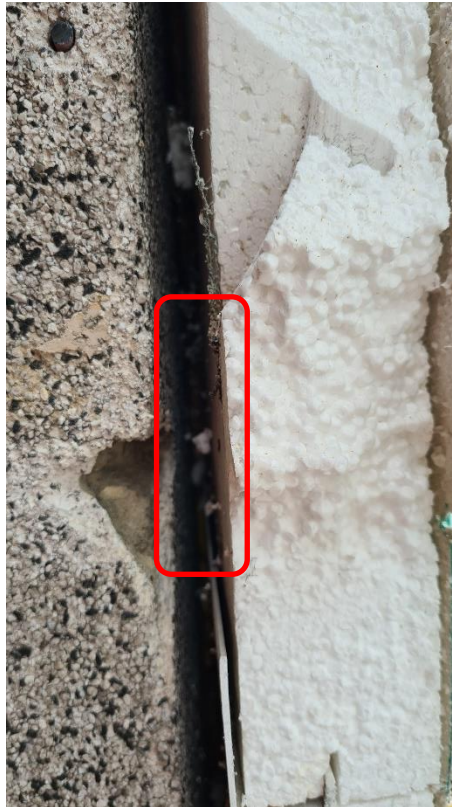
Figure 4: Point 2 Roost Location and Droppings

4.1.4. Point 2 noted a roosting area located behind the remnant cladding strip within the south-eastern corner of the south wing. A small number of droppings were found within the small void between the cladding and wall space. Only one dropping was retrievable for eDNA testing. The endoscopy survey noted that there was a potential void that runs down the full length of the building that would have been available for use by roosting bats if no restriction in movements was in place for the individual bats. The extent of the area could not be fully inspected by endoscope by the ecologist due to access issues. Figure 4 shows the location of the roosting space and droppings found.

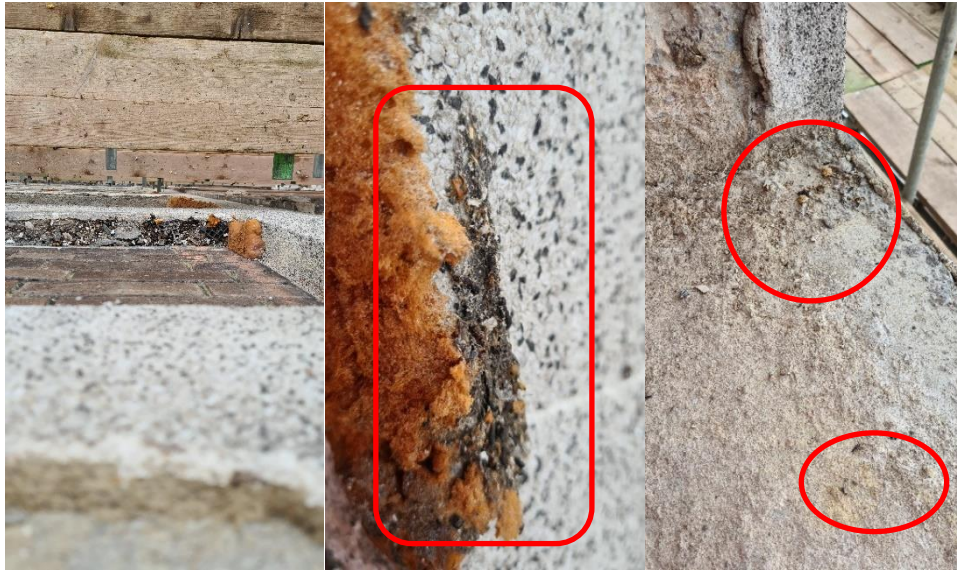
Figure 5: Point 3 Roost Location and Droppings

4.1.5. Point 3 noted droppings located on the window ledge, north facing on the south wing. Droppings found were a mixture of older remnants on outside of wall that were presumably behind cladding originally, and slightly fresher looking droppings on ledges. The photos below in Figure 5, are from the surveyor looking out and down of window. The photo shows the ledge with droppings present with more found at the side of ledge. The other photos include a close up of droppings at just outside a window where the cladding was removed, and remnants of droppings and cladding remain.

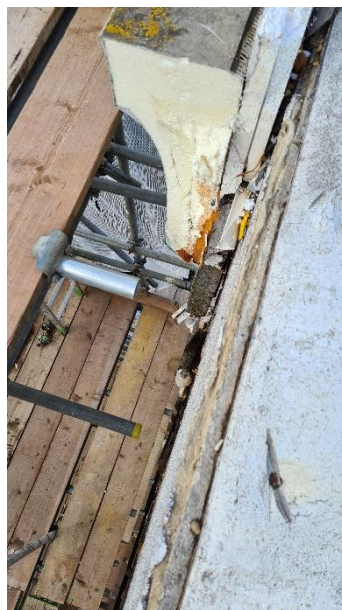
Figure 6: Point 4 Potential Roost Location

4.1.6. Point 4 location is within the north-western corner of the north wing. Whereas the surveyor could not fully inspect this area due to difficulty with access. It was assumed that the gaps between the wall and cladding could have held potential for roosting bats prior to the cladding removal based on the characteristics of the other three roost points found during the survey. Figure 6 below shows the potential roosting space and areas of cladding that has been removed.
