Kingston  
Bridge House,  
Church Grove,  
Hampton  
Wick, KT1 4AG

## Outline Bat Mitigation Plan

February 2023

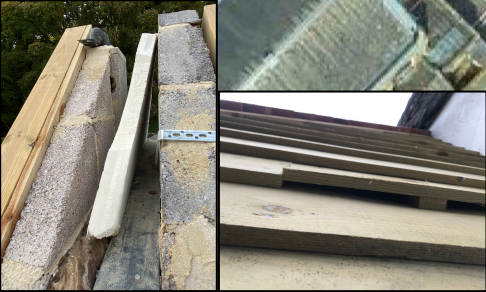
Bespoke features to be created under the supervision of a licenced ecologist, either wooden cladding features and/or lead access features around windows/access features into wall cavities.

4.4. *Mitigation/Compensatory Roosts:* Compensation on site will require the provision of numerous bespoke bat features, including lead cladding access to wall cavity features or timber cladding features and integrated bat boxes. This will be created to provide a variety of roosting spaces at different elevations and to provide micro-climates. The specific details of these will be determined onsite by a Licenced Ecologist. A 2FN Bat Box (similar as available) will be installed on a suitable tree within the site (If this is not possible a 2FN may be installed on the building- preferably south-west facing). This will be installed at a height of at least 4m and will be retained once works have been completed and will be suitable as a release box in the unlikely event that a bat is recorded onsite. This box will remain on site in perpetuity, and count towards the Mitigation of the site.

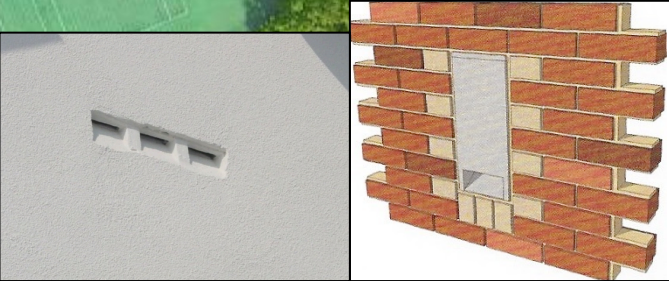
3x 1FR Bat Tube installed together- Internally connected to provide continous roosting space for bats. Enhancement for loss of Maternity Roost.

4.5. *Enhancement:* To enhance the site for pipistrelle bats, four groups of 3x2FR Bat Tubes (12 in total) will be installed at different elevations around the building. These will be connected internally and will provide further roosting opportunity for bats suitable for a maternity roost.
