SURREY COUNTY COUNCIL
THAMES YOUNG MARINERS,
SURREY OUTDOOR LEARNING & DEVELOPMENT CENTRE

DESIGN & ACCESS STATEMENT

PART 2 - SITE ANALYSIS

ISSUE 02

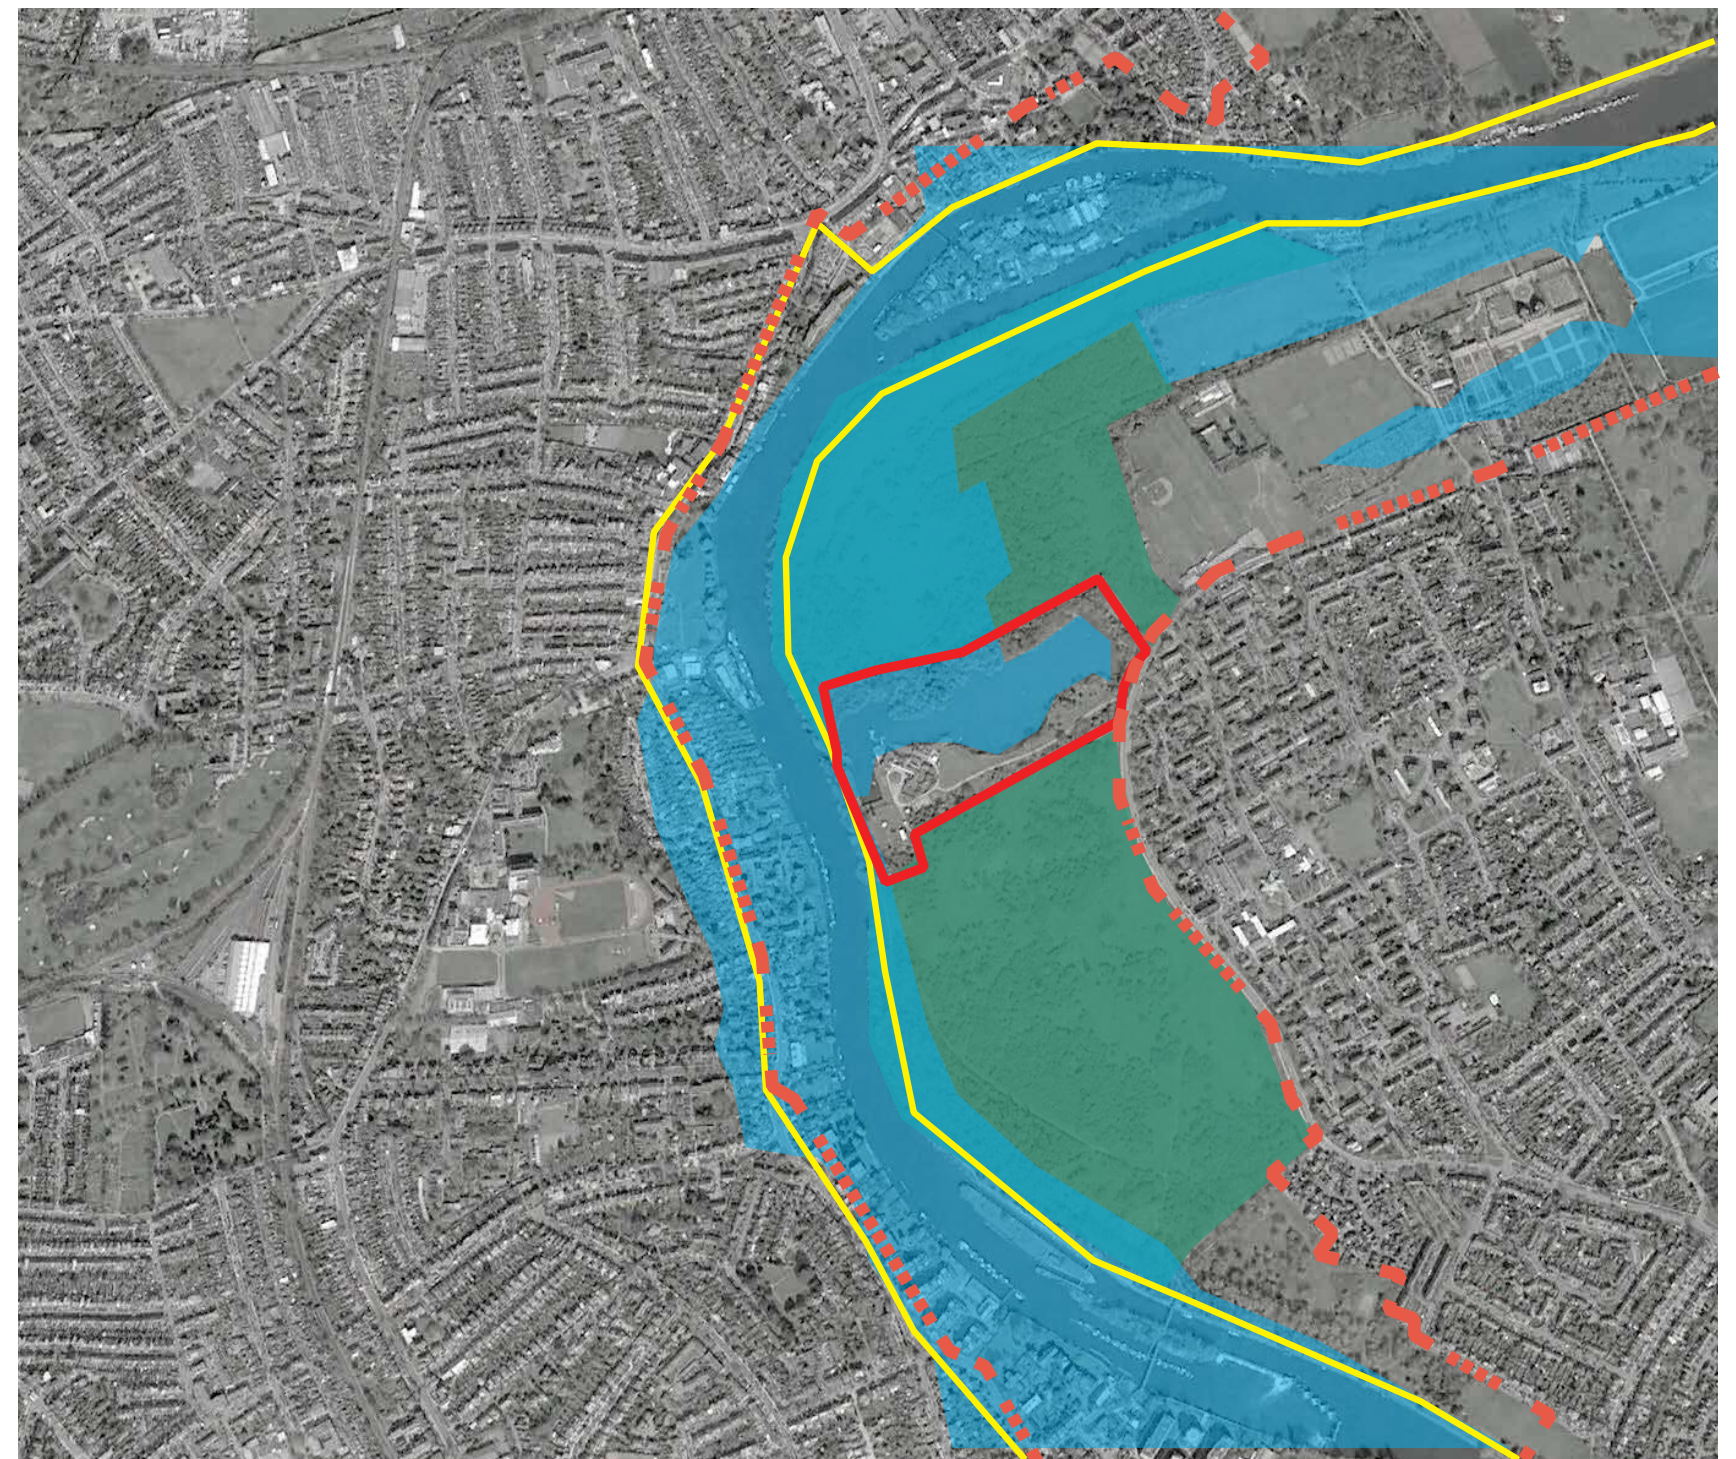
Site Specific Context

-

Thames Path National Trail
-

Ham Lands Local Nature Reserve
-

Flood Zone 3
-

Thames Policy Area

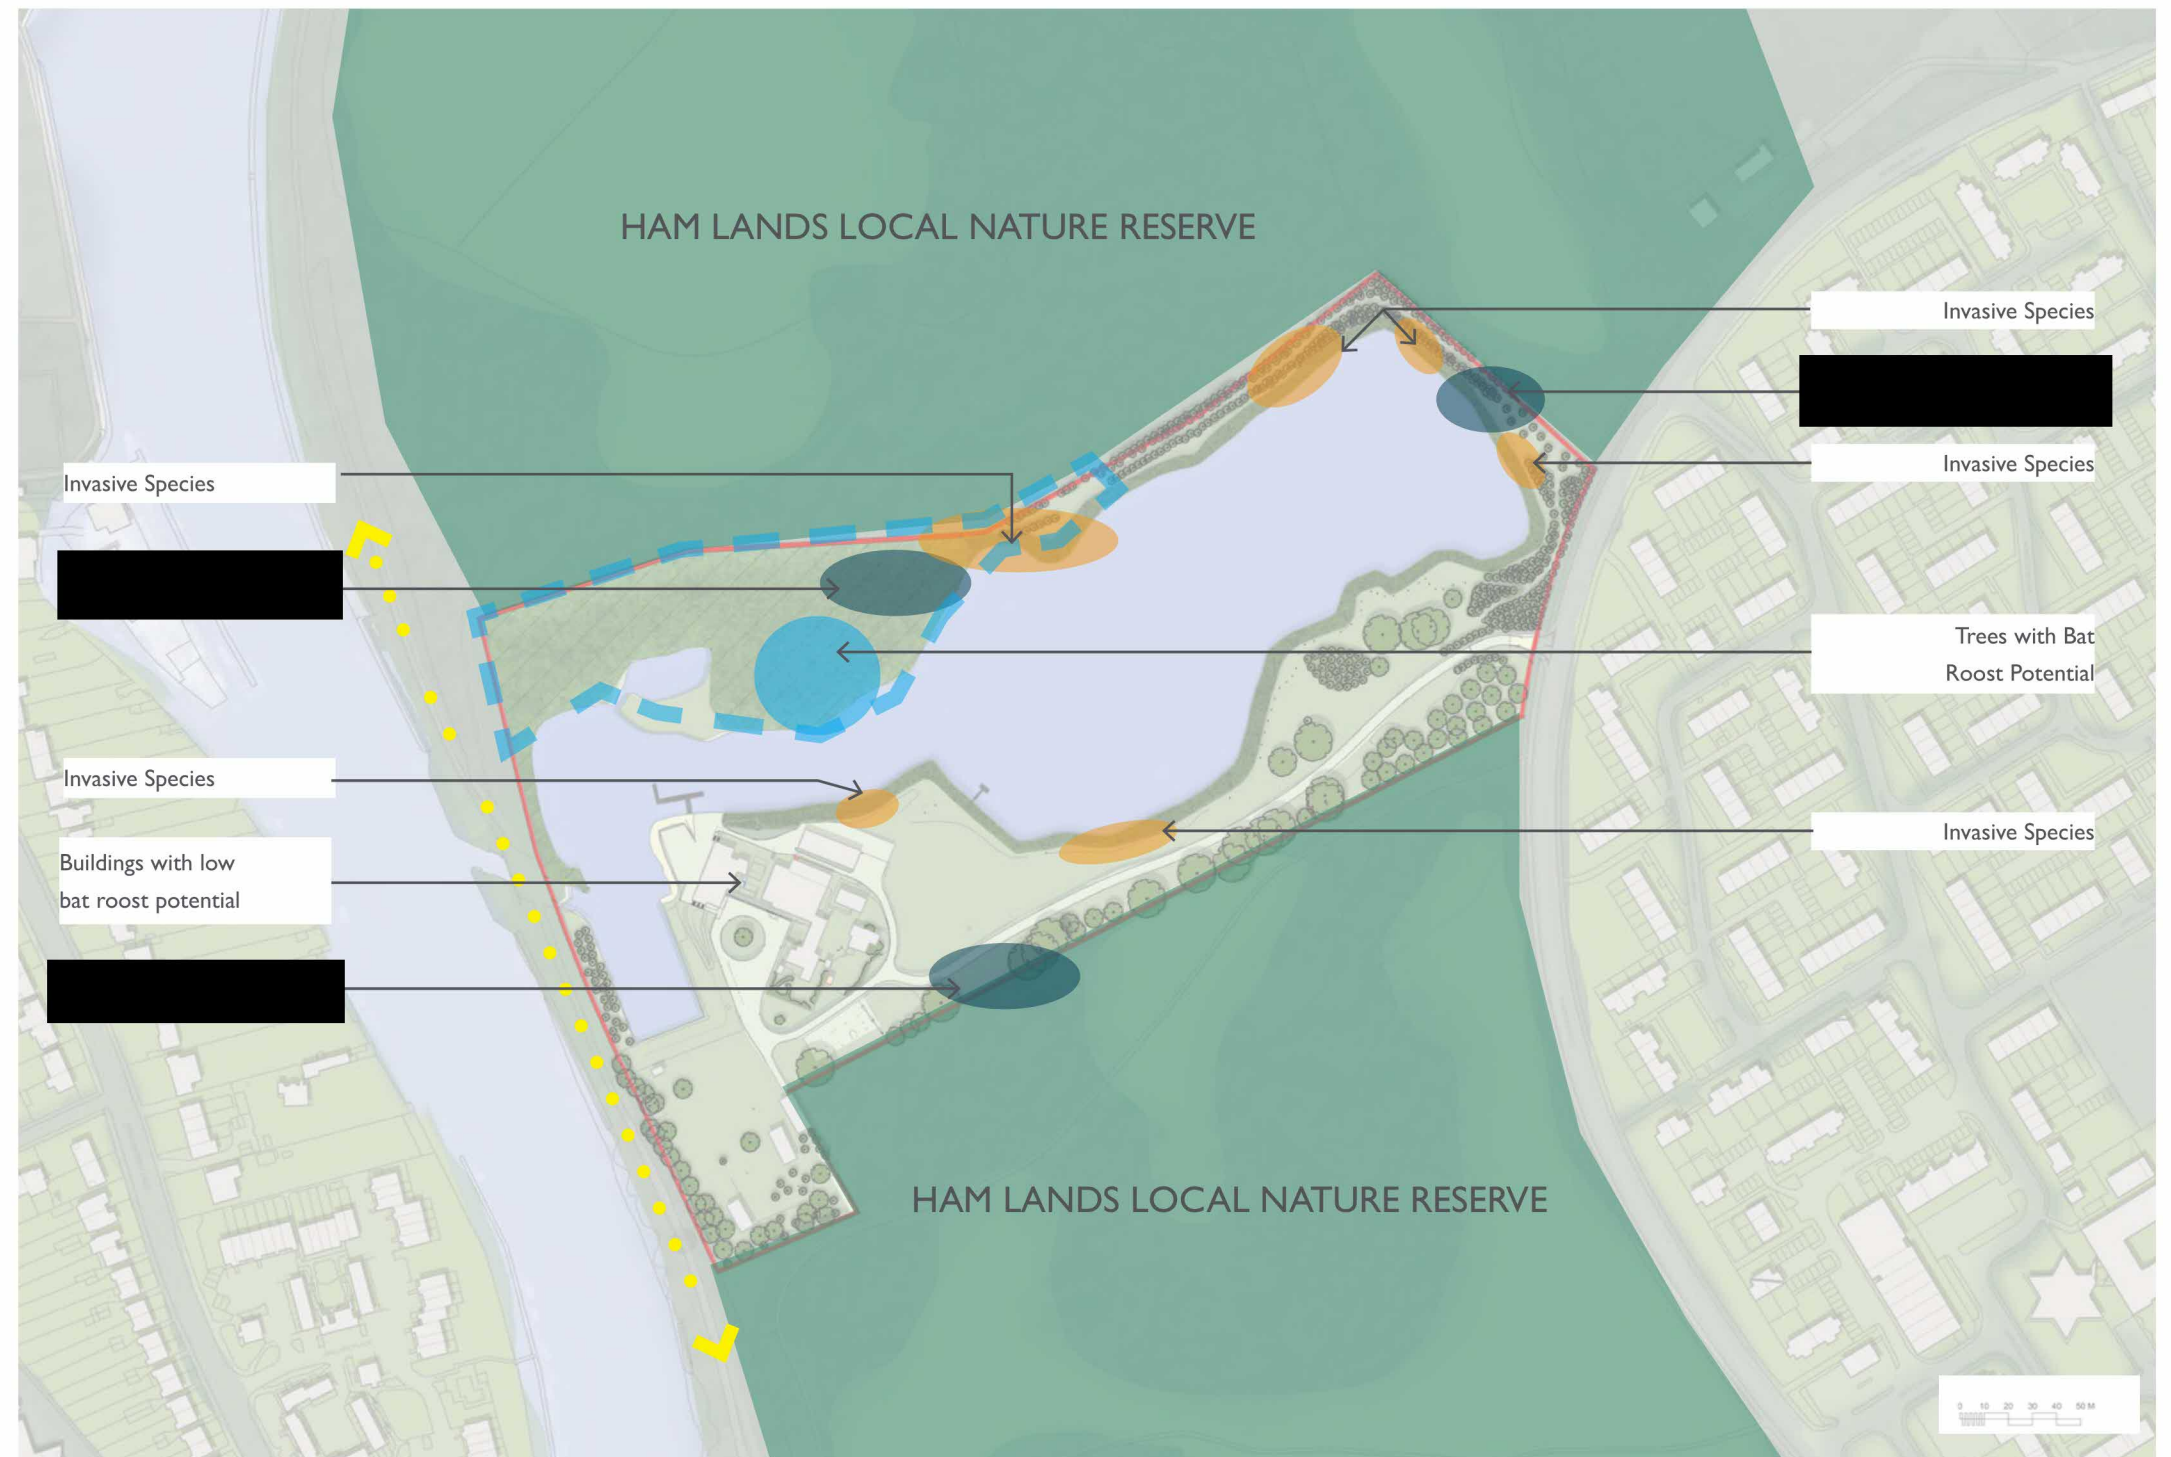
Existing Ecology

The adjacent diagram summarises the primary ecological constraints and findings identified in the Preliminary Ecological Appraisal: Biodiversity Impact Assessment, Preliminary Roost, Assessment and Preliminary Ground Level Roost, Assessment for Trees carried out by Surrey Wildlife Trust (SWT) Ecology Services on 26th October 2020 and by Surrey County Council (SCC).

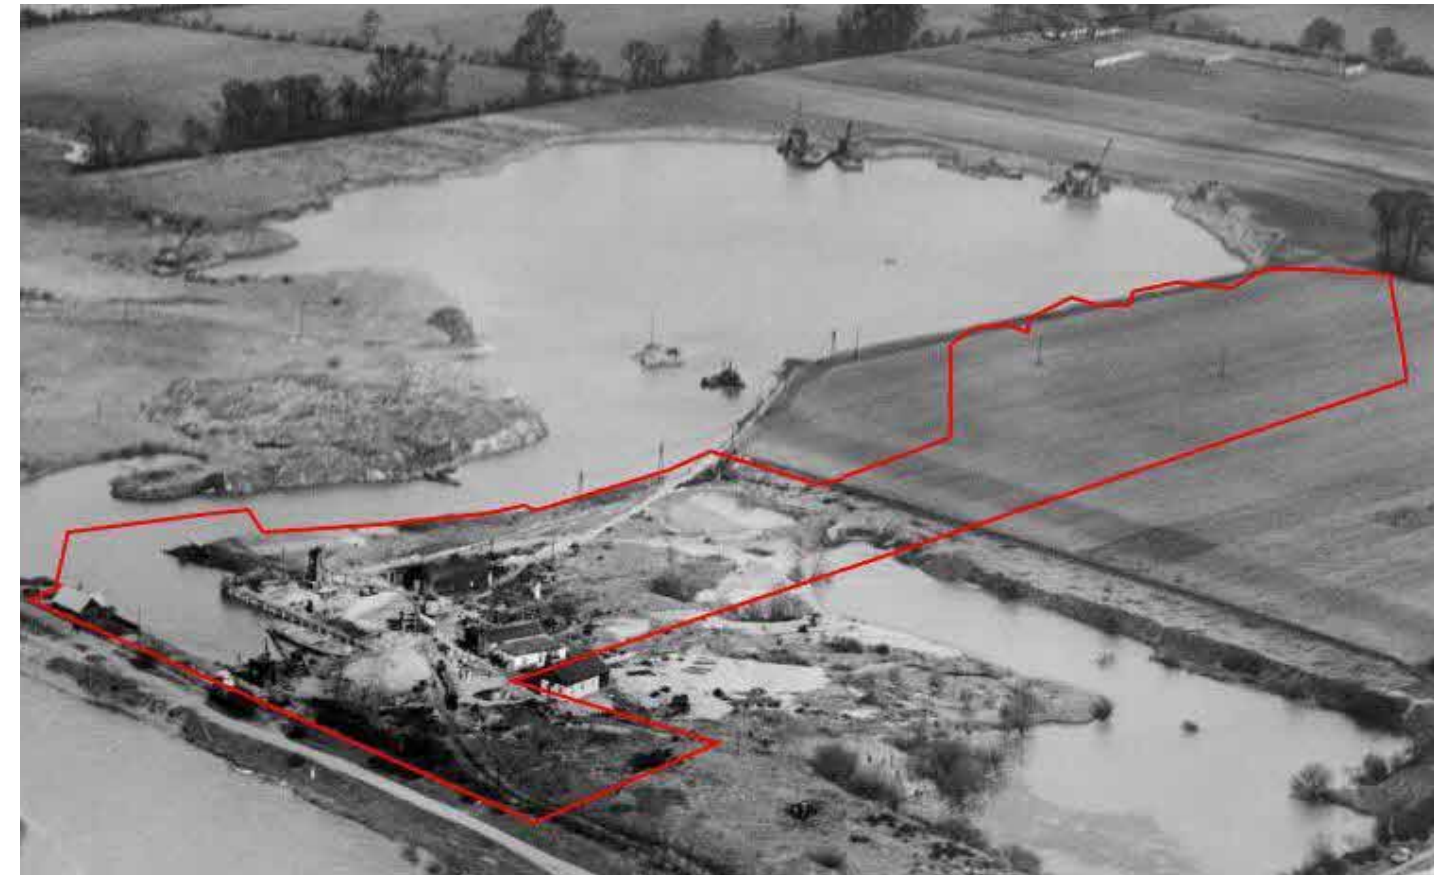
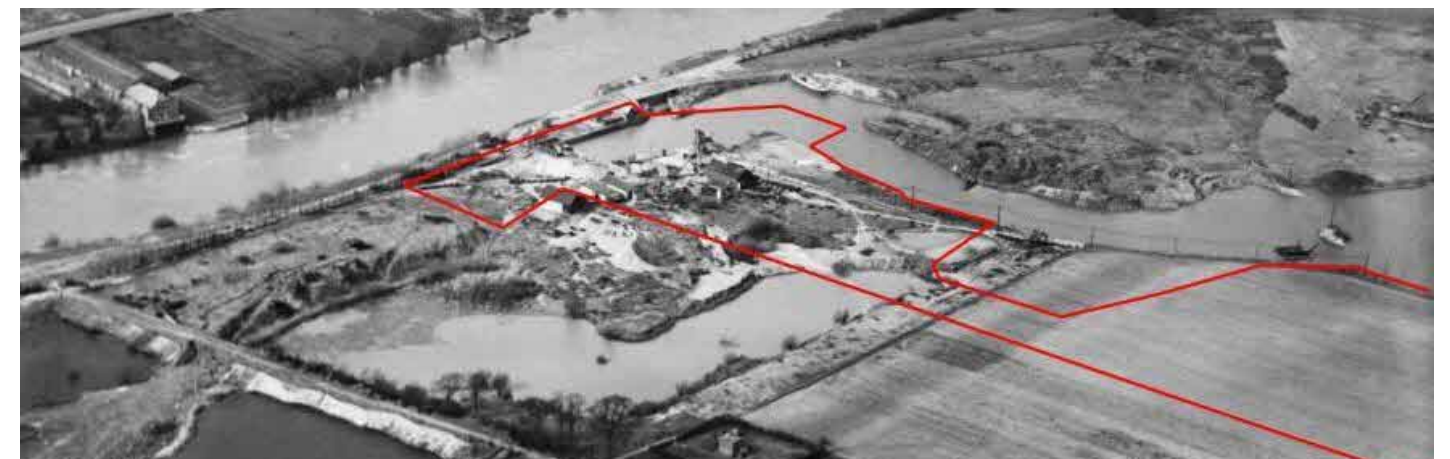
3.5.2 Flood Risk Assessment

Soils Limited were commissioned to undertake a Flood Risk assessment survey. Their findings are provided in report 20295/FRA REV 1.0 titled Flood Risk Assessment. A summary of these findings are provided below for reference:

Most of the new development, including the more vulnerable guest/ staff accommodation buildings were to be emplaced within Flood Zone 1, with a low probability of flooding from fluvial and tidal sources. The risk from surface water flooding was very low risk and negligible to low risk from both groundwater and sewer flooding. The site was in an area where flooding could occur due to reservoir failure, when there is also flooding from rivers. The reservoir breach models are based on a worst-case scenario and the probability of failure occurring was considered low. However, the northwest side of the main building would be in Flood Zone 2 and the peripheral of the building within Flood Zone 3, corresponding to a medium and high probability of flooding. The JBA flood maps model for a 1000-year return showed a flood depth of 0.1 to 0.3m covering the corner of the proposed main building.

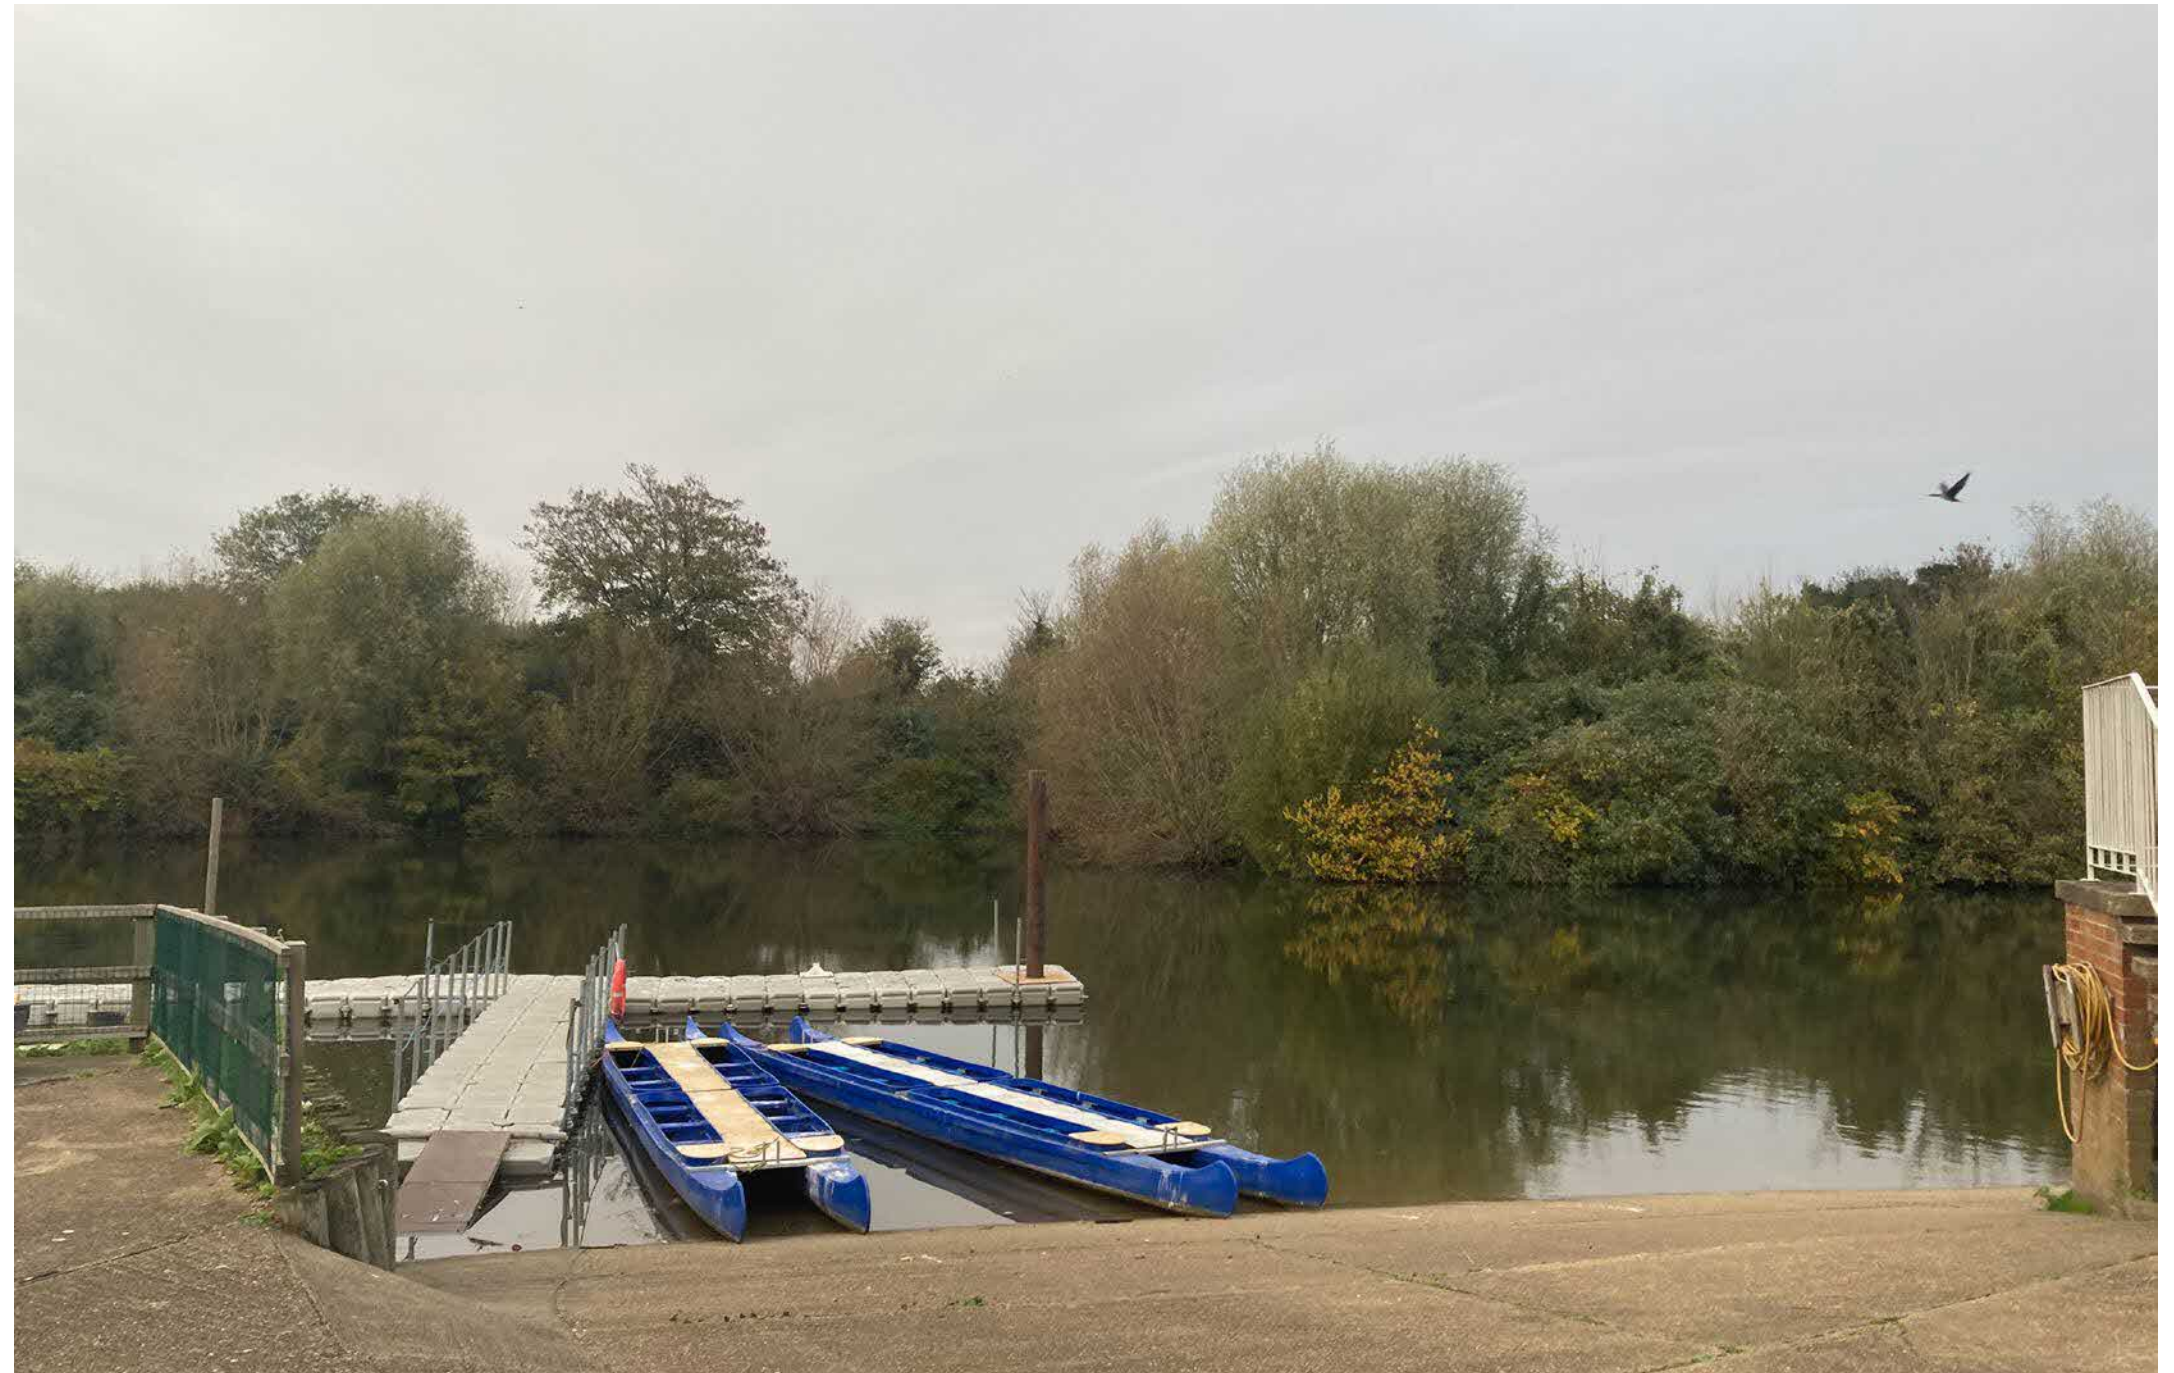
3.5.5 Arboricultural Method Statement

Middlemarch were also commissioned to undertake an Arboricultural Method Statement. Their findings are provided in report RT-MME-158839-01 titled Arboricultural Method Statement. A summary of the scope is provided below for reference:

To determine the status of the trees and hedgerows within the site, a full arboricultural survey has been undertaken, assessing the species and status of all trees and hedgerows present. This survey has been carried out in accordance with British Standard 5837:2012 'Trees in Relation to Design, Demolition and Construction – Recommendations'.

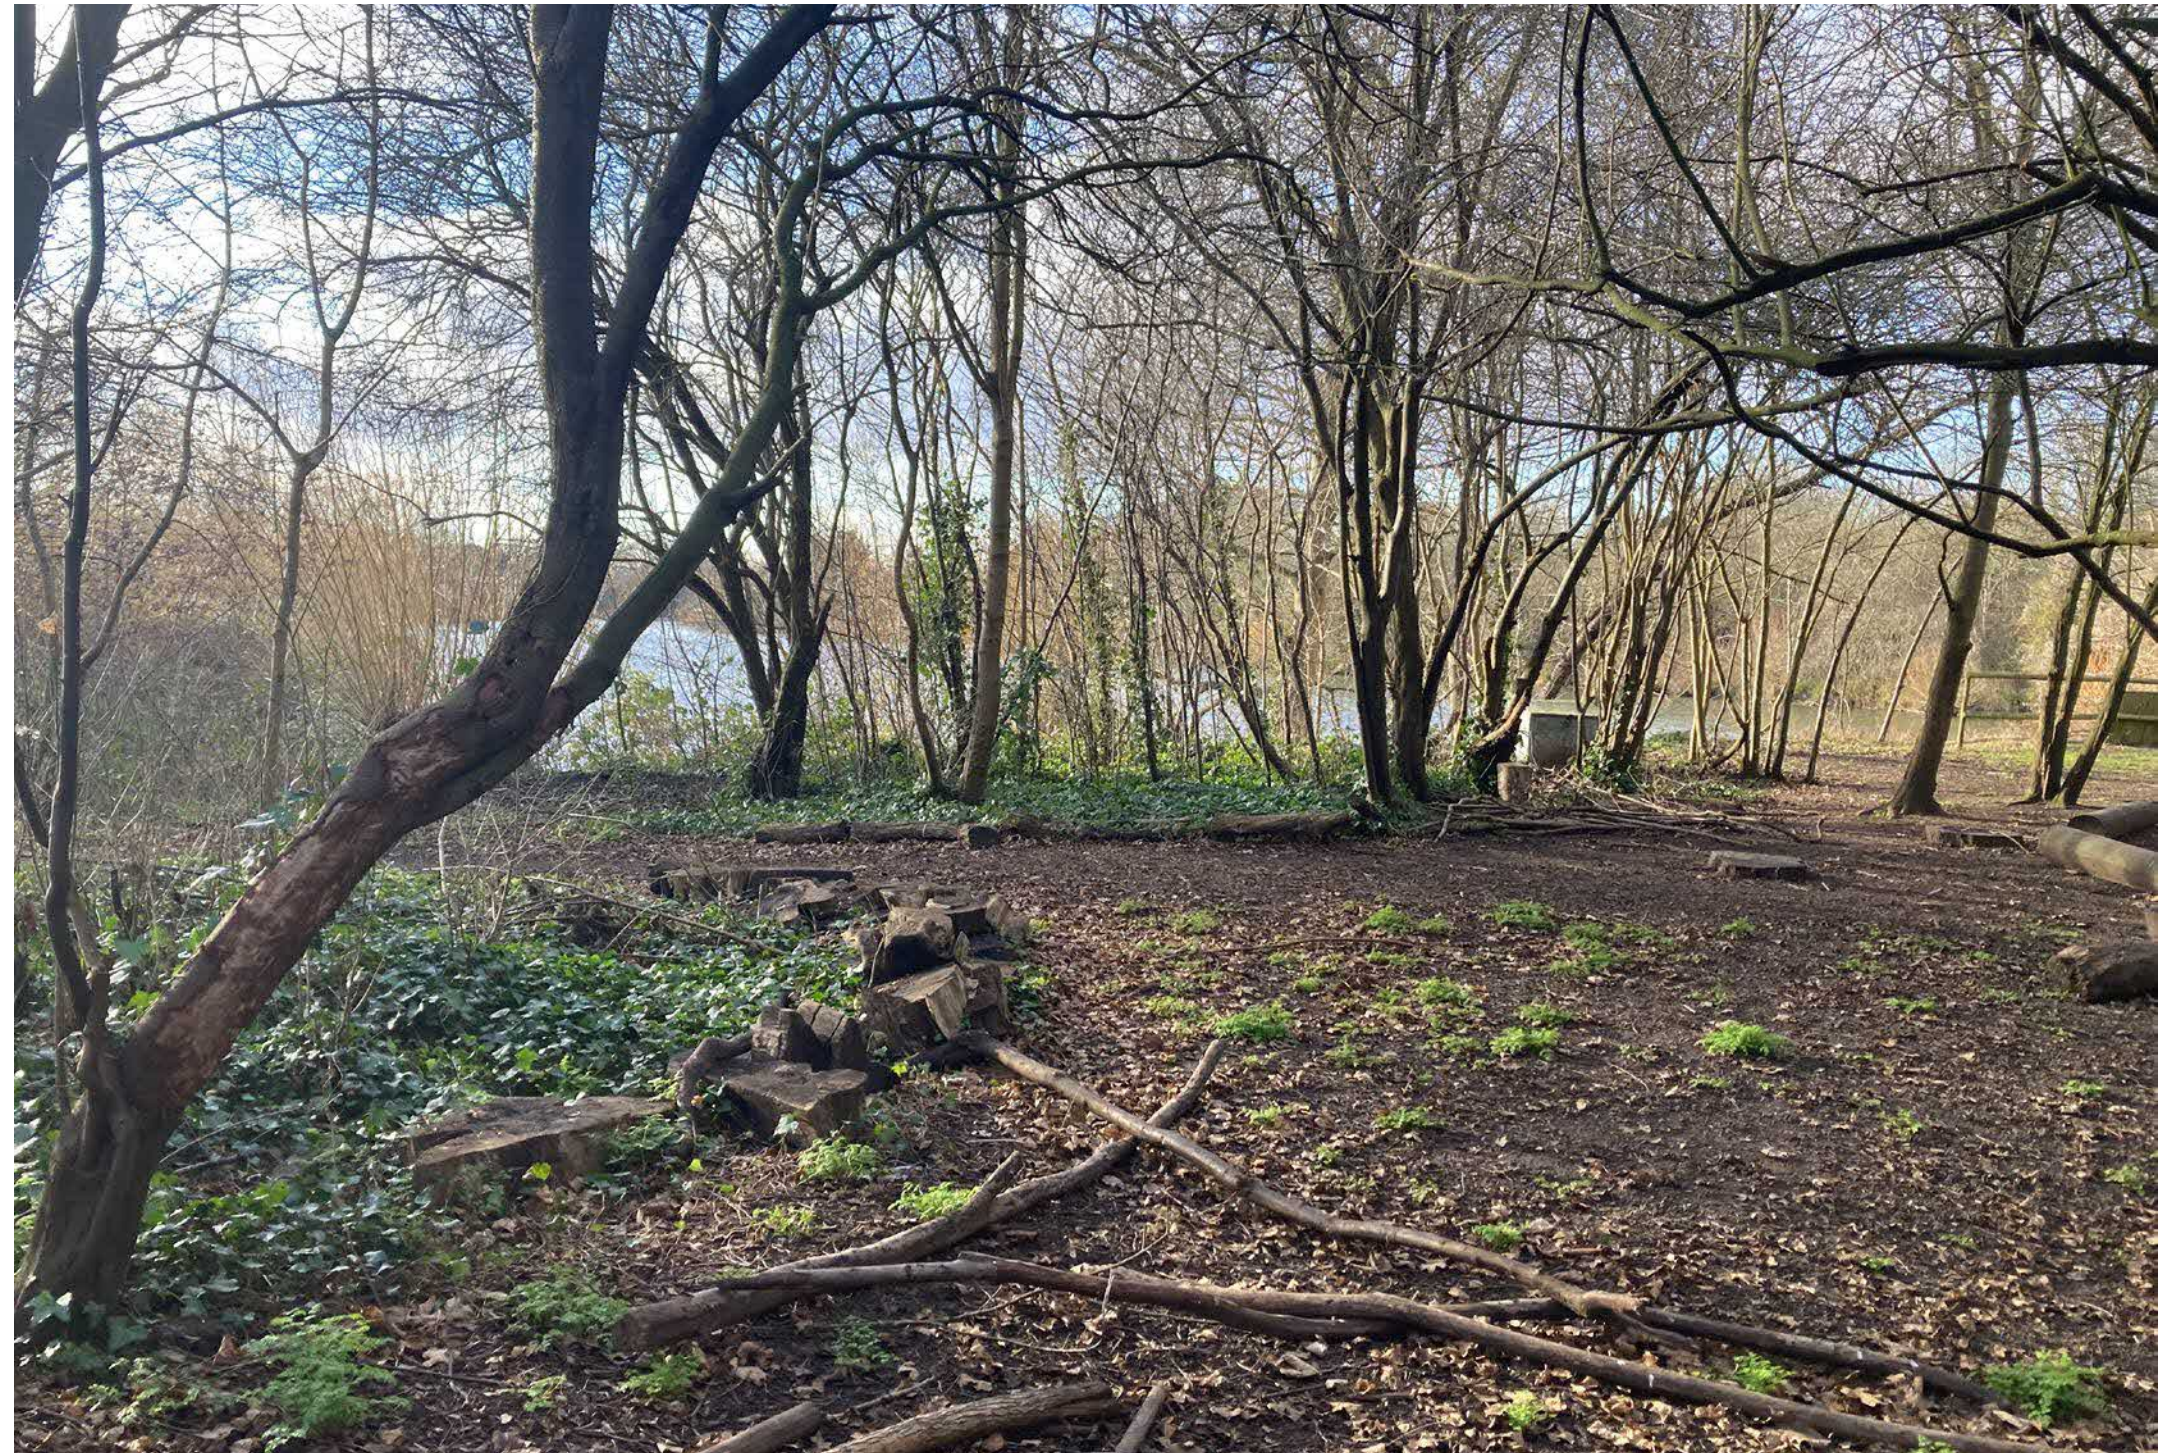
3.5.7 Ecology

Ecological surveys have been undertaken to assess the potential of the site, with detailed habitat and emergence surveys following to inspect individual species, such as bats.

Based on the outcome of these surveys we have advised the client to exclude the dense woodland to the northern bank from the scheme. An existing access around the lake will be retained but no new works are proposed. The redline boundary defining the development area has been changed to the southern bank of the lake to clarify this approach.

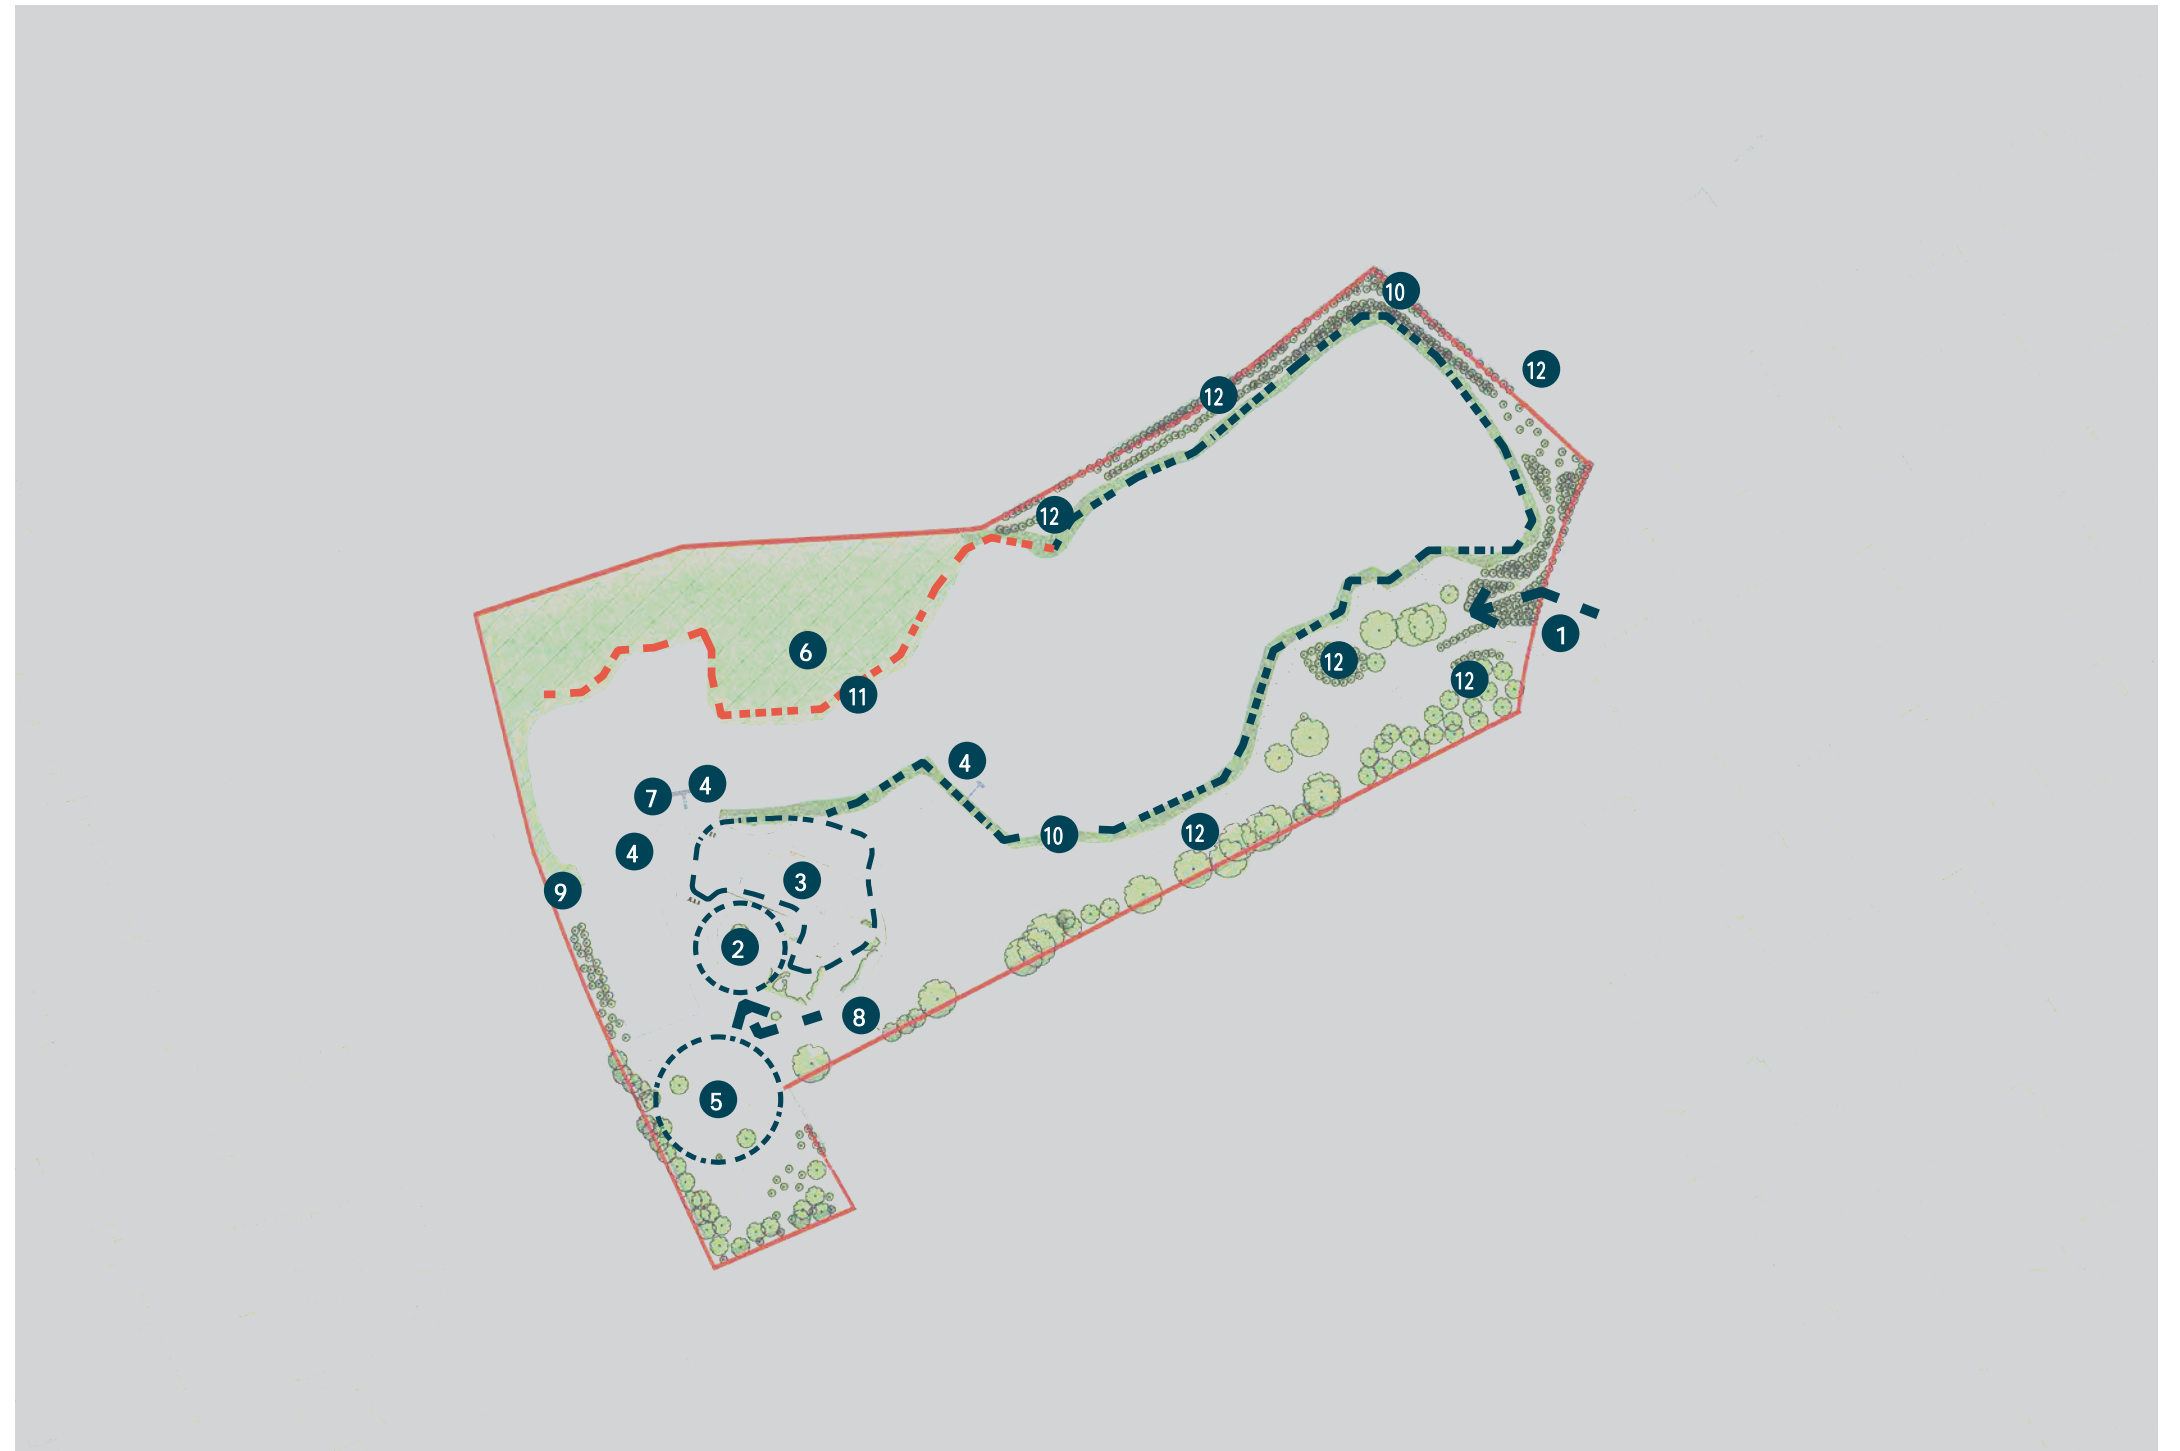
3.6 Existing Landscape Analysis

1. Access point
2. Parking, drop off & delivery
3. Accommodation
4. Slipway / Lake access
5. Camping Area
6. Vegetation area; subject to further investigation
7. Pontoon
8. Assault Course
9. Lock
10. Path around lake
11. Path in overgrown area
12. Little Squirrels & Outdoor Learning Zones
