Hard Landscape Strategy

RESIDENTIAL QUALITY

Land at Barnes Hospital, South Worple Way, East Sheen, London, SW14 8SU

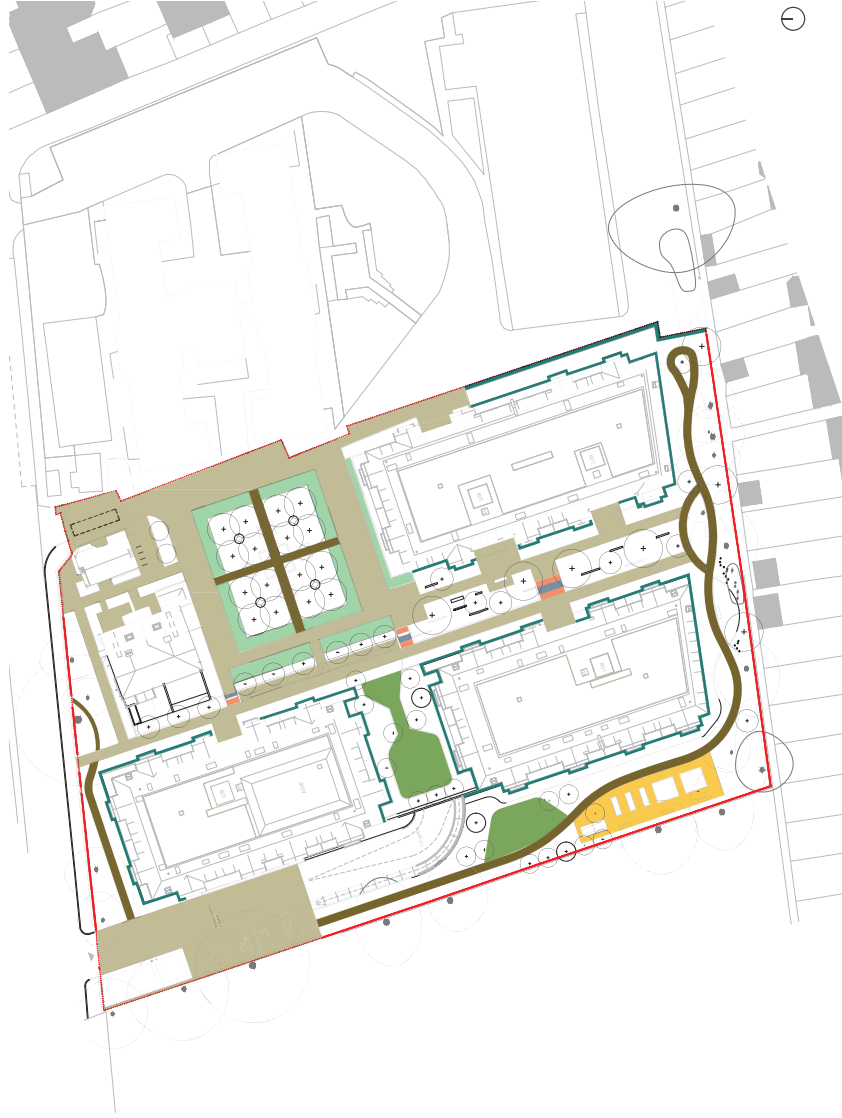
Surface Type 01
Permeable Tegula Concrete Selt
Color: 95% Burnt Ochra
5% Charcoal

Surface Type 03
Reclaimed Brick from site

Surface Type 05
Self-binding gravel

Surface Type 07
Eco Rubber Play chippings
Colour: Green

Surface Type 02
Natural stone paving

Surface Type 04
Grasscrete

Surface Type 06
Natural stone tactile paving

Surface Type 08
Granite chippings
Size: 20-40mm

The aspiration to develop high quality landscape spaces across the site has led to the selection of a number of materials appropriate for the different spaces within the development. Hard landscape elements selected are to be of a physically robust quality, appropriate to the site's intensive use.

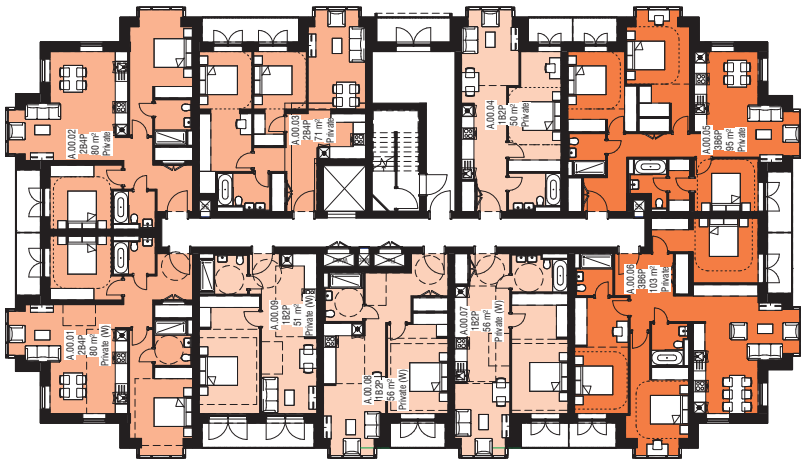
Level 0

Block A

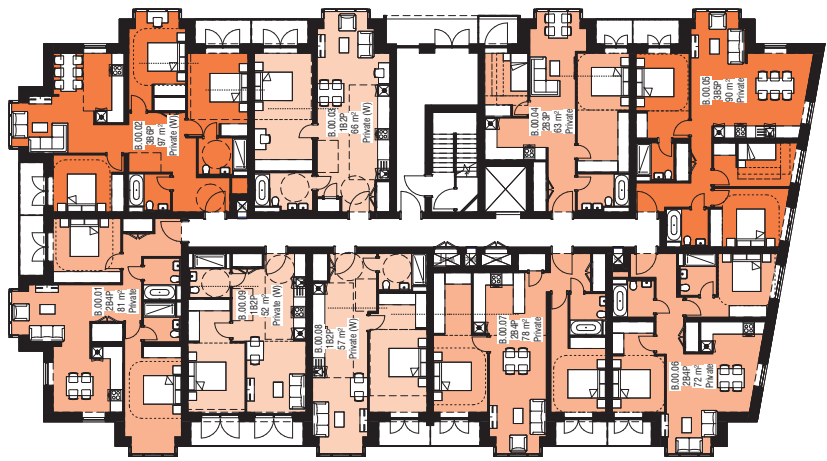
Level 0

Block B

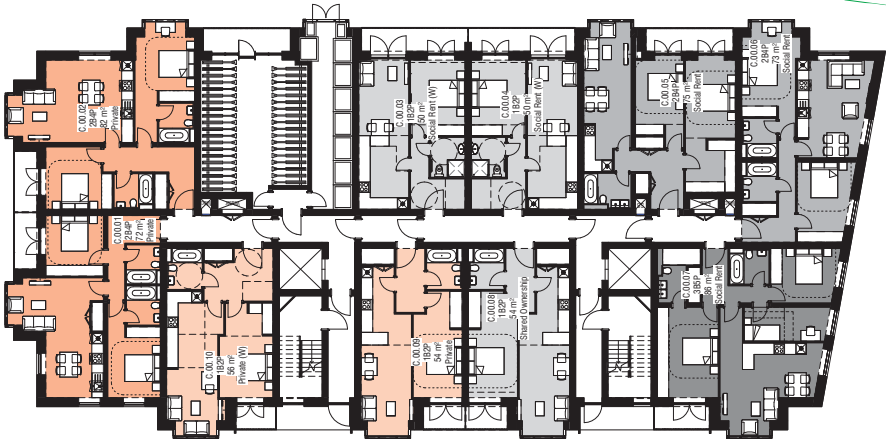
Level 0

Block C

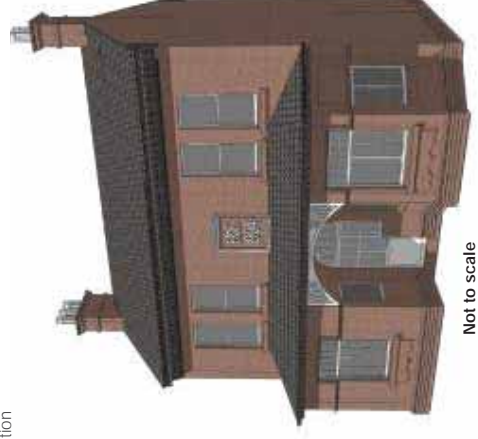
Rear Elevation

Former Recreation Hall -
Barnes Cottages

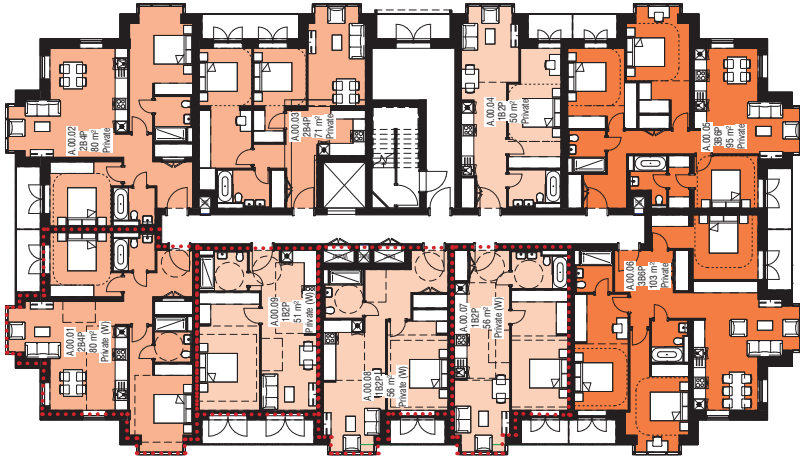
Block A - Level 0

WHEELCHAIR ACCESSIBLE & ADAPTABLE UNITS

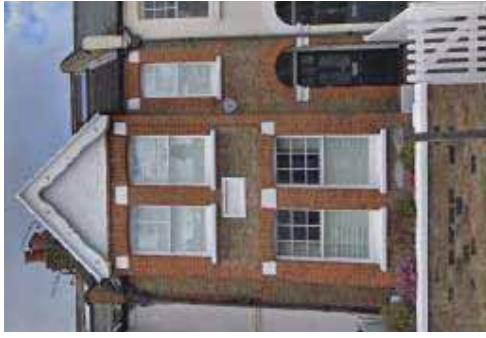
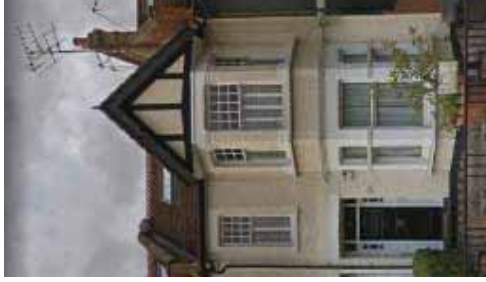
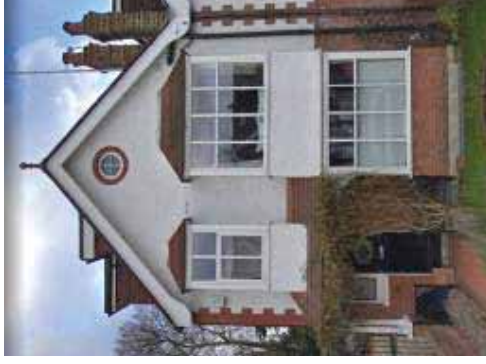
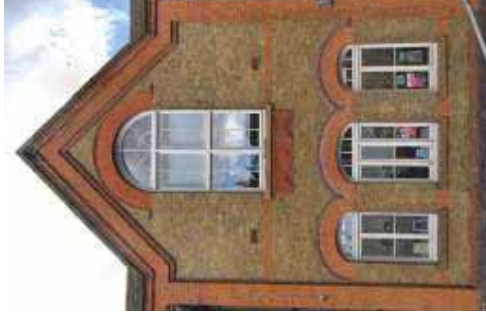
Gables - Mono Pitch

The proposal looks to draw inspiration from these vernacular details as well as the guidelines set in the design code, to ultimately enhance the site character.

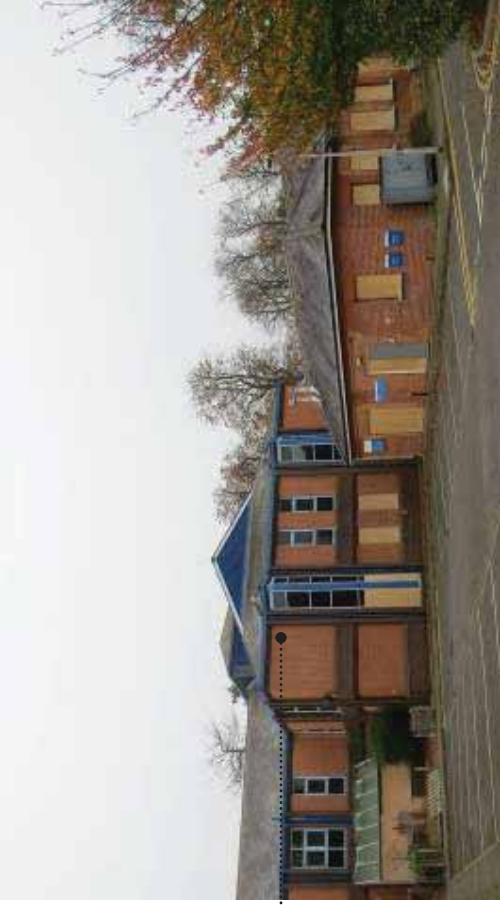
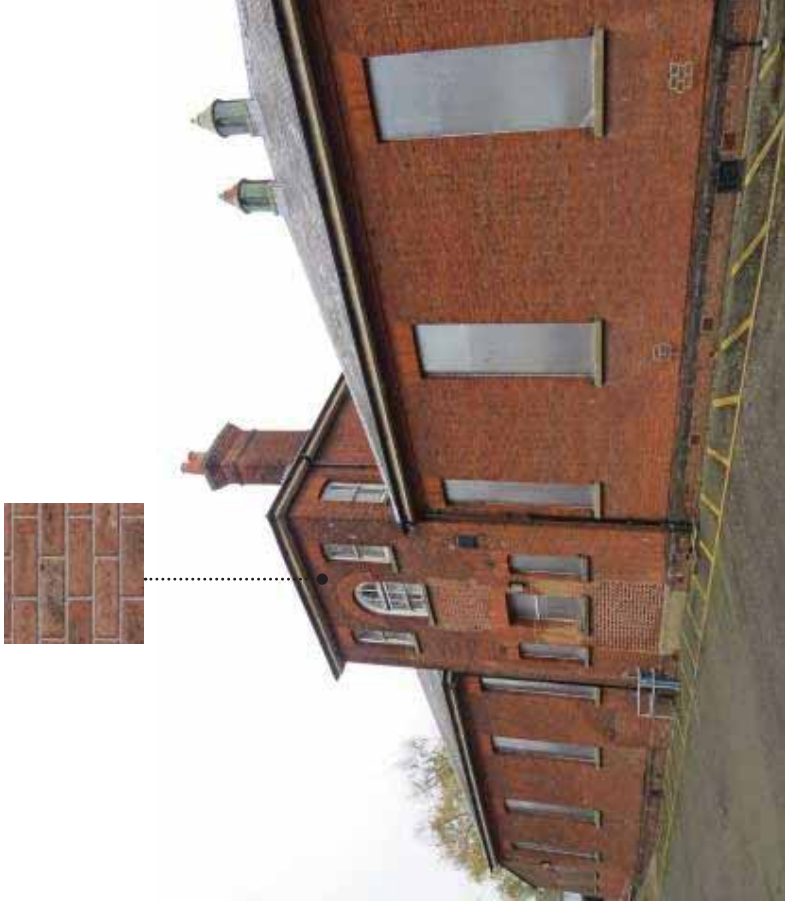
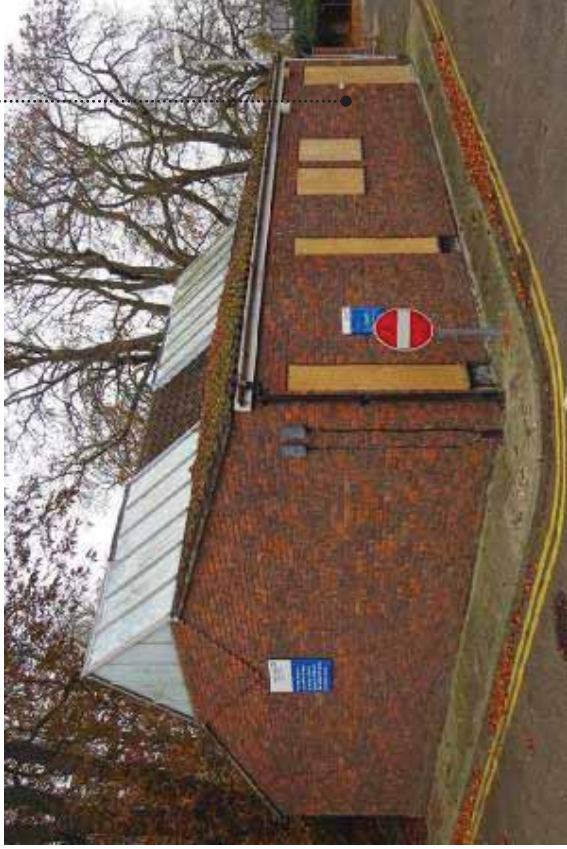
12.2 EXISTING SITE MATERIALITY

The existing buildings on site has a palette of red bricks various shades.

The proposals take precedent from the existing building palette as well as retained BTM's for contextual material response.

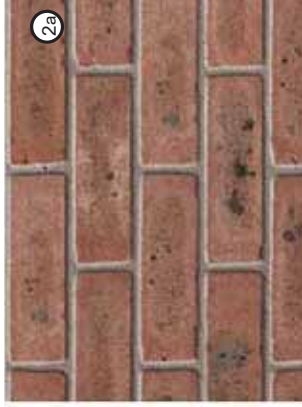
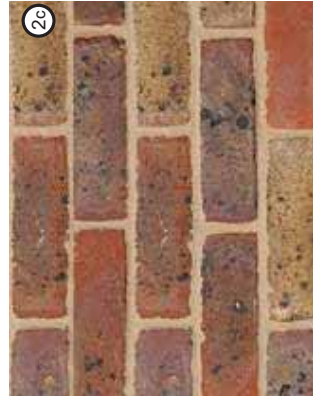
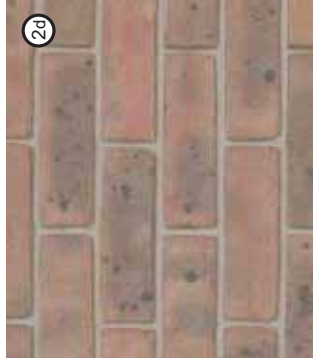
The proposed palette of materials reflects the traditional masonry work found throughout the existing site and the surrounding context. The red-toned brick, stone detailing and roof tiles link the proposed buildings to the retained BTMs on site to create a sense of unison throughout the scheme.

- ① Window/ door clear glass /laminated glass
- ② Stretcher bond brickwork with soldier course detailing to match
- ③ Natural slate roof tiles
- ④ Window frames black grey finish
- ⑤ Brown tone metalwork to residential balconies
- ⑥ Zinc dormer surround

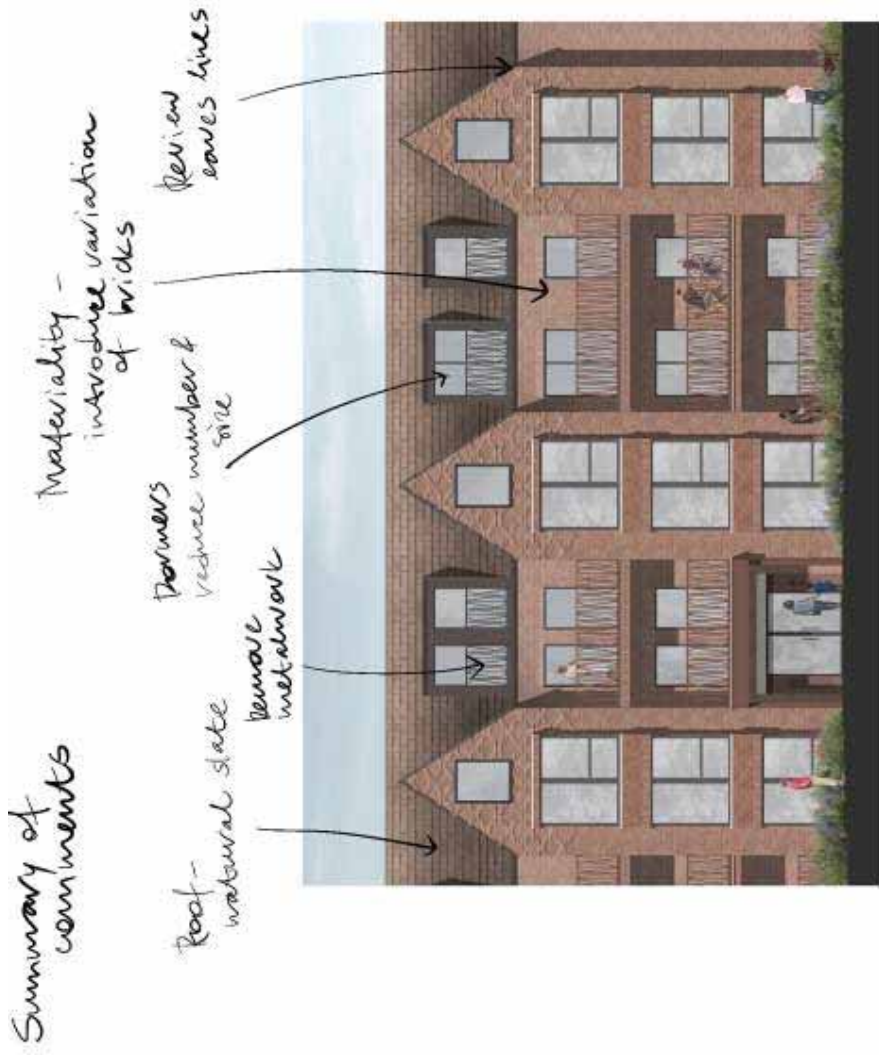
Design Workshop 1, 30th April 2021 – a design workshop with the Case Officer, Conservation Officer and the Urban Design Officer whereby the proposals from the 2nd pre-app meeting were presented and discussed in detail.

- Natural Slate roof tiles
- Review eaves line and relationship with the lower floor

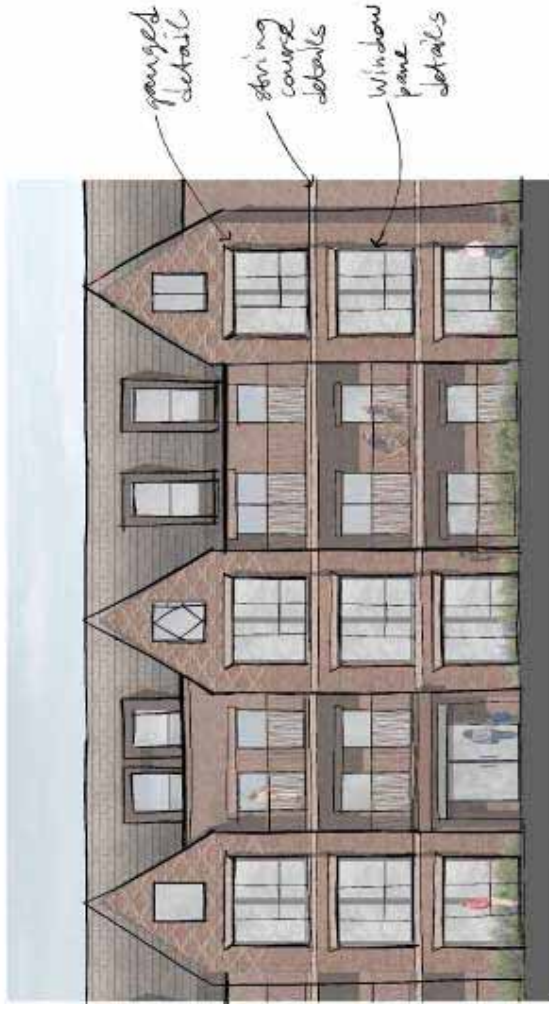
- Introduced variation across blocks and include Richmond blend brick
- Gauged detail above windows
- String courses/ lintels to add variety between each block

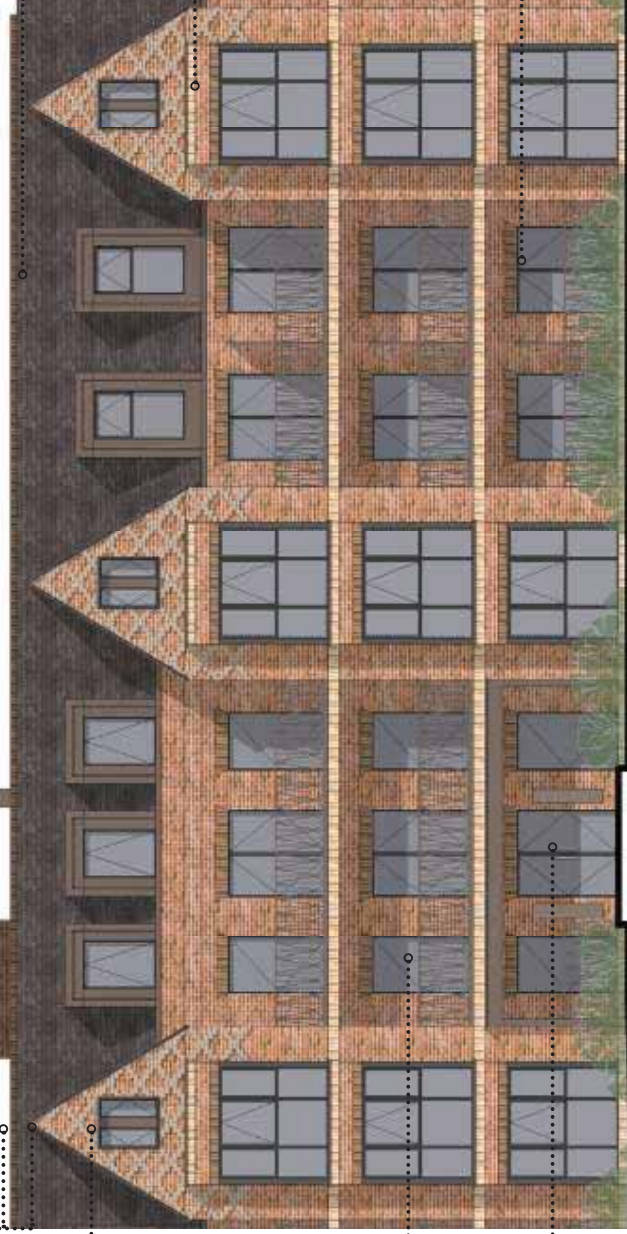
Block B bay study

Windows are set back into a brick reveal and have a soldier course lintel detail.

Various window types are used to reduce the impression of standardisation

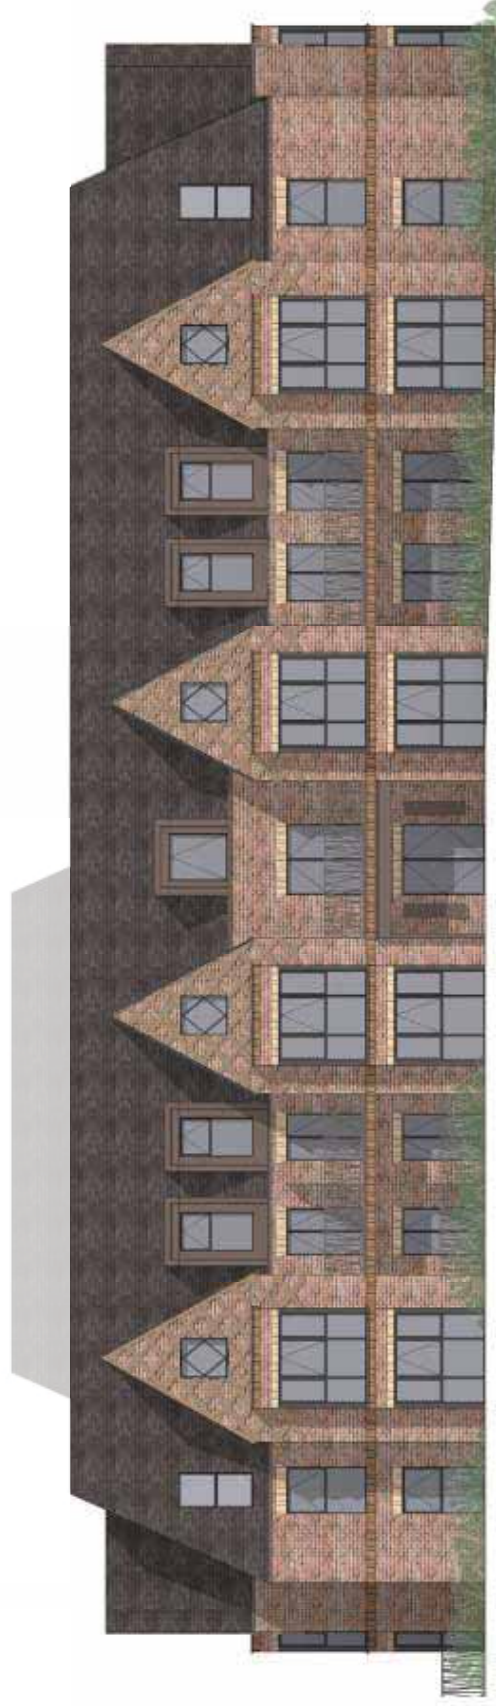
ELEVATIONS DESIGN DEVELOPMENT

- Single dormers
- Variation of window types in the top of the gable
- Widen end gable bays
- Gauged detail above windows

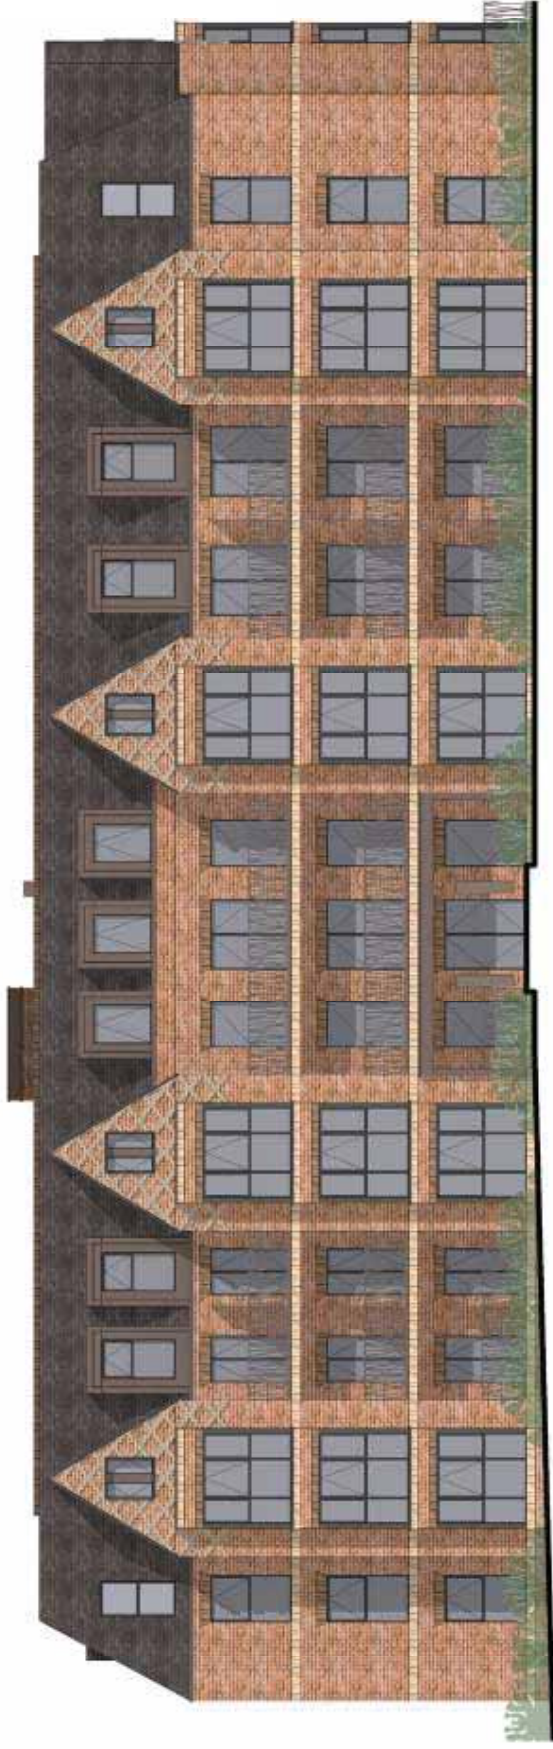
Block B

- Single dormers
- Variation of window types in the top of the gable
- Widen end gable bays
- Gauged detail above windows

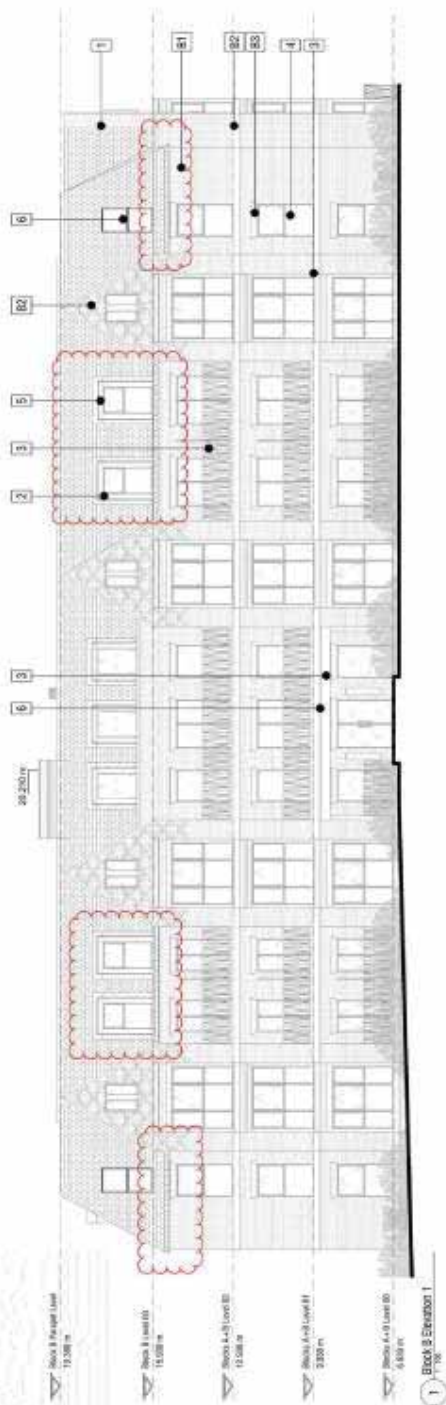
Block B revised elevation

- Dormers moved away from the eaves by approximate. 200mm;
- Reduced the size of the dormers and omission of some dormers;
- Eaves overhang introduced to all blocks;
- Dormer removed on the far right in elevation 4 of Block C;
- Accessible units internal layouts update;
- Revision of attenuation volume and bin store in Block C and collection point layout;
- Revised site boundary.

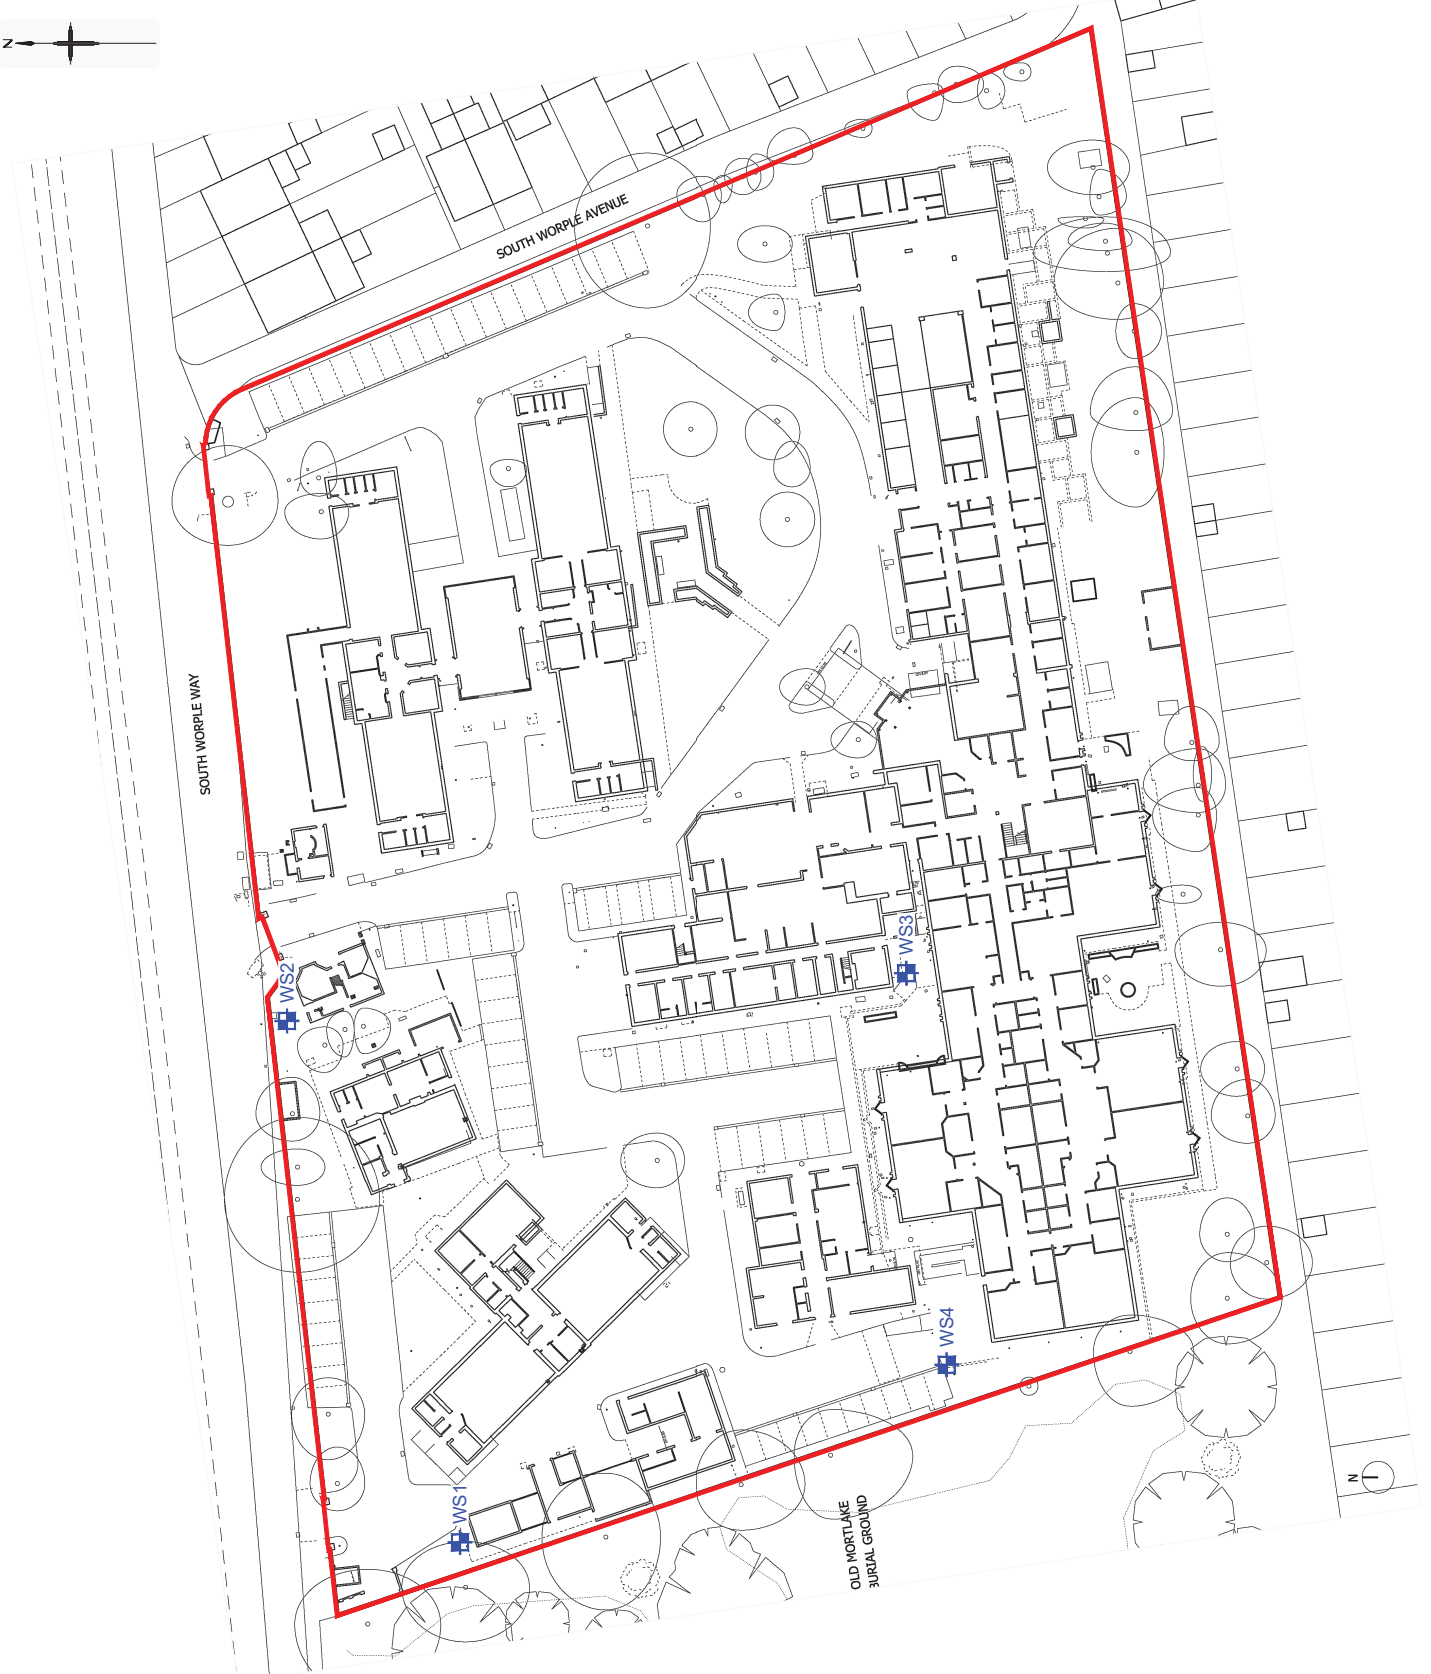
Drawing No. FIGURE 2
 Rev. P1

Figure 1	Site location plan
Figure 2	Site layout and exploratory hole location plan

A site layout plan is presented as **Figure 2**.

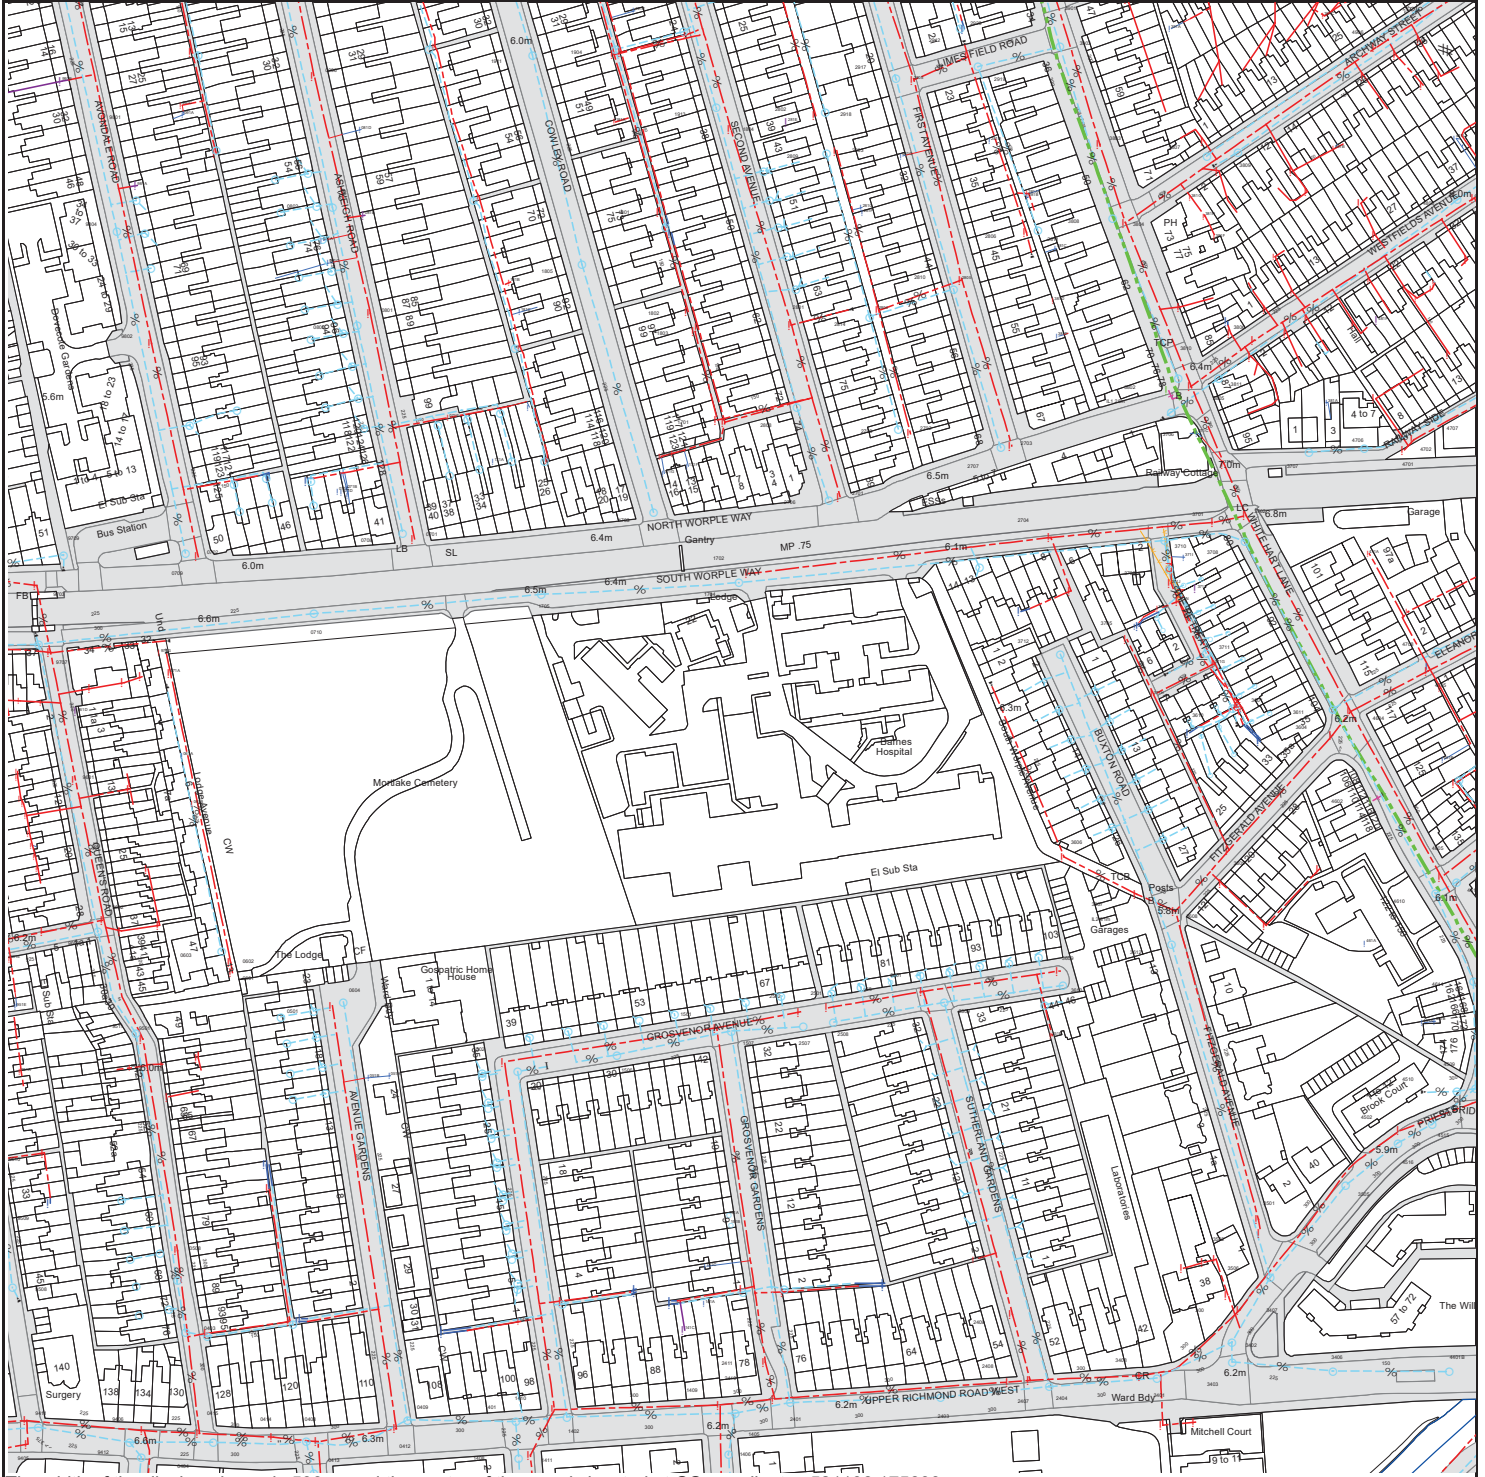
Asset Location Search Sewer Map - ALS/ALS Standard/2019 3954752

The width of the displayed area is 500 m and the centre of the map is located at OS coordinates 521196,175690

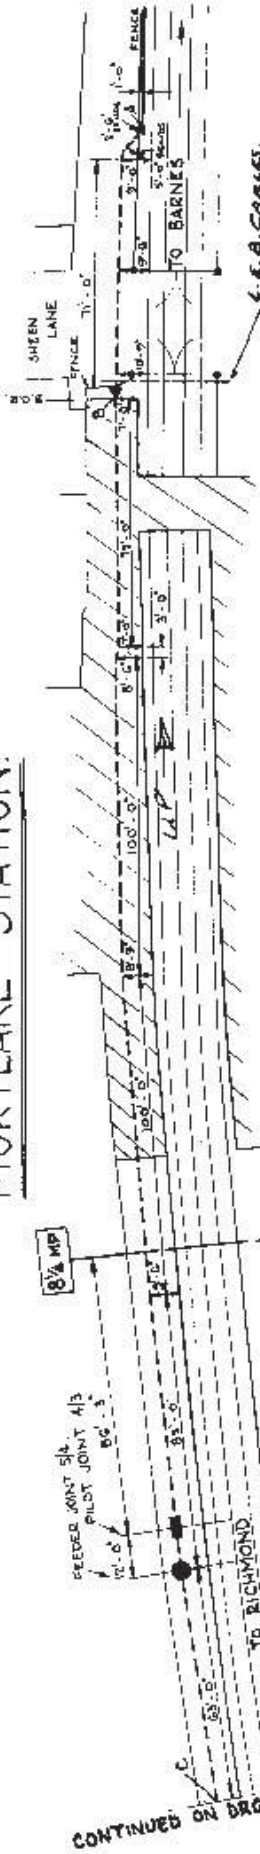
P.M.J.
 11-10-57
 713100/WESTERN/B.C.C. 49 SHEET 2.

MORTLAKE STATION.

CONTINUED ON DRG. 713100/WEST/B.C.C. 50. SHEET 2.

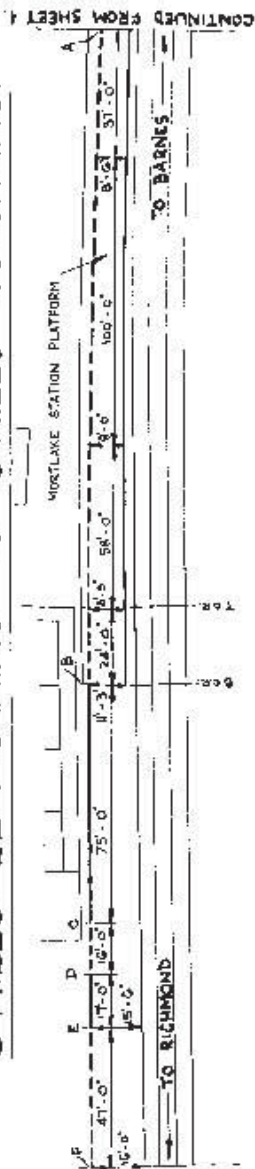
DRAWN BY
 CHECKED BY
 DATE 21-10-51
 713100/WESTERN/B.C.C. 60. SHEET 4

8 MILES 22 3/4 CHAINS TO 8 MILES 40 CHAINS.

- ROUTE DETAILS.**
- A To B 12 1/2' B.C.T. DOUBLE LIDS, 3' AV. COVER.
 - C To D. 12 1/2' B.C.T. G' AV. COVER.
 - E To F. 12 1/2' B.C.T. 9' AV. COVER.
 - G To H. BURIED DIRECT, ONE SLAB.
 - J To K. BURIED DIRECT, ONE SLAB.

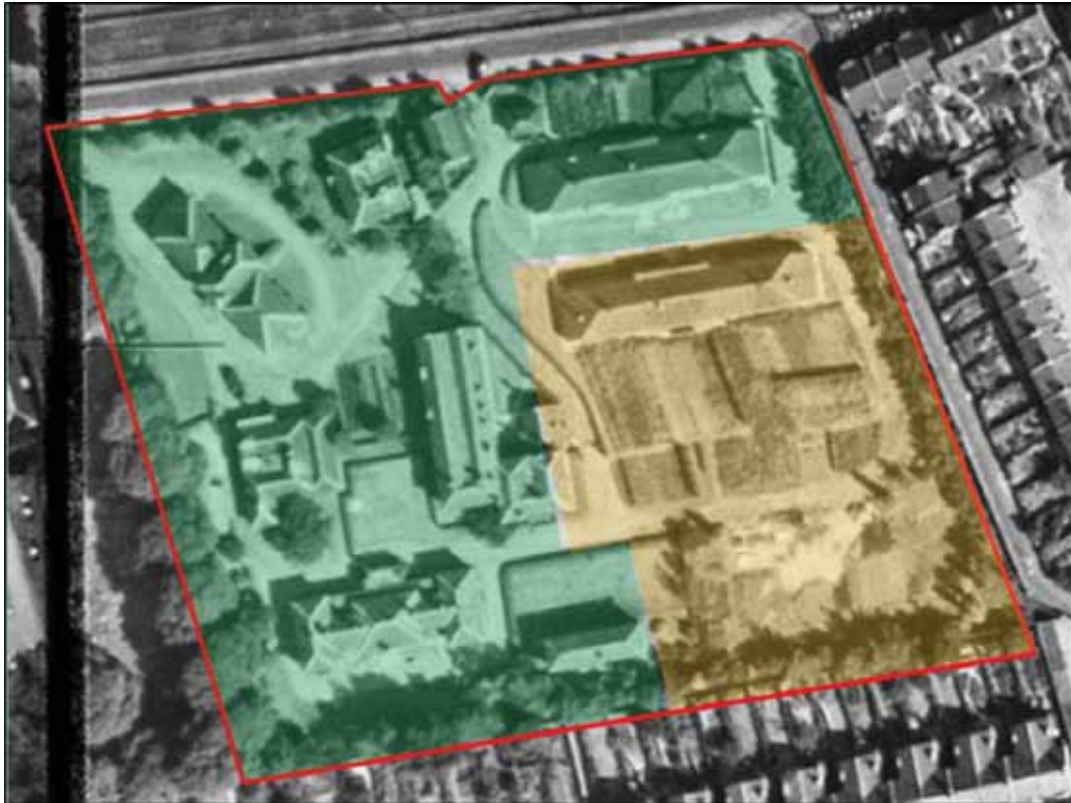
Risk Map

For indicative purposes – not to scale.
Please note that this assessed risk map may not take into account all post-war redevelopment/excavations on site.

- Intrusive Magnetometer Survey of all borehole and pile locations/clusters down to maximum bomb penetration depth.

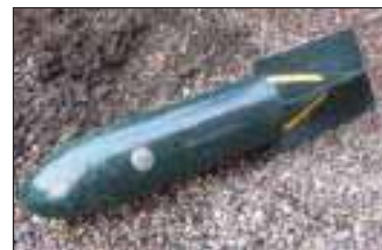
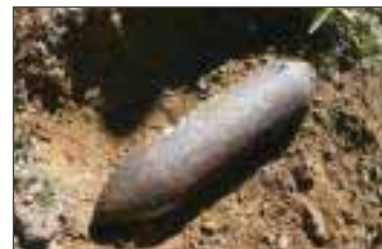
Bomb Weight	40-54kg (88-119lb)
Explosive Weight	25kg (55lb)
Fuze Type	Impact fuze/electro-mechanical time delay fuze
Bomb Dimensions	1,090 x 280mm (42.9 x 11.0in)
Body Diameter	200mm (7.87in)
Use	Against lightly damageable materials, hangars, railway rolling stock, ammunition depots, light bridges and buildings up to three stories.
Remarks	The smallest and most common conventional German bomb. Nearly 70% of bombs dropped on the UK were 50kg.

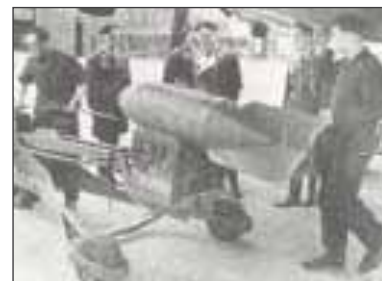
SC 250kg High Explosive Bomb

Bomb Weight	245-256kg (540-564lb)
Explosive Weight	125-130kg (276-287lb)
Fuze Type	Electrical impact/mechanical time delay fuze.
Bomb Dimensions	1640 x 512mm (64.57 x 20.16in)
Body Diameter	368mm (14.5in)
Use	Against railway installations, embankments, flyovers, underpasses, large buildings and below-ground installations.
Remarks	It could be carried by almost all German bomber aircraft, and was used to notable effect by the Junkers Ju-87 Stuka (Sturzkampfflugzeug or dive-bomber).

SC250 bomb being loaded onto German bomber

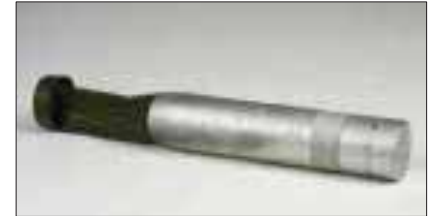
C50 A Incendiary Bomb

Bomb Weight	Approx. 41kg (90.4lb)
Explosive Weight	Approx. 0.03kg (0.066lb)
Incendiary Filling	12kg (25.5lb) liquid filling with phosphor igniters in glass phials. Benzene 85%; Phosphorus 4%; Pure Rubber 10%
Fuze Type	Electrical impact fuze
Bomb Dimensions	1,100 x 280mm (43.2 x 8in)
Use	Against any targets where an incendiary effect is required
Remarks	Early fill was a phosphorous/carbon disulphide incendiary mixture

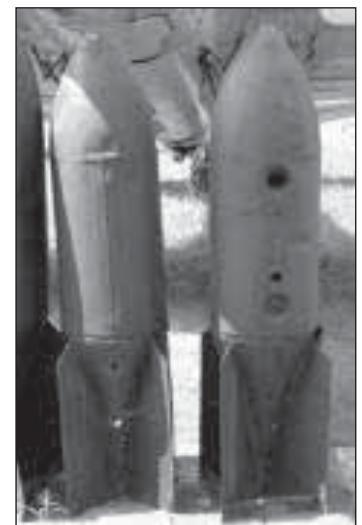
Flam C-250 Oil Bomb

Bomb Weight	Approx. 125kg (276lb)
Explosive Weight	Approx. 1kg (2.2lb)
Fuze Type	Super-fast electrical impact fuze
Filling	Mixture of 30% petrol and 70% crude oil
Bomb Dimensions	1,650 x 512.2mm (65 x 20.2in)
Body Diameter	368mm (14.5in)
Use	Often used for surprise attacks on ground troops, against troop barracks and industrial installations. Thin casing – not designed for ground penetration

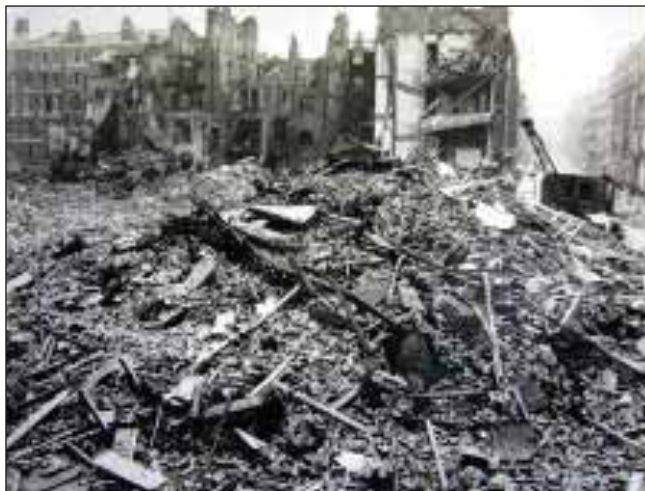
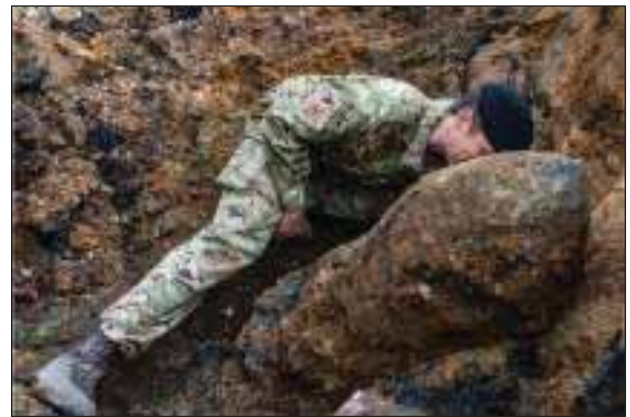
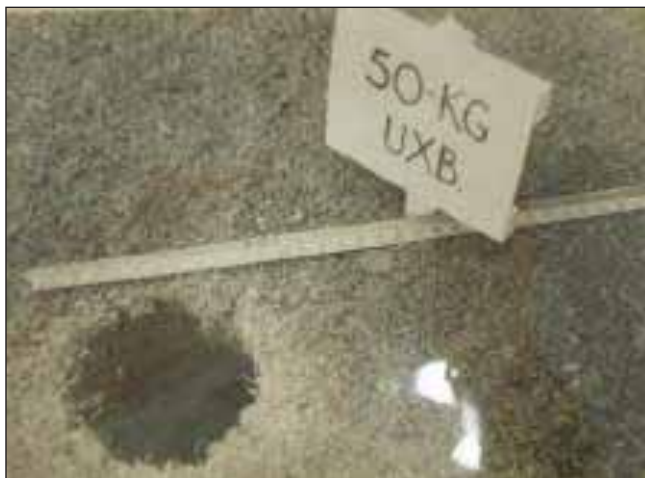
Top: J-curve Effect - Due to angle of entry, unexploded bombs would often end their trajectory at a lateral offset from point of entry, often ending up beneath adjacent extant structures/sites. The photograph above shows 250kg bomb found in Bermondsey pointing upwards, demonstrating 'J-curve'

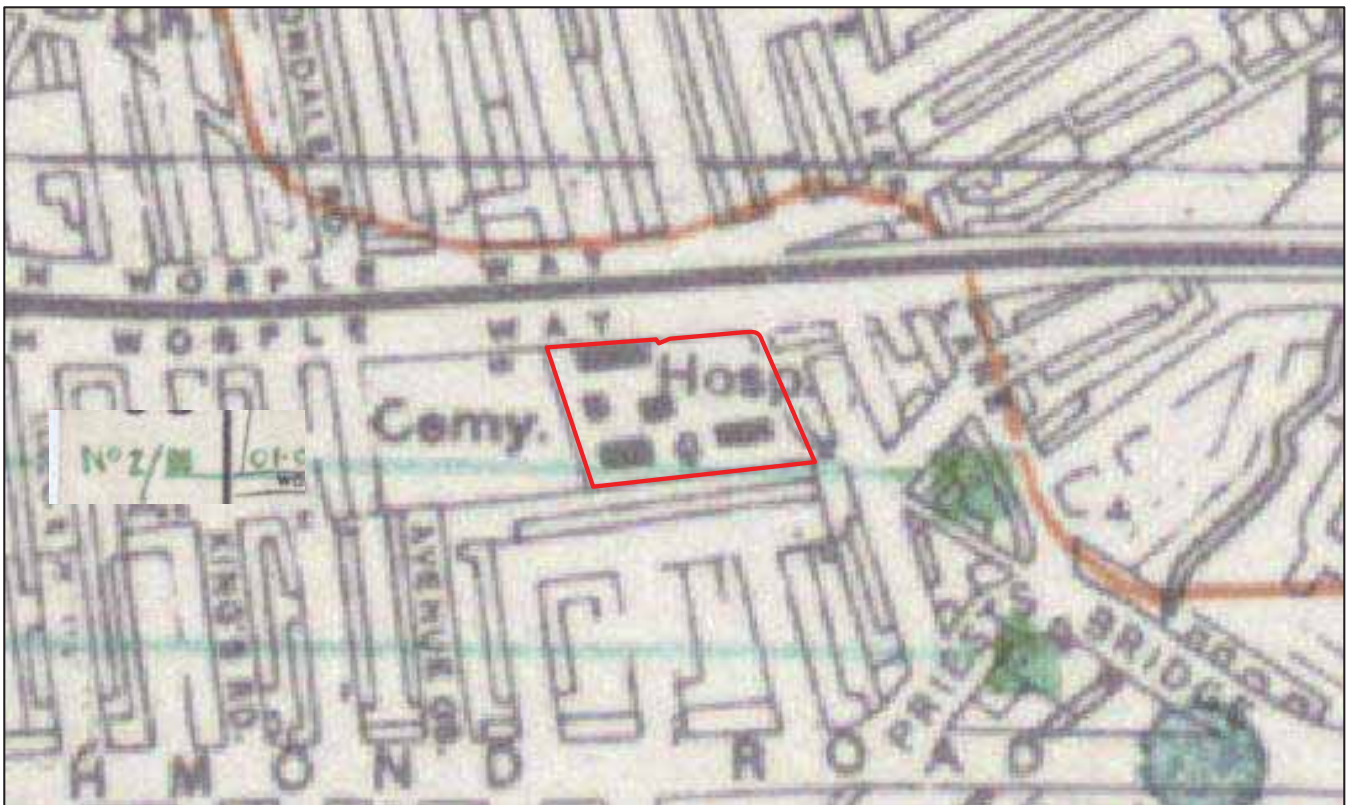
Night Bombing – 14th to 20th February 1944

- Recorded HE bomb strike
 - ⊕ Recorded UXB strike
 - ▨ Recorded incendiary bomb shower
 - Recorded oil bomb strike
- Colour refers to day of the week.*

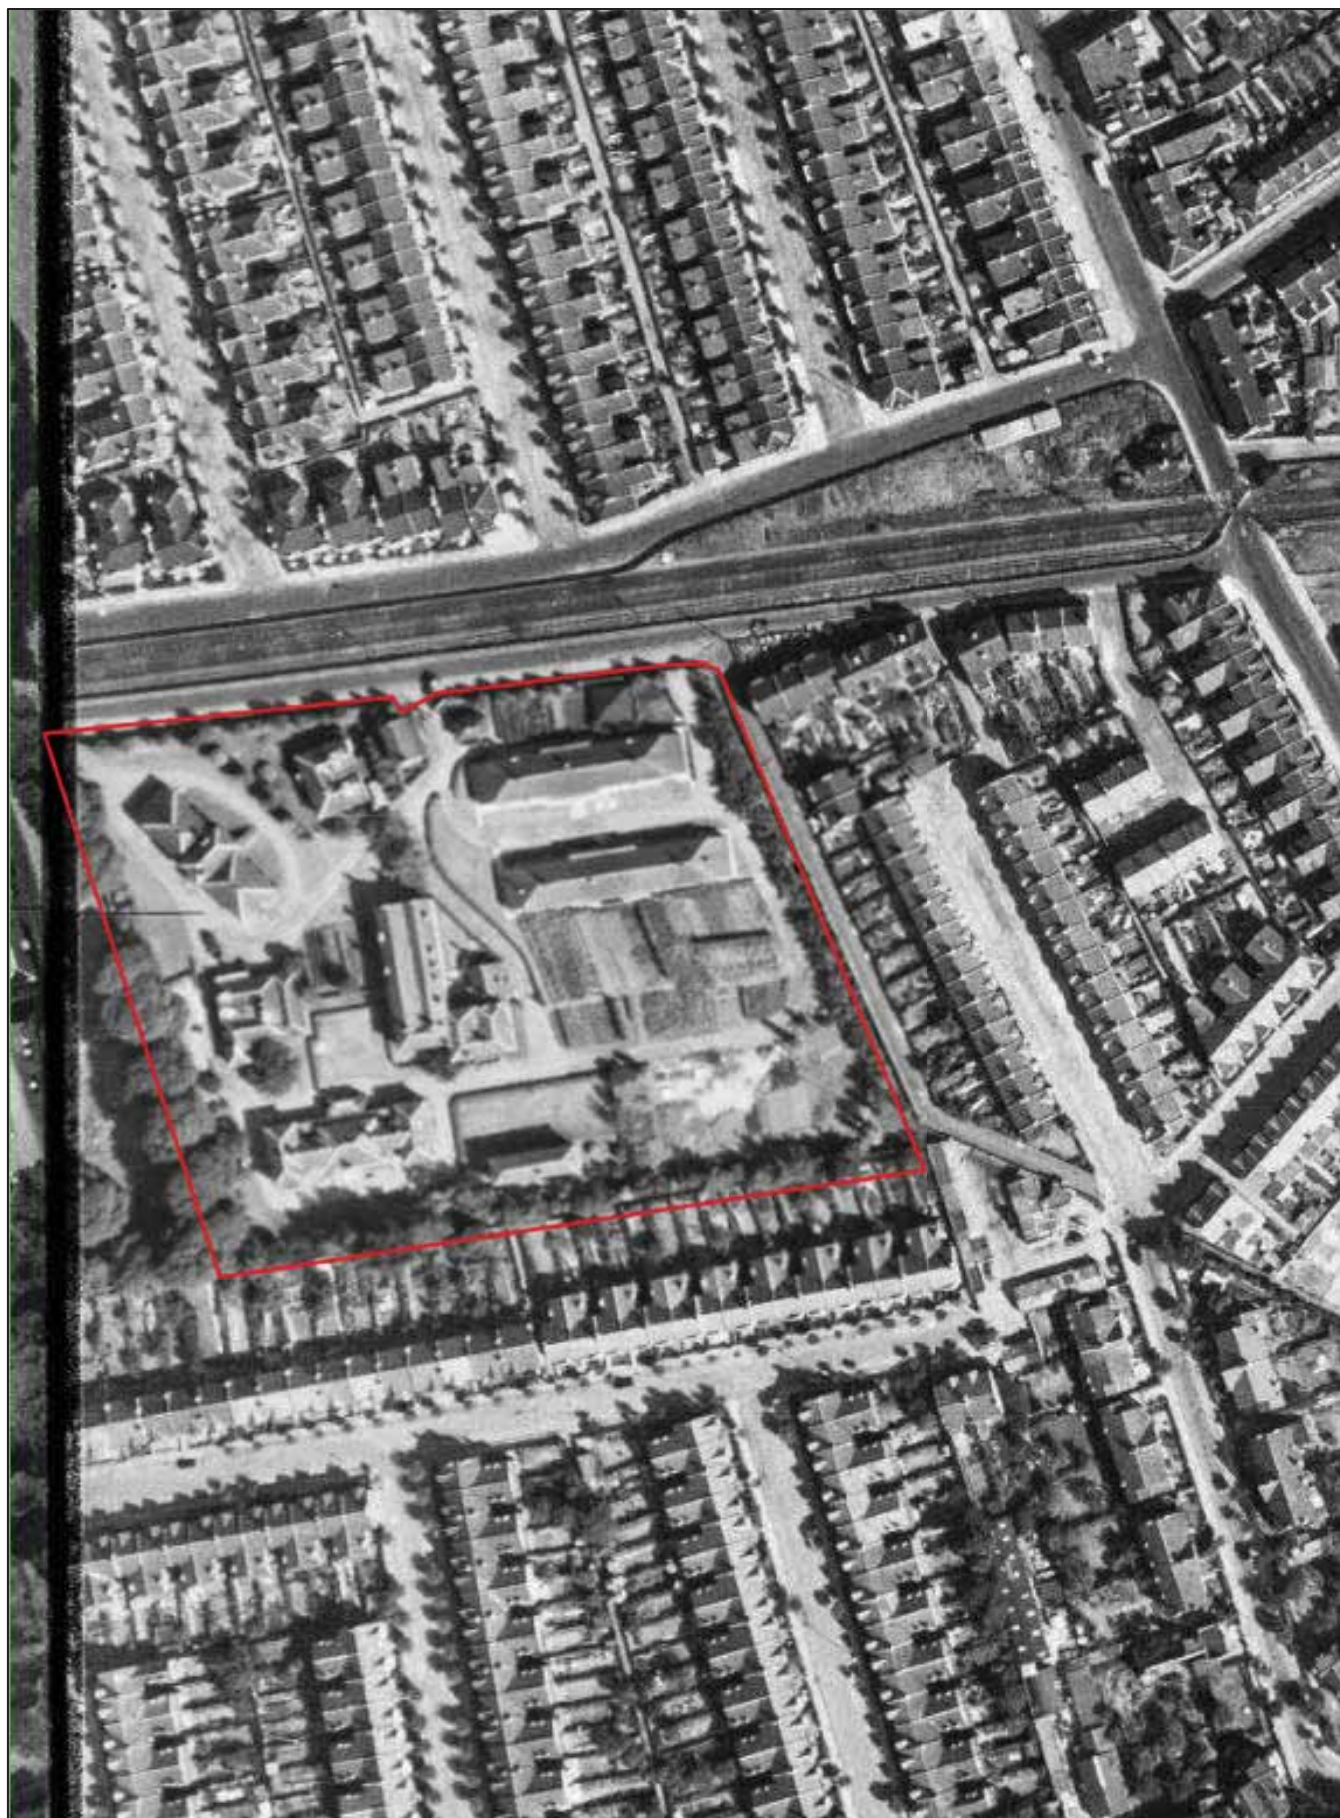
The blue shaded areas denote the areas cleared of buildings on the available post-war imagery (compared to pre-war mapping to left). At least two bombs were recorded in this eastern half of the site. It is considered that this clearance may have resulted from bomb damage.
