Hard Landscape Strategy

RESIDENTIAL QUALITY

Land at Barnes Hospital, South Worple Way, East Sheen, London, SW14 8SU

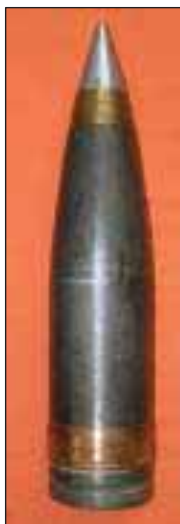
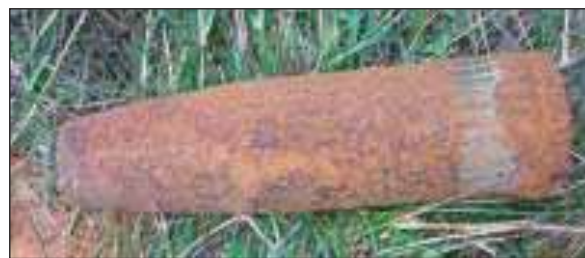
Projectile Weight	28lb (12.6 kg)
Explosive Weight	2.52lbs
Fuze Type	Mechanical Time Fuze
Dimensions	3.7in x 14.7in (94mm x 360mm)
Rate of Fire	10 to 20 rounds per minute
Use	The 3.7in AA Mk3 were the standard Heavy Anti-Aircraft guns of the British Army.
Ceiling	30,000ft to 59,000ft

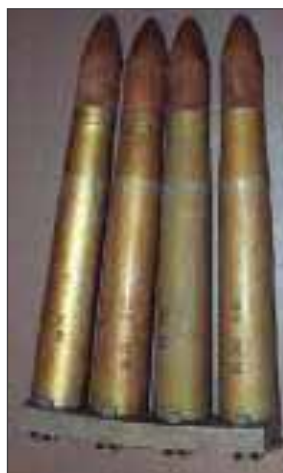
40mm Bofors Projectile

Projectile Weight	1.96lb (0.86kg)
Explosive Weight	300g (0.6lb)
Fuze Type	Impact Fuze
Rate of Fire	120 rounds per minute
Projectile Dimensions	40 x 180mm
Ceiling	23,000ft (7000m)
Remarks	Light quick fire high explosive anti-aircraft projectile. Each projectile fitted with small tracer element. If no target hit, shell would explode when tracer burnt out. Designed to engage aircraft flying below 2,000ft

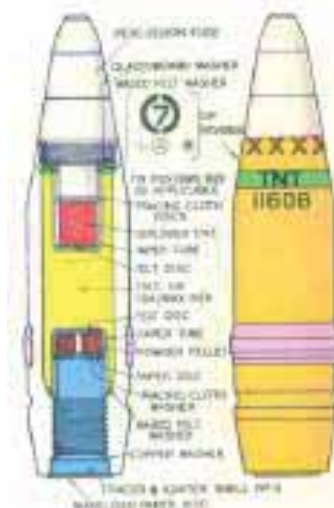
3in Unrotated Projectile (UP) Anti-Aircraft Rocket ("Z" Battery)

HE Projectile Weight	3.4kg (7.6lb)
Explosive Weight	0.96kg (2.13lb)
Filling	High Explosive – TNT. Fitted with aerial burst fuzeing
Dimensions of projectile	236 x 83mm (9.29 x 3.25in)
Remarks	As a short range rocket-firing anti-aircraft weapon developed for the Royal Navy. It was used extensively by British ships during the early days of World War II. The UP was also used in ground-based single and 128-round launchers known as Z Batteries. Shell consists of a steel cylinder reduced in diameter at the base and threaded externally to screw into the shell ring of the rocket motor

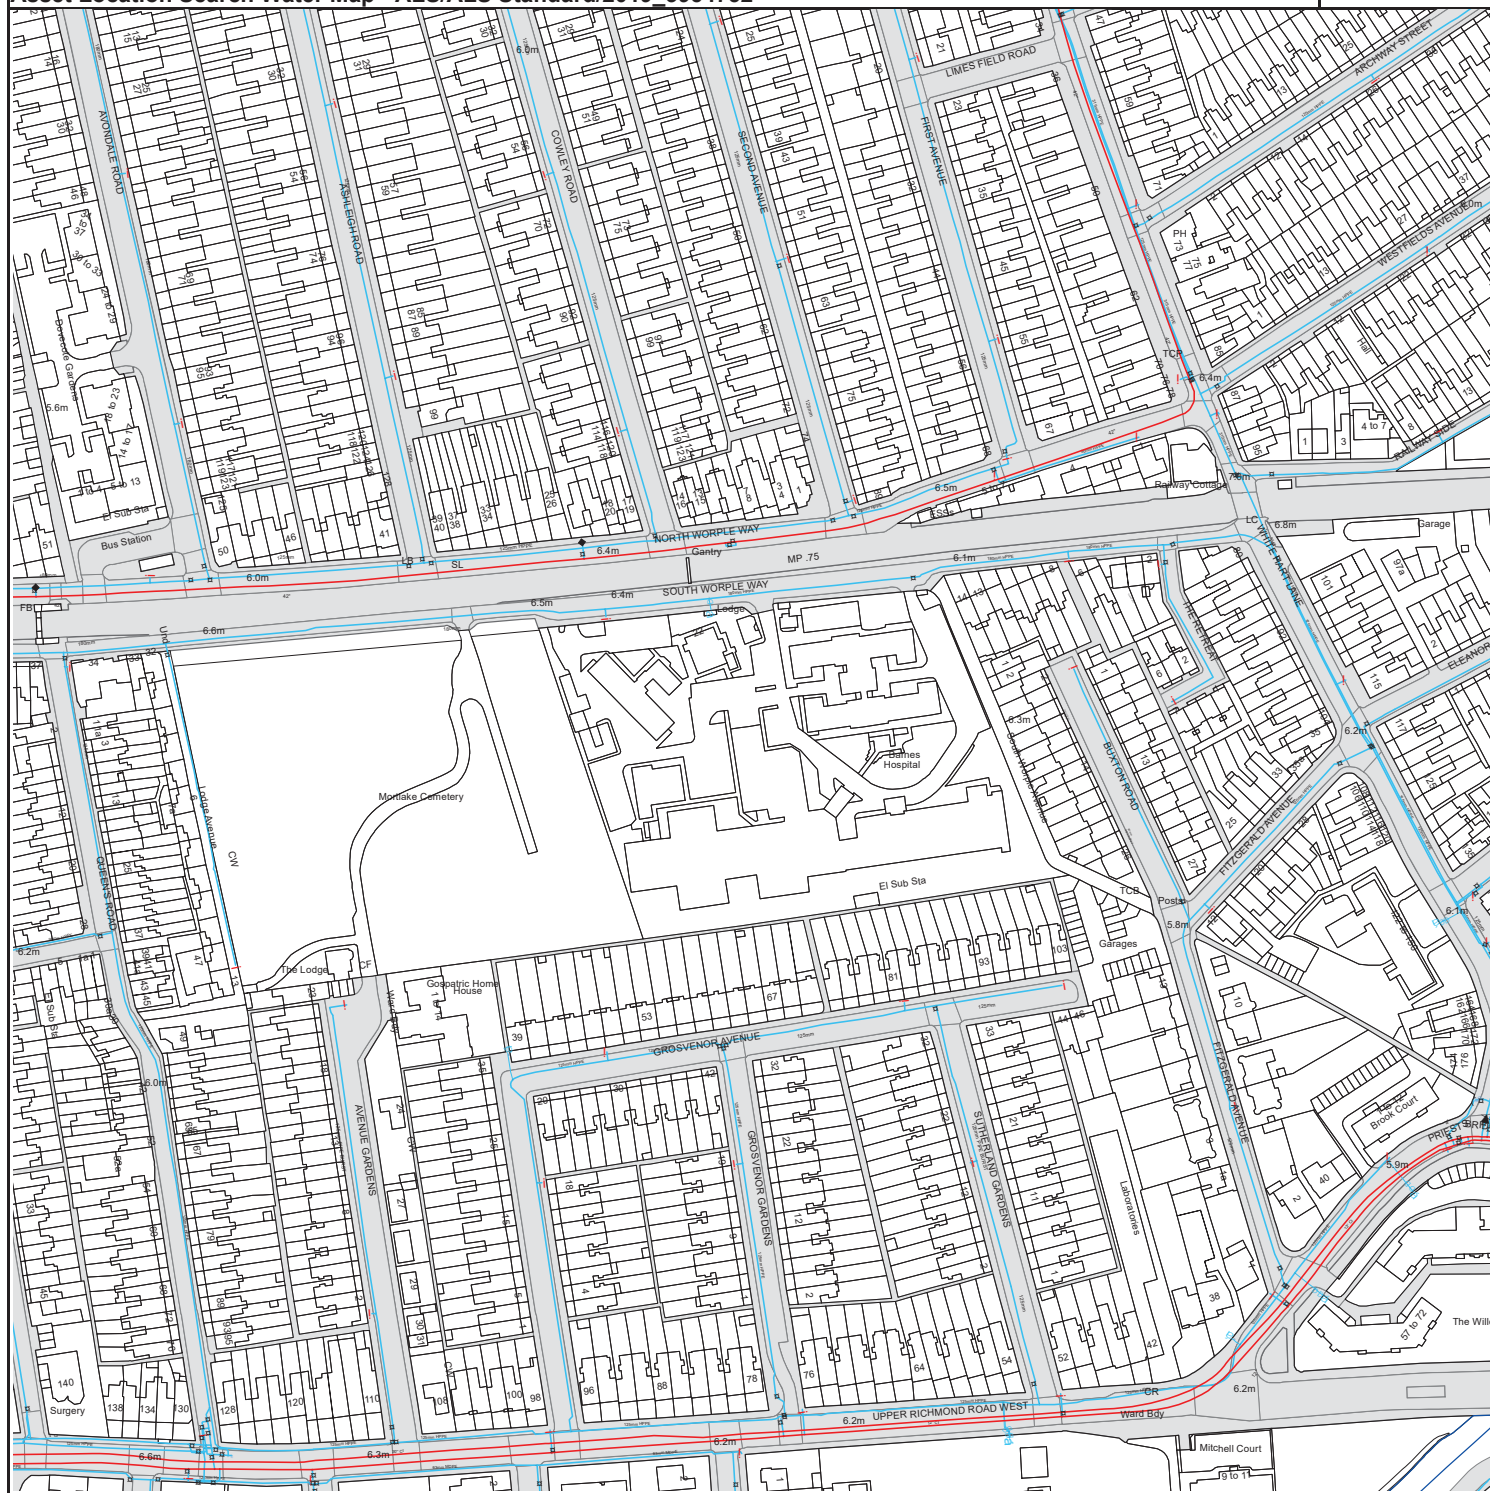
Asset Location Search Water Map - ALS/ALS Standard/2019_3954752

Foul Sewer		Surface Water Sewer
	Combined Sewer		Gulley
	Culverted Watercourse		Proposed
			Abandoned Sewer

The width of the displayed area is 500 m and the centre of the map is located at OS coordinates 521196, 175690.
The position of the apparatus shown on this plan is given without obligation and warranty, and the accuracy cannot be guaranteed. Service pipes are not shown but their presence should be anticipated. No liability of any kind whatsoever is accepted by Thames Water for any error or omission. The actual position of mains and services must be verified and established on site before any works are undertaken.
Based on the Ordnance Survey Map with the Sanction of the controller of H.M. Stationery Office, License no. 100019345 Crown Copyright Reserved.
