From: Plantenquiries <plantenquiries@catelecomuk.com>
Sent: 26 February 2019 11:23
To: Jessica Western
Subject: RE: URGENT 28836 Barnes Hospital, South Worple Way, London SW14 8SU

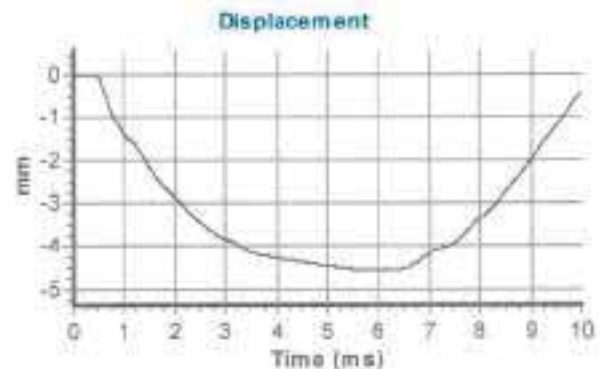
CHARLWOODS

Area of Rod A (mm²): 905
Theoretical Energy E_{theor} (J): 473
Measured Energy E_{meas} (J): 273

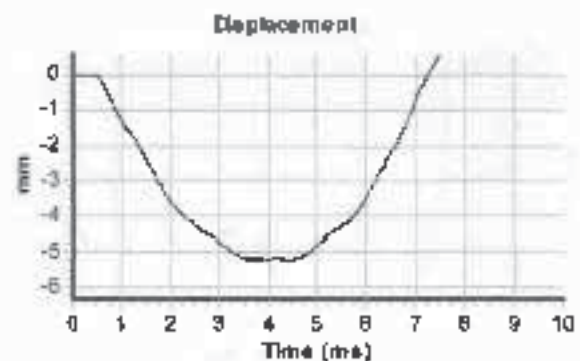
CJ associates hammer tested at Dynamic samplings yard.

Area of Rod A (mm²): 905
Theoretical Energy E_{theor} (J): 473
Measured Energy E_{meas} (J): 320

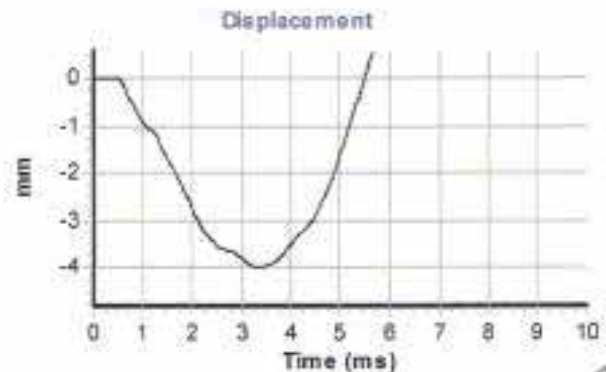
CJ associates hammer tested at Dynamic samplings yard.

Area of Rod A (mm^2): 905
Theoretical Energy E_{theor} (J): 473
Measured Energy E_{meas} (J): 317
