3.0 HERITAGE IMPACT ASSESSMENT

3.1 MODERN INTERVENTIONS

3.2 MASSING ANALYSIS

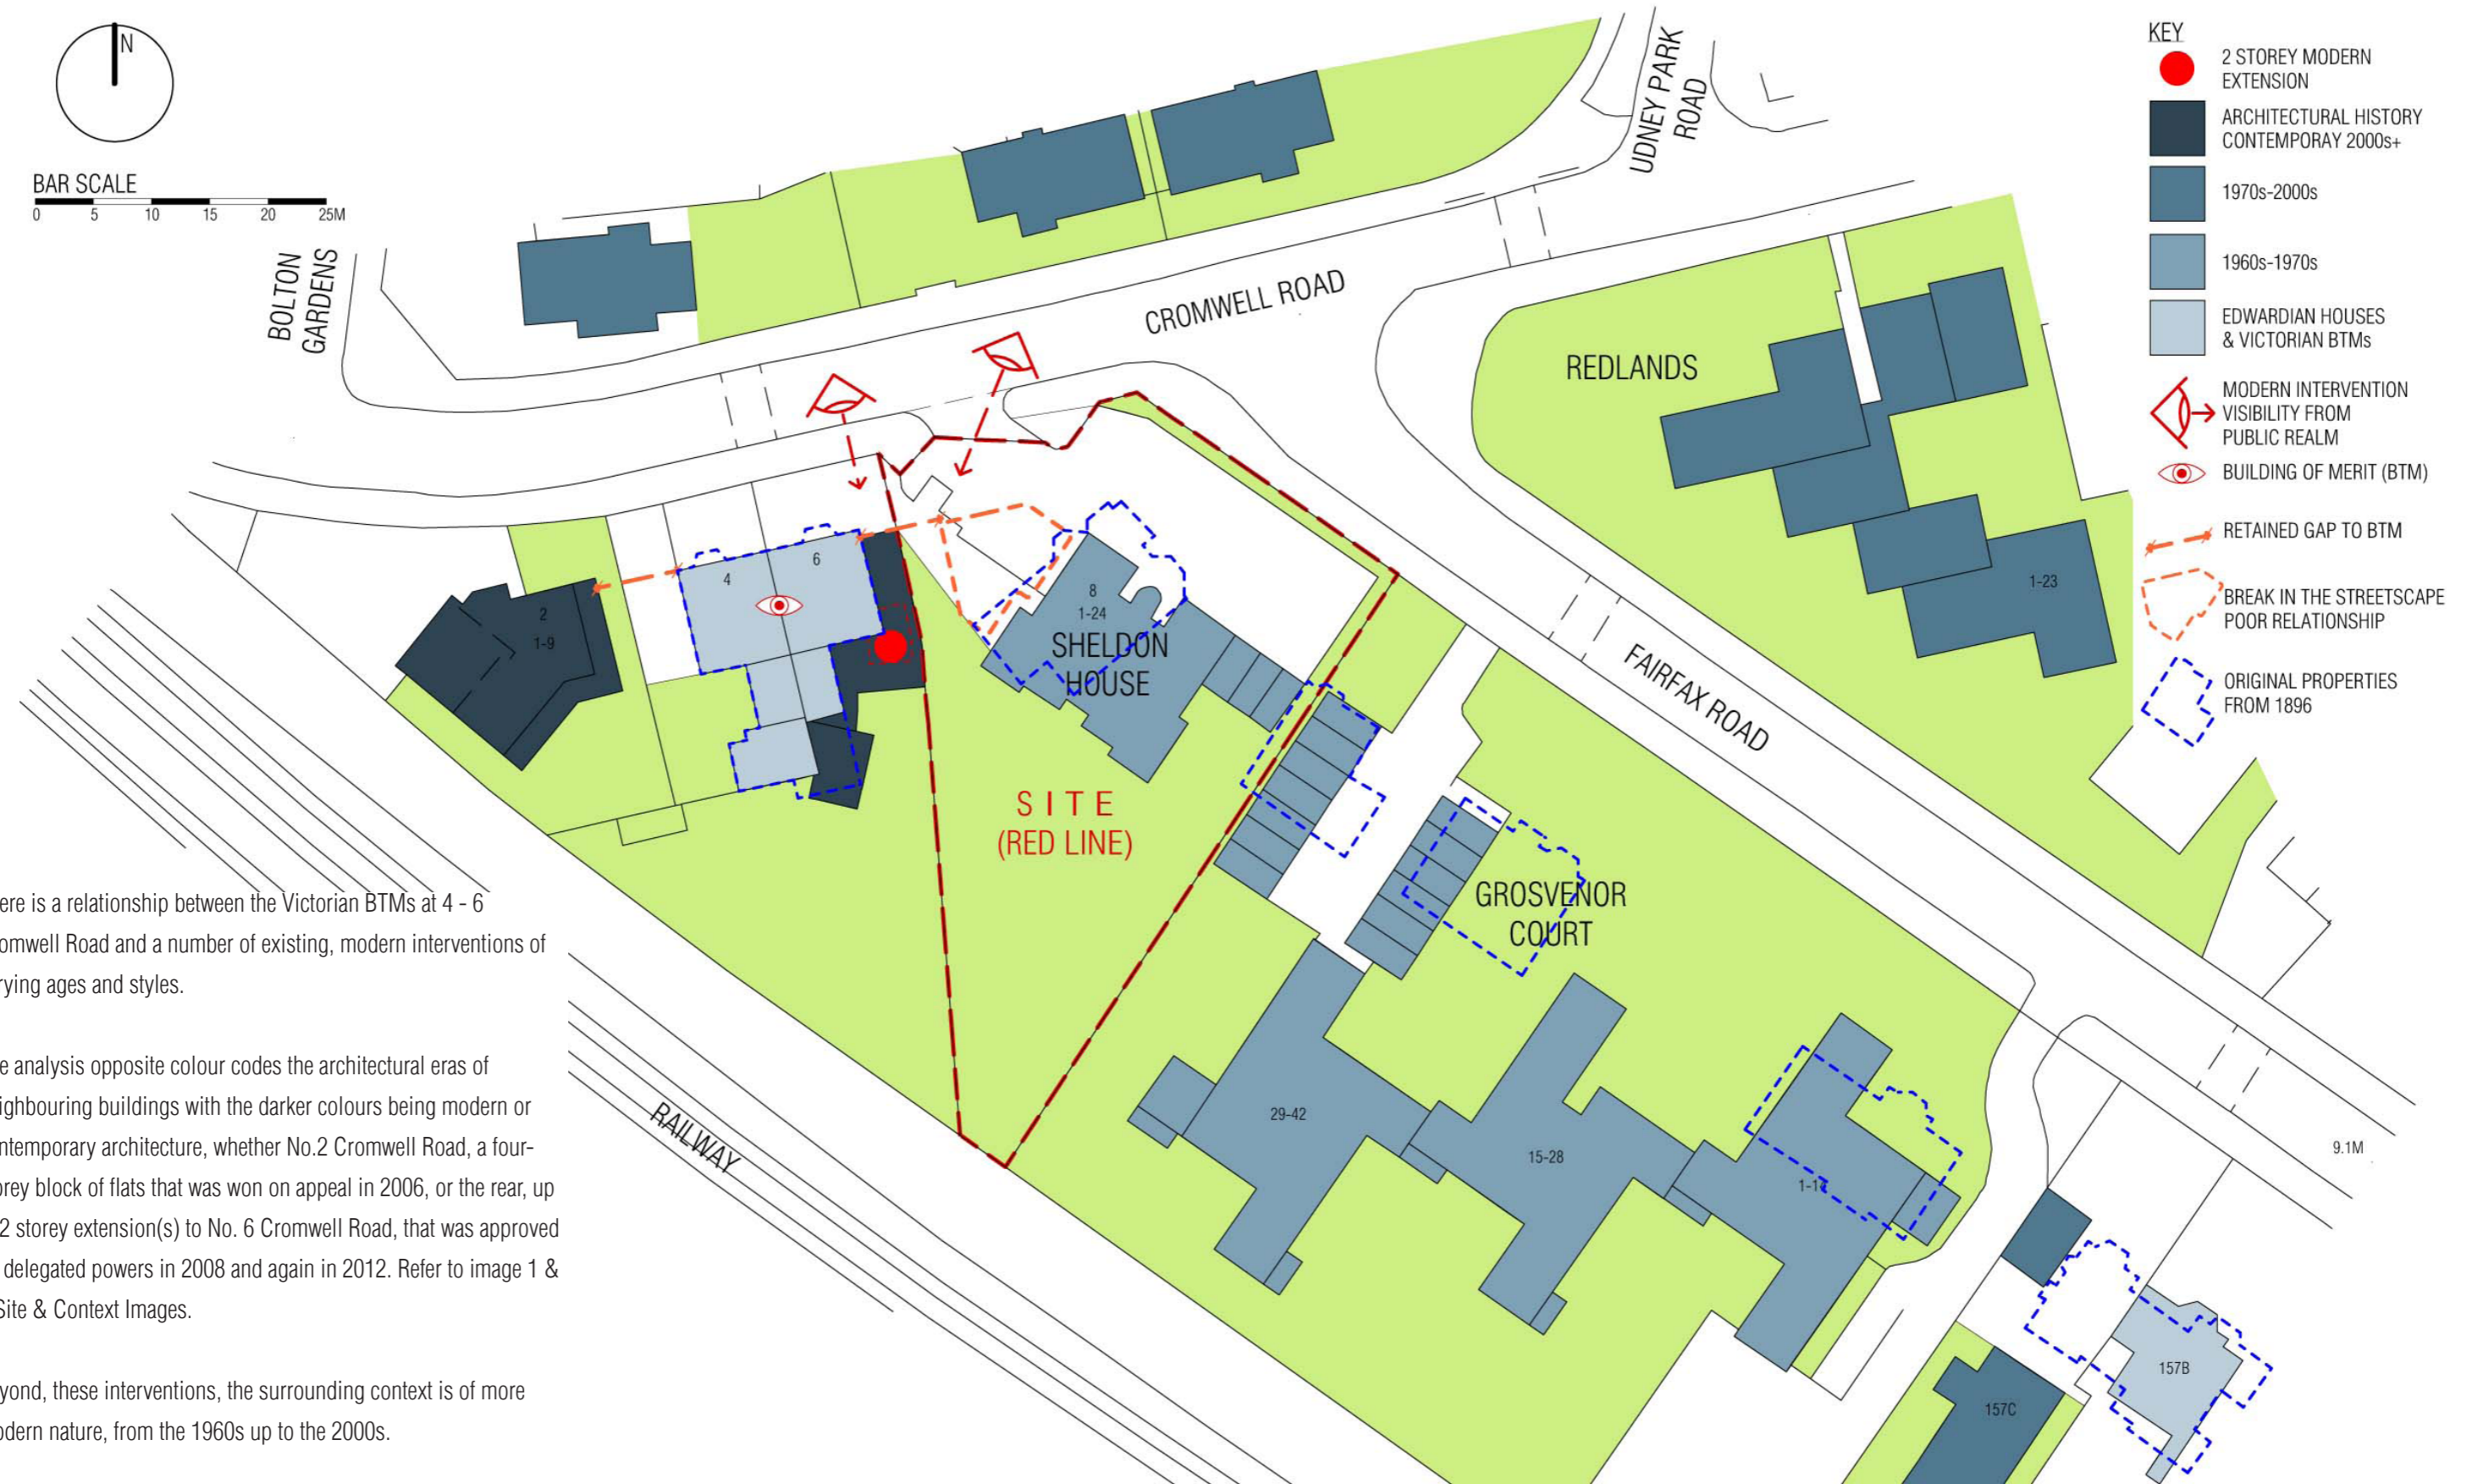
There is a relationship between the Victorian BTMs at 4 - 6 Cromwell Road and a number of existing, modern interventions of varying ages and styles.

The analysis opposite colour codes the architectural eras of neighbouring buildings with the darker colours being modern or contemporary architecture, whether No.2 Cromwell Road, a four-storey block of flats that was won on appeal in 2006, or the rear, up to 2 storey extension(s) to No. 6 Cromwell Road, that was approved by delegated powers in 2008 and again in 2012. Refer to image 1 & 4 Site & Context Images.

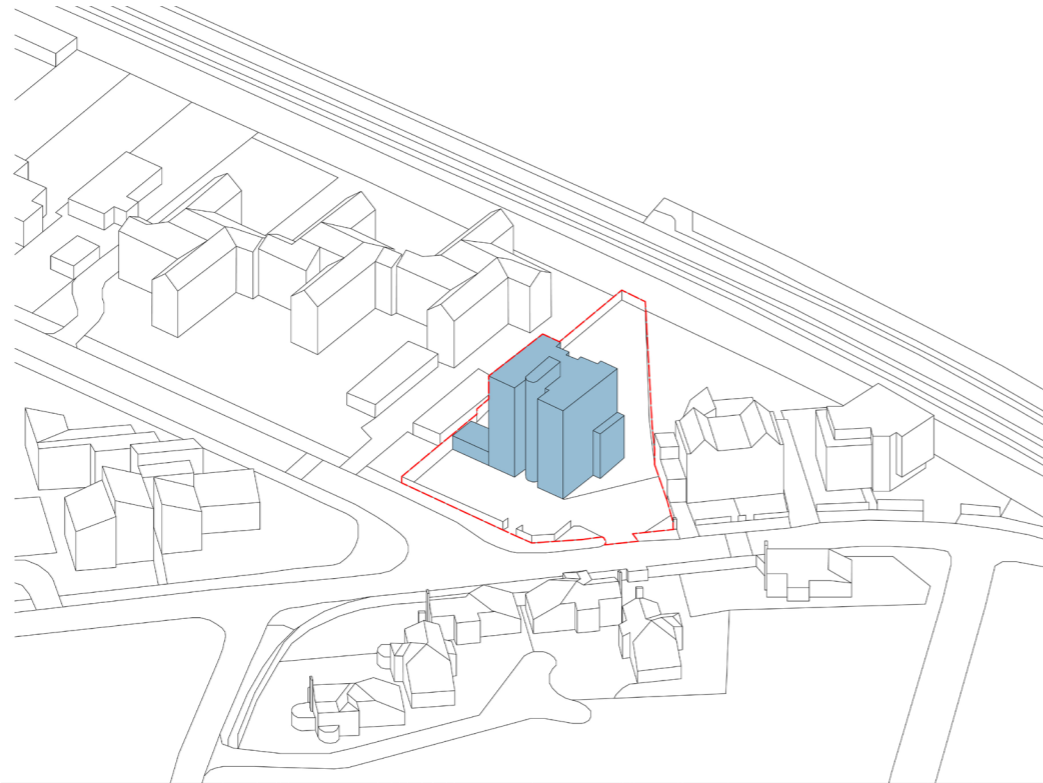
Existing seven-storey building and triangular site.

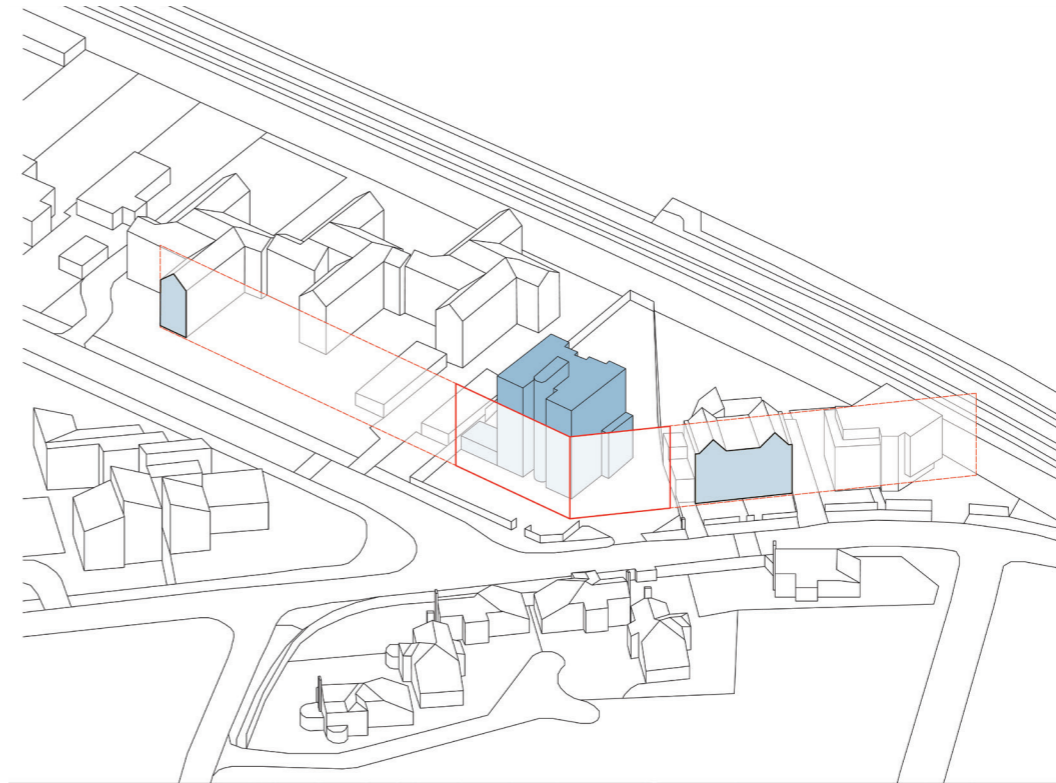
Establishing the building lines.

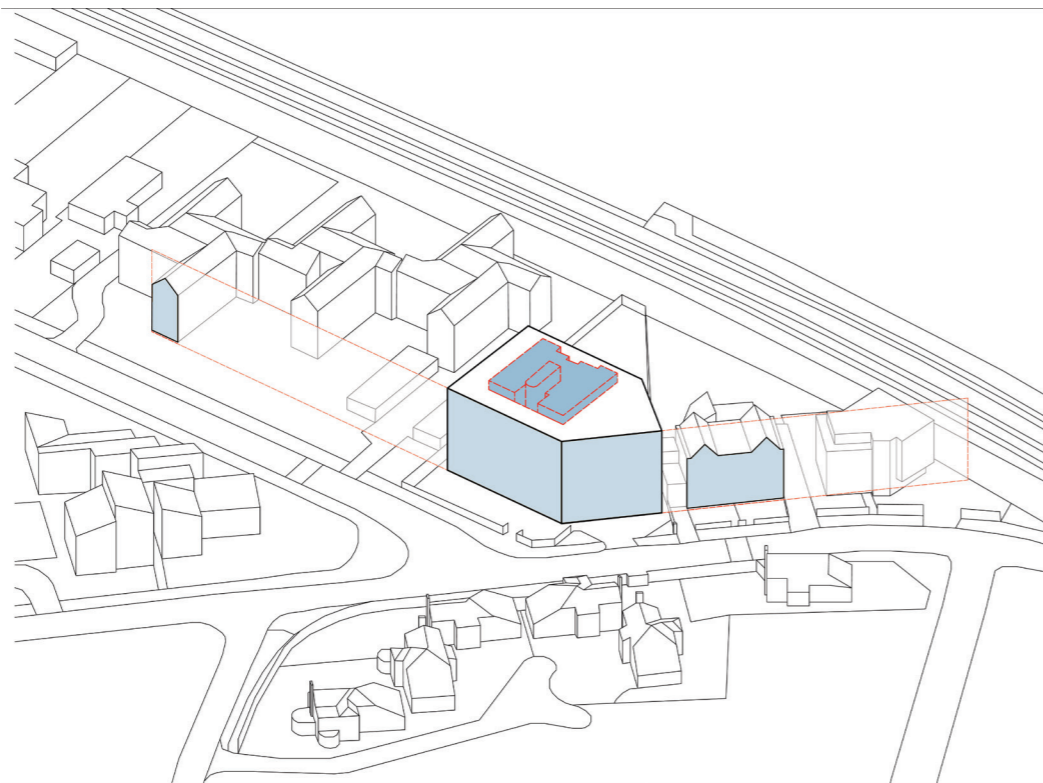
New volume responding to corner, with increased footprint and six storeys.

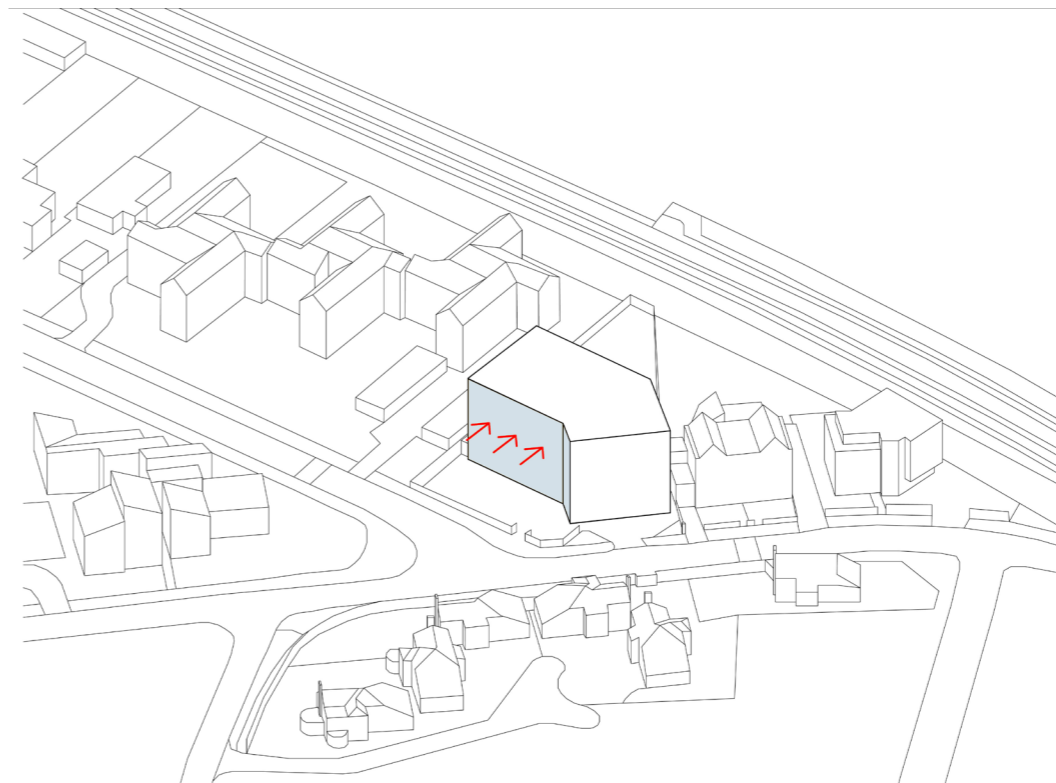
Central section pushed back, responding to street trees.

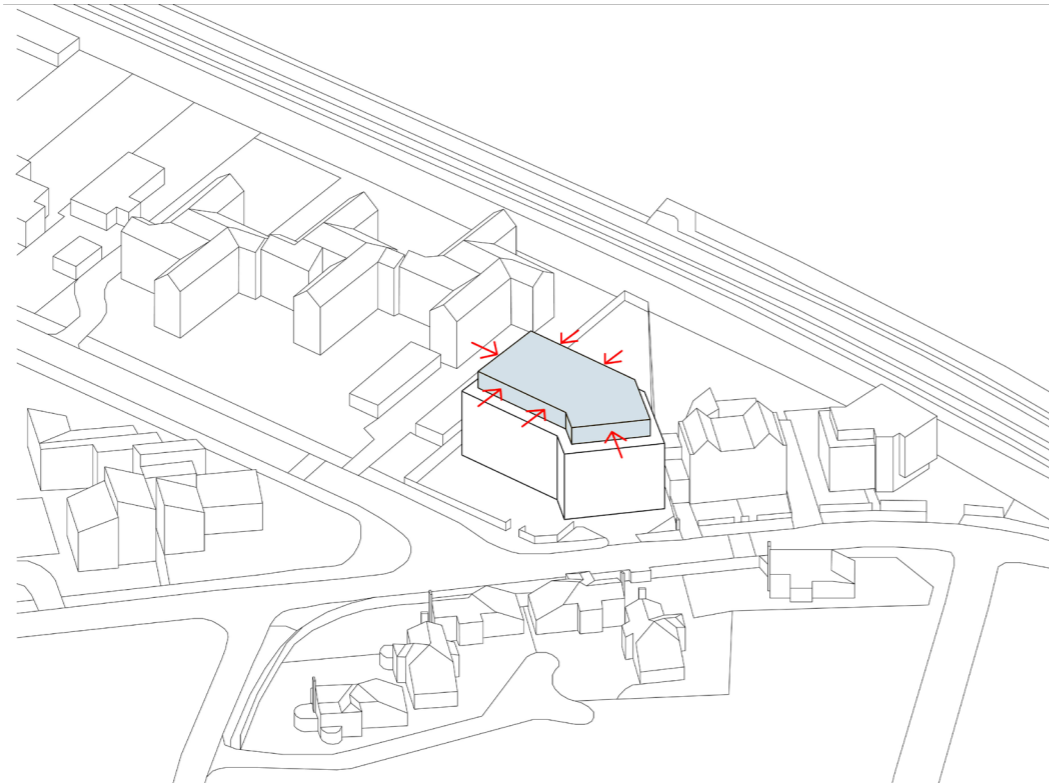
Top floor set back from main building.

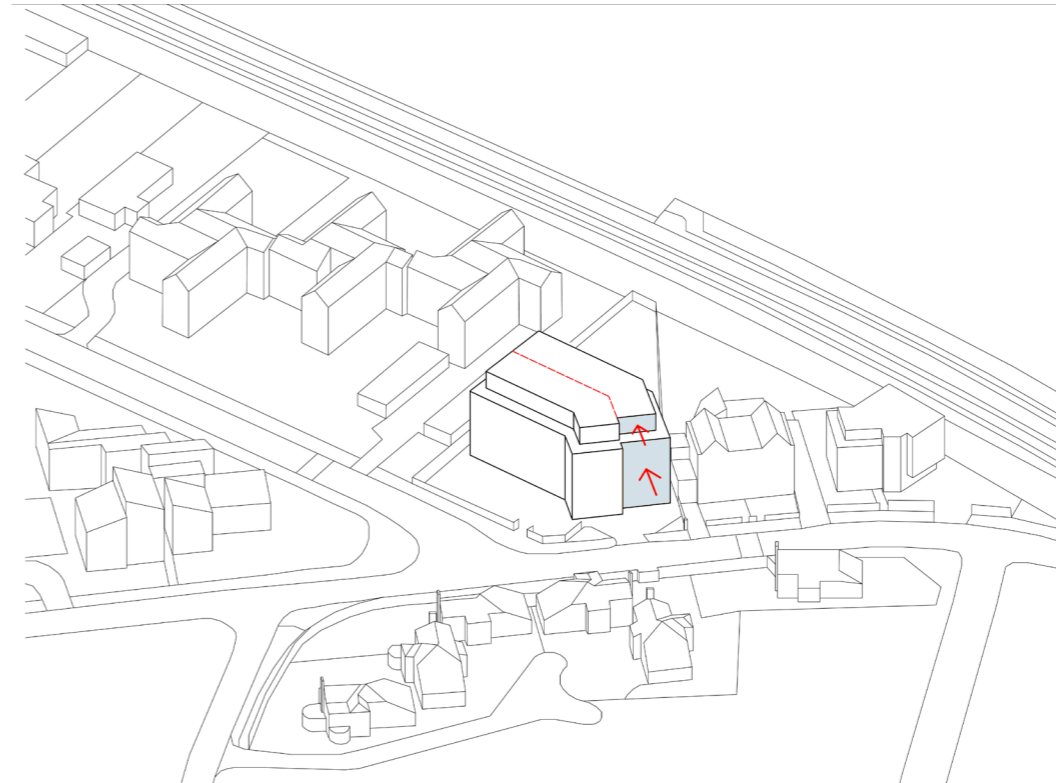
Corner wing pushed back to respect BTMs frontage, plus notional split along spine of new building.

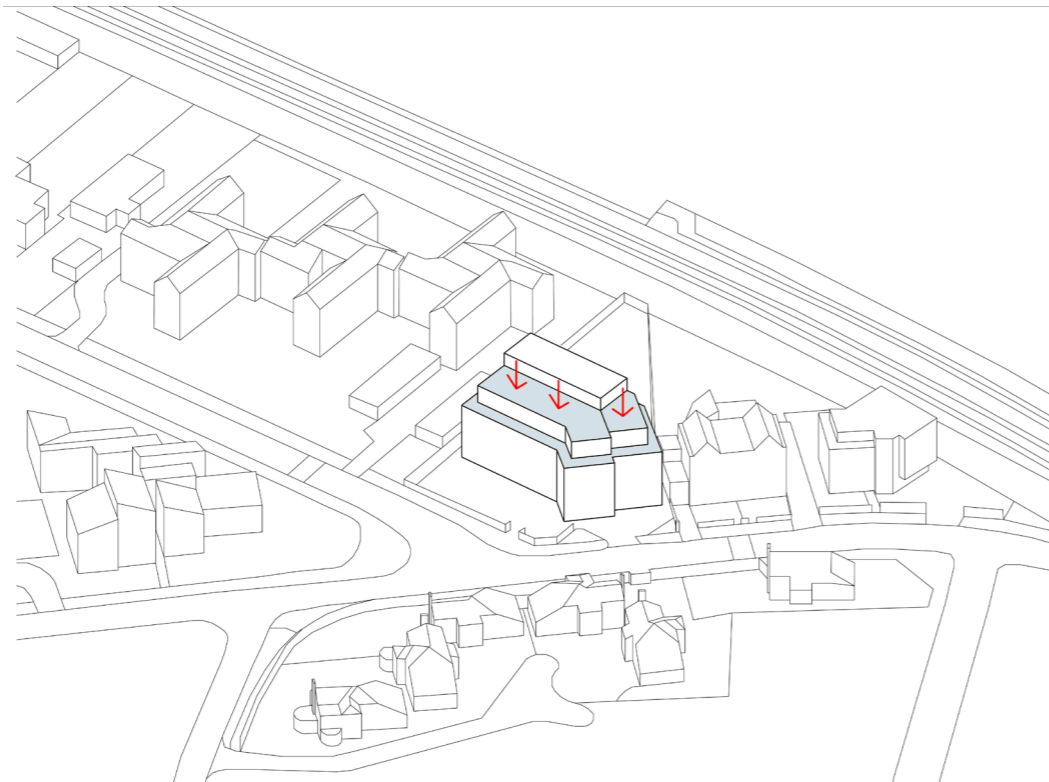
Front top floor section removed in response to overshadowing assessment to neighbouring buildings to the north along Davenport Close, and improving visual relationship with BTMs.

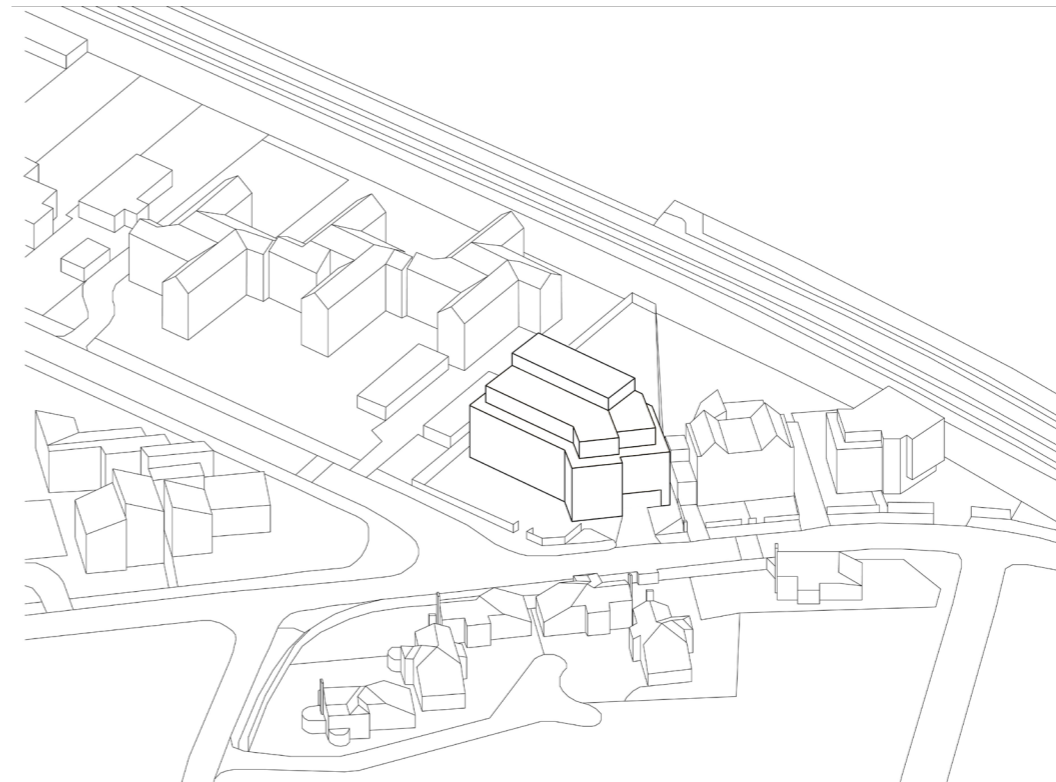
The final form of the proposal.

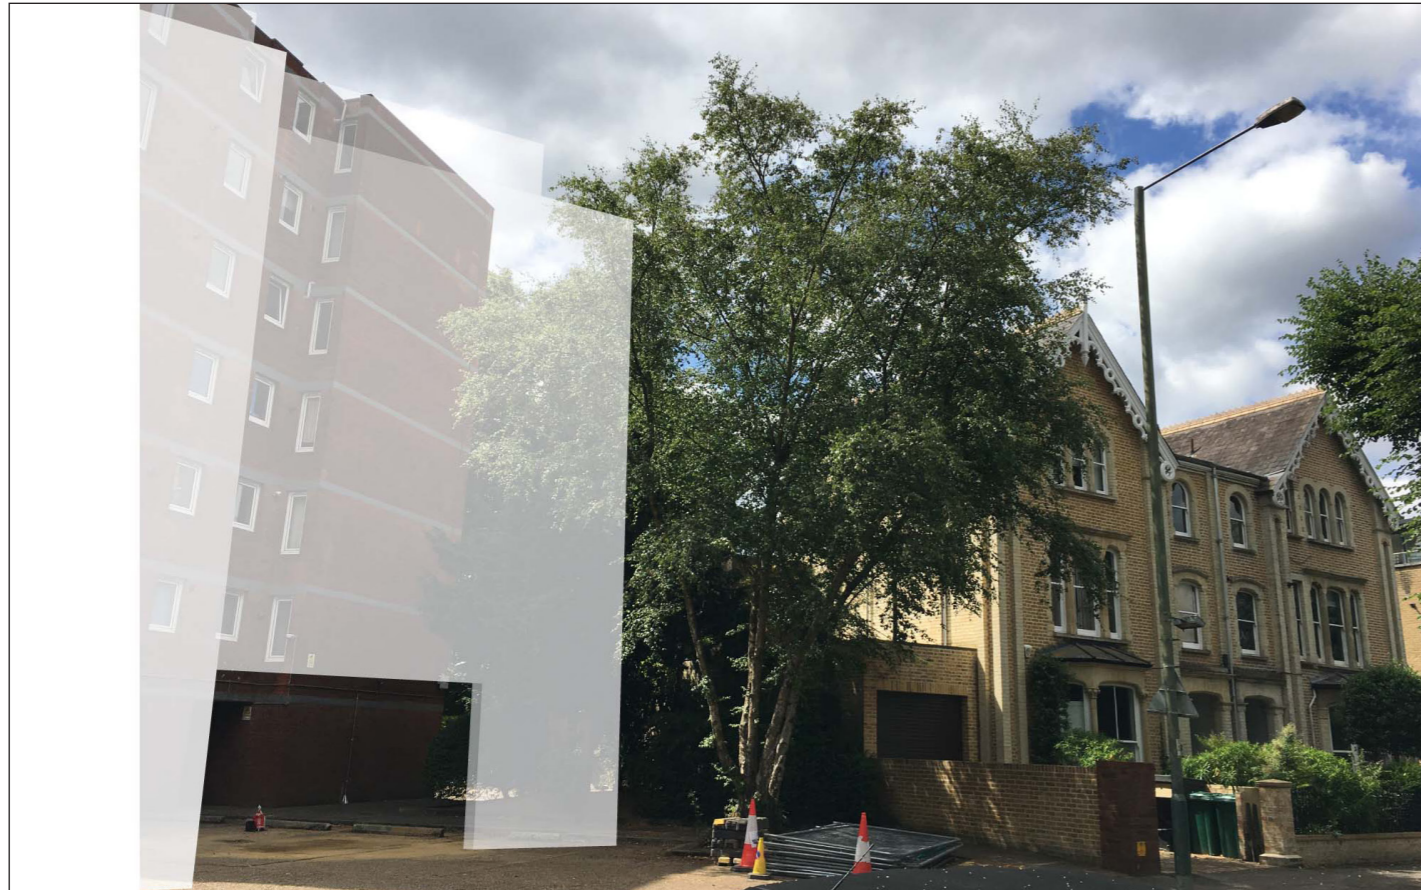
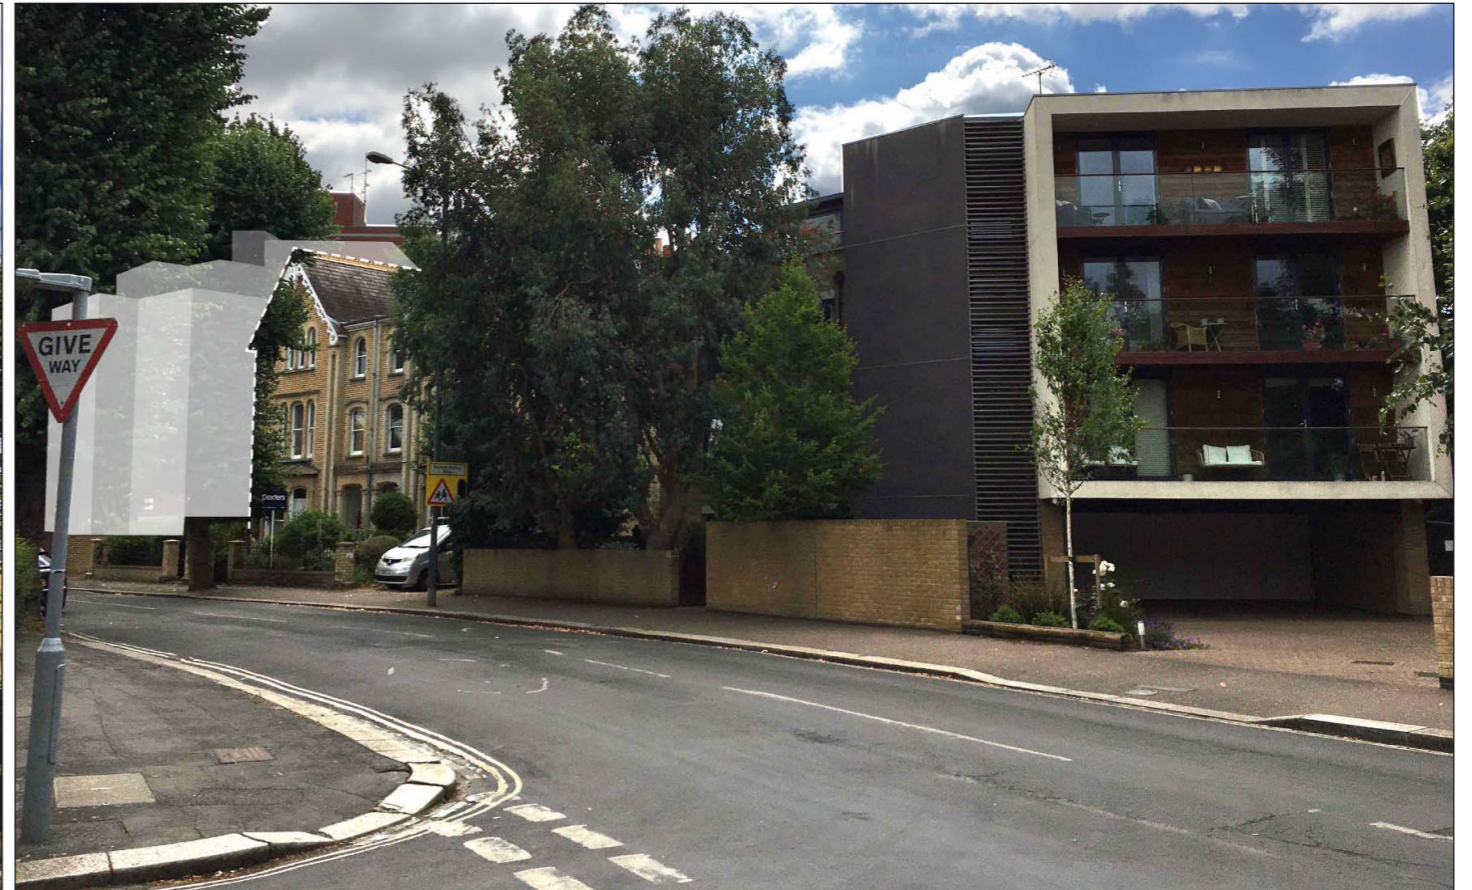
Photographic analysis of the massing model compared to the existing condition in relation to the adjacent BTMs, showing the height of Sheldon House and the gap within the street-scene.

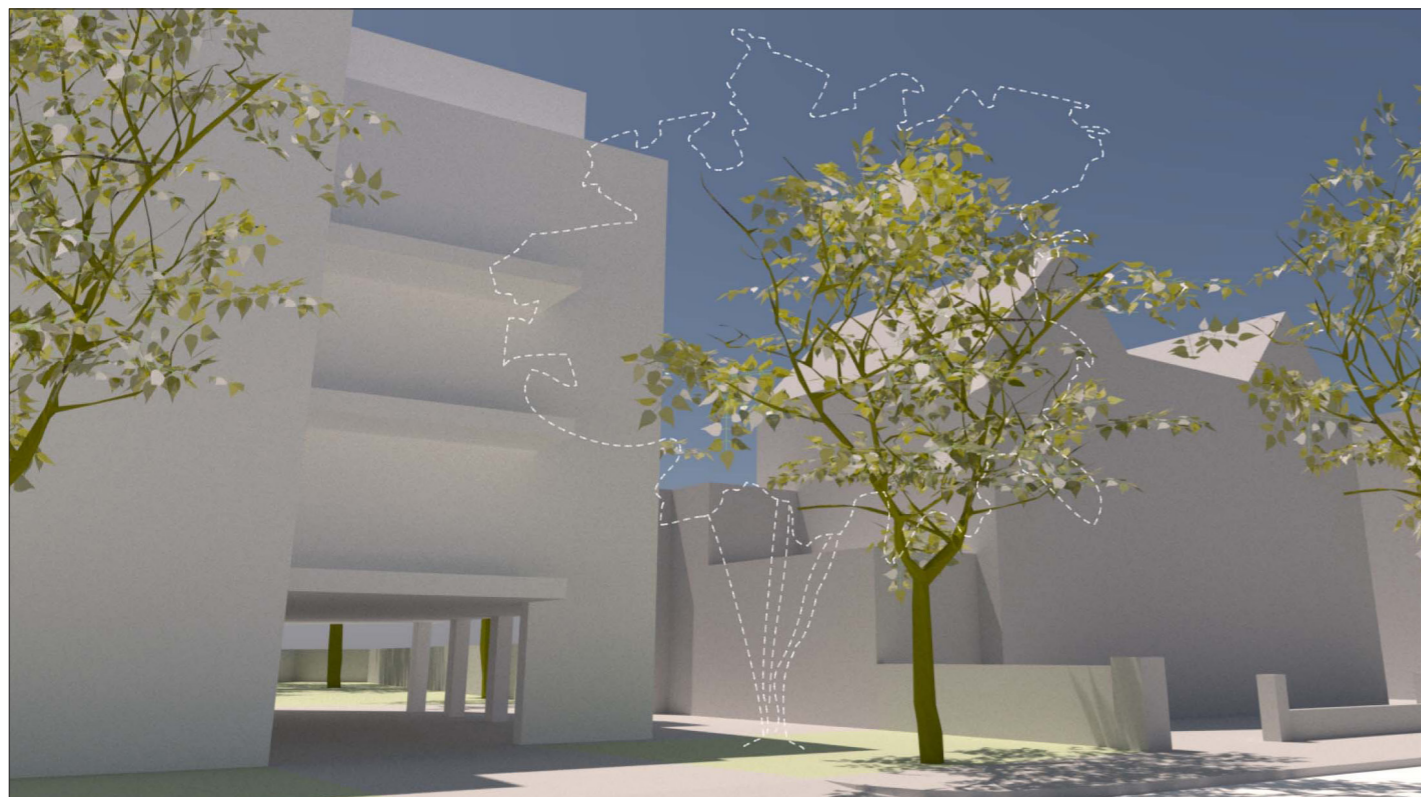
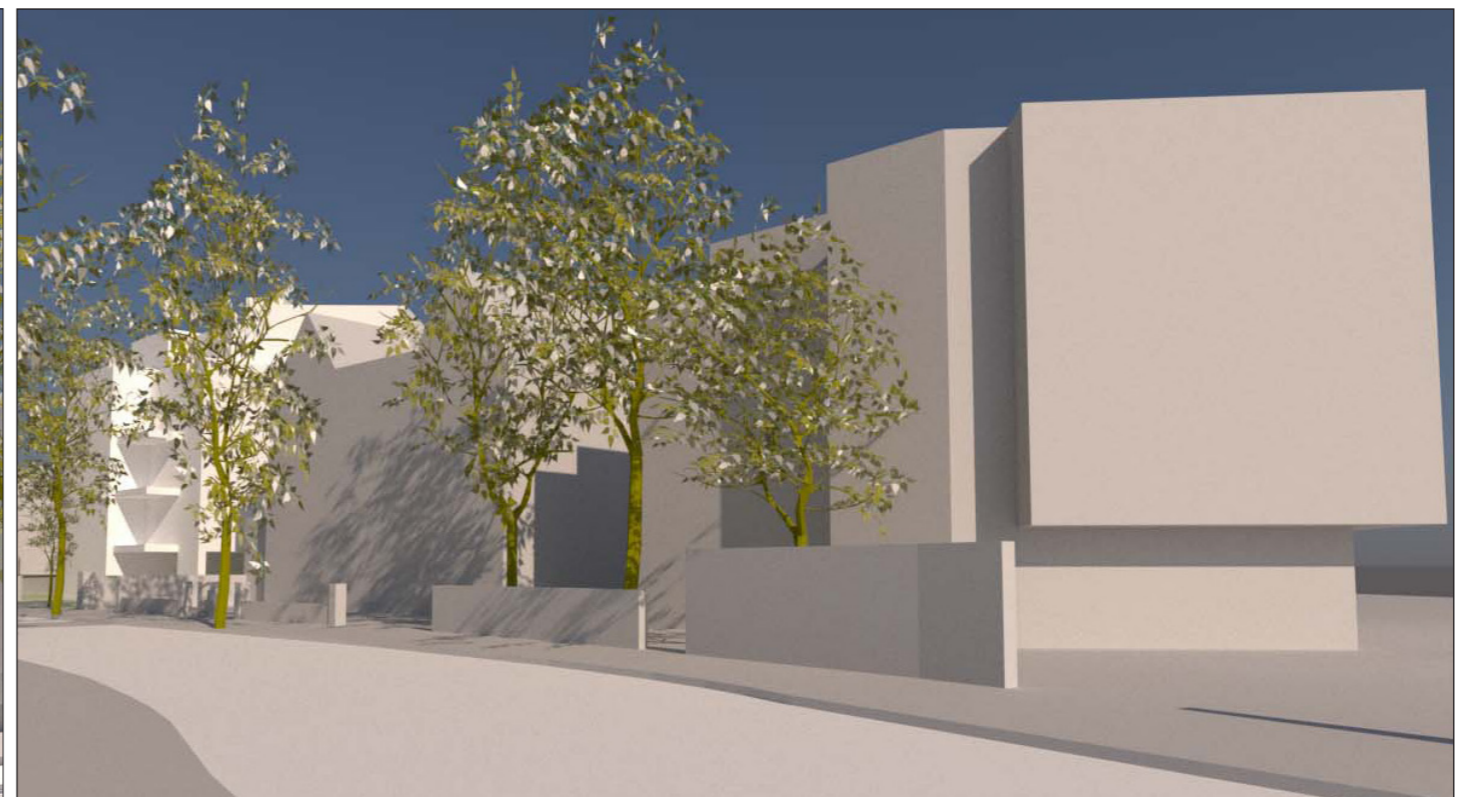
The final proposal modelled, overlaid, and the analysis matched to the photographs (as closely as possible). Sheldon house can be seen at the top of the image.

16 The existing multi-stemmed birch tree (category C) is removed, as shown dotted, and replaced with two new semi-mature trees on either side of the access road.

Existing street trees screen the site and the new proposal.

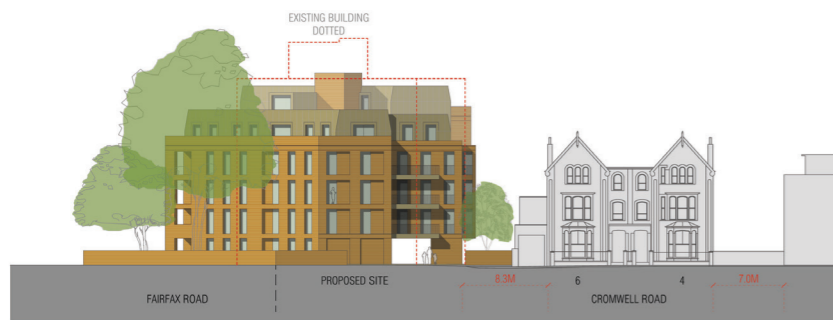
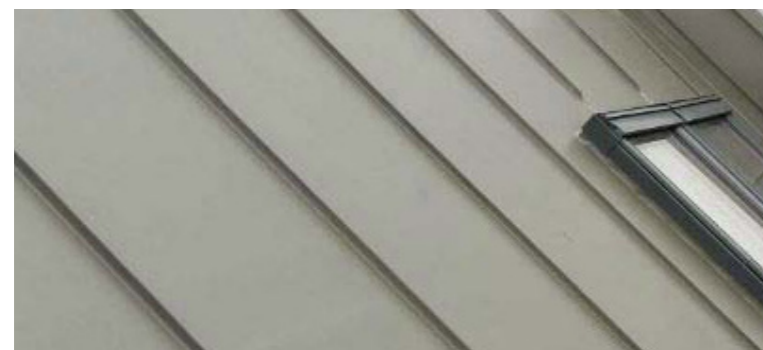
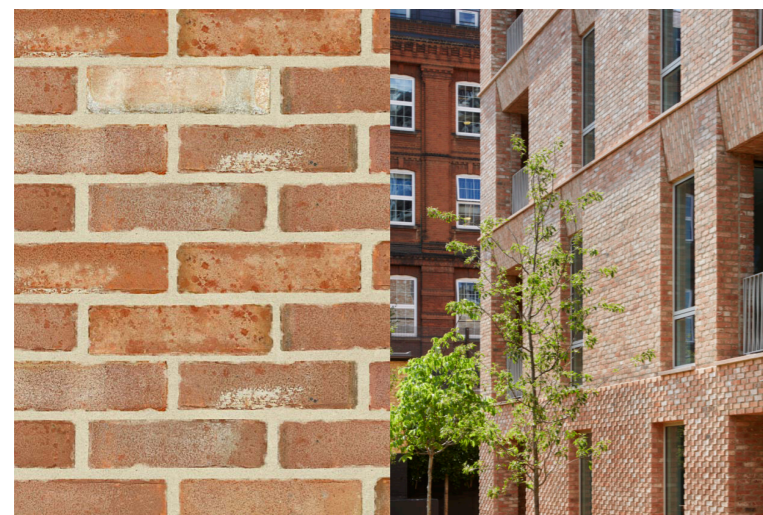
Mansard roof - Zinc standing seam - Lichen / taupe colour (Green)
 Main walls - Stock multi facing brick - Warm red

- Different brick colour from BTMs, which was welcomed by the Planning Department.
- Possibly too similar to the original Sheldon House, and therefore 'bad' connotations.

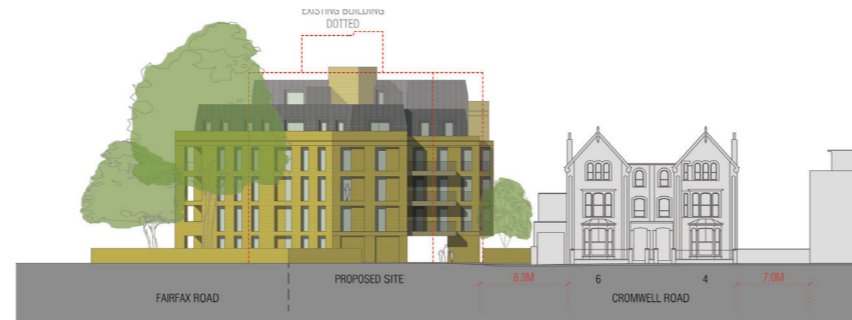
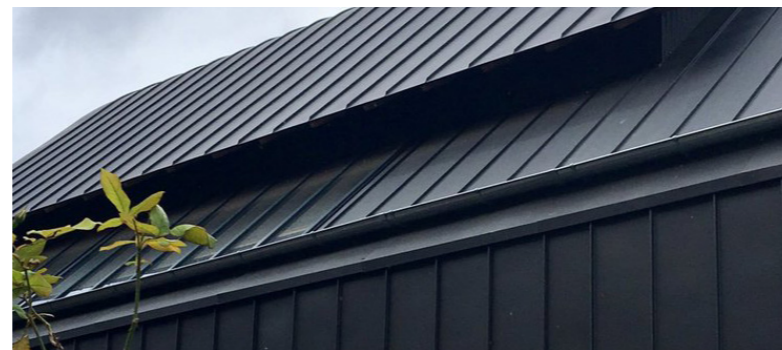
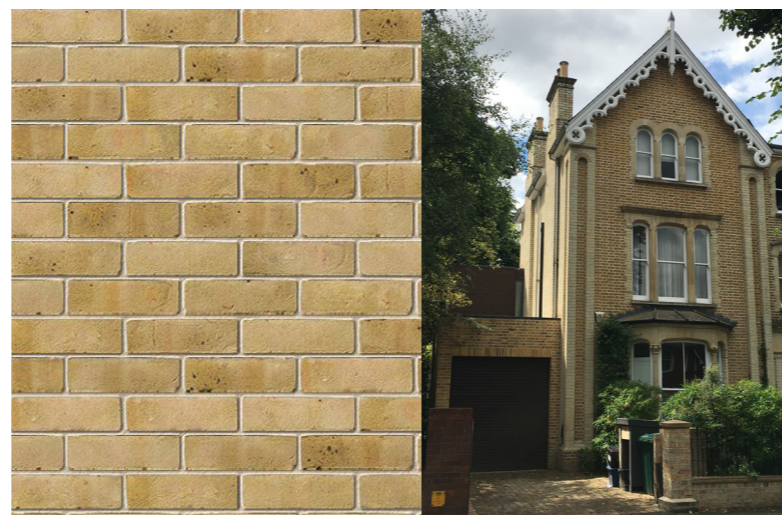
Mansard roof - Zinc standing seam - Anthracite (dark grey)
 Main walls - Stock facing brick - Buff / yellow

- Similar to the main brick used on the existing BTMs and the modern No. 2 Cromwell Road.
- Could distract from the visual prominence of the heritage asset.

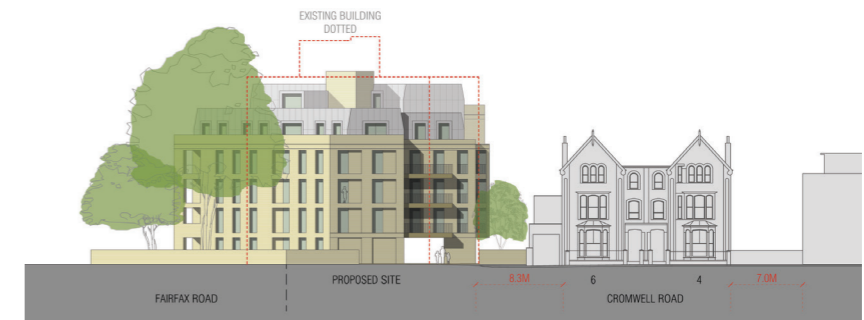
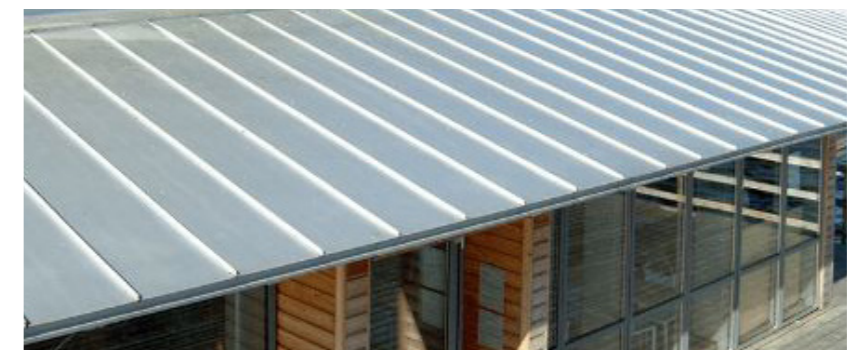
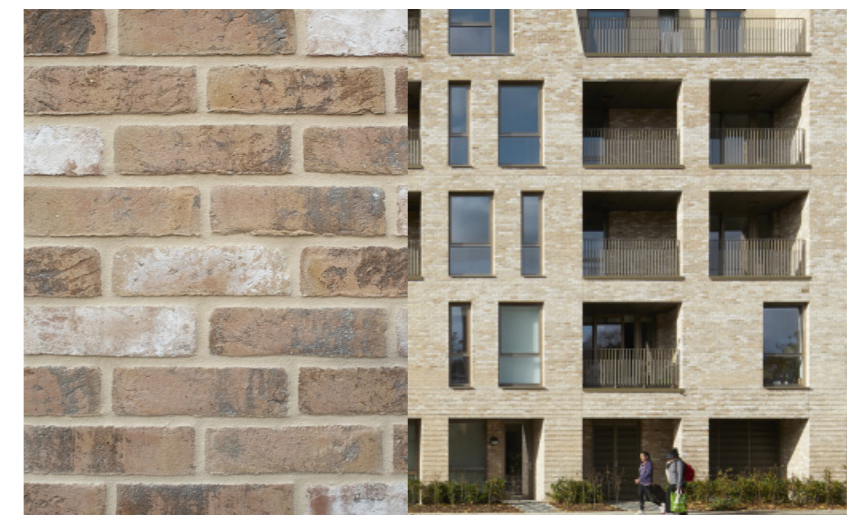
Mansard roof - Zinc standing seam - Natural zinc finish (shiny light grey)
 Main walls - Stock multi facing brick - Weathered gault (buff to white)

- Elegant colour palate.
- Lightens the overall appearance of the new building.
- Not a direct copy of BTMs, but picks-up on the gault brick used as detailing elements on the existing buildings, and perceived as sympathetic approach.
