**SHELDON HOUSE, CROMWELL ROAD,  
TEDDINGTON, GREATER LONDON**

**PRELIMINARY BAT ROOST  
ASSESSMENT**

Report No: RT-MME-154365-02

Date: March 2021

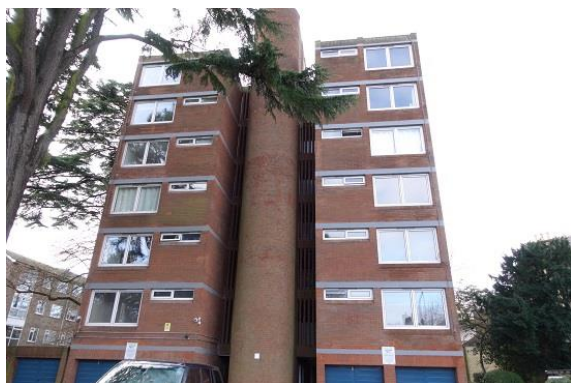
The main building on site was block of apartments with a boiler/plant room on the flat rooftop. The building was six storey, brick built with double glazed UPVC framed windows on all elevations (Plate 4.1). On the northern elevation, a lift tower was present that was in use at the time of the survey. On the eastern elevation, single storey garages were attached to the building (Plate 4.2). Overall, the building was in good condition although general signs of wear and tear were recorded.

**Plate 4.1: Overview of the Building (Northern Aspect)**

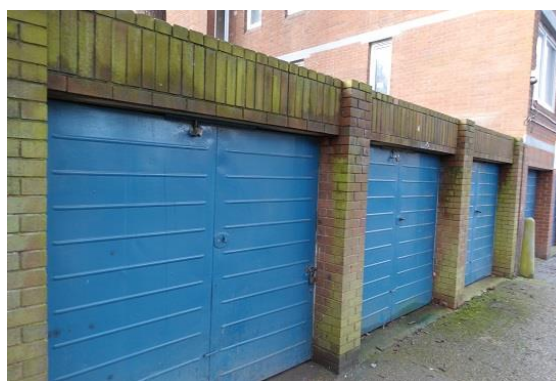
**Plate 4.2: Garages on the Eastern Elevation**

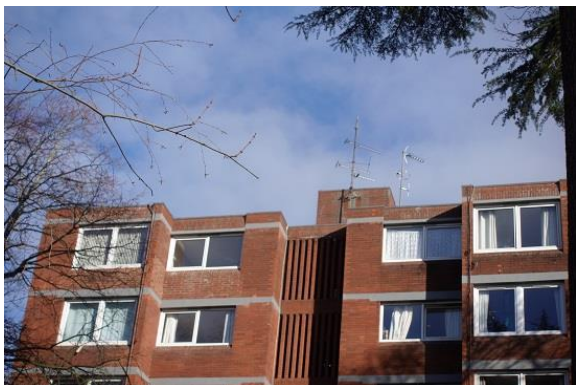
The roof appeared to be in a good state of repair as viewed from the ground level, however, the boiler/plant room on the roof top (Plate 4.3) could not be accessed for external or internal inspection on the day. It was also noted that a small fraction of lead flashing around the lift lower was lifted therefore creating a gap between the lead flashing and the brickwork (Plate 4.4). This gap creates potential roosting opportunities for bats.

Plate 4.3: Boiler/Plant Room

It was not possible to inspect these features due to the height at which they were located and as such it was not possible to establish if bats had used these features to enter a roost location at the time of surveying. No evidence of roosting bats, e.g. droppings, urine staining, feeding remains or scratch marks, was recorded within the features that could be fully inspected during the survey.

Sheldon House and attached garage structures been identified as having high potential to support roosting bats. Bat Surveys: Good Practice Guidelines published by the Bat Conservation Trust (Collins, 2016) recommends that for structures with high bat roosting potential at least three dusk emergence and/or dawn re-entry surveys be undertaken during the bat emergence/re-entry survey season to determine the presence/absence of roosting bats within the structures. The bat emergence/re-entry survey season extends from May to September. At least two of the surveys should be undertaken during the peak season for emergence/re-entry surveys between May and August and one of the three surveys should be a dawn re-entry survey. If a roost is discovered during these surveys, a Natural England licence application may be required.

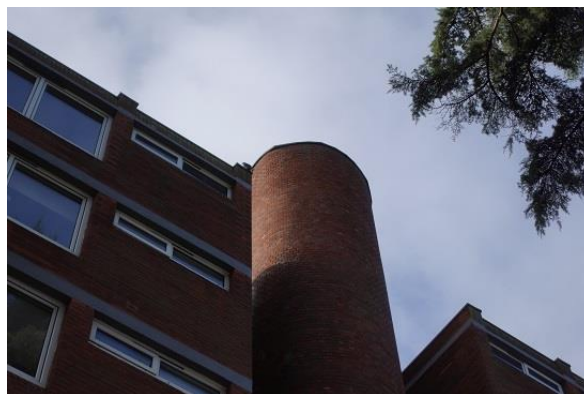
- Boiler room on the rooftop;
- Lifted LED flashing on the lift tower: and
- Weep holes leading into a cavity wall.

Plate 4.4: Lifted Lead Flashing on the Lift Tower

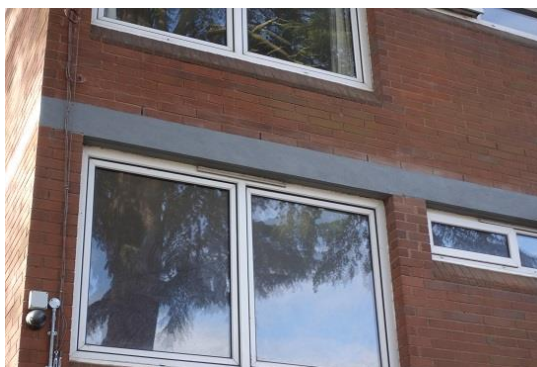
The window frames were all tightly fitted within the brickwork and window lintels. Multiple weep holes were recorded on all aspects of the building, located on the top of the window lintels (Plate 4.5). These weep holes extended into a cavity wall which provides a suitable roosting feature potentially for a large number of bats. Therefore, these weep holes provide a high potential roosting feature for bats. The feature could not be fully inspected as it extends into the cavity wall of the building and could not be accessed by the surveyor.

Plate 4.5: Weep Holes Above Window Lintels

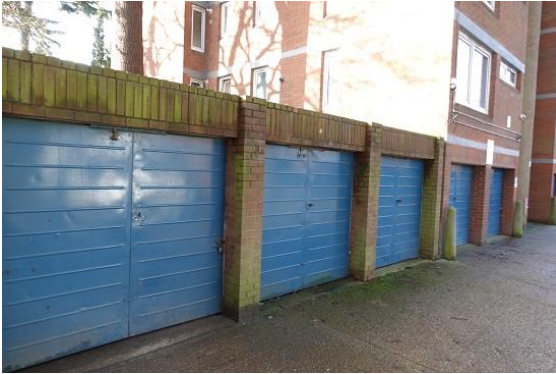
There were three external garages on site that were attached to Sheldon House on the eastern aspect (Plate 4.6). Two more garages were built-in within the Sheldon House building. The external garages were generally modern and in a good state of repair, with flat bituminous roof and brick walls. The metal doors were not tightly fitted around the brickwork therefore creating gaps between doors and walls. These gaps were noted to be free of cobwebs (Plate 4.7) which indicates that the garages may be in regular use and could also be used by fauna.

**Plate 4.6: External Garages Plate**

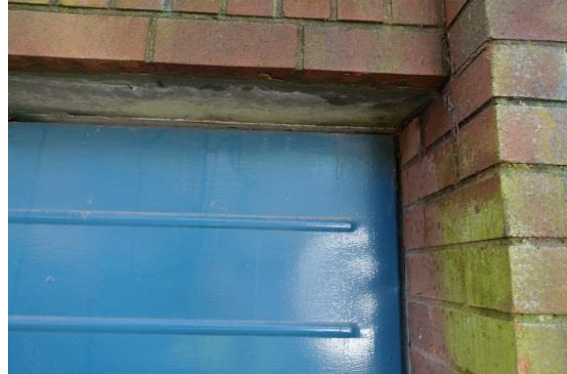
**4.7 Gaps Between Doors and Brickwork**
