PHASE 1 GEO-ENVIRONMENTAL DESK STUDY AND PRELIMINARY RISK ASSESSMENT

25 CHURCH ROAD TEDDINGTON TW11 8PF

Reference Number 3219/Rpt 1v1 February 2023

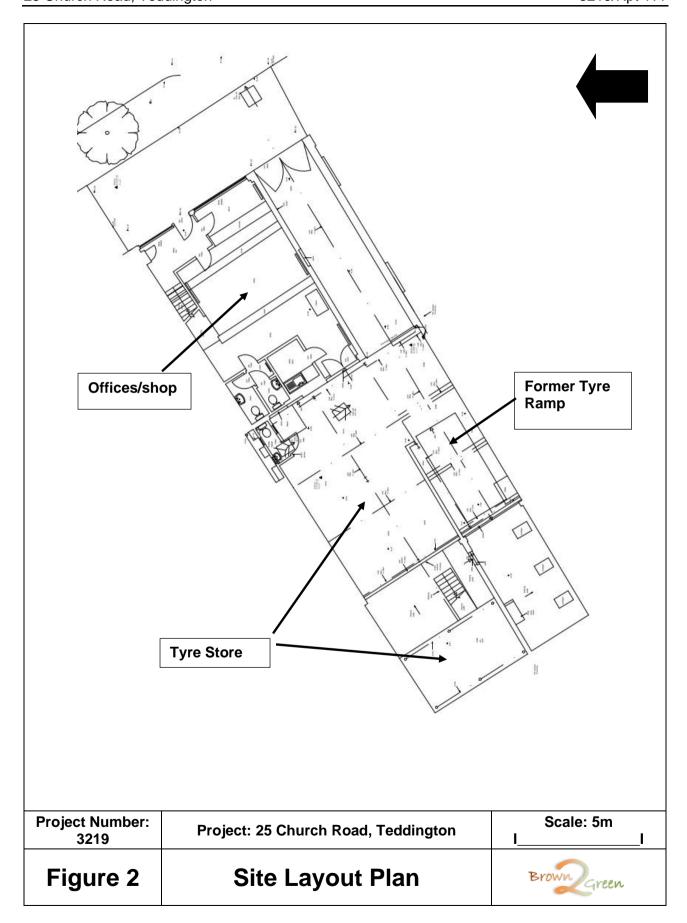
The site layout is presented in Figure 2. A photographic record of the site is included in Appendix III.

The subject parcel of land is rectangular in shape and covers 0.02 hectares. Access to the site is from Church Road along the eastern side of the site.

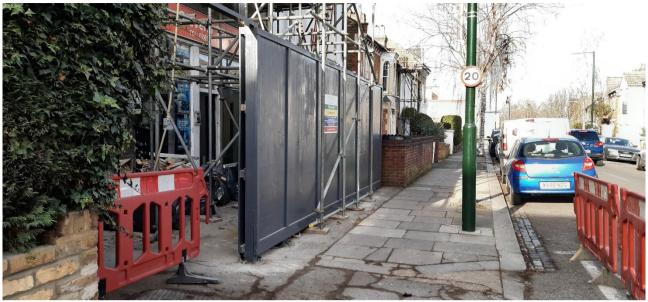
Site entrance

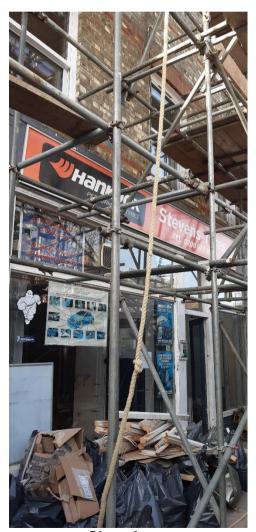
At the time of the site walk-over the site was vacant and was under refurbishment. Signage on the front of the buildings, indicates that it was formally a tyre fitter (Steve's Tyres). The site is occupied by a single building that is constructed of brick, with a slate roof. The ground floor would have been used as the tyre fitters. The upper floors would have been used as offices. Along the front of the building there is an open forecourt that is paved with concrete.

Shop front

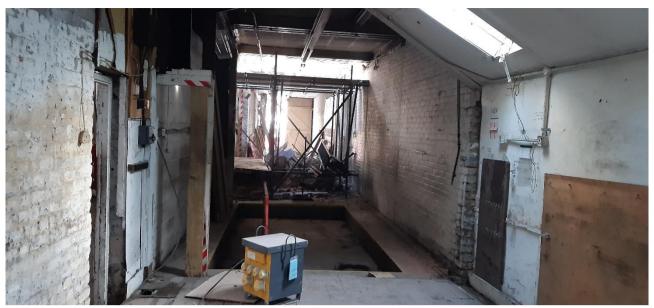
The north east corner is an areas containing a shop/offices and welfare facilities. Along the south side of the site is the access to the rear. The rear of the site would have contained contains the workshop and storage for tyres. Within the floor of the workshop there is a 300mm sump is present in the floor. This sump would have contained the vehicle lift. No other inspection pits were noted.

Former vehicle ramp pit

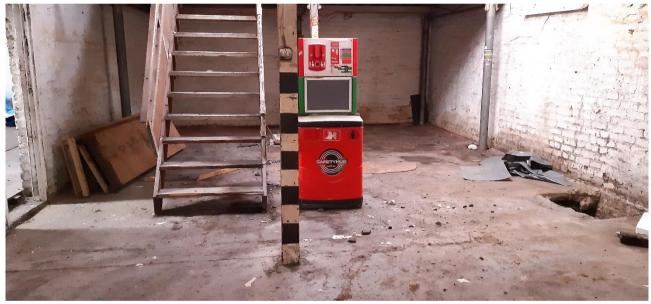
Tyre store
