QTS Environmental Report No: 16-50918

Site Reference: Stag Brewery, Lower Richmond Road, Mortlake, London

Project / Job Ref: 10022/JW

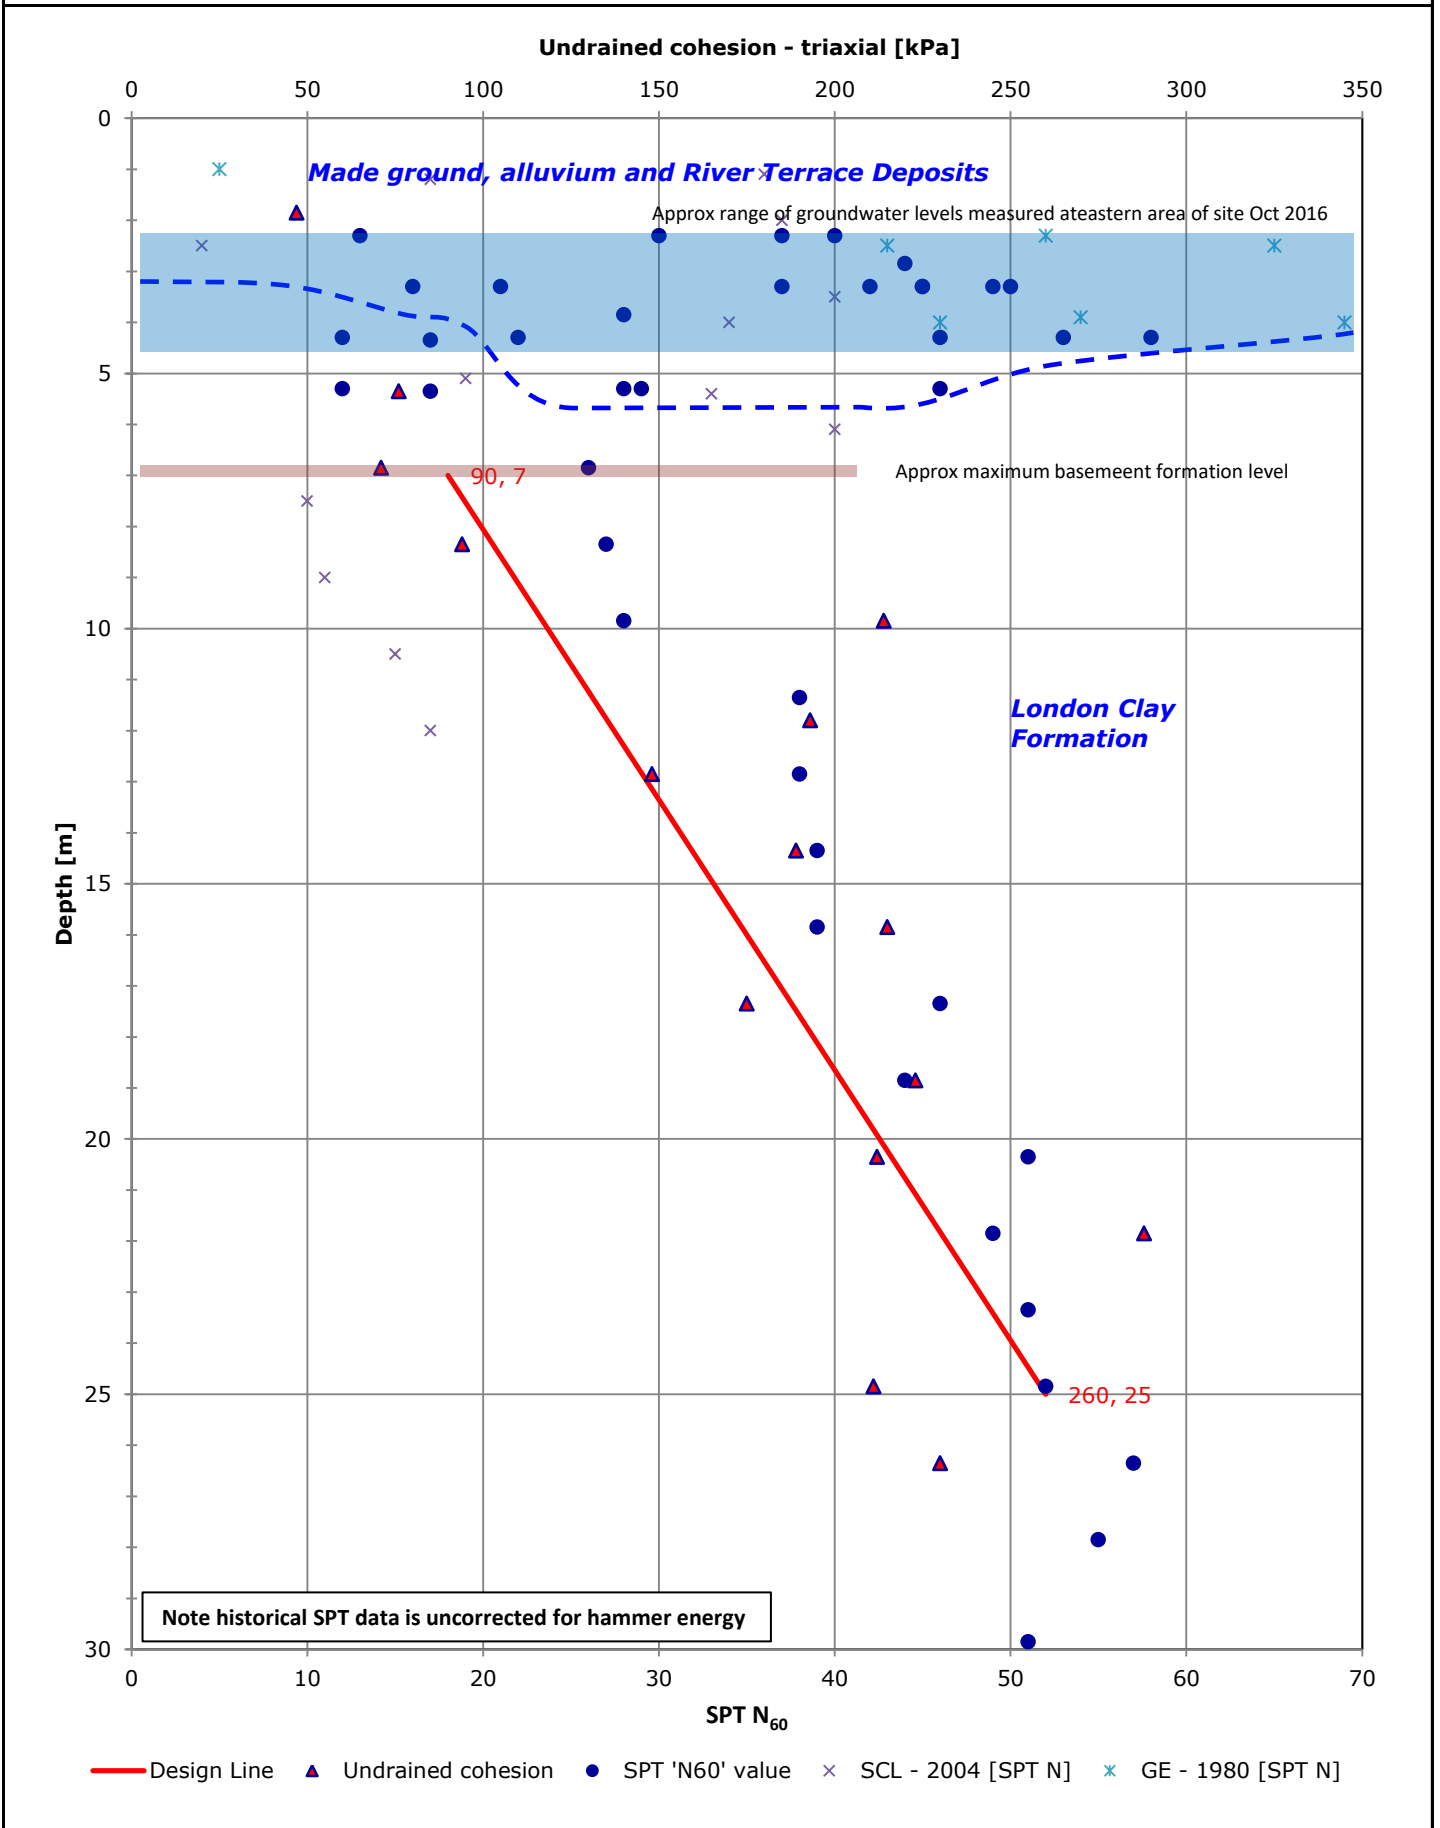
Undrained cohesion and SPT [N60] vs depth

Design Line $\Delta cu = 9.44kPa/m$

Note: this plot may incorporate extrapolated results, generally where 'N' >50 - these are indicative only and should be used with caution
