OVERVIEW

PART ONE
CHANGES TO THE MAIN HOUSE

MAIN HOUSE - GROUND FLOOR

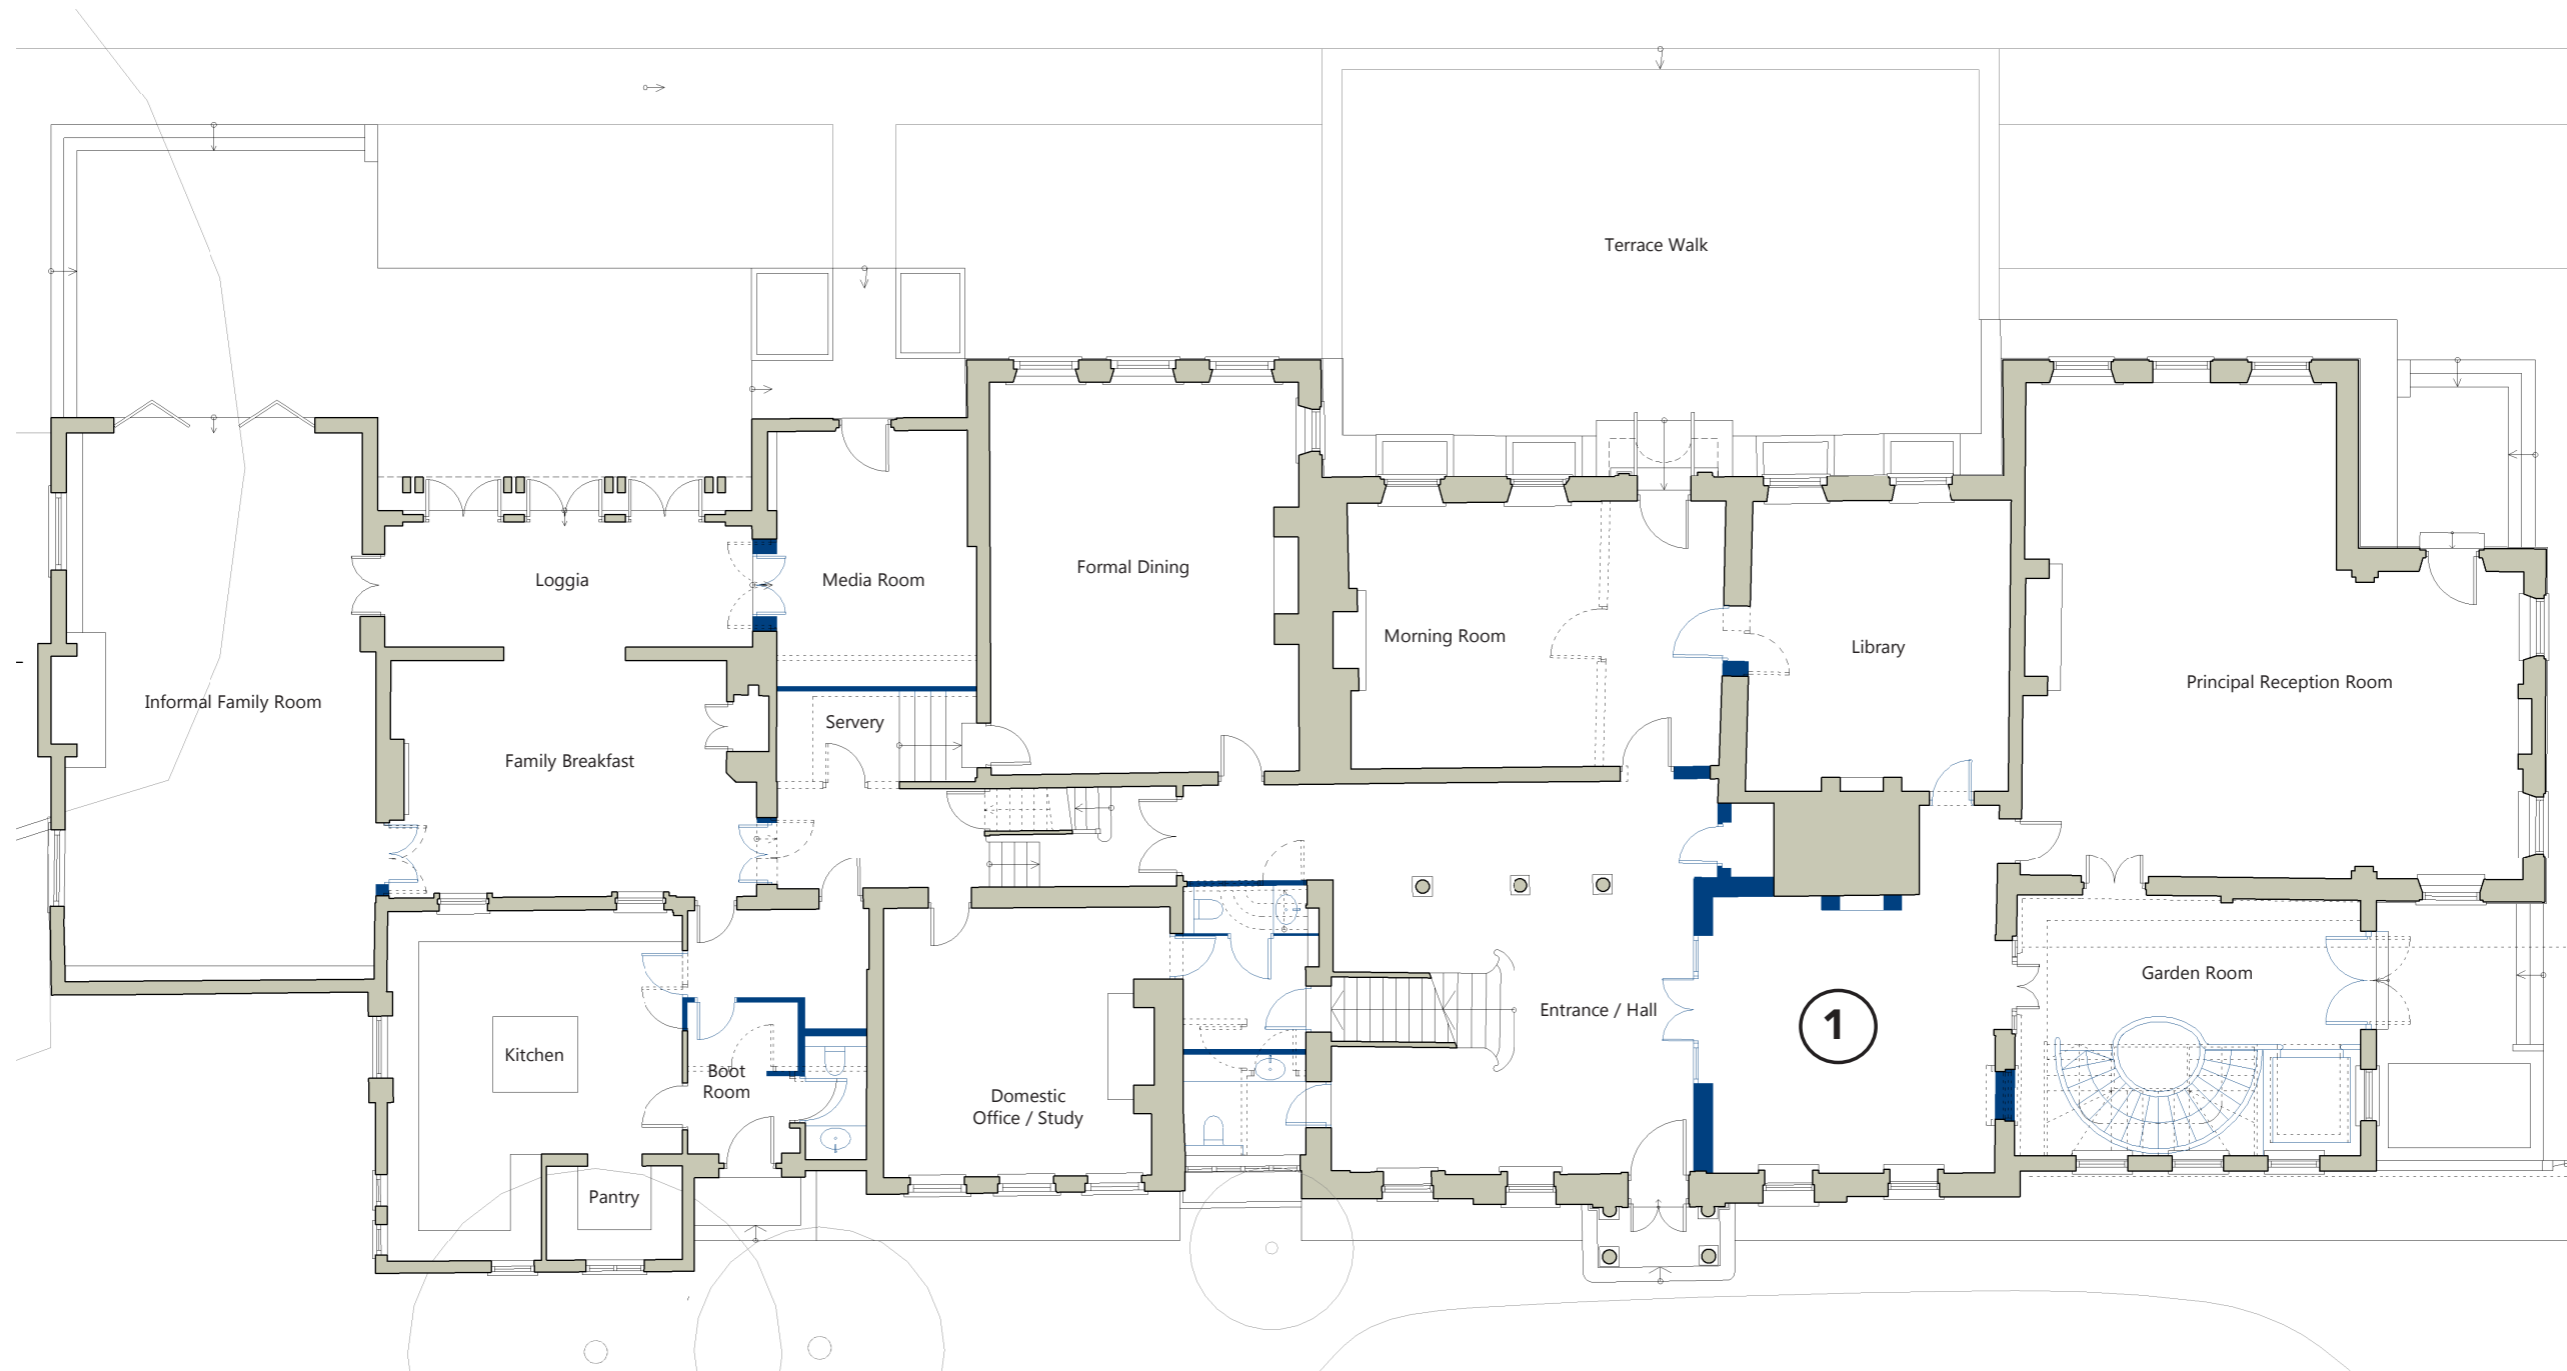
Proposed Change GF1 to Entrance Hall

Rebuild original partition to restore the historic plan form and reinstate original chimney place and retain original fabric previously consented to be removed.

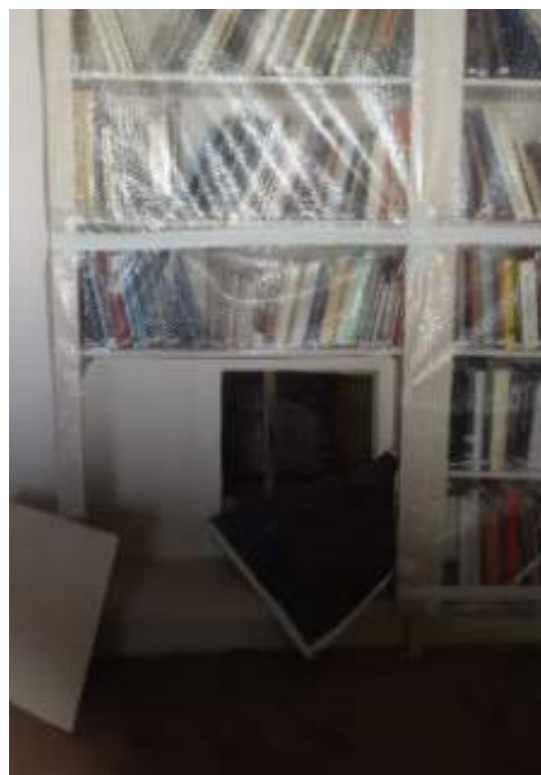
GF1_A Picture 1

GF1_A Opening up location

Previous investigation works revealed an existing chimney opening in the Entrance hall. Please refer to GF1_C in particular. Photographs and diagram taken from DAS of consented scheme
