**THE MANOR HOUSE,
HAM ST, RICHMOND**

STRUCTURAL IMPACT ASSESSMENT

PROPOSED BASEMENT DEVELOPMENT ADJACENT
TO A GRADE II* LISTED BUILDING AND
ASSOCIATED ALTERATIONS & EXTENSIONS

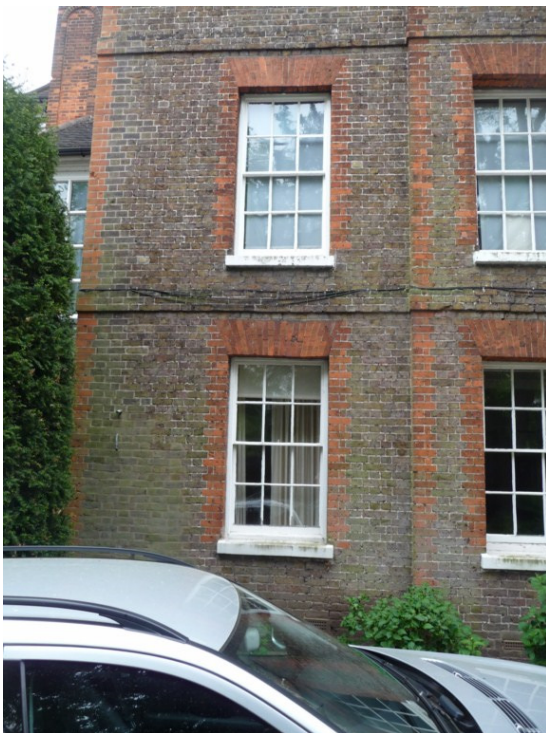
Slight distortion of spandrel panel on west elevation

4.2.2 There are two locations on the original building where there is evidence of slight ground movement. One is on the west elevation at the north end and the other is on the east elevation between each pair of windows either side of the doorway. The brickwork spandrel panels between the windows appear to suggest that the piers between the windows have dropped very slightly. This will be historic and probably dates from the time of construction. Its most likely cause is that the brick piers between the windows continue down to basement level and lead to a concentrated load on the foundations which may have settled more elastically as a result. No action is required.

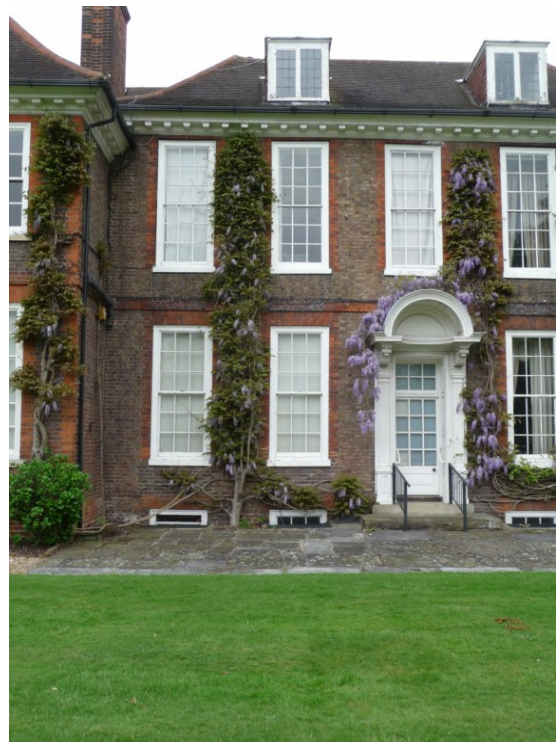
Slight drooping of pier between windows

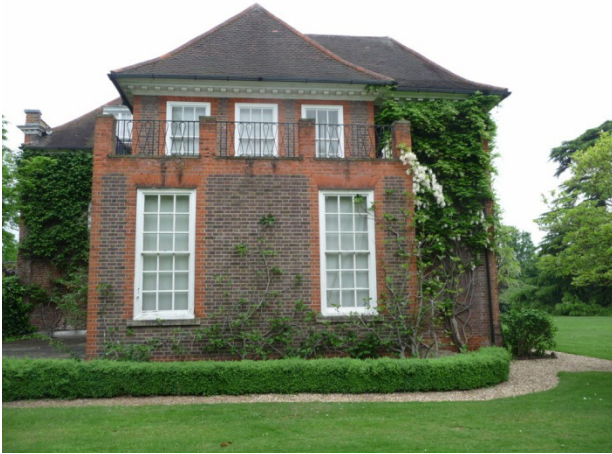
South elevation

4.2.4 There is cracking on the south elevation of the single storey part of the Edwardian extension. This is thought to be the result of expansion of metal ties within the wall and not the result of foundation movement.

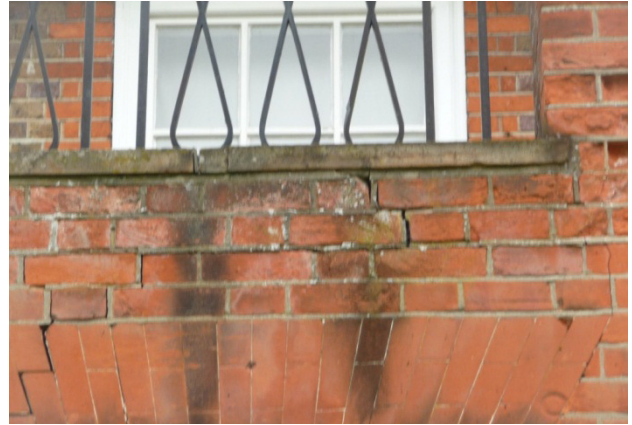
Cracking

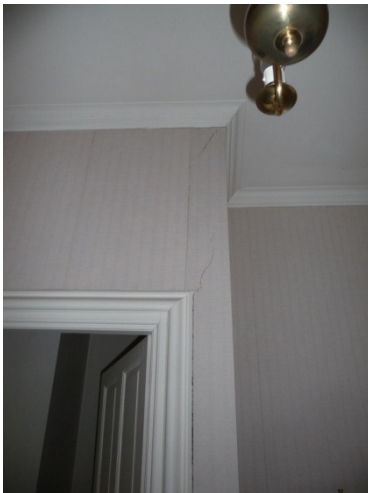
Cracking in partition wall

4.3.1 The first floor structure under Master bedroom suite 1 lobby and dressing rooms is overloaded by heavy partition walls. This deflection of the floor has resulted in the visible cracking within the dressing room. This should be remedied by floor strengthening works.

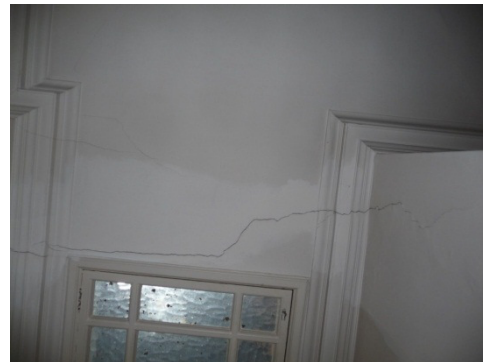
Cracking in ceiling

4.3.2 There is also cracking at high level in the lobby at the junction with the southern Edwardian extension (main master bedroom). This is due to deflection of the beam

under the wall between above noted lobby and dressing room. It is not of structural concern and should be remedied by the floor strengthening works.

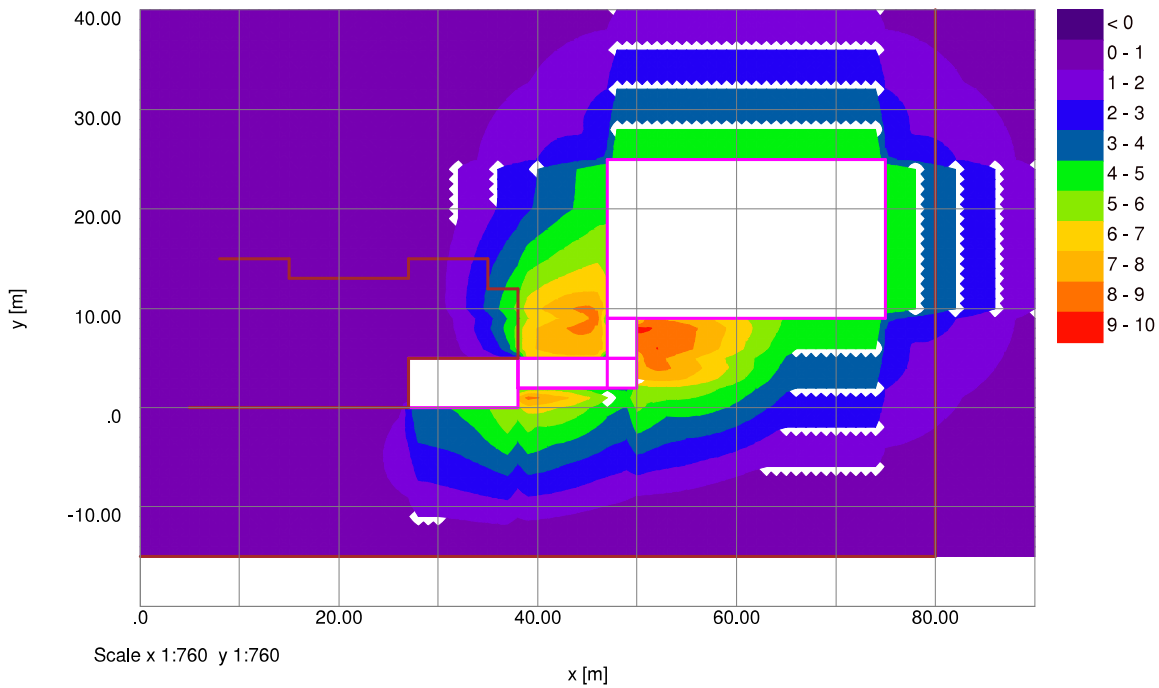
Vertical Settlement Contours: Grid 1 (level 7.000m) (Interval 1mm)

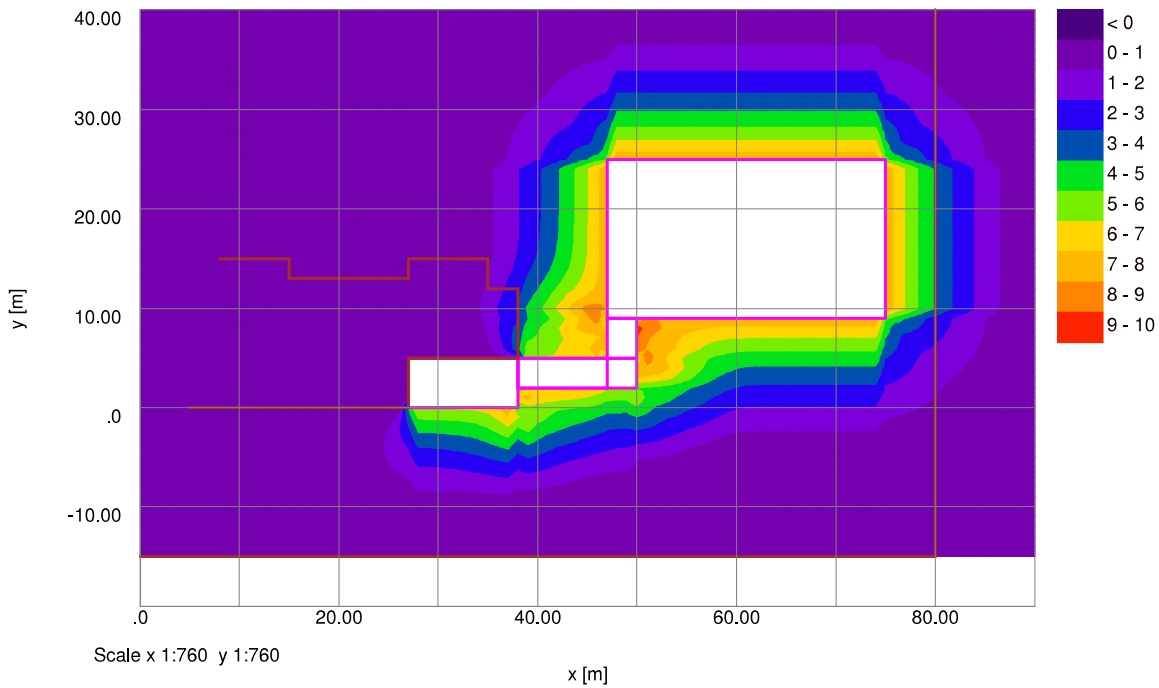
Horizontal Displacement Contours: Grid 1 (level 7.000m) Interval 1mm

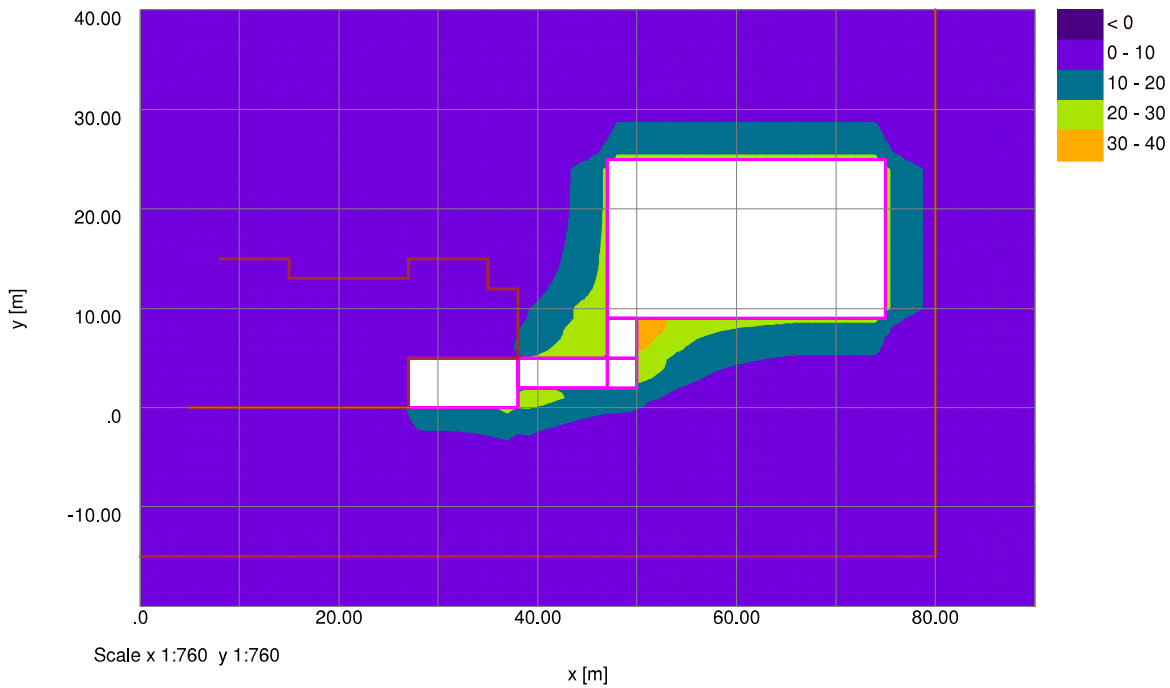
Vertical Settlement Contours: Grid 1 (level 7.000m) (Interval 10mm)
