Hampton Waterworks

Phase 1 Ground Conditions Desk Study

Waterfall Hampton Investment Ltd

Doc ref: 12193-HYD-XX-DS-RP-G-1000

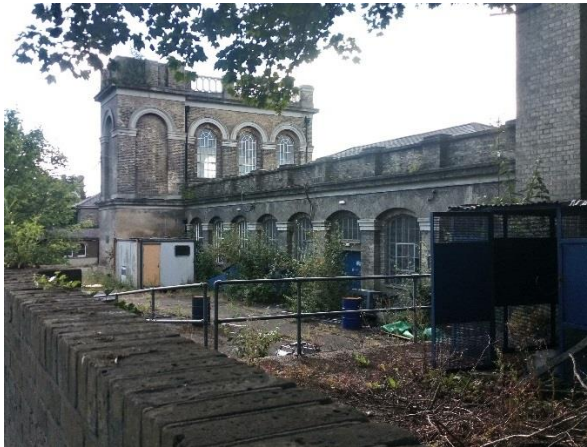
Figure 2.3: Looking east along northern site boundary.

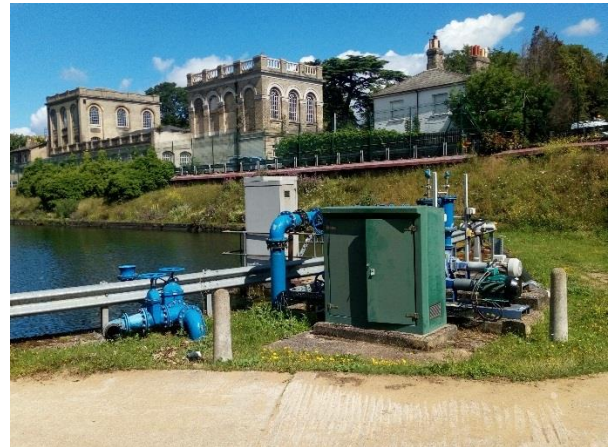
Figure 2.4: taken from the operational waterworks towards the site, showing the southern edge of the site in the background.

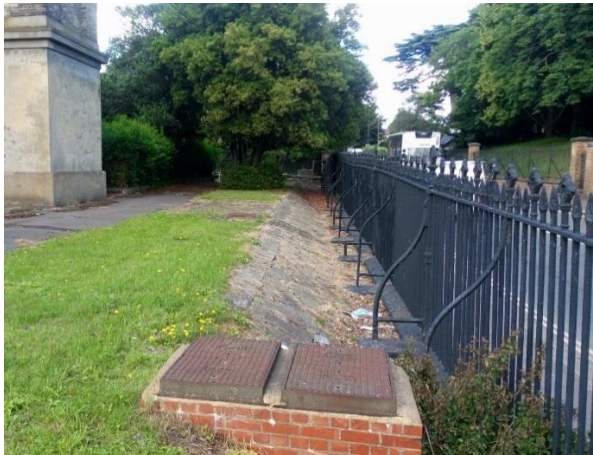
Figure 2.5: Raised ground and manholes (potential underground tank) in the north east corner of the site.

- Attack of buried concrete by aggressive ground conditions (e.g. sulphates in London Clay).
- Obstructions and services (including potential underground tanks and pipework).

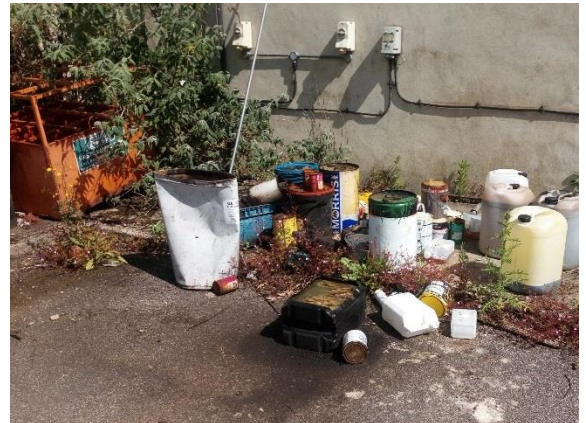
Figure 2.6: Chemical containers in central southern part of site.

- S 7. Storage, spillage, leakage and disposal of chemicals used in water treatment works (chlorine and flocculating agents (generally aluminium sulphate or iron sulphate), acids and alkali (sulphuric acid and sodium hydroxide))
- S 8. Migratory ground gases (carbon dioxide and methane) from alluvium south of the site.
