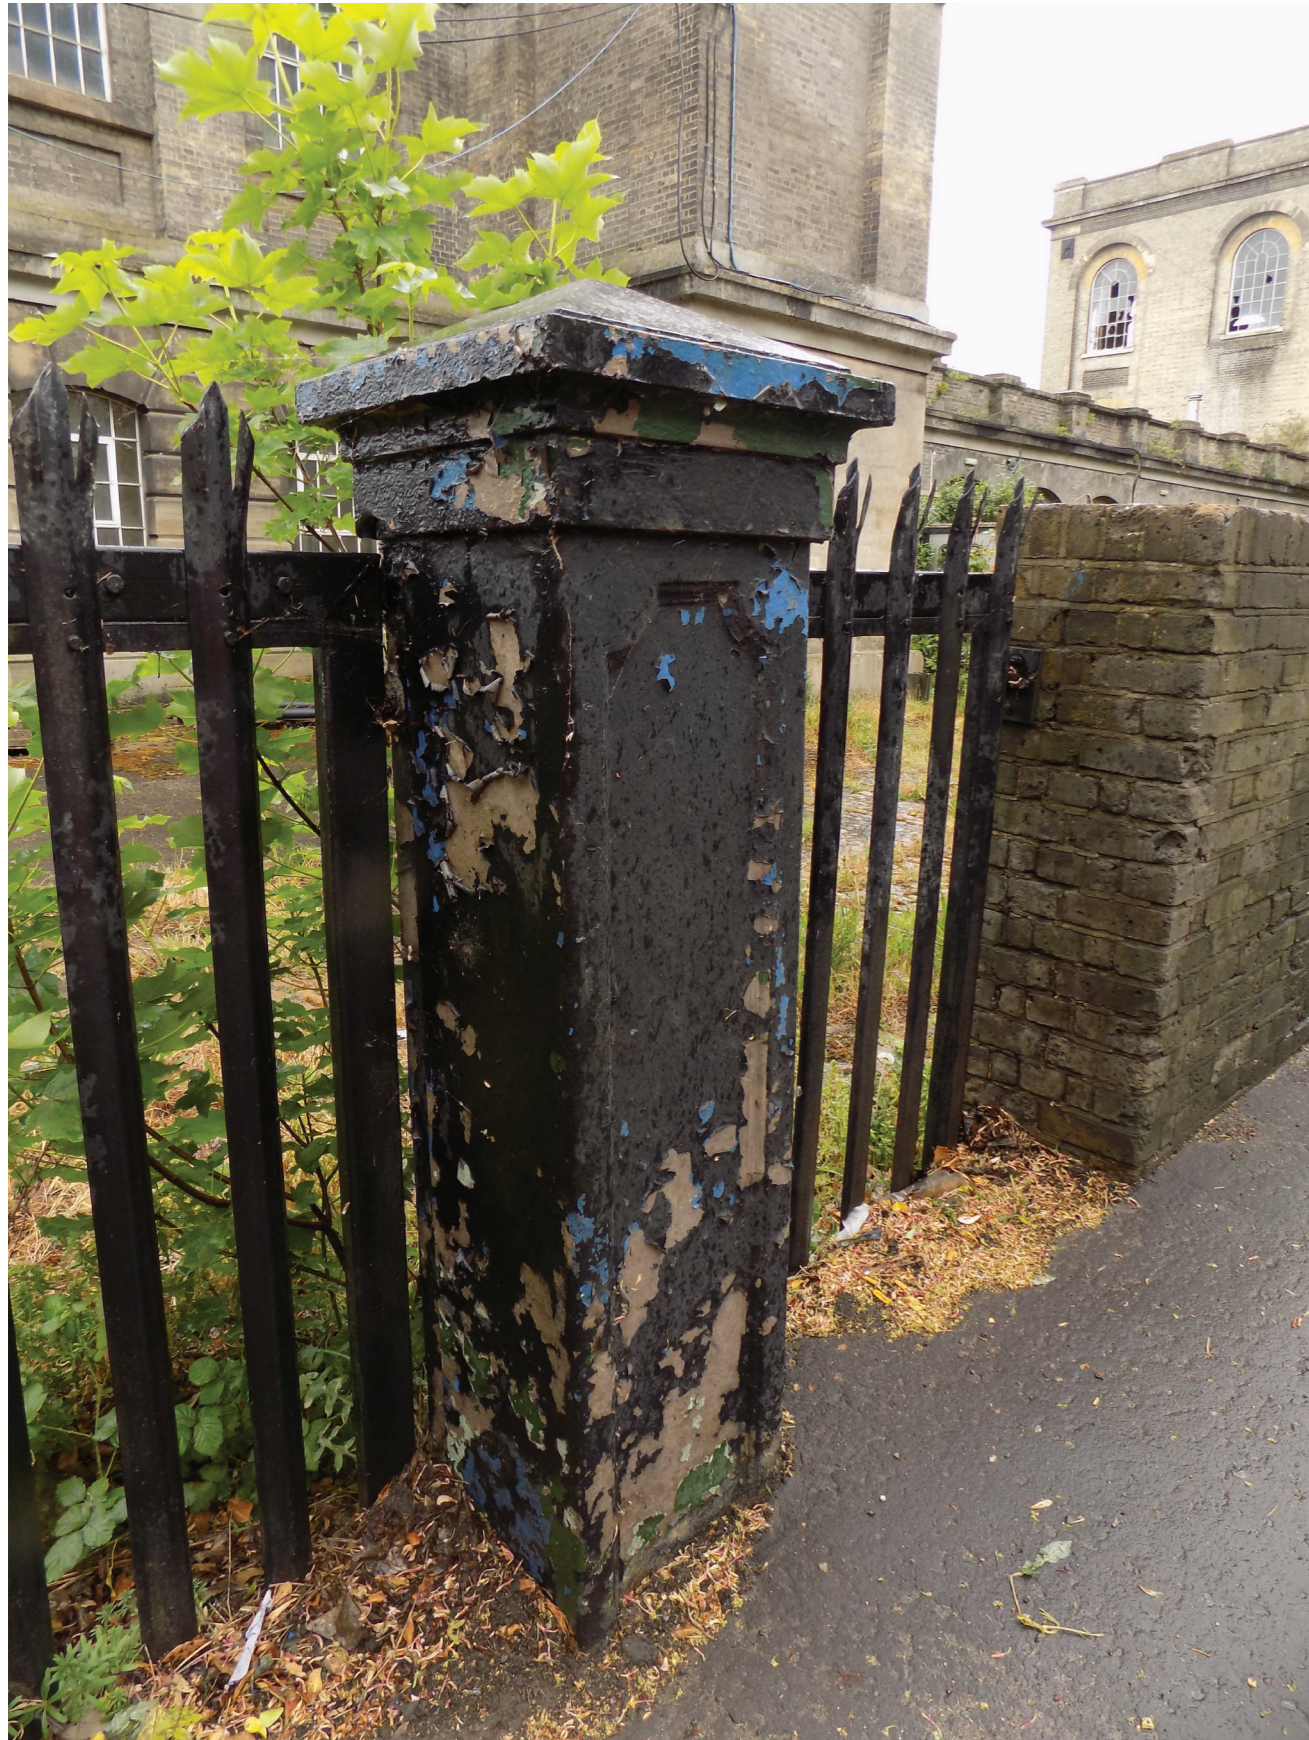
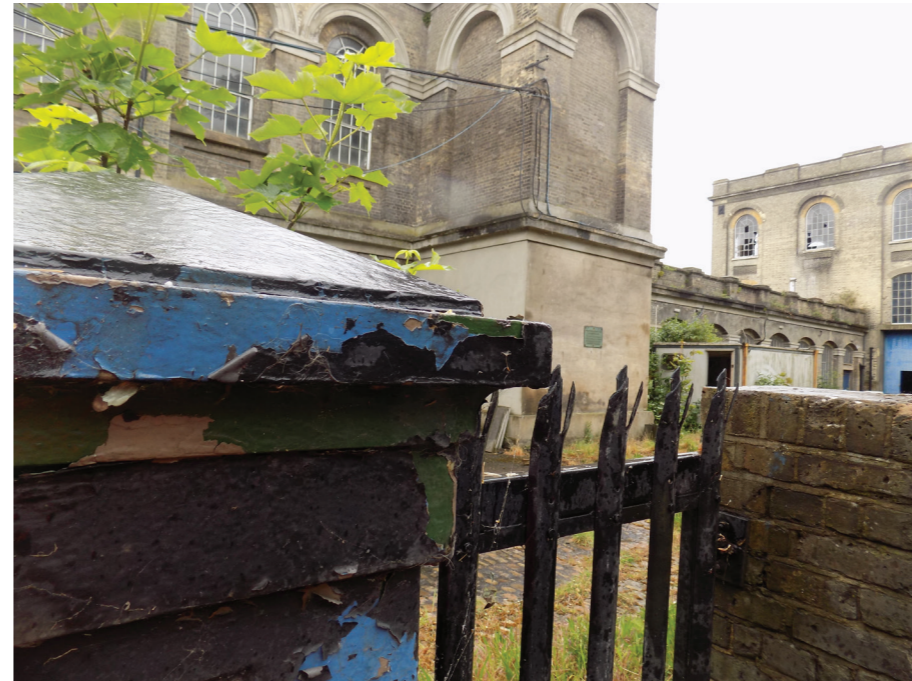
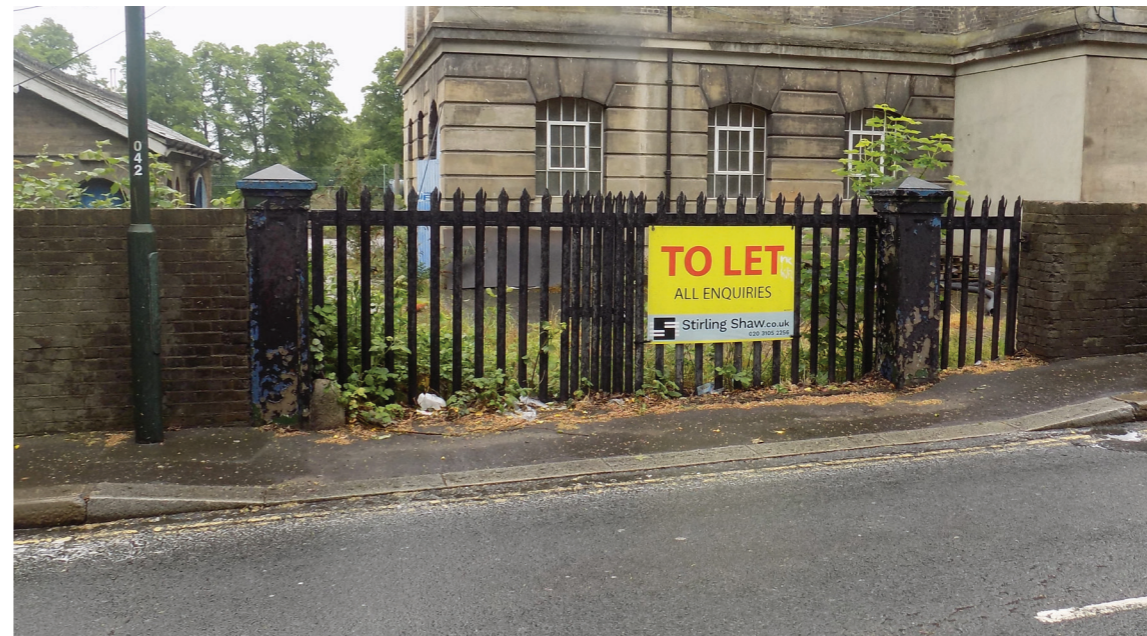
Figures 147-149: Painted, cast iron piers of medium - high heritage interest. Palisade fence considered to be intrusive and later brick wall considered to be of neutral heritage value. The smaller size of these piers demonstrates the historic hierarchy of circulation in to and out of the site.
