Design, Access and Heritage Impact Statement

Refurbishment and Repairs to:

Japanese Gateway Chokushi-Mon
Royal Botanic Gardens, Kew
Richmond, TW1 9AE

R3/23_082 Rev B

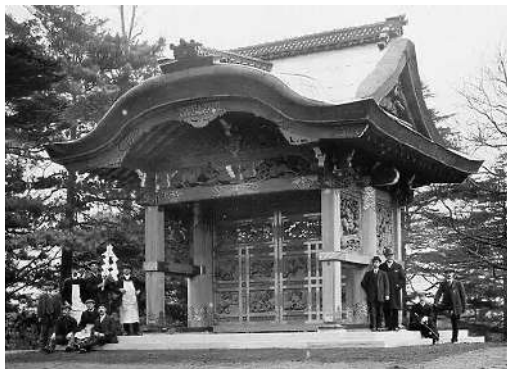
Fig. 2 South elevation, 1910 Kew Archive

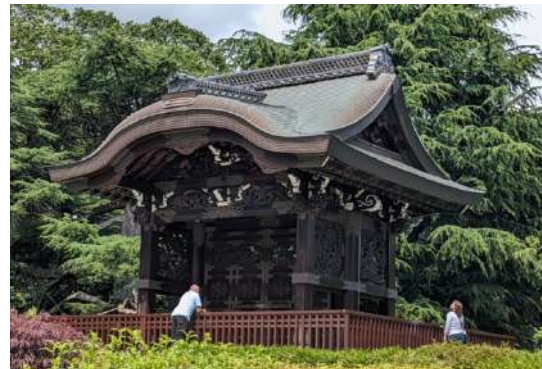
Fig. 3 South elevation, 2023

The Japanese gateway is a softwood timber framed construction with elaborate carvings and copper repoussé details. It has six posts and mid-height rails on its north and south sides. Gablets on the north and south show iconographic carvings above a timber sill. The roof features small copper shingles and metallic glazed terracotta ridge tiles.

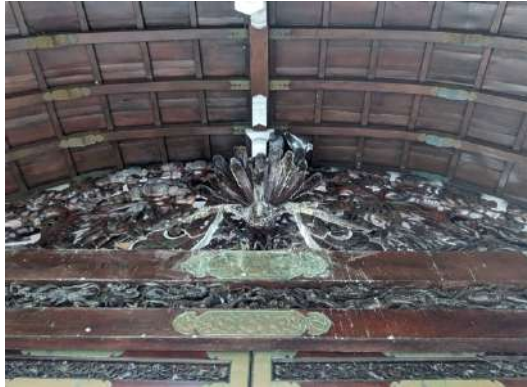
Fig. 4 Guano on high level carvings on the North elevation

- The ridge finial brackets are loose and can be moved by hand.
- The ridge tiles could possibly not have achieved a good bond with their bedding mortar as one tile could be lifted away behind west finial.
- There are pigeons roosting underneath the copper roof. As a consequence, guano has covered some of the elaborate carvings and the pavement. Pigeon spikes have been previously installed but this has not deterred the pigeons.

- vii) Carefully re-fix ridge tiles to match existing
- viii) Install bat mitigation as designed by ecologist
- ix) Install bird deterrent measures as designed by specialist

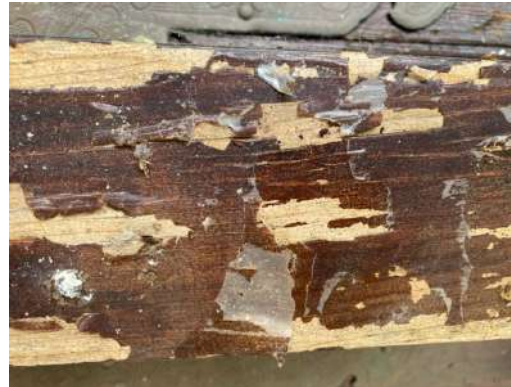
Fig. 5 Degraded decoration on the door on the South elevation

- The decoration on the timber has degraded, which is particularly evident in some of the more exposed locations.
- Highly elaborate carvings within the gateway move quite easily and some have some developed splits

- iv) Repair decayed timber to match existing
- v) Splits in carved joinery to be repaired to match existing
- vi) Redecorate the gateway and balustrade in appropriate finish to compliment the traditional Japanese architecture using paint analysis and historical records to determine the finish

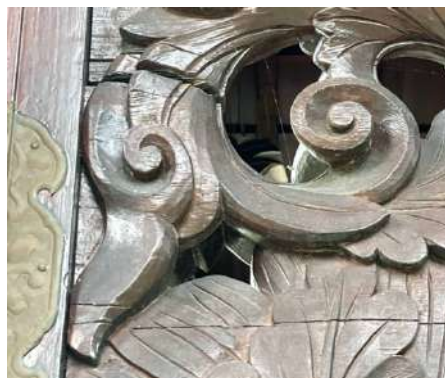
Fig. 6 Split in carving on east elevation

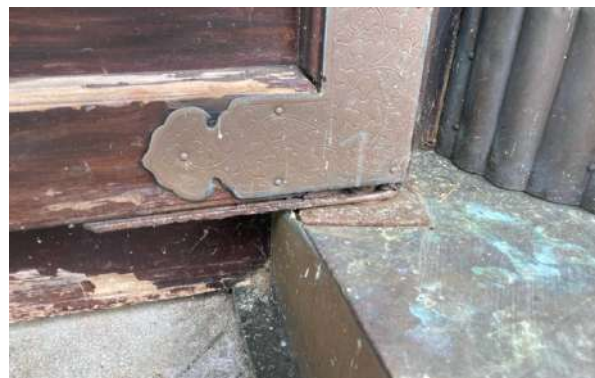
Fig. 7 Degraded decoration on the door on the south elevation

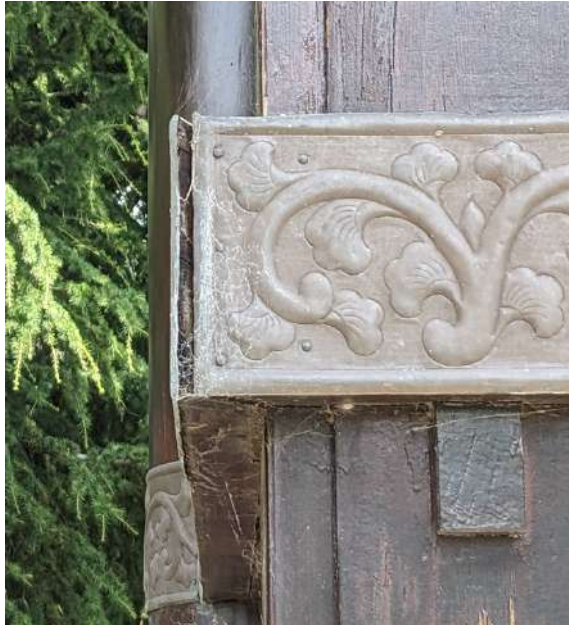
Fig. 8 Split in bracket on the south east corner

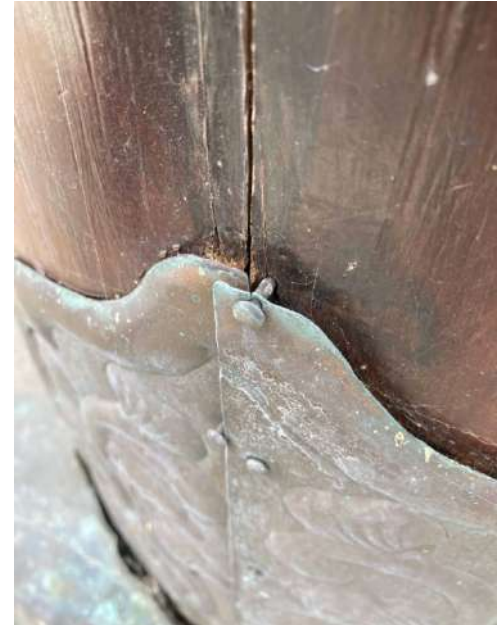
Fig. 9 Copper repousse detail coming away from post

- The gate leaves have slightly sagged towards the centre.
- The copper detailing has become tarnished. In historic photographs the copper detailing appeared to have a mirror finish.
- Some of the fine copper repousse details have started to become loose and have some projecting nail heads. In particular, the bracket on the south east corner has split
- Water run off from above is causing copper staining to stone paving below, mostly along the East and West sides.
- Some of the steps and paved surfaces are slightly proud and may present a trip hazard.
- The perimeter balustrade is suffering patches of local decay.
- A bat box is mounted in the North West corner beside the top of the post. Any works will need to be coordinated and mitigated accordingly.

- i) Carefully refix loose ridge finial brackets to match with existing fixing detail
- ii) Carefully refix loose carved joinery to match existing
- iii) Specialist conservation clean and carefully refix loose copper repousse detail to match existing

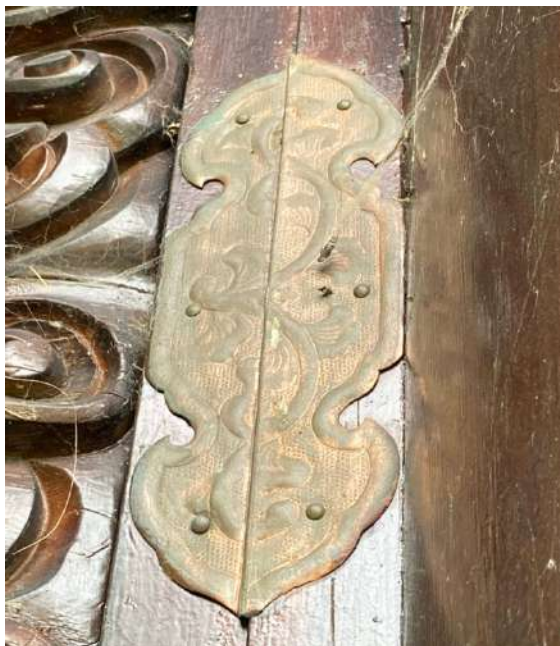
Fig. 10 Copper repousse detail evidence of mirror polish finish on east elevation

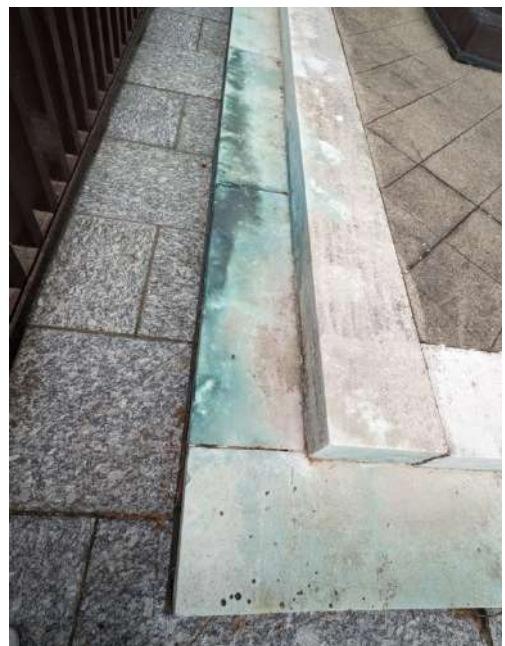
Fig. 11 Copper staining to pavement in south east corner

- x) Replace corroded bottom iron hinge journals with new to match existing and adjust hinges
- xi) Clean paving stones to remove blue/green staining caused by copper roof
