**Richmond College, Queen's Road,
Richmond-upon-Thames TW10 6JP**

Appendix 4

APPENDIX 4: DESCRIPTION OF RICHMOND COLLEGE INTERIOR WITH PHOTOGRAPHS

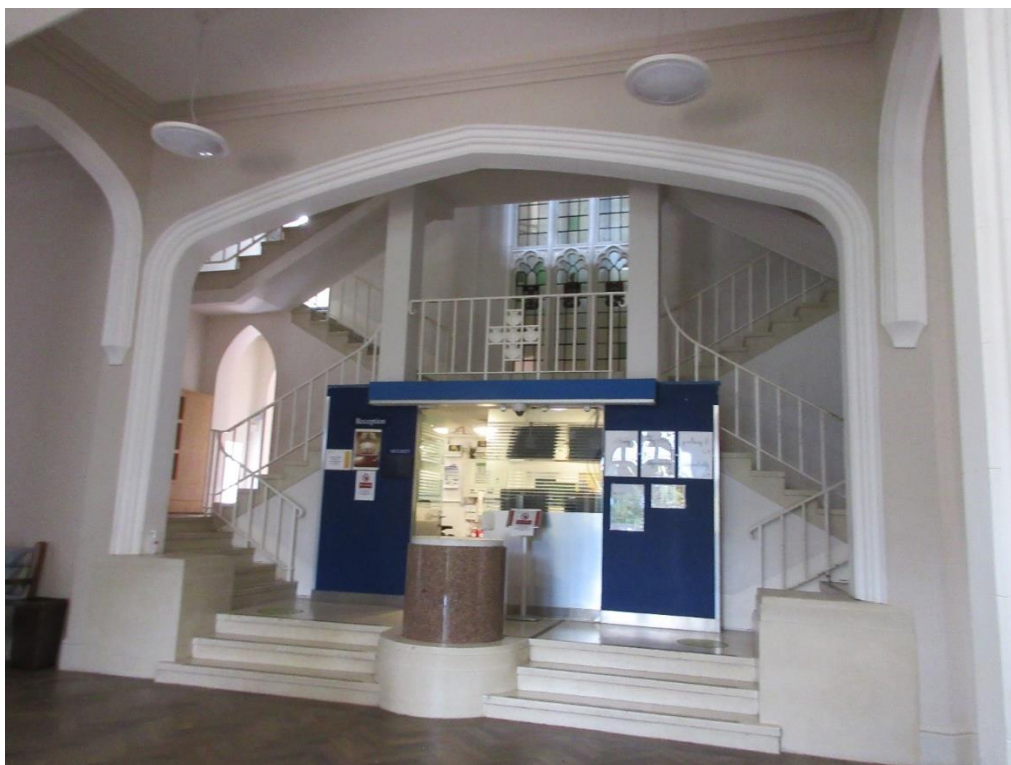
Figure 7: Ground floor – Hall. Note modern reception desk, and stairs.

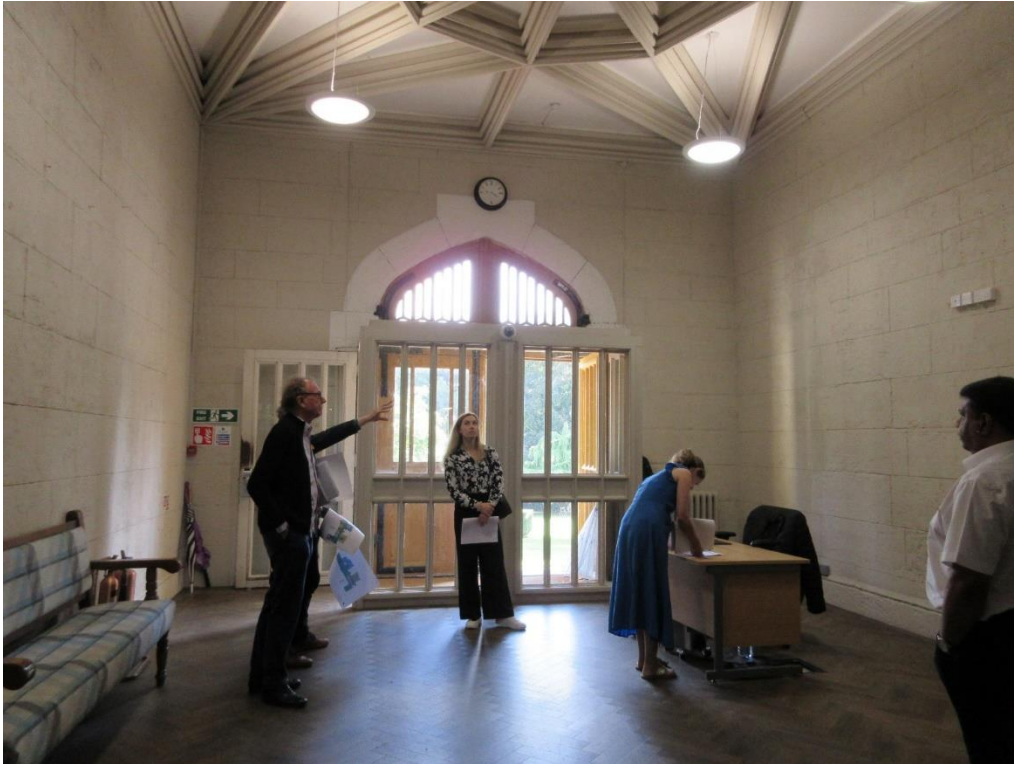
Figure 10: Ground floor – Hall.

- 5.2.3. **Ground floor** [Figure 2]: The interior of the building at ground floor level comprises a central entrance hall, with two long corridors running north-westward [Figure 13, Figure 15 & Figure 29] and south-eastward [Figure 14]. The central hall has retained its original volume, although it has been somewhat altered – with modern parquet flooring, some stairs (which likely date from c.1930s) [Figure 9], a modern reception office in the former location of the central staircase [Figure 7], and a modern secondary screen around the front door [Figure 10, Figure 11 & Figure 12]. The original stained glass window has been retained, although it may only be seen when ascending/descending the stairs [Figure 8]. There are rooms to the north of the corridors, which have been much altered. Such alterations include the provision of a new mezzanine floor [Figure 17, Figure 22, Figure 31 & Figure 32] (with associated staircases [Figure 43, Figure 44 & Figure 46]), some glazed screens which sub-divide one of the principal rooms [Figure 19, Figure 20 & Figure 24], new door openings/doors [Figure 27], and the removal of fireplaces. Most of the original chimney breasts appear to have been retained, although all but one of the fireplaces have been removed [Figure 26]. Some of the original doors (including ironmongery [Figure 34]), architraves, cornicing, skirting and high “dado rails” [Figure 21, Figure 22, Figure 23, Figure 25, Figure 28 & Figure 30] have been retained (as have one of the fireplaces [Figure 21 & Figure 22]), and the original ceiling mouldings may be glimpsed in some of the rooms [Figure 16 & Figure 24]. At the end of each corridor at ground floor level, there are staircases [Figure 35, Figure 36, Figure 37 & Figure 42], and northward projecting wings containing small rooms accessed from narrow central corridors. These rooms have largely been kept intact in terms of planform and retention of chimney breasts, although some fireplaces have been removed [Figure 39, Figure 40 & Figure 41]. The skirting is pared back in design, and there is no cornicing. The staircase located at the south end of the south-eastward corridor is likely to be original, given the robust nature of that stair hall [Figure 36 & Figure 37]. The existing staircase located behind the reception desk (formerly the location of an altar), appears to date from the 1930s [Figure 9].

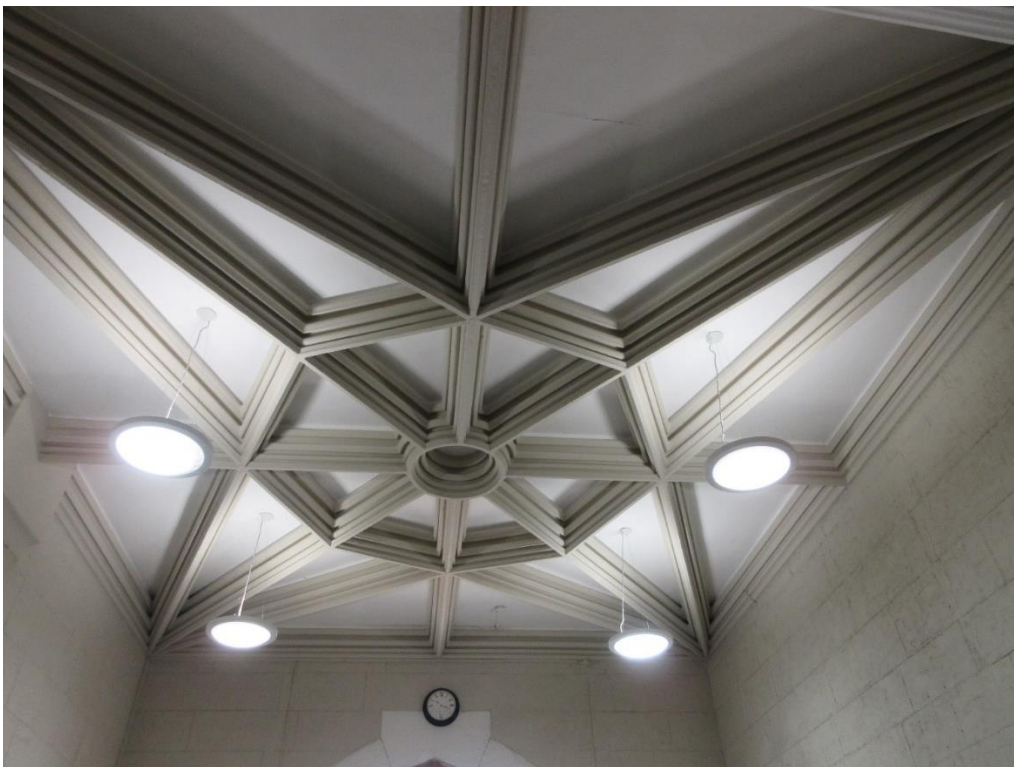
Figure 11: Ground floor – Hall (ceiling).

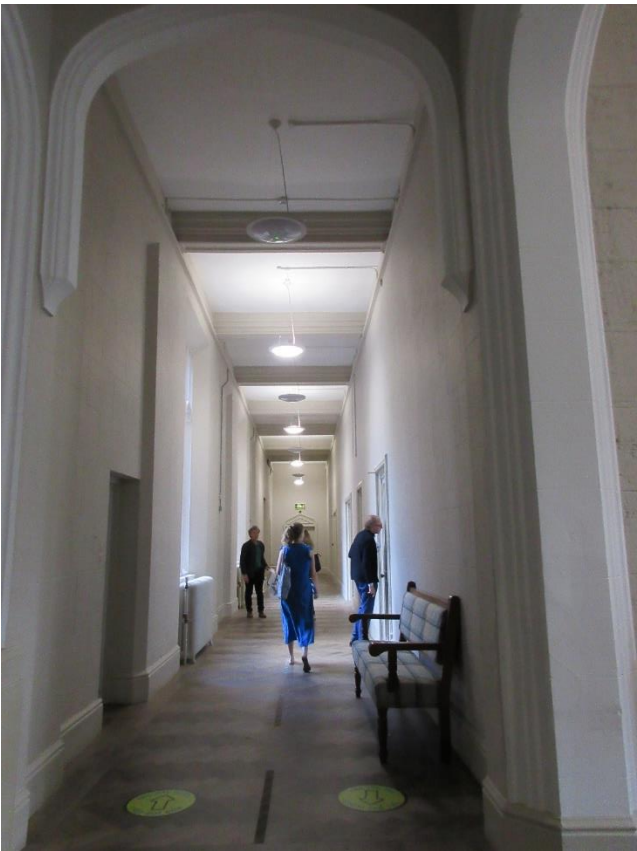
Figure 13 (left): Ground floor – North-west corridor, looking north-westward.

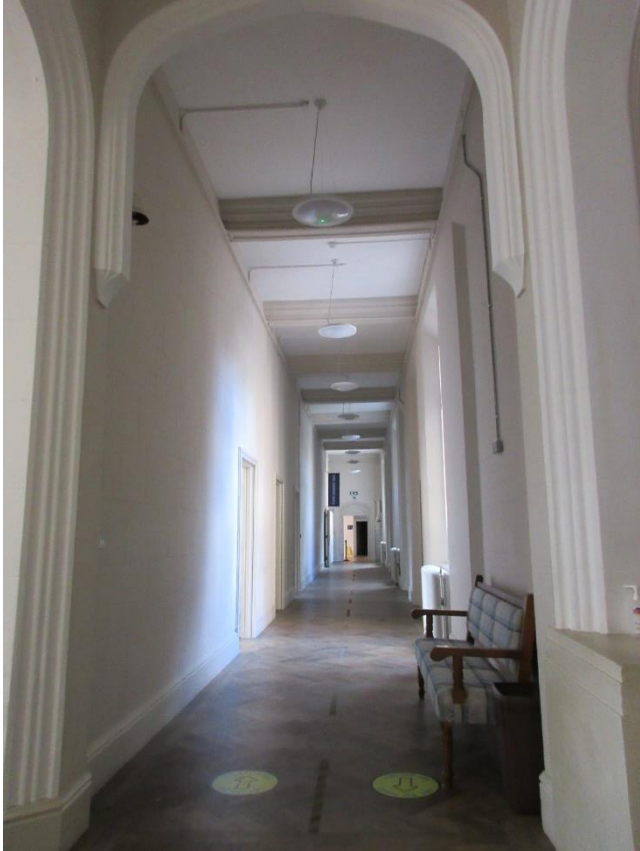
Figure 14 (right): Ground floor – South-east corridor, looking south-eastward.

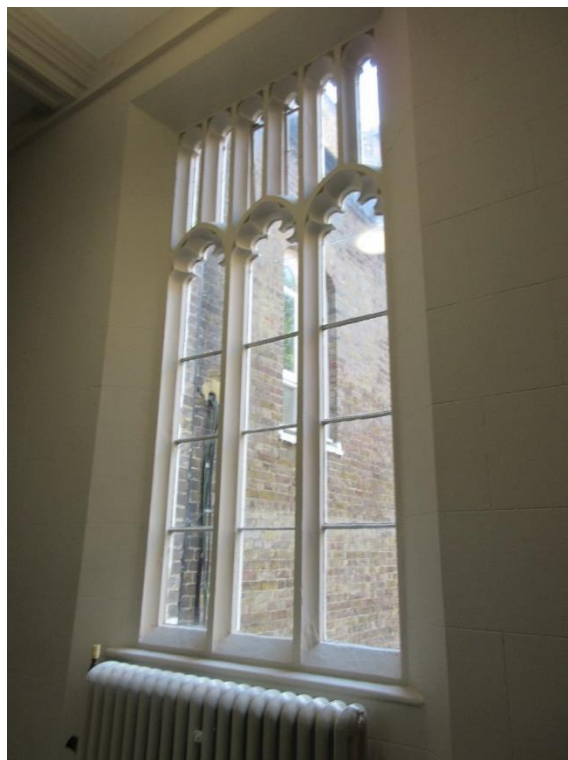
Figure 15: Ground floor – Rear-facing window in north-west corridor.

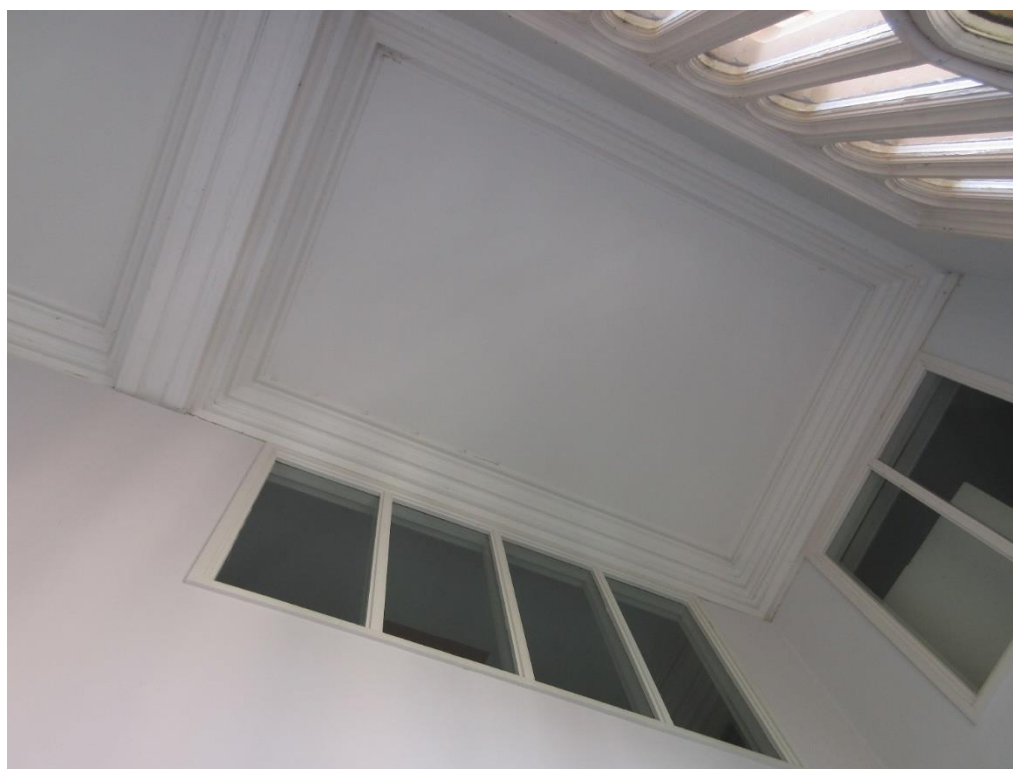
Figure 16: Ground floor – Full-height part of one of the rooms accessed from the north-west corridor.

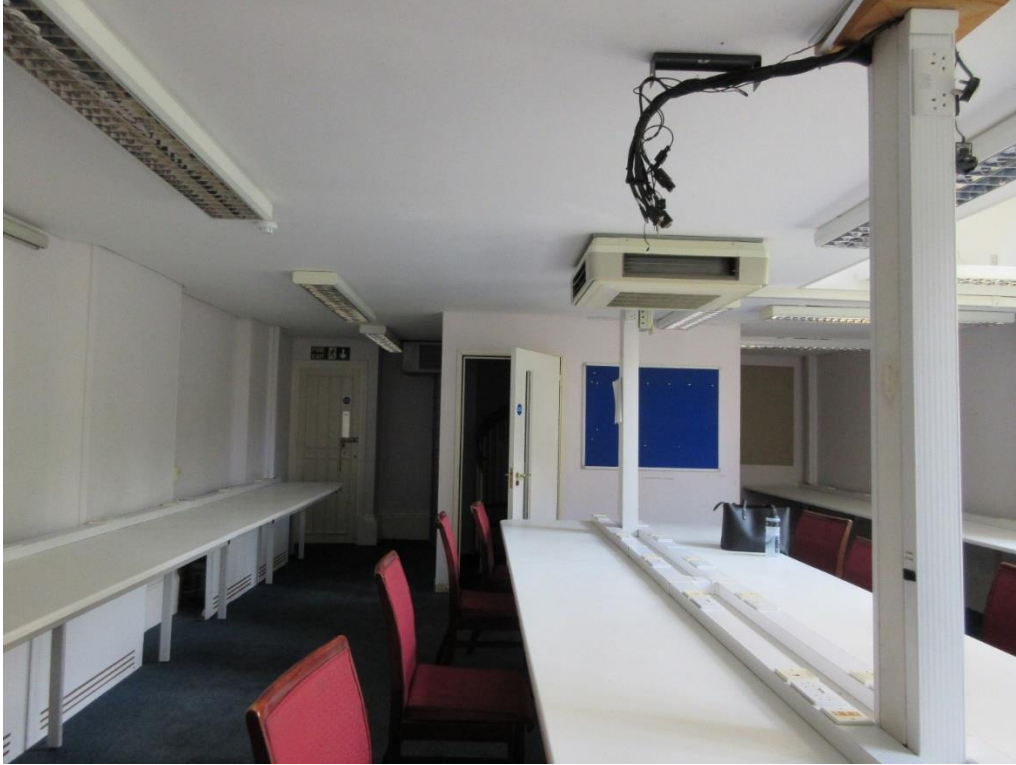
Figure 17: Ground floor – One of the rooms accessed from the north-west corridor, with its ceiling lowered by the mezzanine floor. Note modern partition walling around original fireplace and modern spiral staircase (see Figure 18).

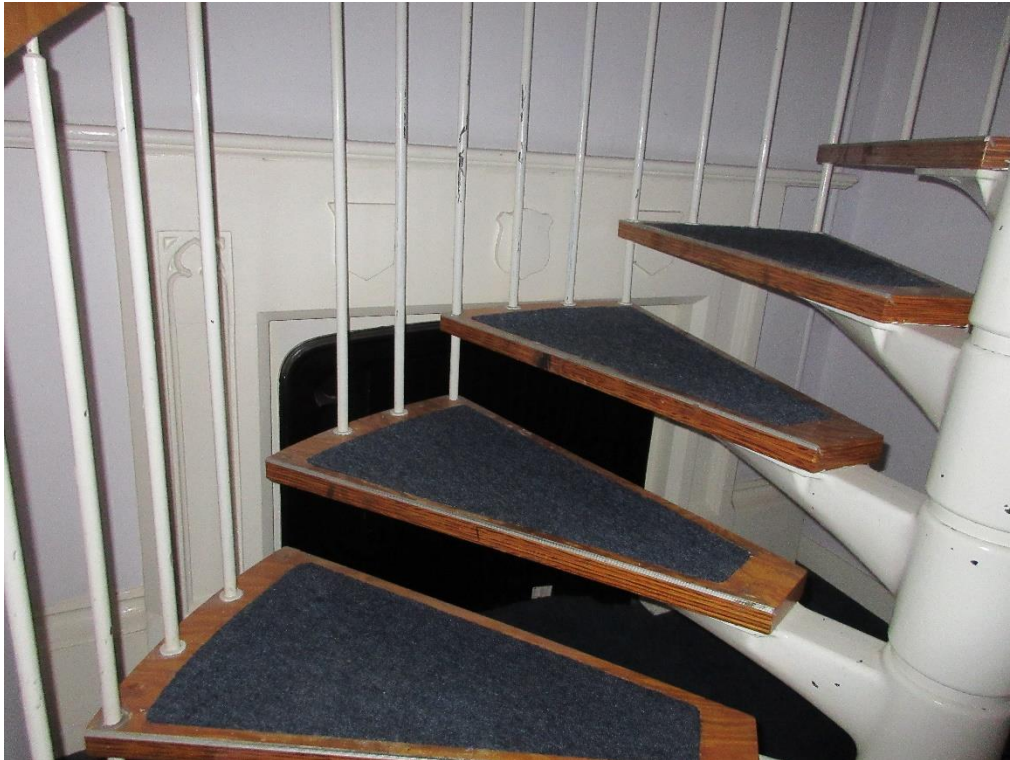
Figure 18: Modern spiral staircase (which leads to the mezzanine floor) and original fireplace, in ground floor room accessed from the north-west corridor (see Figure 17).

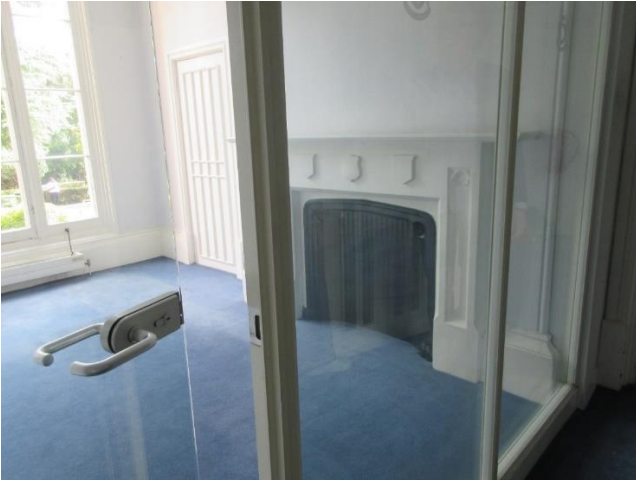
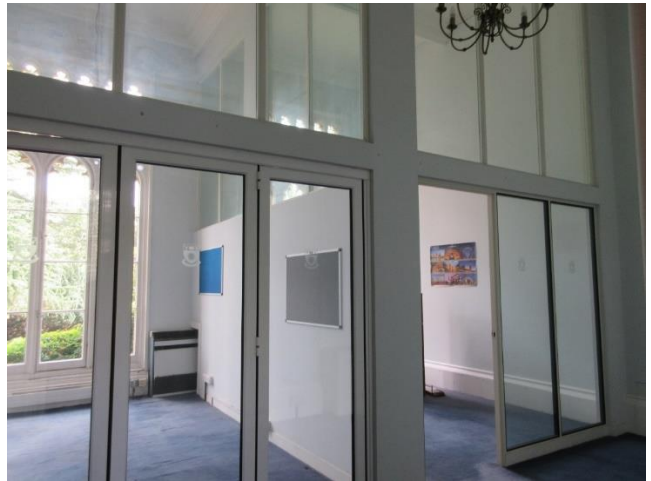
Figure 19 (left): Ground floor – One of the rooms accessed from the north-west corridor. Note modern glazed partitioning.
Figure 20 (right): Ground floor – One of the rooms accessed from the north-west corridor. Note modern glazed partitioning.

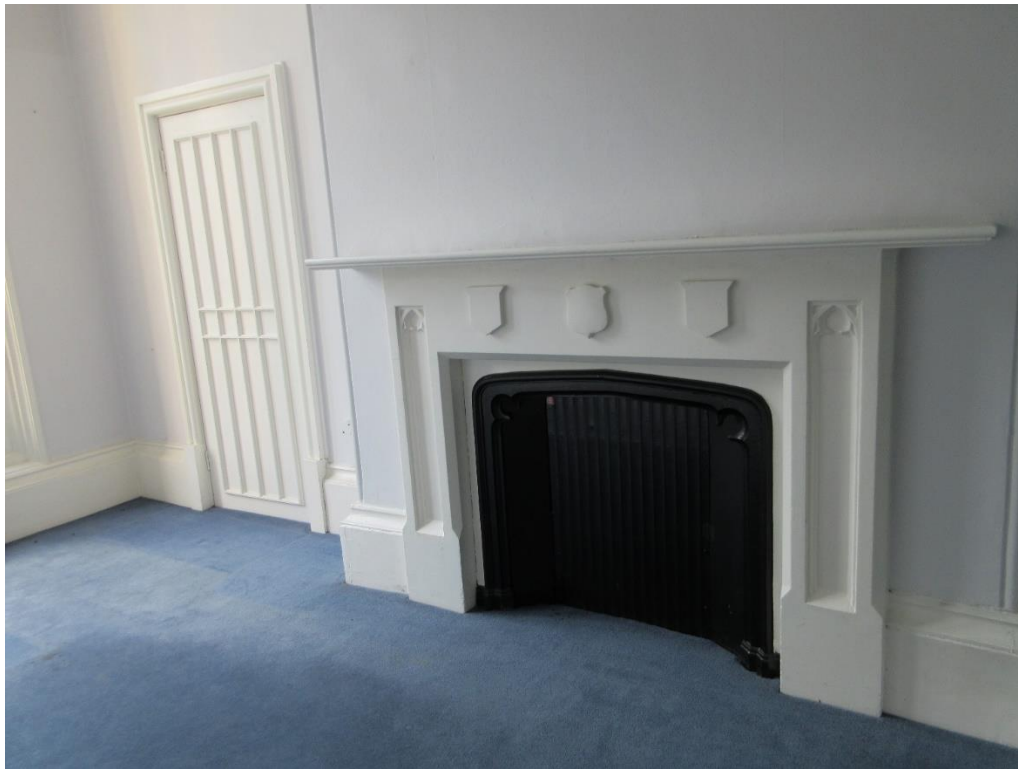
Figure 21: Ground floor – One of the rooms accessed from the north-west corridor. Note original door, chimney breast and fireplace.

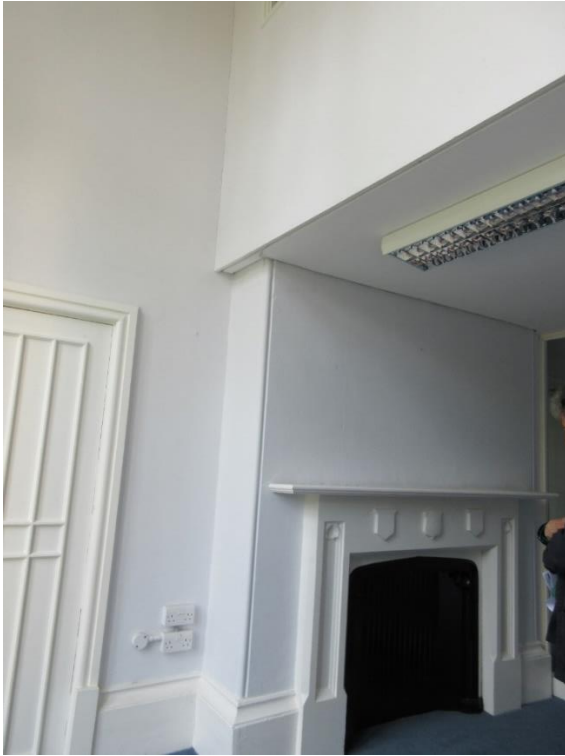
Figure 22 (left): Ground floor – One of the rooms accessed from the north-west corridor. Note original door, chimney breast and fireplace. Note also lowered ceiling to form mezzanine.

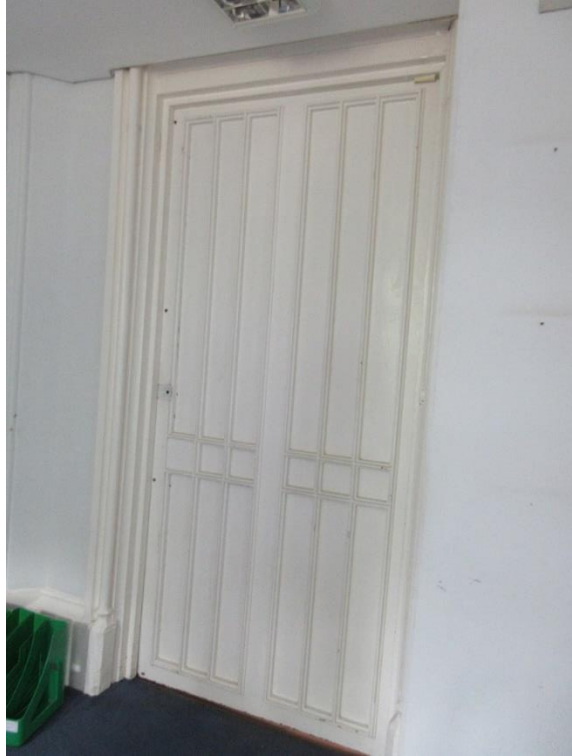
Figure 23 (right): Ground floor – One of the rooms accessed from the north-west corridor. Note original door, architrave and skirting – and lowered ceiling.

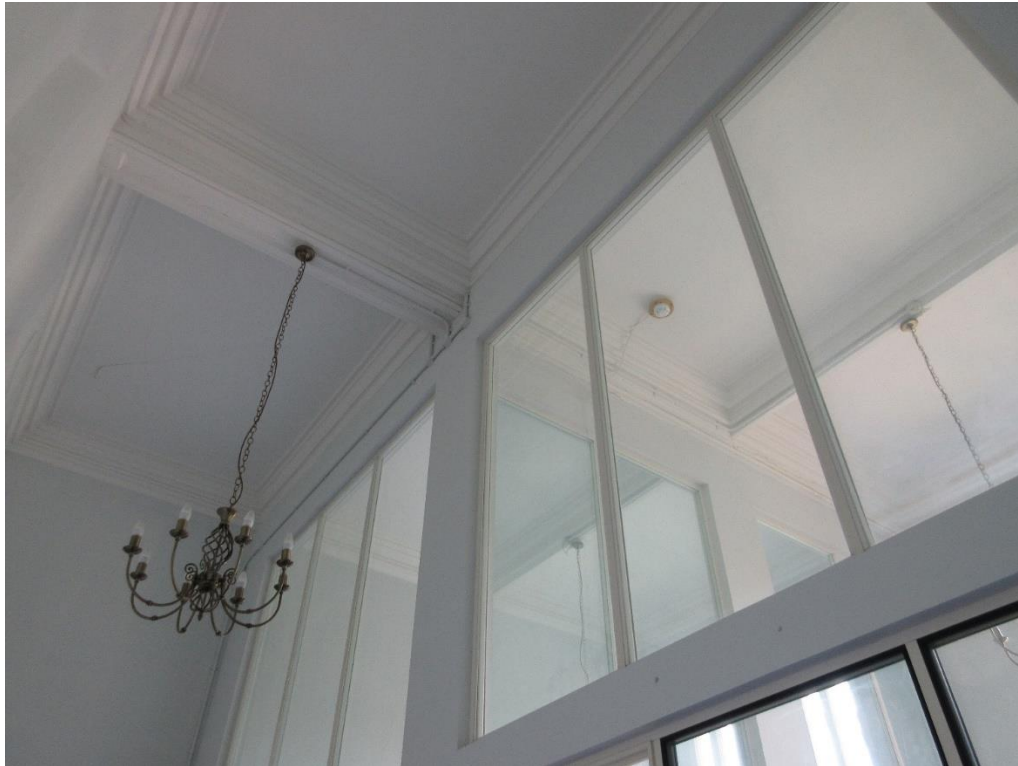
Figure 24: Ground floor – One of the rooms accessed from the north-west corridor. Note ceiling, and modern partitions.

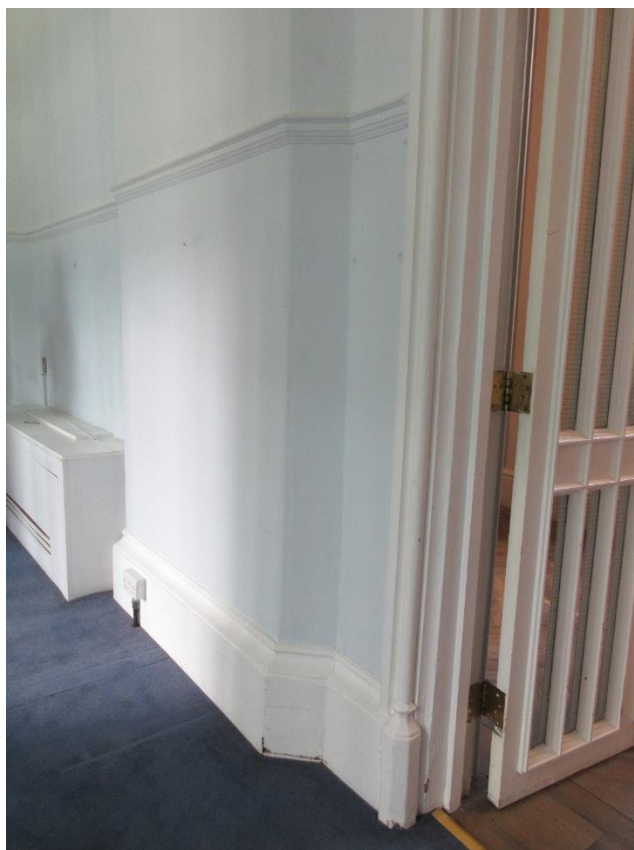
Figure 25: Ground floor – One of the rooms accessed from the north-west corridor. Note original architrave, skirting, and high “dado rail”.

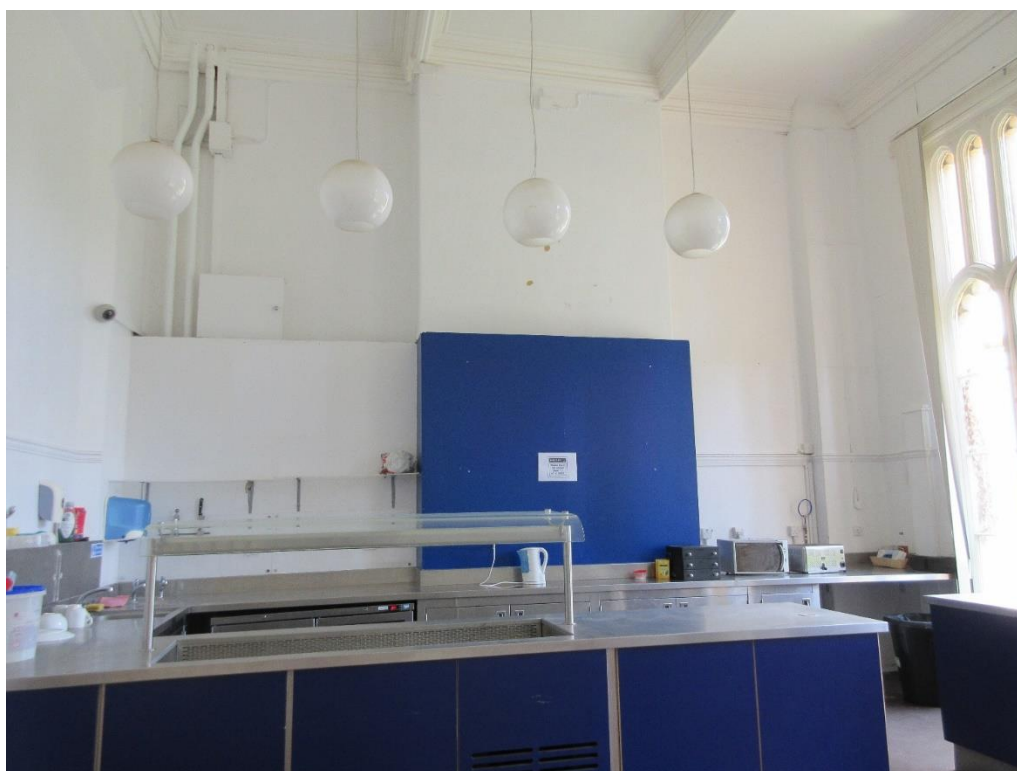
Figure 26: Ground floor – One of the rooms accessed from the south-east corridor. Note chimney breast.

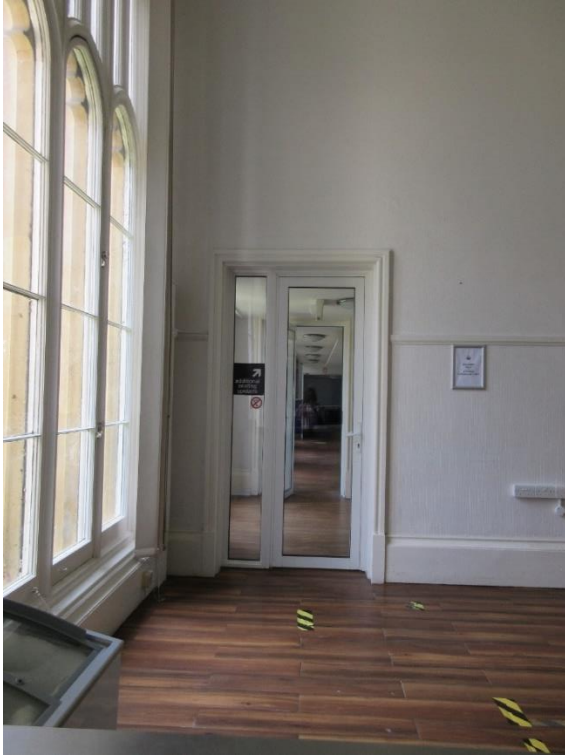
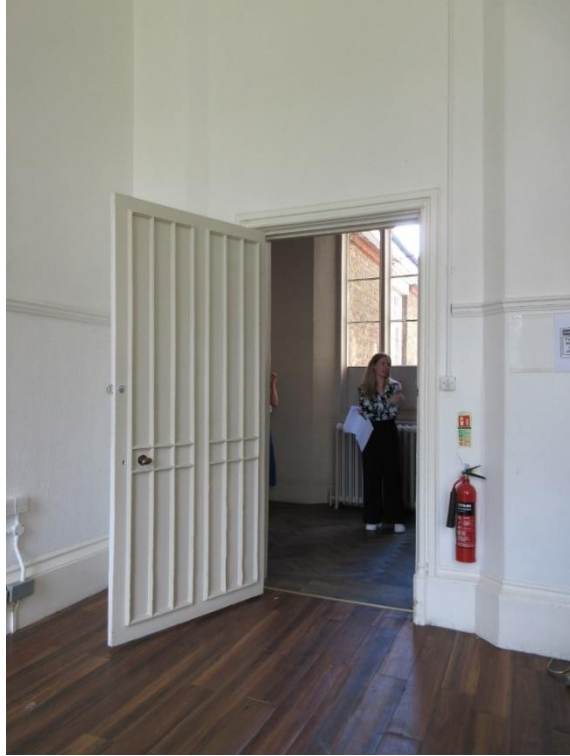
Figure 27 (left): Ground floor – One of the rooms accessed from the south-east corridor. Note modern door.
Figure 28 (right): Ground floor – One of the rooms accessed from the south-east corridor. Note original door and architrave.

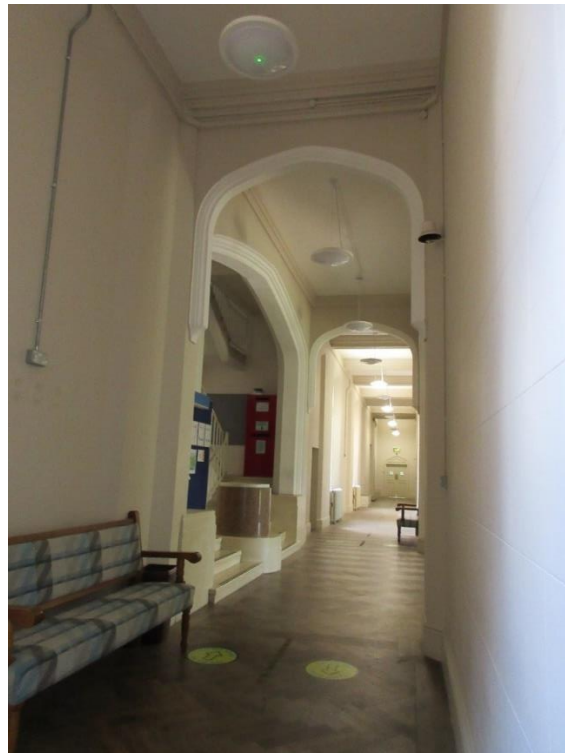
Figure 29: Ground floor – North-westward view towards hall from south-east corridor.

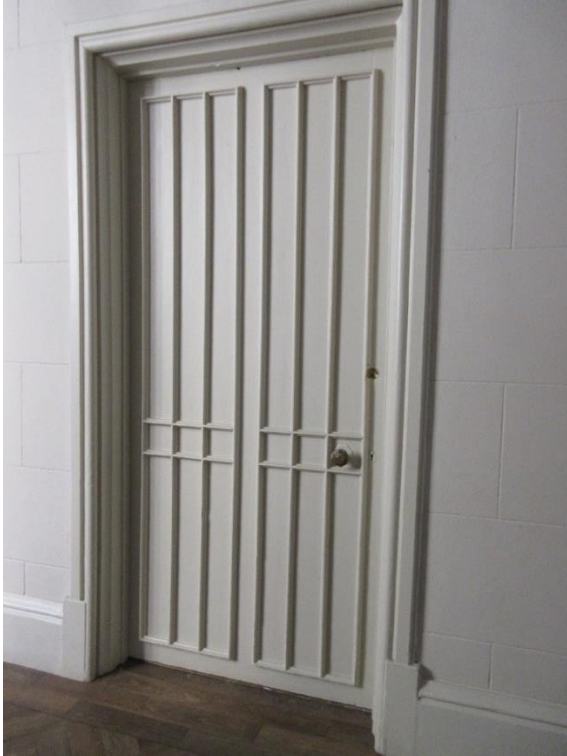
Figure 30 (left): Ground floor – Original architrave and door in south-east corridor.

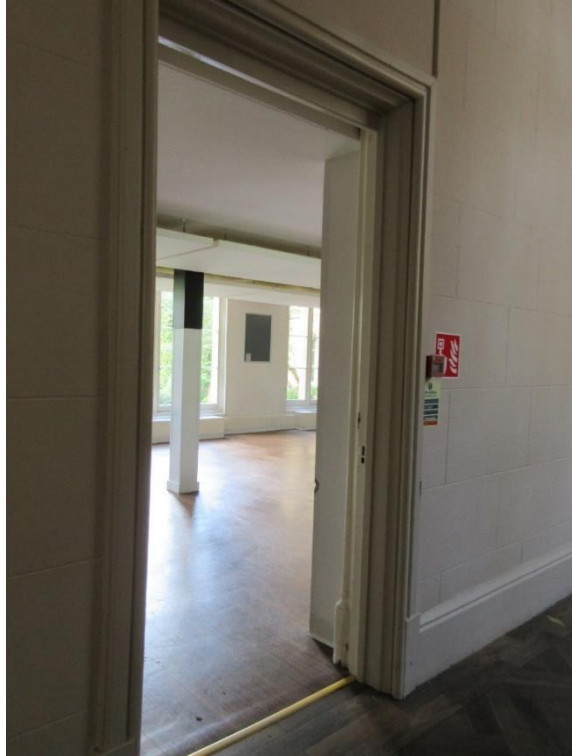
Figure 31 (right): Ground floor – South-east corridor. Note low mezzanine-level ceiling in the room accessed from the corridor.

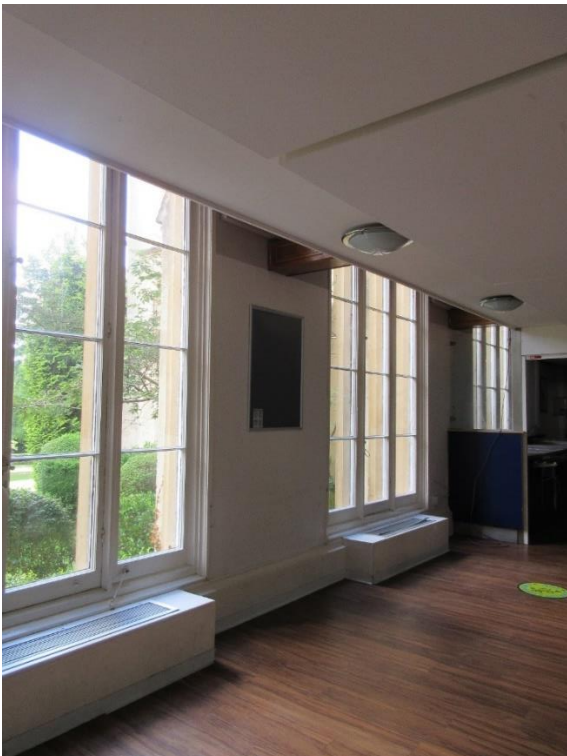
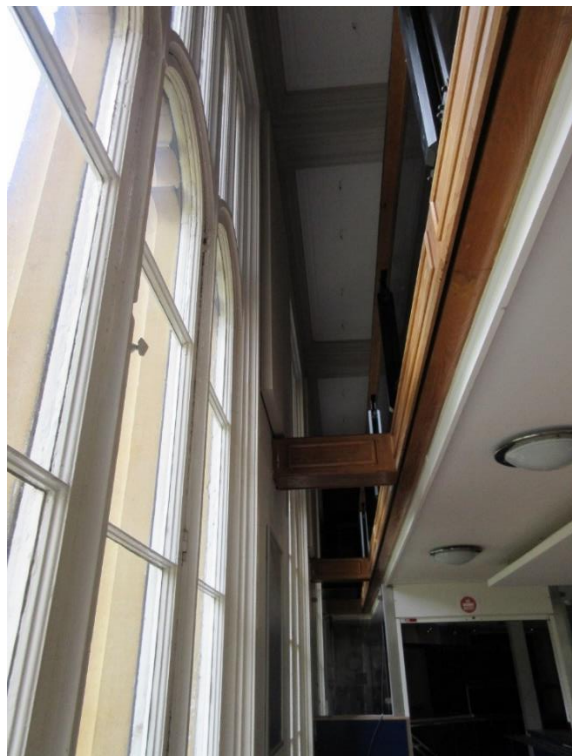
Figure 32 (right): Ground floor – One of the rooms accessed from the south-east corridor. Note mezzanine-height ceiling.

Figure 33 (right): Ground floor – One of the rooms accessed from the south-east corridor. Note full-height and mezzanine-height ceilings.

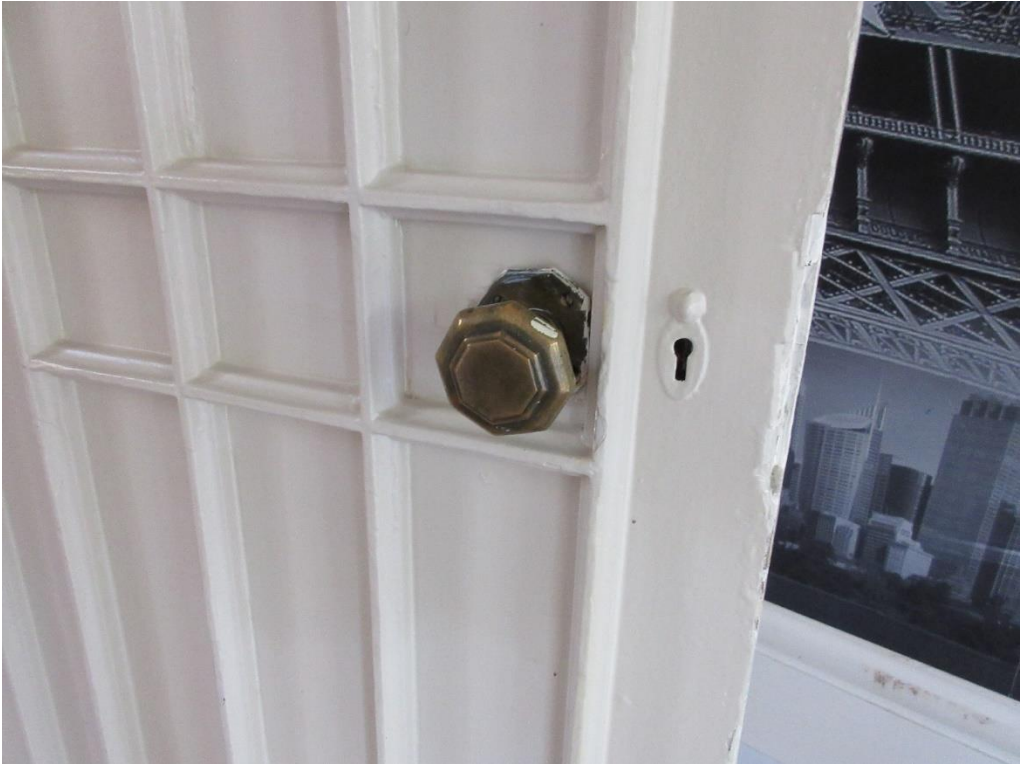
Figure 34: Ground floor – One of the rooms accessed from the south-east corridor. Note ironmongery.

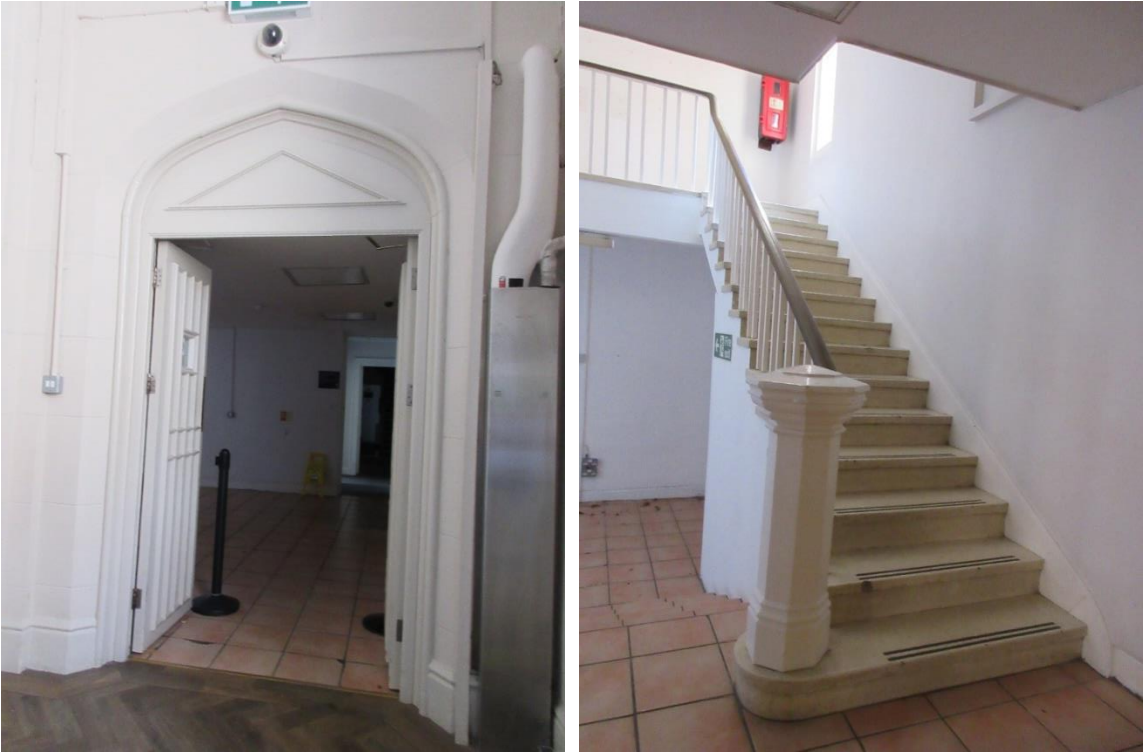
Figure 35 (left): Ground floor – South-east corridor, looking south-eastward towards end door.
Figure 36 (right): Main staircase by the south wing.

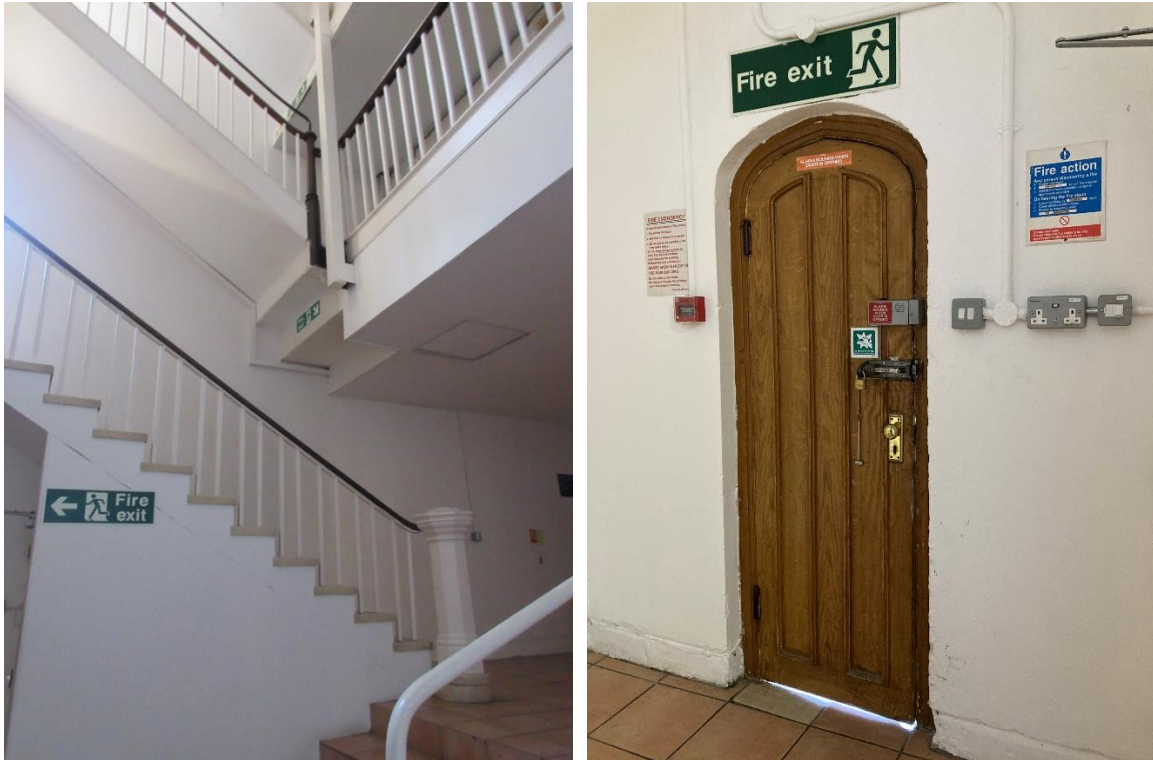
Figure 37 (left): Main staircase/landing by the south wing. Note newel post, balustrading and handrailing. This is the location of the proposed disability lift.

Figure 38 (right): Interior of side entrance door to south-east elevation. (See Figure 13, Appendix 3, for the exterior of the door.)

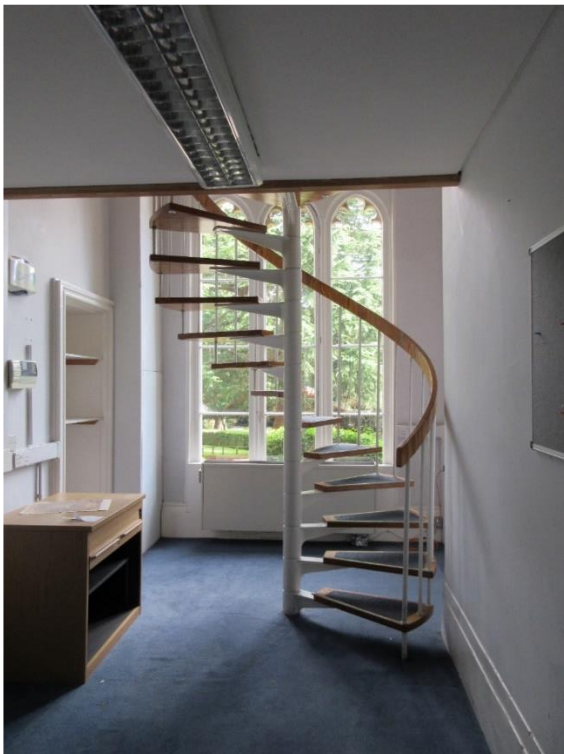
Figure 43 (left): Ground floor – One of the rooms accessed from the north-west corridor. Note mezzanine floor and modern staircase.

- 5.2.4. **Mezzanine floor to central part of building** [Figure 3]: The modern mezzanine floor is accessed by some mis-matched modern idiom staircases [Figure 43, Figure 44 & Figure 46], which are not considered to be of a quality befitting of a Grade II listed former Methodist college. The flooring at mezzanine floor level is modern laminate, and in general the materials are modern – although the original ceiling mouldings are mostly intact [Figure 45].

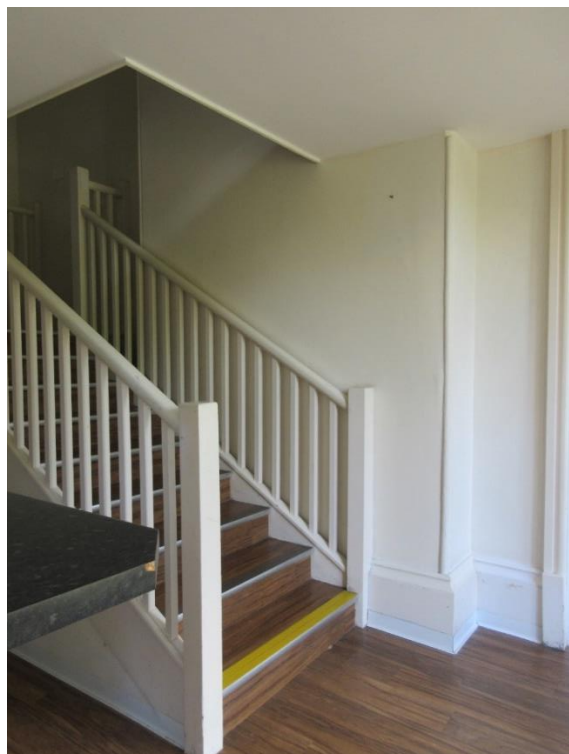
Figure 44 (right): Ground floor – One of the rooms accessed from the south-east corridor. Note modern staircase, and chimney breast.

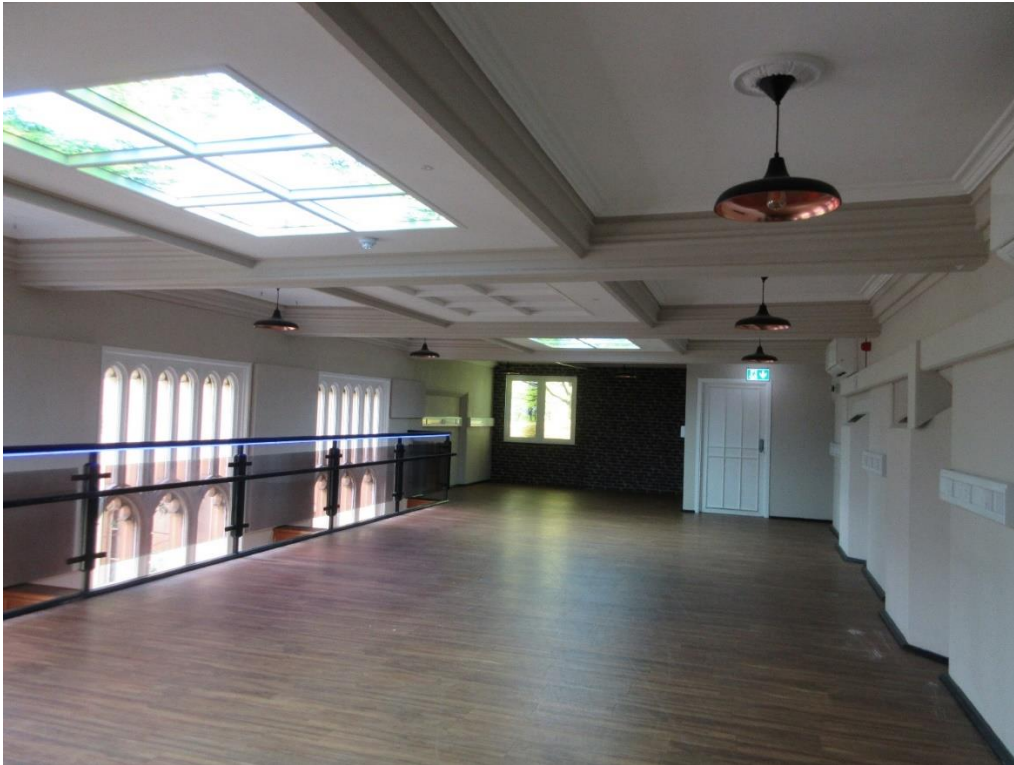
Figure 45: Mezzanine floor – One of the rooms accessed from the south-east corridor.

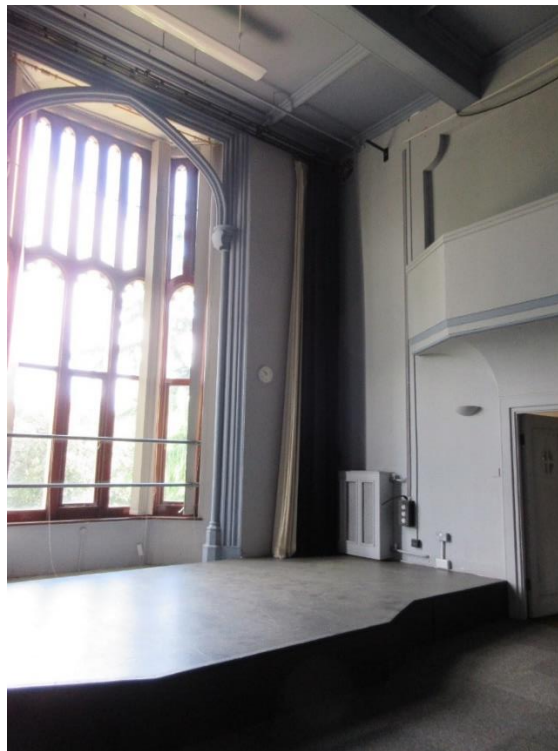
Figure 47: Second floor – former chapel.

- 5.2.6. **Second floor** [Figure 4]: The planform at second floor level has largely been retained – with the principal north-west and south-east corridors [Figure 49], providing access to small cellular rooms. These rooms have retained their chimney breasts, and chimney pieces (which are of a pared back design befitting of second floor level bedrooms for students) [Figure 50 & Figure 51]. The room located above the central hall (which was originally used as a library, then a chapel from the 1930s, and then a theatre from the 1990s) has lost most of its historic features, and all of its historic character [Figure 47 & Figure 48]. The stairs between the first and second floors are historic and may well be original [Figure 52]

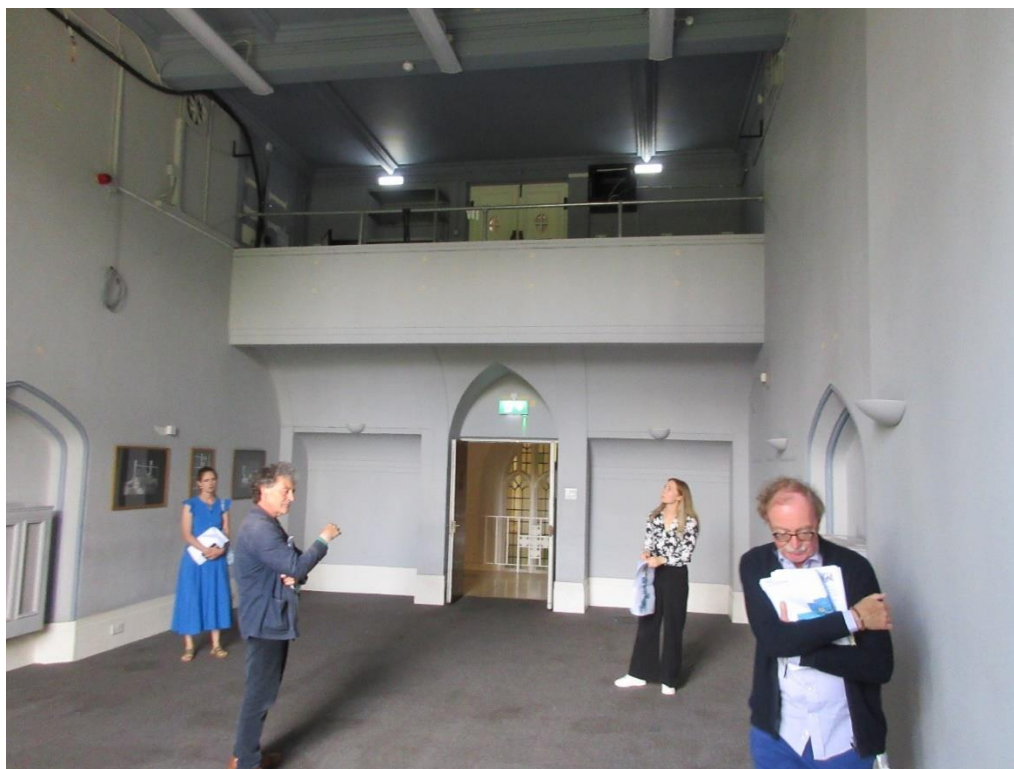
Figure 48: Second floor – former chapel.

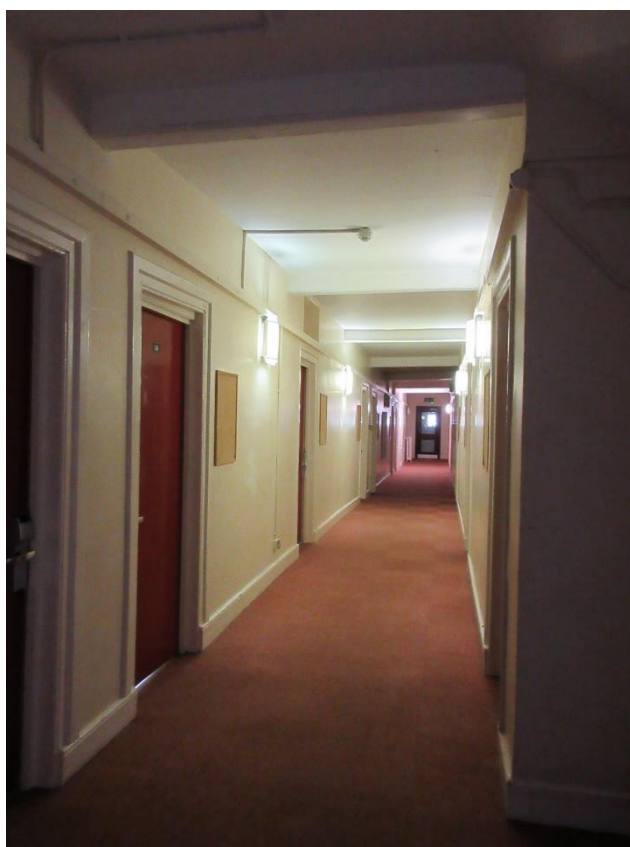
Figure 49: Second floor – principal corridor.

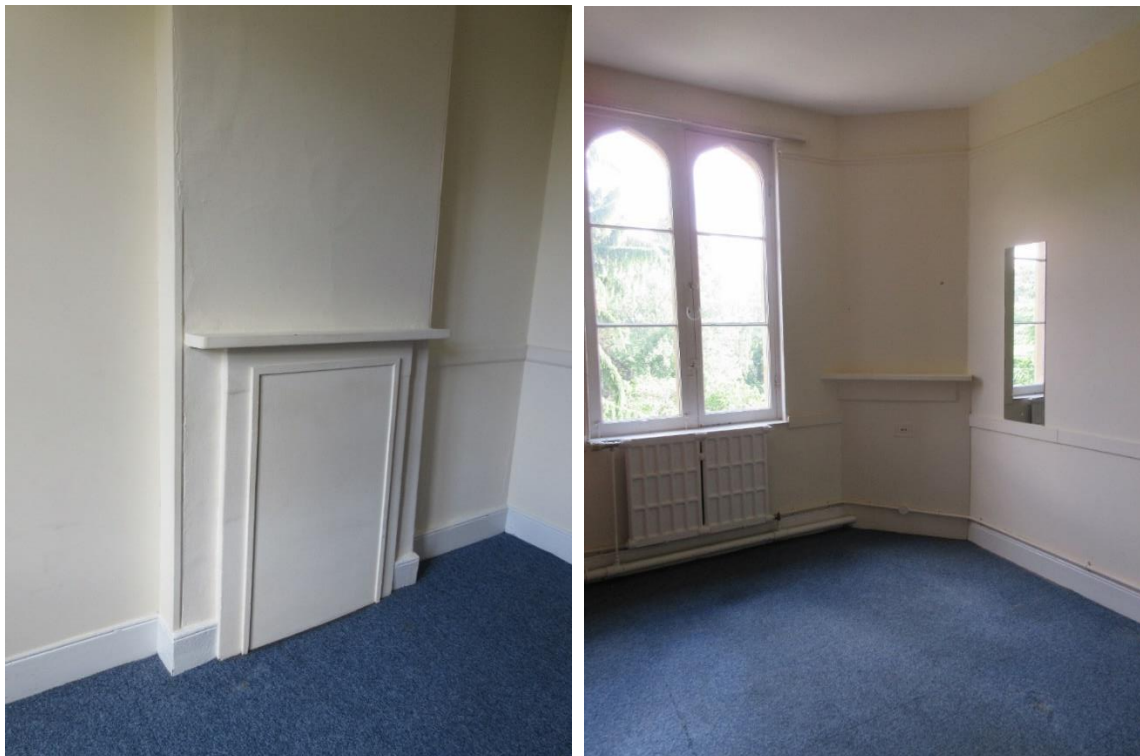
Figure 50 (left): Second floor – bedrooms accessed from main corridor.

Figure 51 (right): Second floor – bedrooms accessed from main corridor.
