**Richmond College, Queen's Road,
Richmond-upon-Thames TW10 6JP**

Appendix 4

APPENDIX 4: DESCRIPTION OF RICHMOND COLLEGE INTERIOR WITH PHOTOGRAPHS

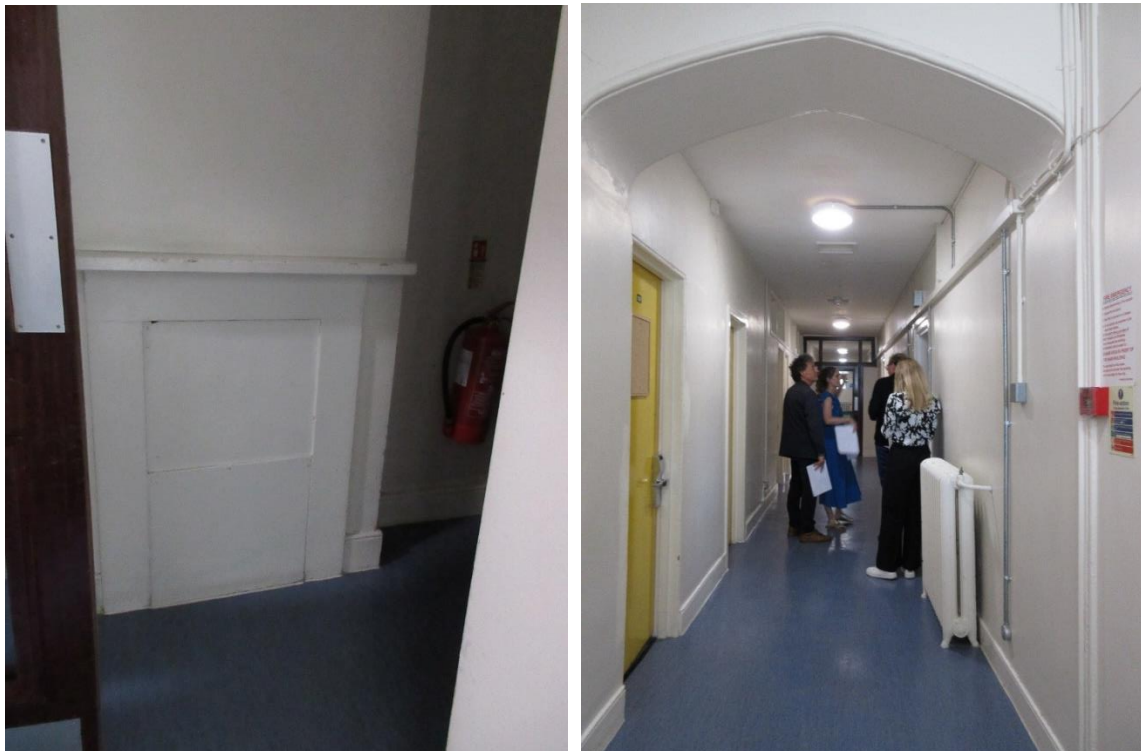
Figure 54 (left): Third floor – bedrooms accessed from main corridor.

Figure 55 (right): Third floor – main corridor.

5.2.7. **Third floor** [Figure 5]: The planform at third floor level has largely been retained – with the principal north-west and south-east corridors [Figure 55], providing access to small cellular rooms. These rooms have mostly retained their chimney breasts, and chimney pieces (which are of a pared back design befitting of third floor level bedrooms for students) [Figure 54].

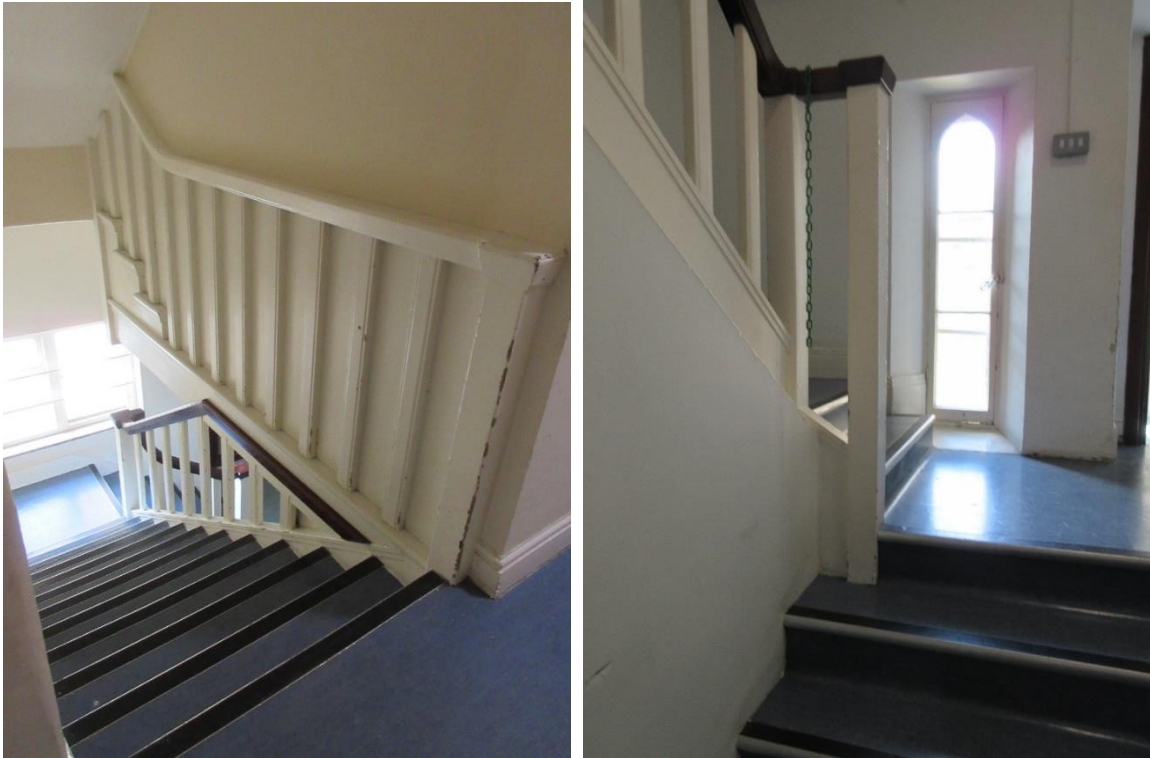
Figure 56 (left): Stairs between third floor and fourth floor.

Figure 57 (right): Stairs between third floor and fourth floor.

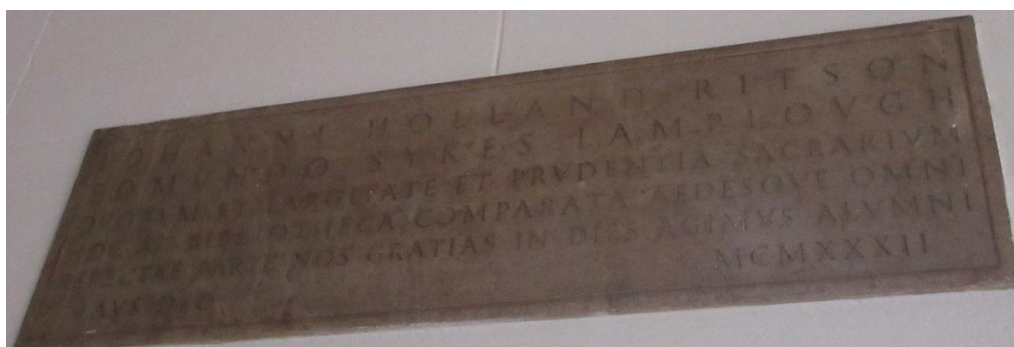
Figure 59: Plaque on wall.

- 5.2.8. **Fourth floor** [Figure 6]: The planform at fourth floor level has largely been retained – with the small corridor providing access to small cellular rooms [Figure 60]. These rooms have mostly retained their chimney breasts, and chimney pieces (which are of a pared back design befitting of fourth floor level bedrooms for students) [Figure 58 & Figure 62]. There is a plaque on the wall in Latin dated 1932, making reference to a John Holland Ritson, who was a Wesleyan Methodist minister (1868-1953) [Figure 59].

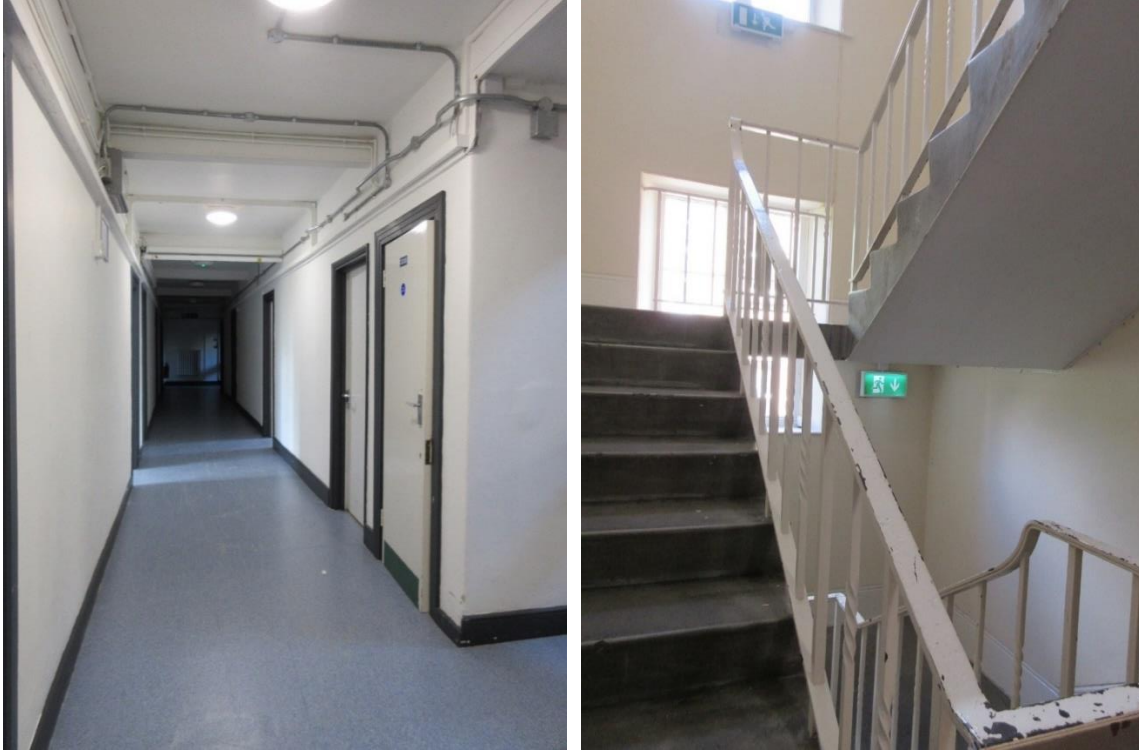
Figure 60 (left): Fourth floor corridor above central section of building.

Figure 61 (right): Stairs with likely mid-20th century balustrading.

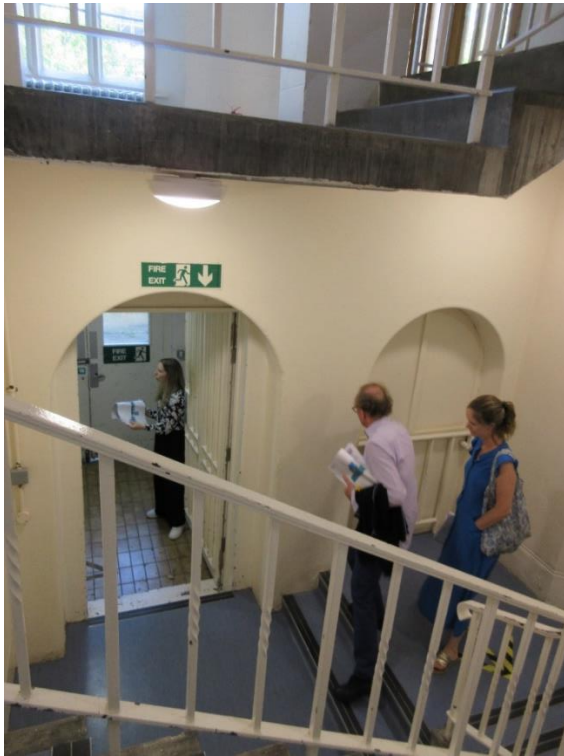
Figure 63 (left): Basement – Staircase.

5.2.9. **Basement** [Figure 1]: The basement is accessed at the north end of the building [Figure 63]. It is located beneath the north-west and south-east corridors and the north wing at ground floor level. The rooms beneath the north wing provide storage spaces [Figure 64 & Figure 65], whereas the rooms further southward are currently taken up by plant.

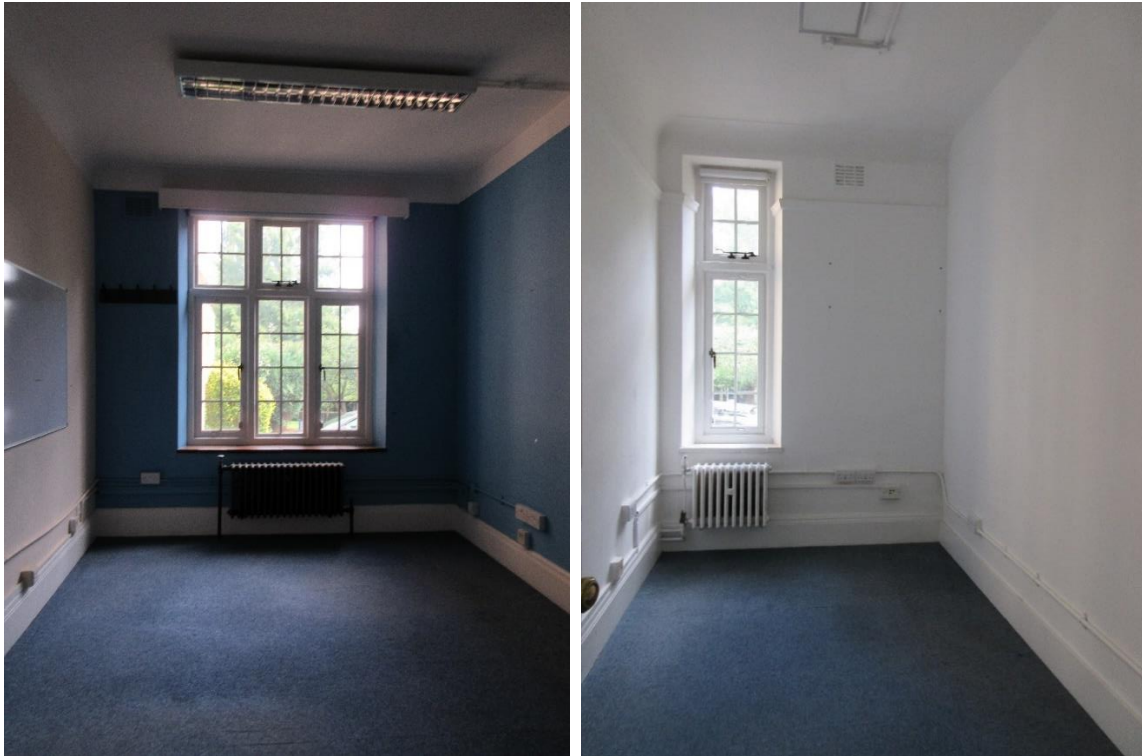
Figure 66 (left): Ground floor of George House – room immediately adjacent to principal building.
Figure 67 (right): Ground floor of George House – one of the rooms.

- 5.3.1. The interior of George House has lost any historic character it may have formerly had, and it now has a rather institutional character. Any remaining historic skirting, architraves, doors, and stair balustrading are notably pared back in design, and there is no cornicing [Figure 66, Figure 67, Figure 68, Figure 69, Figure 70 & Figure 71].

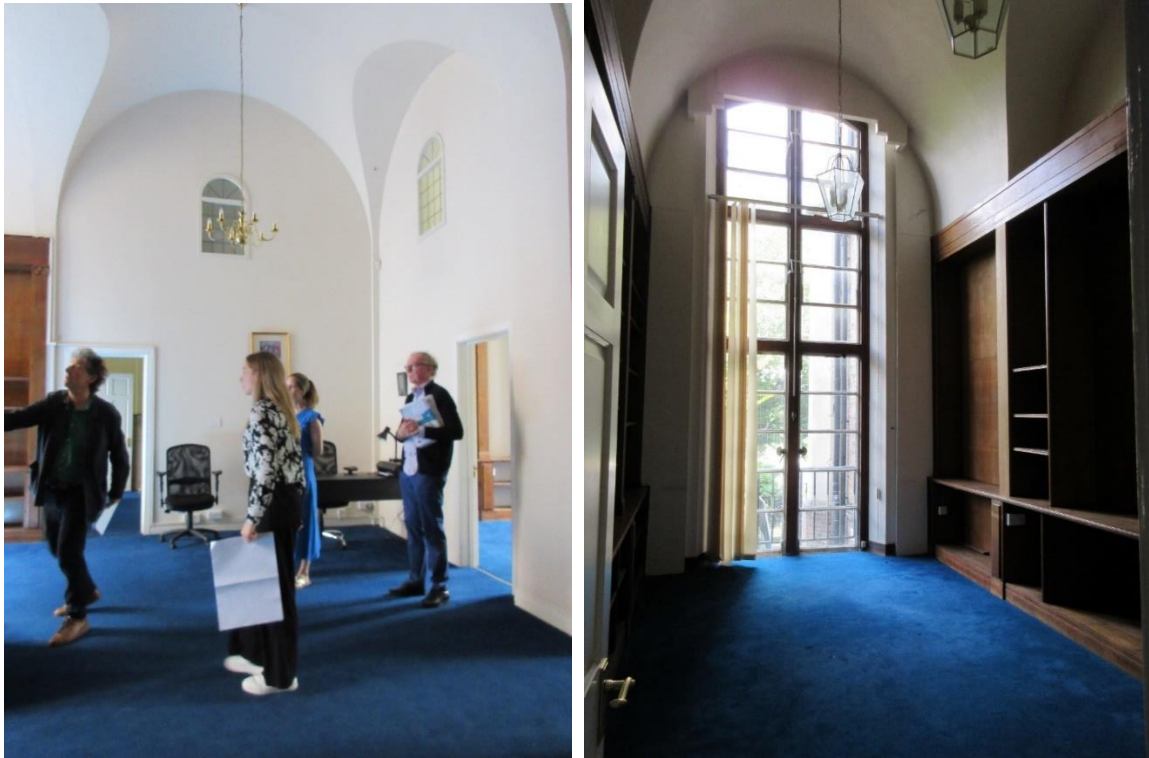
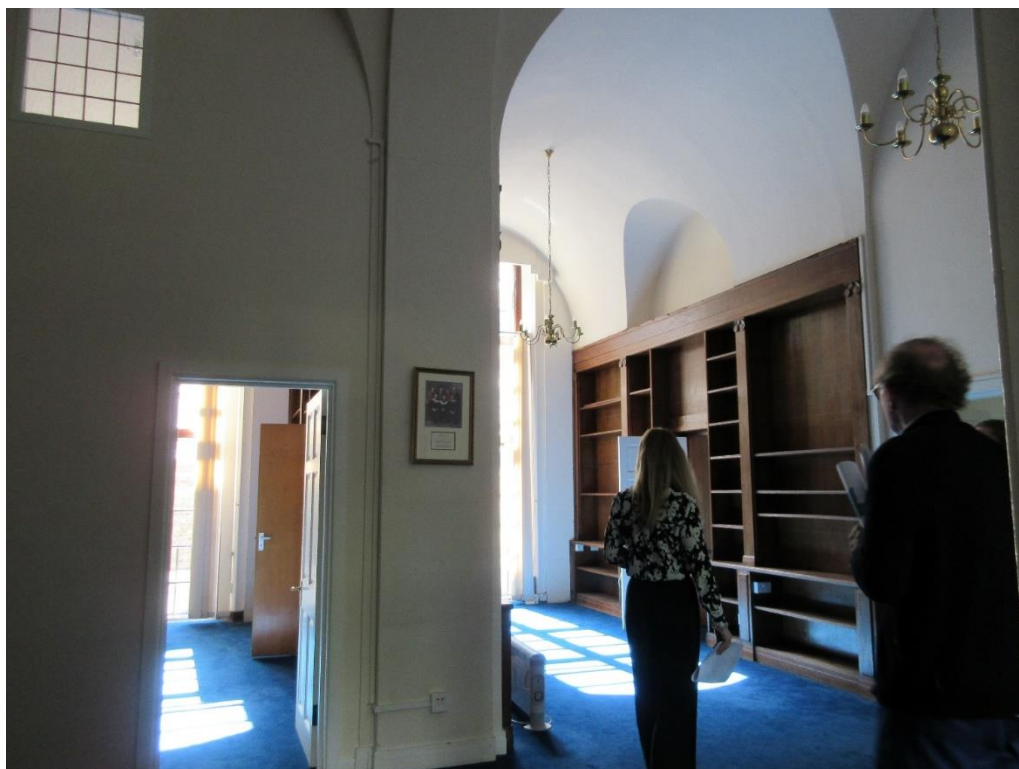
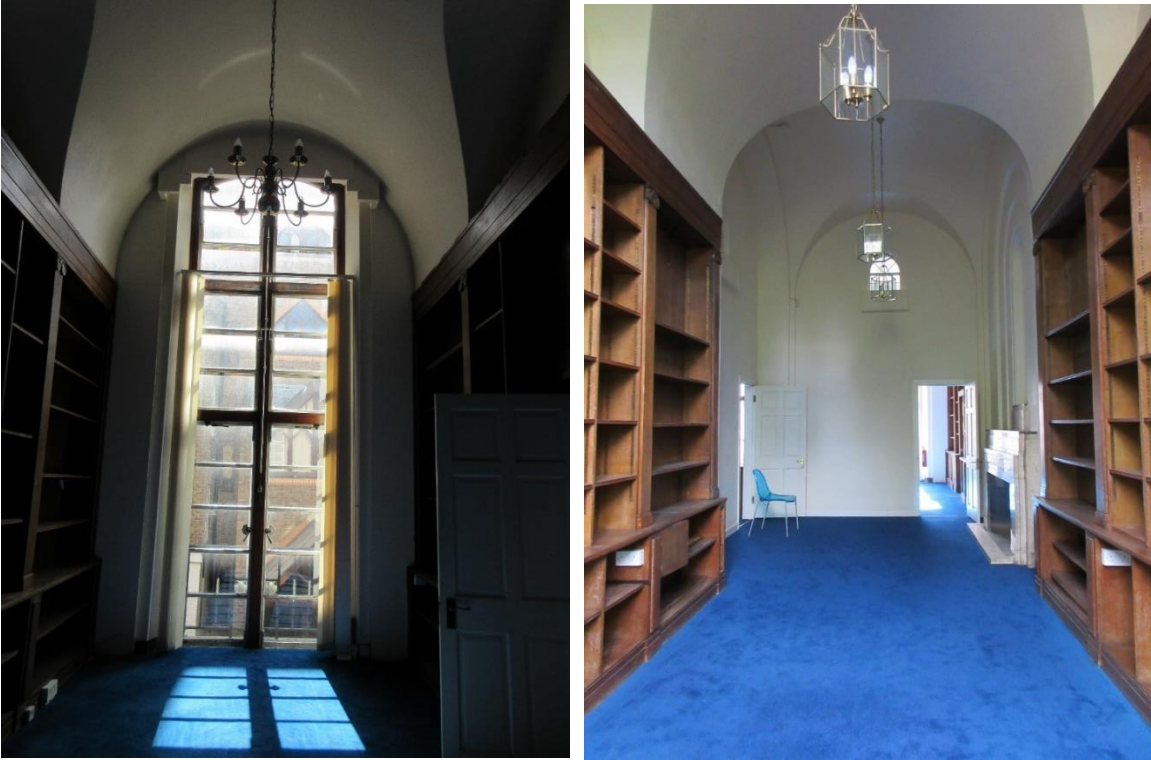
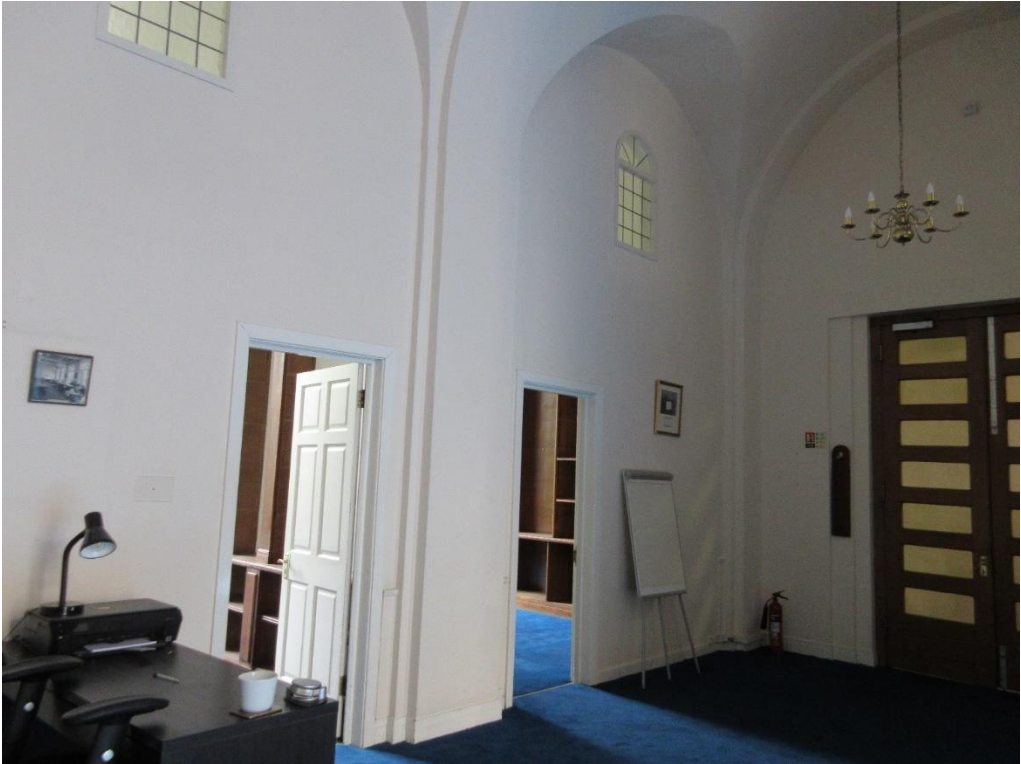
- 5.4.2. **Rear extension A** [Figure 1, Figure 2, Figure 3 & Figure 4]: This extension was built by the celebrated architect Edward Maufe in 1932 to provide a new library at upper-ground floor level [Figure 83]. It comprises three storeys (i.e. lower-ground floor, ground floor and second floor). As the ceiling height of the rooms at ground floor level is the same as that of the principal building (minus the modern mezzanine floor), the height of the building is equivalent to that of the second floor (i.e. former first floor) of the principal building. This extension is accessed from the principal building at lower-ground and ground floor levels via the north-west corridors [Figure 72], and it is accessed from the principal building at second floor level via a stairwell [Figure 84]. The rooms at ground floor level have high vaulted ceilings [Figure 73 & Figure 80]. At ground floor level, there is a lobby area [Figure 74, Figure 76 & Figure 79] providing access to rooms with built-in bookcases [Figure 75, Figure 77, Figure 78 & Figure 80]. There is a grand art deco style fireplace in one of the rooms which is rather awkwardly located off-centre from a door opening [Figure 81]. This awkward juxtaposition is due to the fact the partition walls were added later (possibly in the 1980s or 1990s). The metal-framed windows at ground floor level and basement level have some ironmongery with fan-like motifs which are repeated elsewhere in the building [Figure 82 & Figure 86]. The rooms at second floor level are comparatively pared back in appearance [Figure 85]. At basement/lower-ground floor level, there are two rooms which are pared back in design, with no notable architectural detailing [Figure 87 & Figure 88] other than the metal-framed windows with the aforementioned decorative ironmongery [Figure 86].

Figure 74 (left): Ground floor of extension A – central area.
Figure 75 (right): Ground floor of extension A – one of the rooms.

Figure 76: Ground floor of extension A – Central area.

Figure 77 (left): Ground floor of extension A – The room in which the fireplace is located, looking northward.
Figure 78 (right): Ground floor of extension A – The room in which the fireplace is located, looking southward.

Figure 79: Ground floor of extension A – Central area.

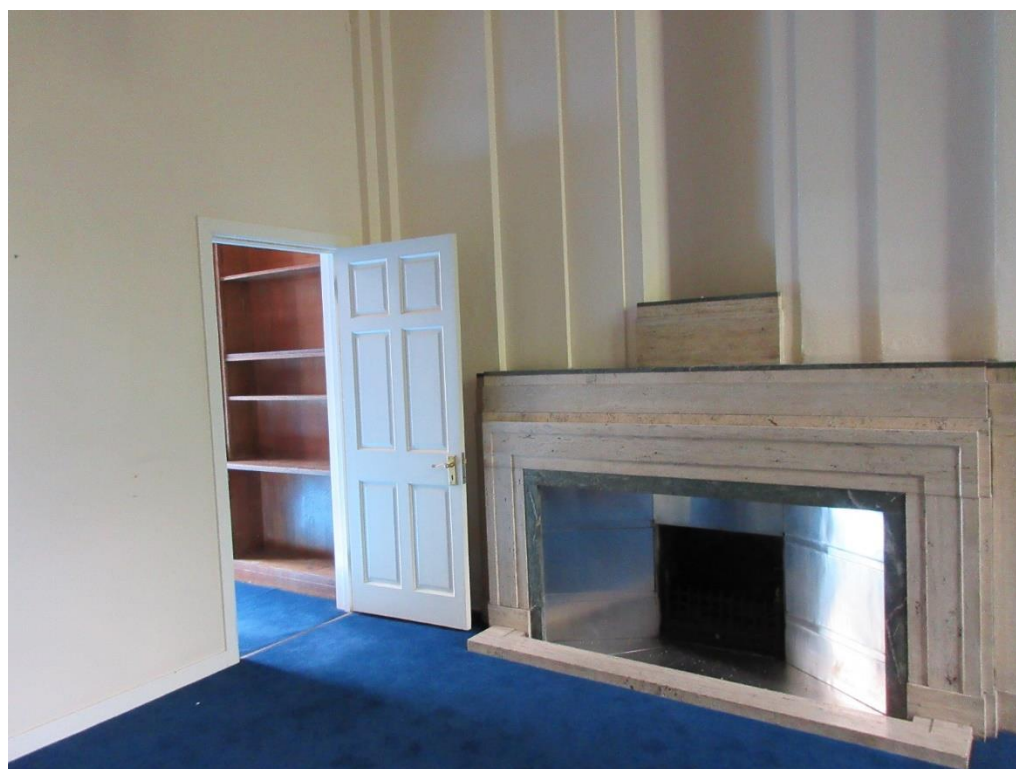
Figure 81: Ground floor of extension A. Note modern wall partitioning and door, and original 1930s fire surround.

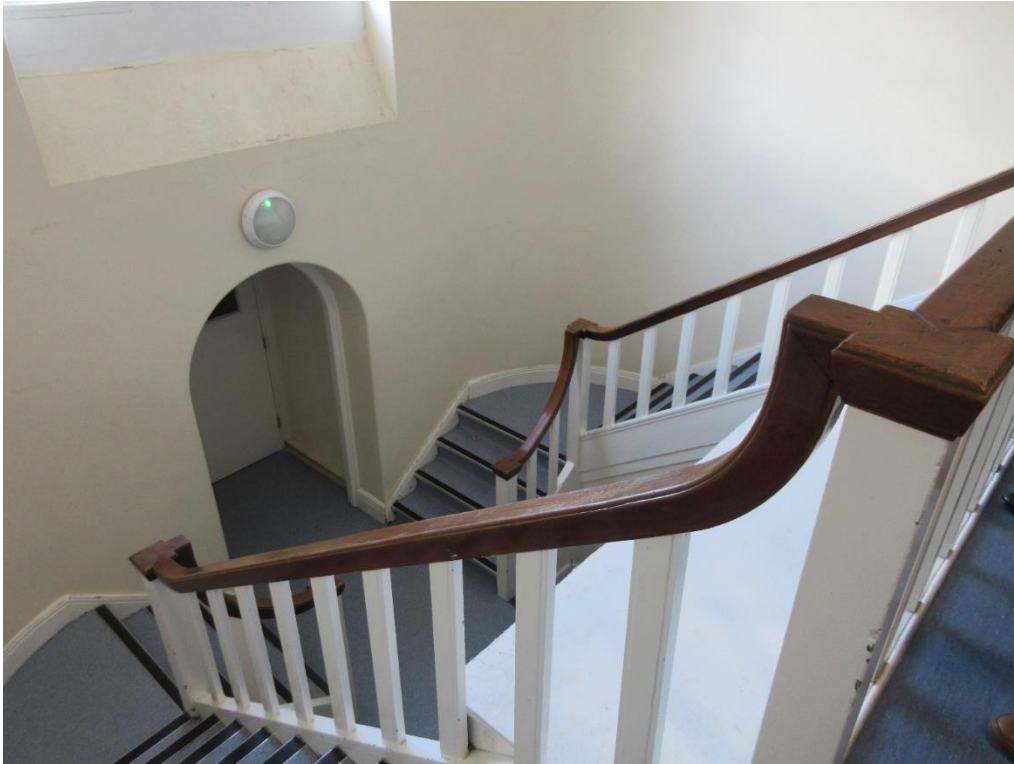
Figure 84: Stairs between second and third floors, with a door opening to extension A at second floor level.

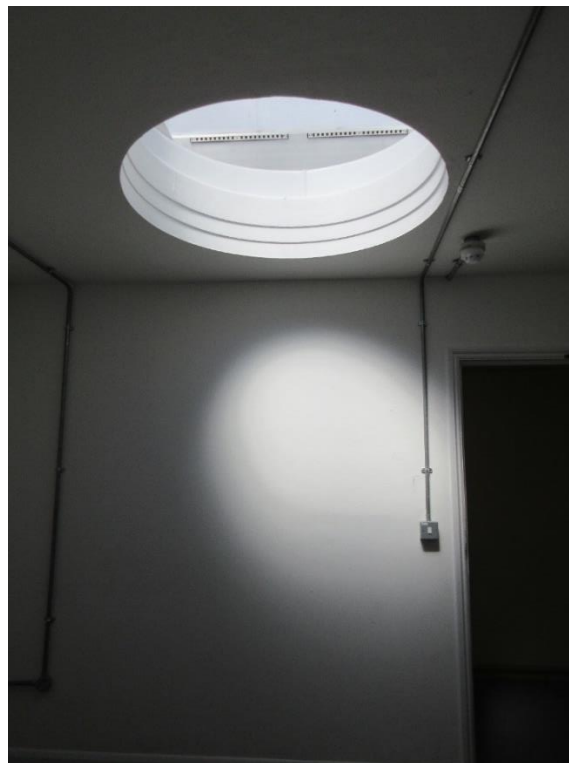
Figure 85: Second floor of extension A – Rooflight in one of the rooms.

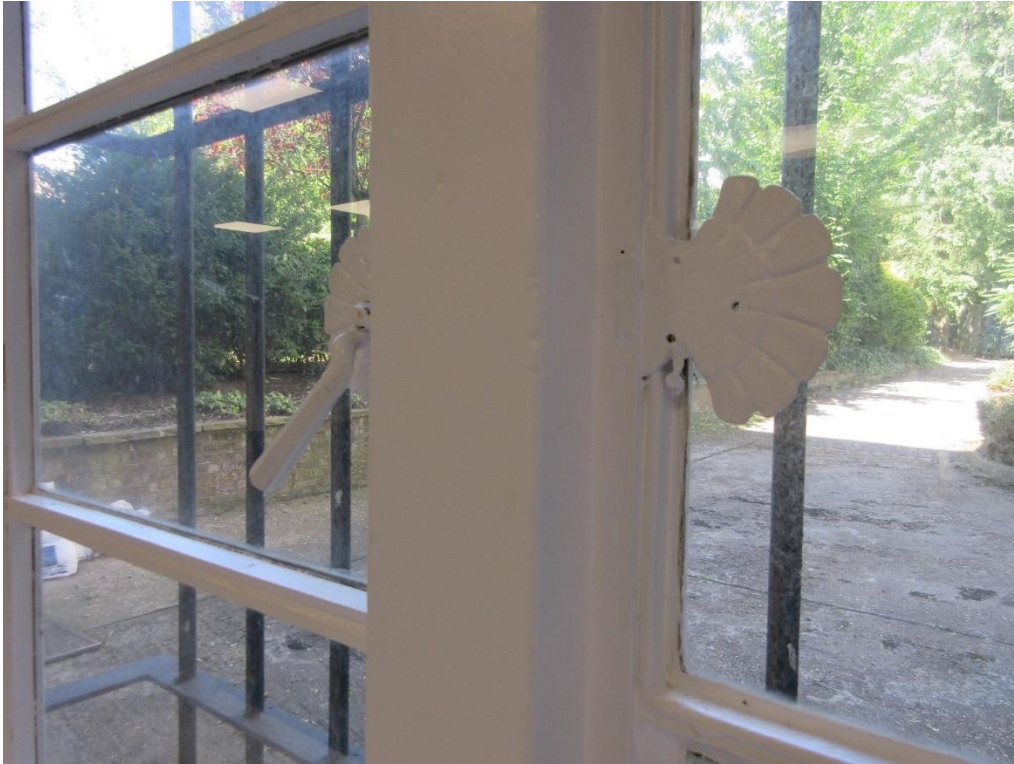
Figure 86: Basement of extension A – Ironmongery.

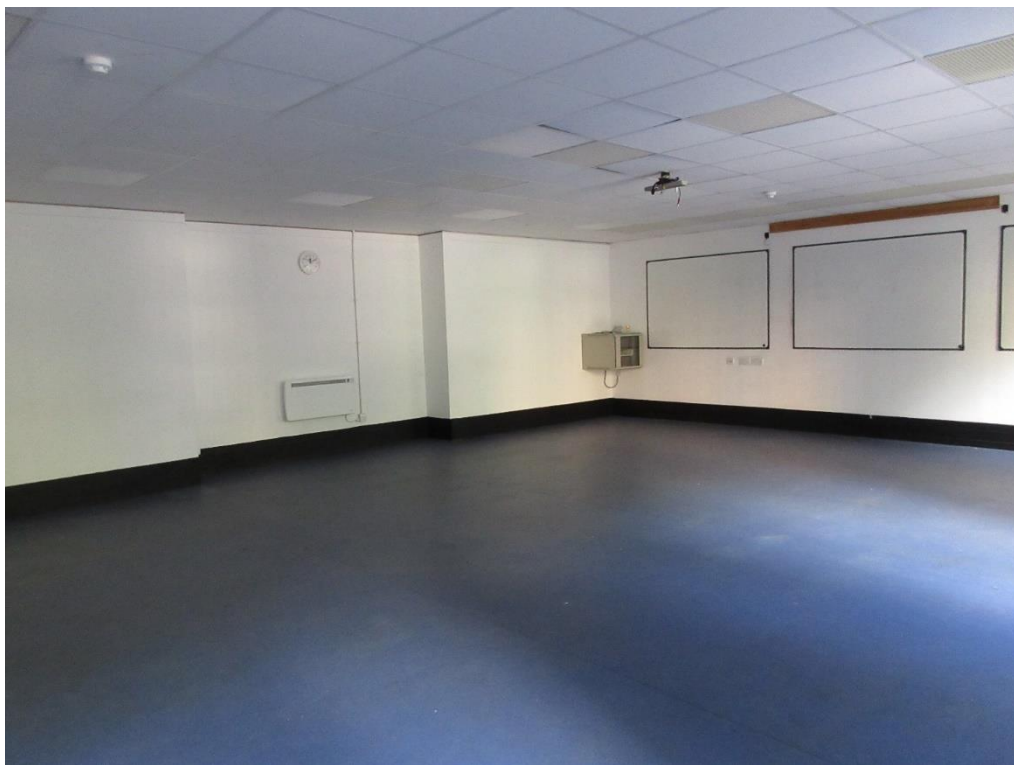
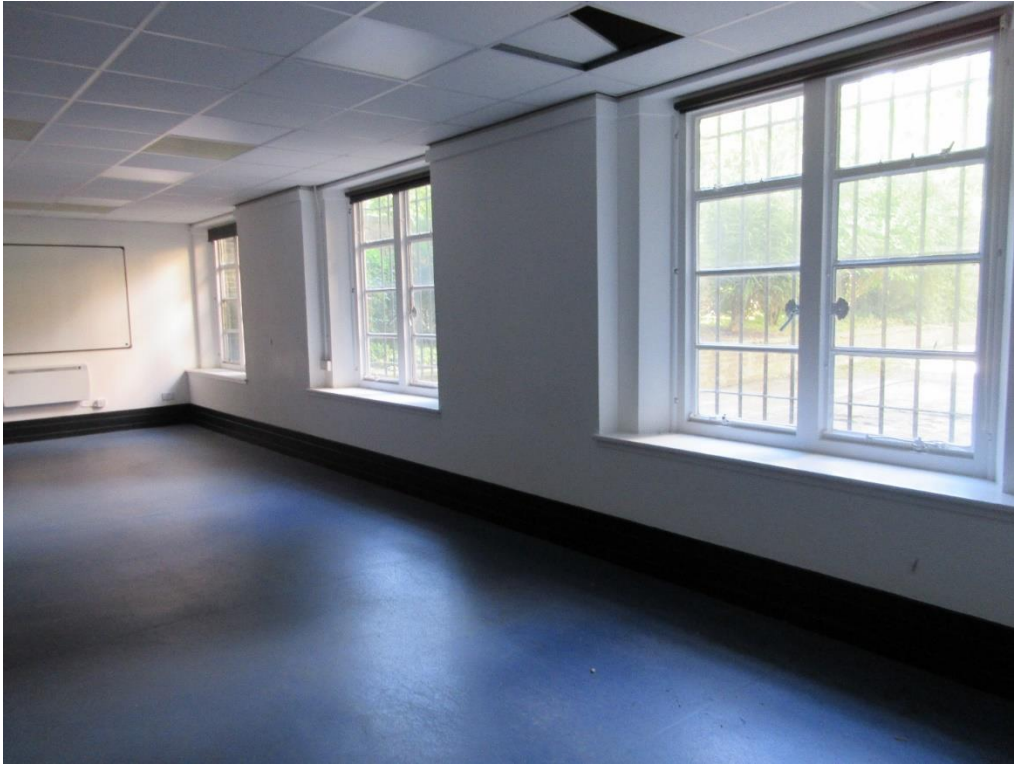
Figure 87: Basement of extension A.

Figure 88: Basement of extension A.

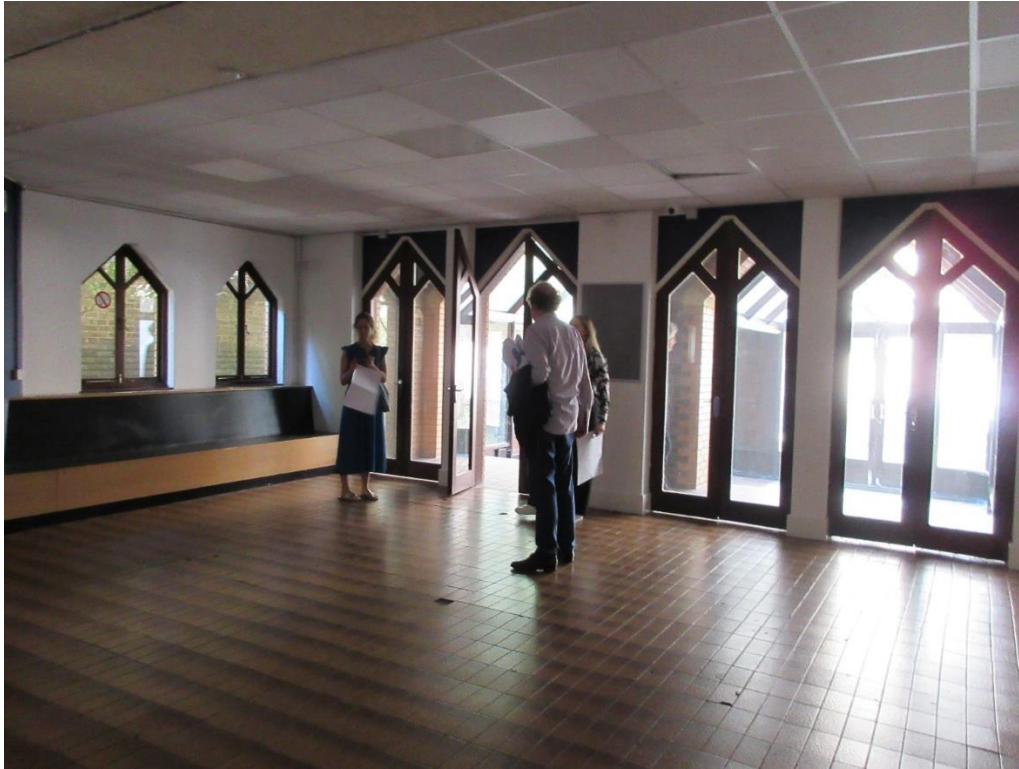
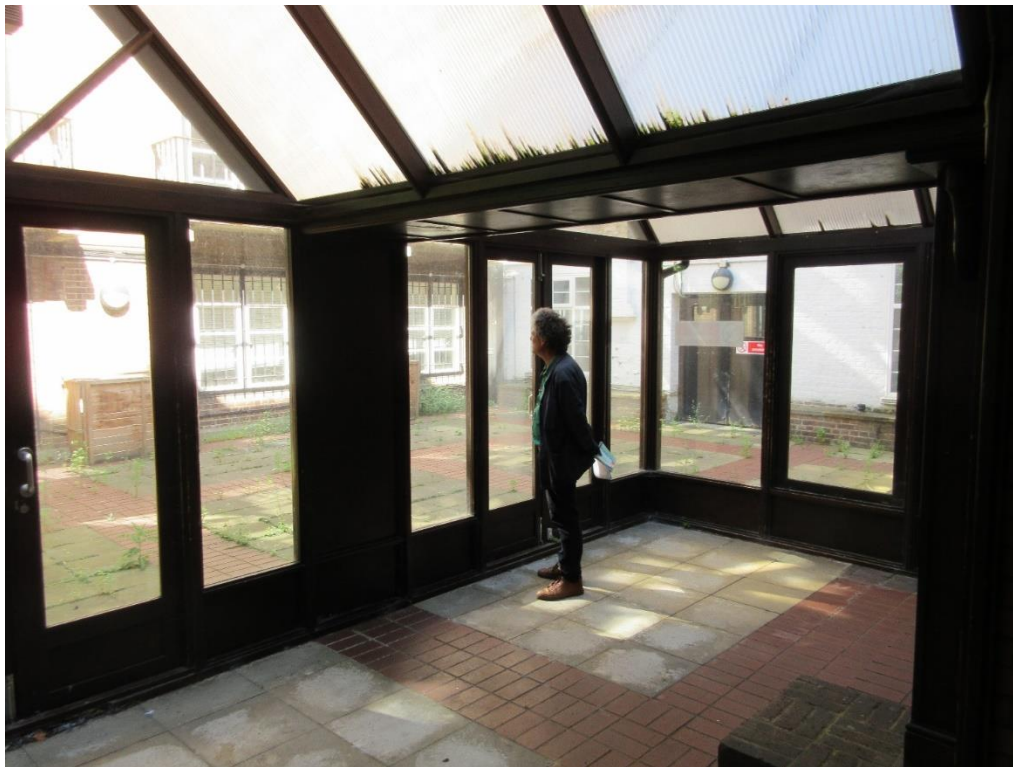
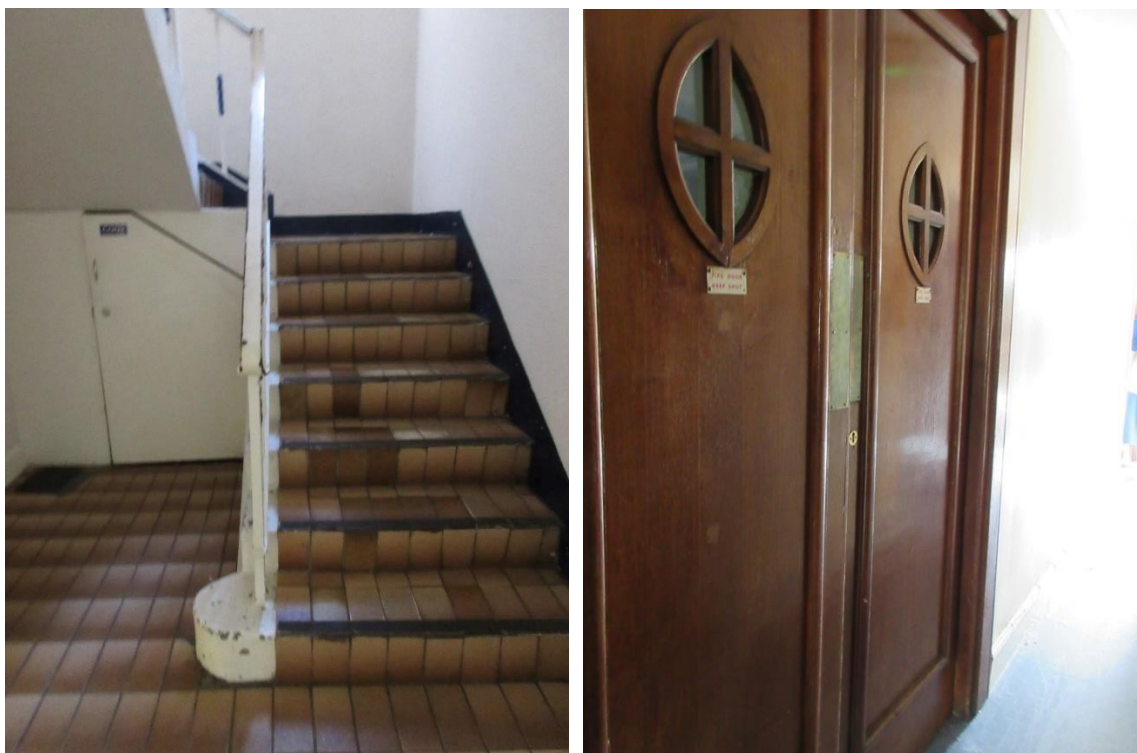
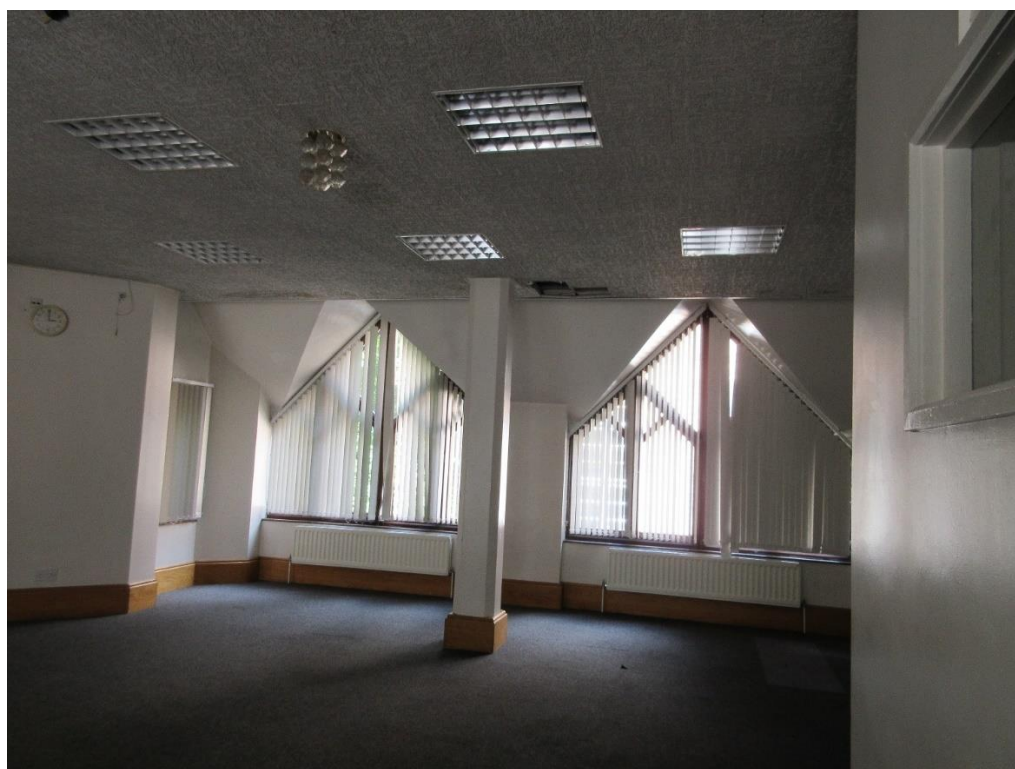
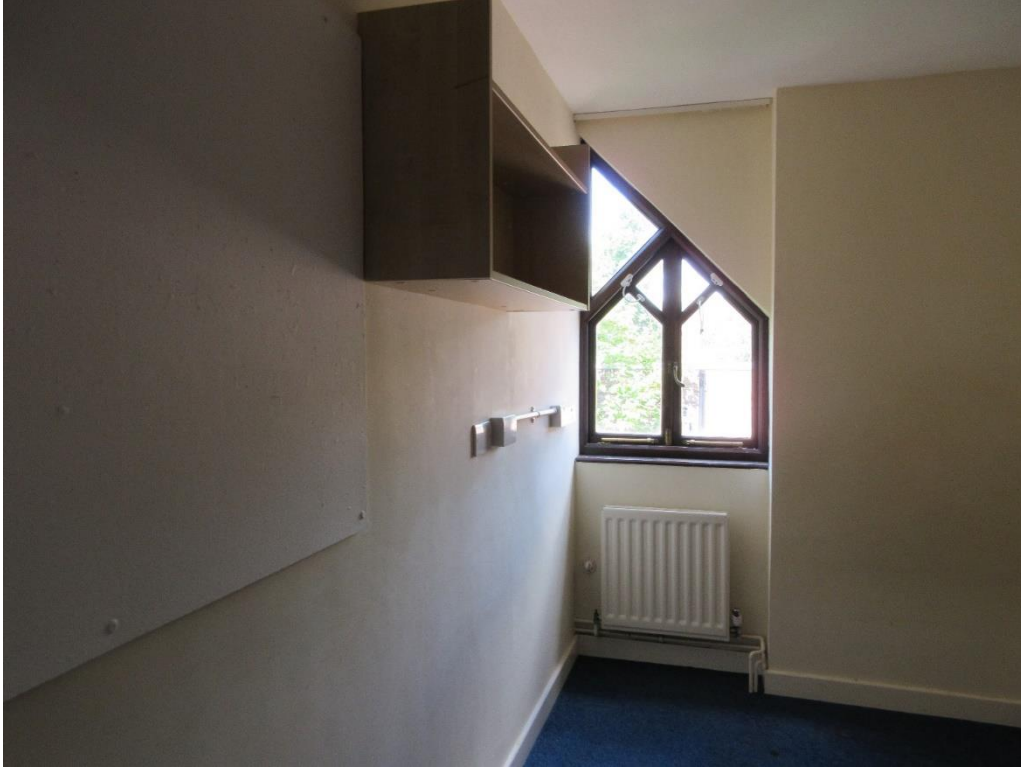
- 5.4.3. **Rear extension B** [Figure 1, Figure 2, Figure 3, Figure 4, Figure 5 & Figure 6]: This extension comprises five storeys (i.e. lower-ground floor, ground floor, first floor, second floor and third floor). It is accessed from the principal building at ground floor level via an opening to the rear of the former altar in the central hall. The interior is entirely modern – likely dating from the 1980s. The most notable architectural features of this extension are its geometric-shaped fenestration which loosely evokes Gothic arches, the decorative doors, and the varnished timber skirting at ground floor level [Figure 89, Figure 92, Figure 93 & Figure 94]. There is a staircase with metal balustrading, and floor tiles matching those at ground floor level [Figure 91]. There are two small “conservatories” at basement level [Figure 90]. A plaque on the wall commemorates a design award by the Richmond Society in 1986.

Figure 89: Basement floor of extension B.

Figure 90: Basement floor of extension B.

Figure 91 (left): Stairs from basement floor to ground floor in extension B.
Figure 92 (right): First floor of extension B.

Figure 93: First floor of extension B.

Figure 94: Fourth floor of extension B.

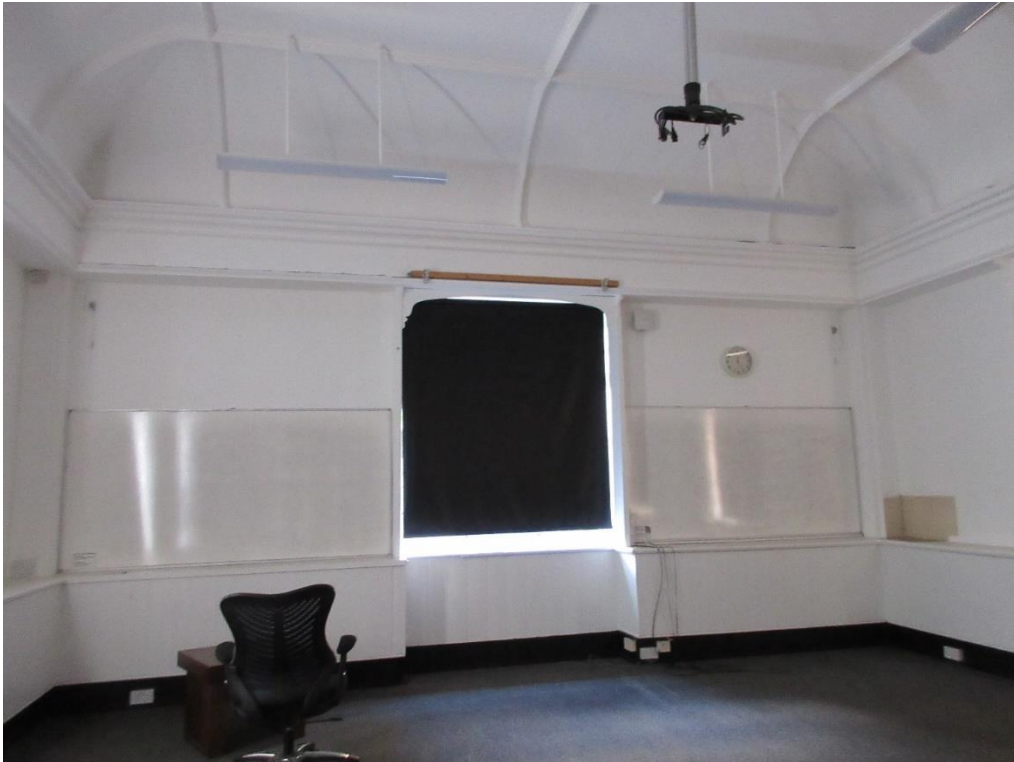
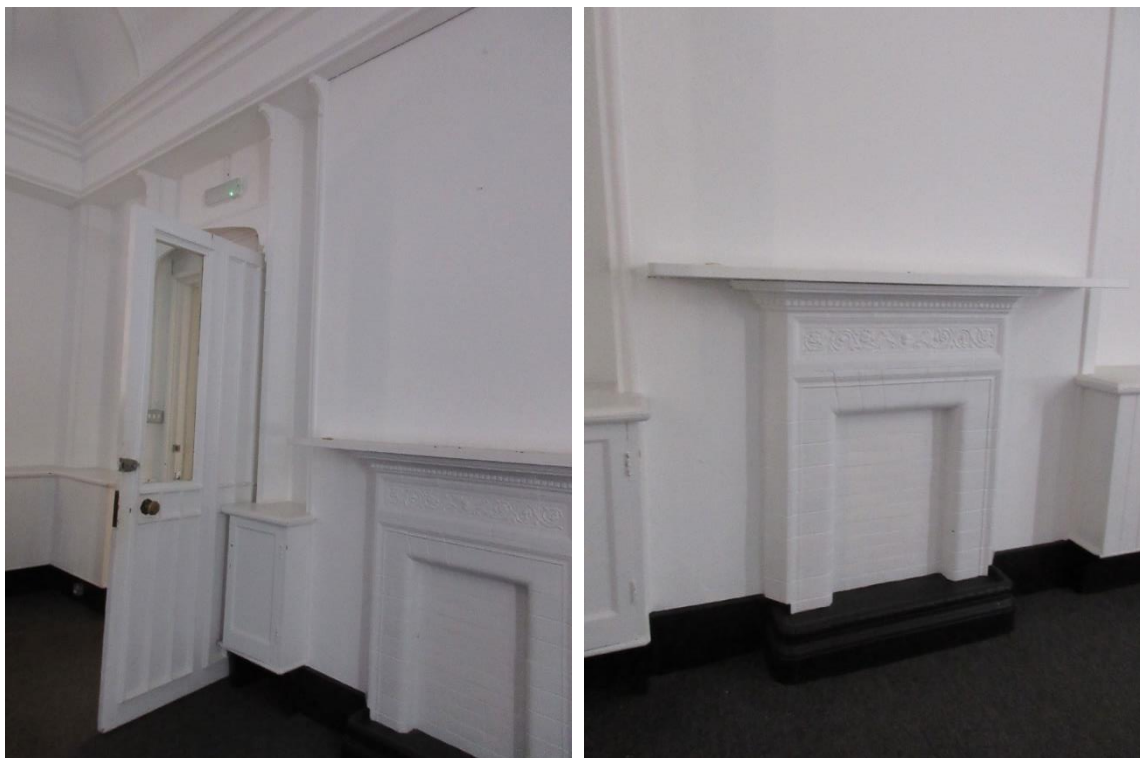
- 5.4.4. **Rear extension C** [Figure 1 & Figure 2]: This extension comprises two storeys (i.e. lower-ground floor and ground floor). It is accessed from the principal building via the south-east corridor. It was added to the building in the 1897, as the “Lycett Room”. Notable architectural features include concave edging to the ceiling, cornicing and a decorative fireplace [Figure 97, Figure 95 & Figure 96].

Figure 95: Ground floor of extension C.

Figure 96 (left): Ground floor of extension C.

Figure 97 (right): Ground floor of extension C.

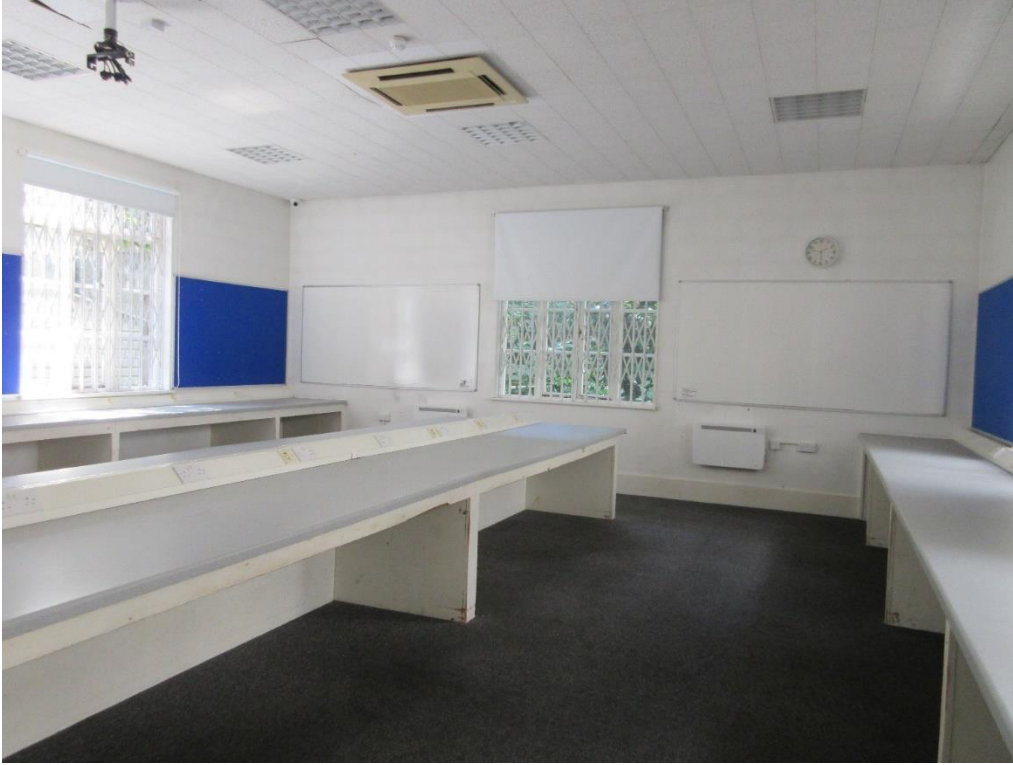
Figure 98: Ground floor of extension D.

- 5.4.5. **Rear extension D** [Figure 2]: This extension comprises a single storey (i.e. ground floor). It is accessed from the principal building via the south-east corridor. The pared back, utilitarian detailing and modern materials used both in the interior and exterior suggest that this extension was likely built in the 1990s [Figure 98].
