**Richmond College, Queen's Road,
Richmond-upon-Thames TW10 6JP**

Appendix 4

APPENDIX 4: DESCRIPTION OF RICHMOND COLLEGE INTERIOR WITH PHOTOGRAPHS

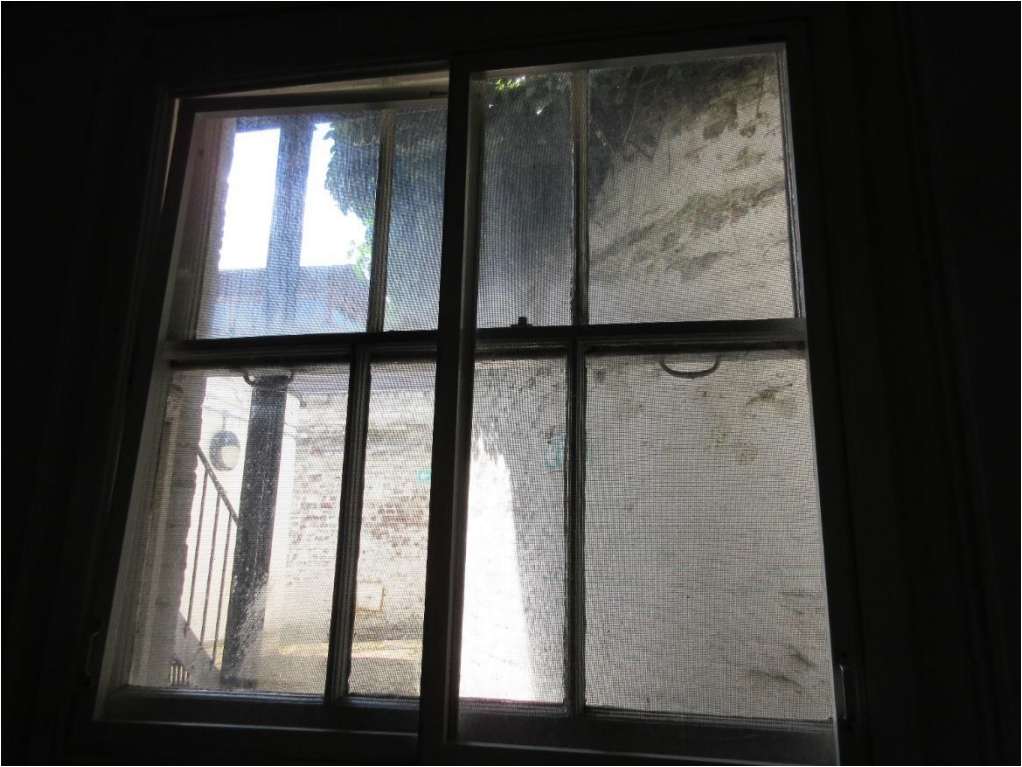
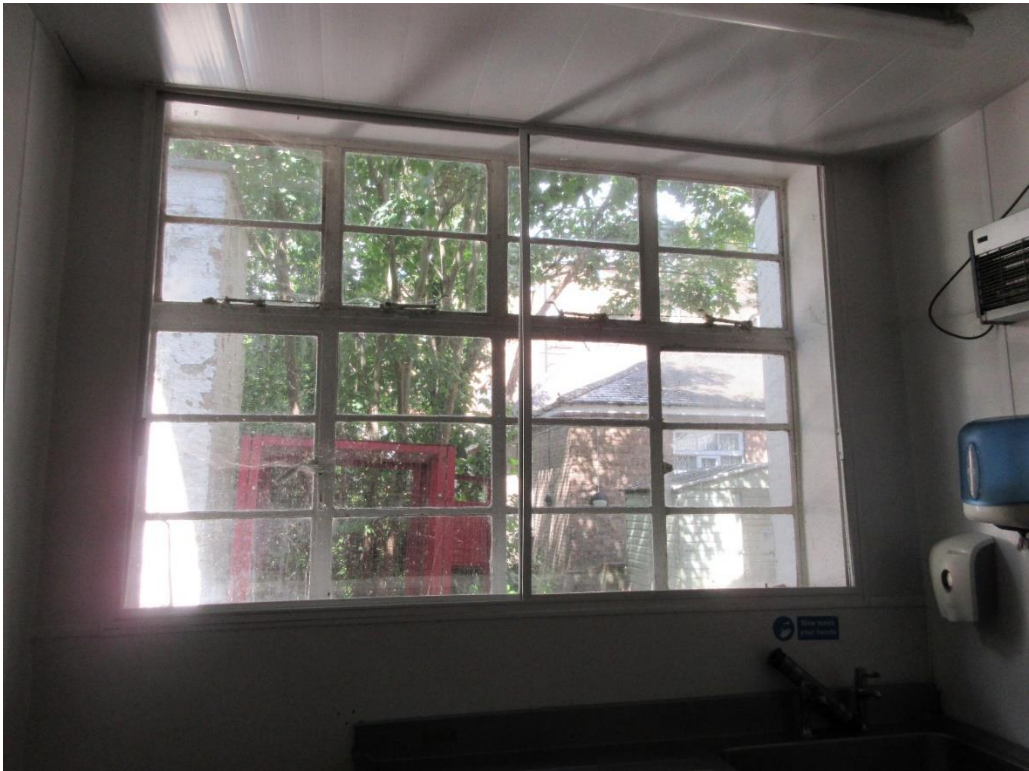
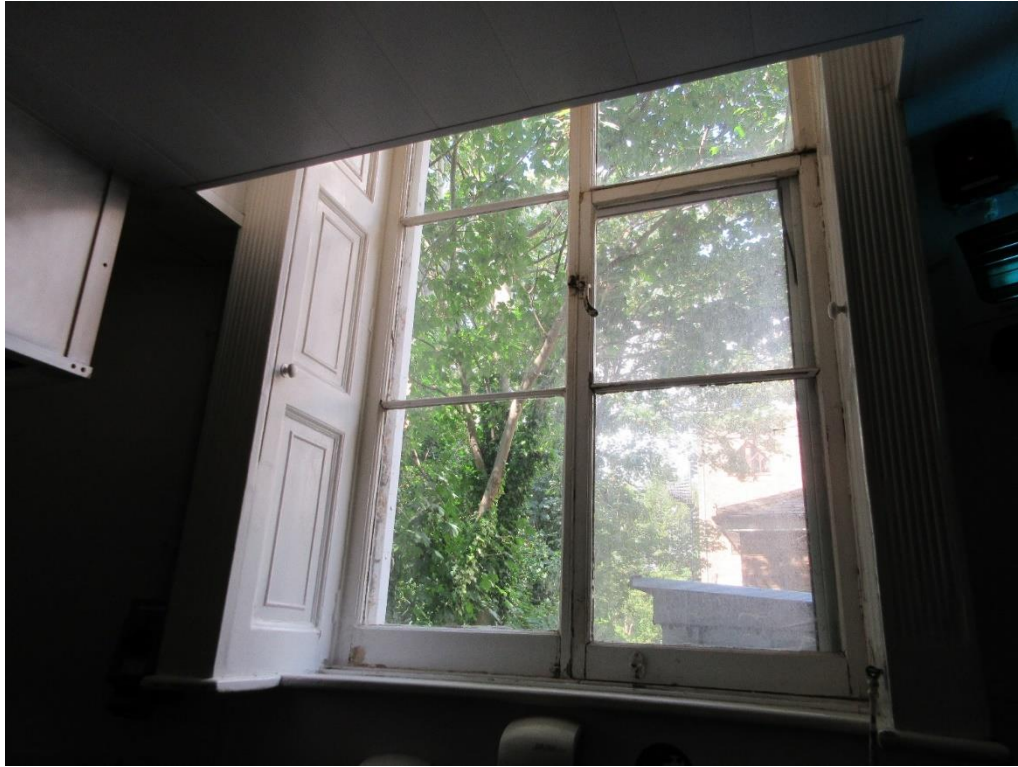
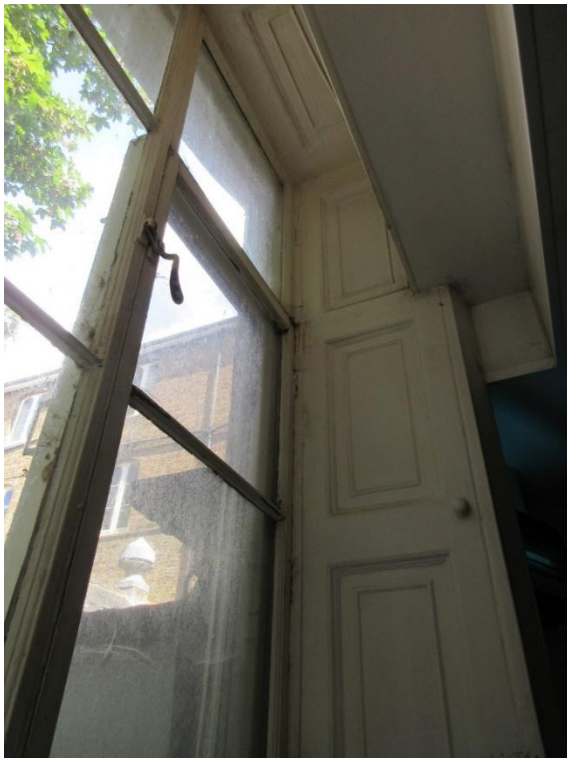
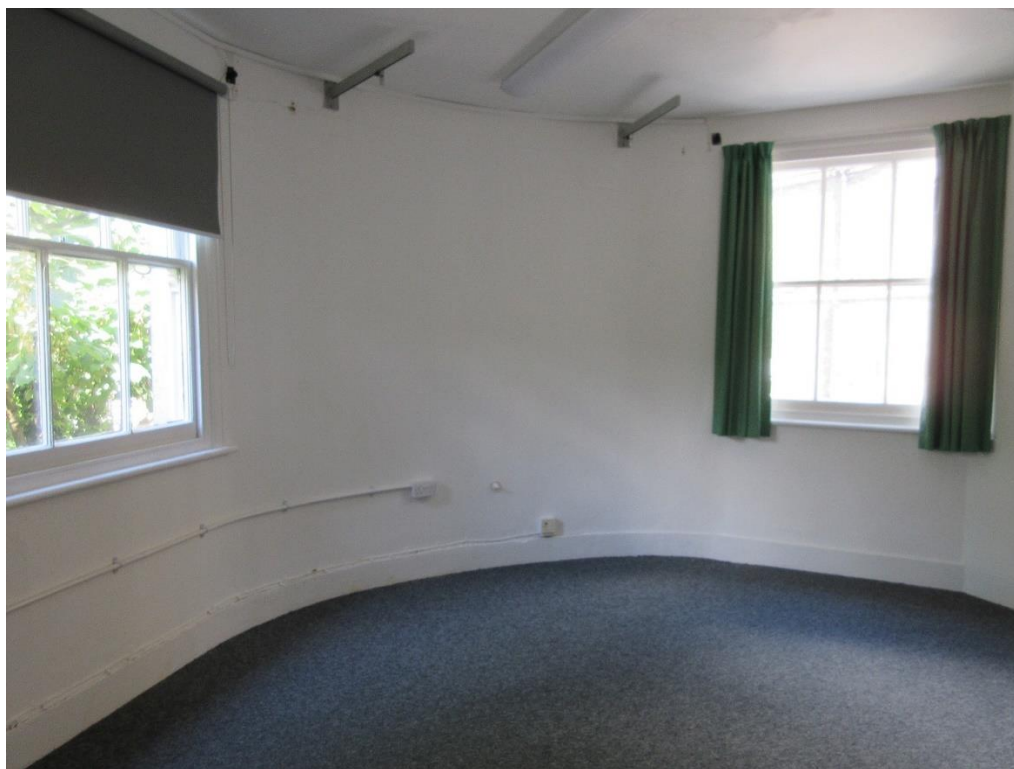
- 5.4.7. **Rear extension F** [Figure 2 & Figure 3]: This extension comprises four storeys (i.e. ground floor and first floor). It adjoins George House. Although much of it corresponds with the 1920 application, the mixture of metal-framed casements (with timber shutters) [Figure 101 & Figure 102] and timber-framed sash windows [Figure 99 & Figure 100] indicates that it was built in stages. It appears that the ceiling at ground floor level was lowered at some point, cutting off the tops of the casement windows to the north-west elevation. There is some wrought iron balustrading to the staircase [Figure 103]. The rounded room at first floor level has some three-over-three sash windows [Figure 104].

Figure 99: Ground floor of extension F.

Figure 100: Ground floor of extension F.

Figure 101: Ground floor of extension F.

Figure 102 (left): Ground floor of extension F.
Figure 103 (right): Staircase within rear extension F.

Figure 104: First floor of extension F.

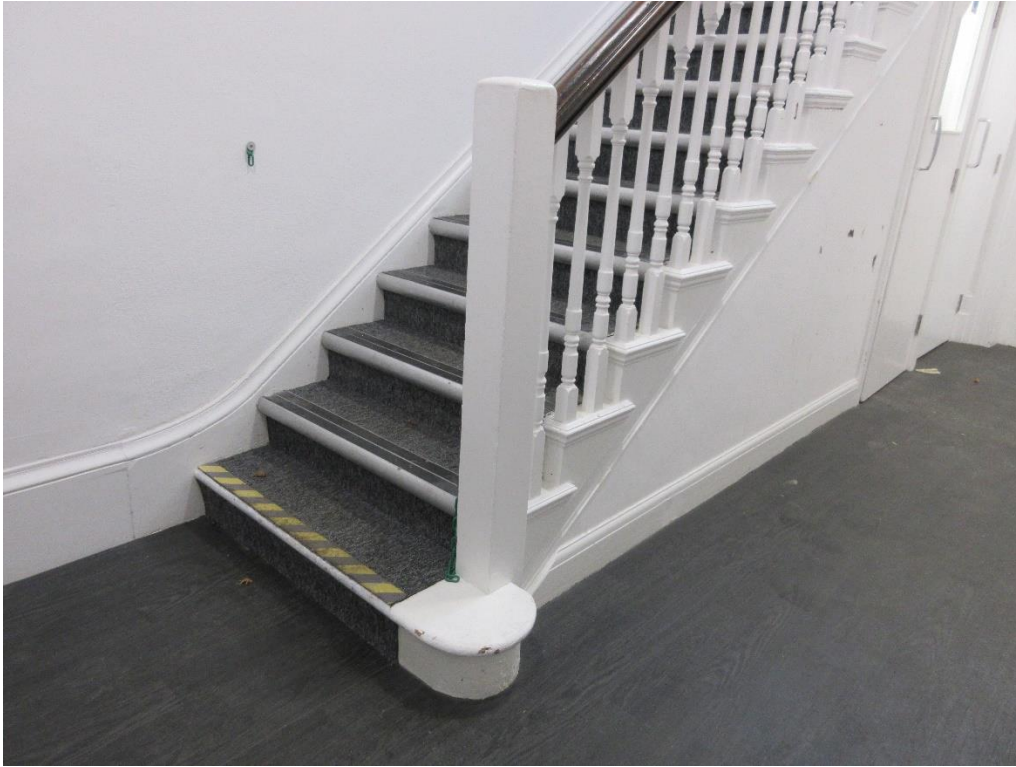
Figure 105: Ground floor of Red House – Stair hall. Note modern treads and risers and skirting to the staircase, and the modern newel post and balustrading. Note also modern skirting to boxing beneath staircase.

- 5.5.1. The interior of the building has lost its historic character due to its various unsympathetic alterations over the years [Figure 105, Figure 106, Figure 107, Figure 108, Figure 109, Figure 110, Figure 111, Figure 112, Figure 113 & Figure 114]. The original planform remains largely legible, although the modern stud walling (to provide WCs, for example), have had a detrimental impact on the appearance of the building. The interior has lost many of its original architectural features such as its doors (save for one [Figure 113]) which have been replaced by modern fire doors, most of the original fire surrounds, some skirting and cornicing, and the balustrading and newel posts of the main staircase have likely been replaced [Figure 105]. The interior of the building has also suffered as a result of the use of poor quality, utilitarian materials, and the provision of unsightly wiring and boxing-in. The ceilings of some of the rooms at ground floor level (within the north-west part) have been lowered [Figure 111 & Figure 112].

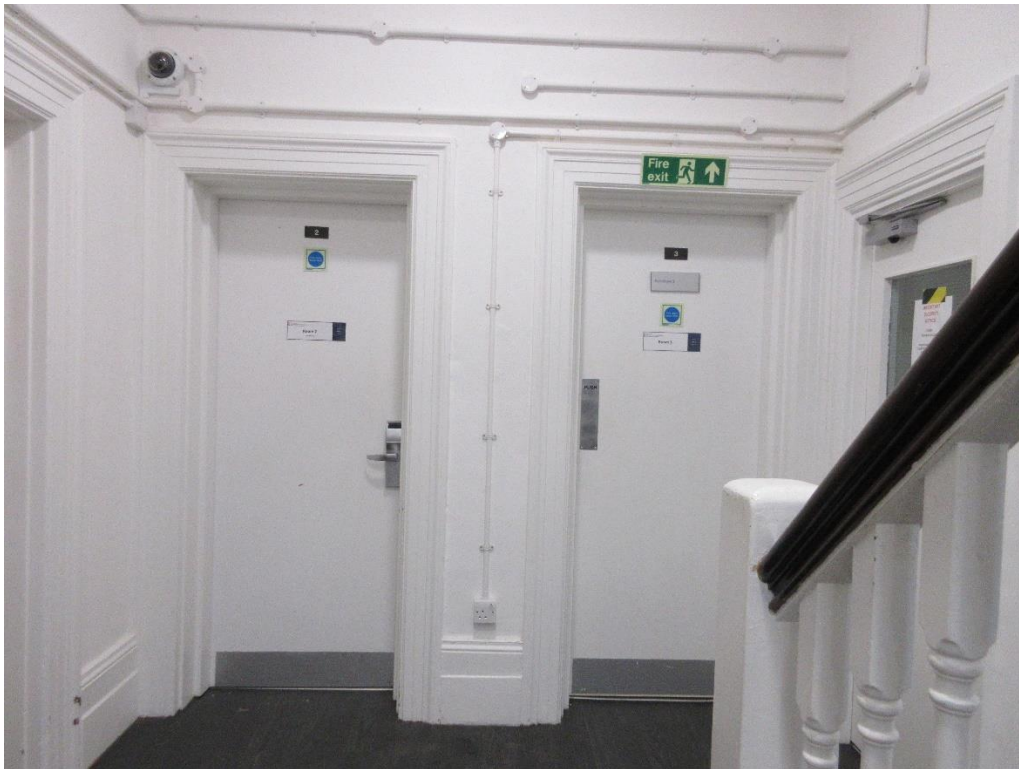
Figure 106: Ground floor of Red House – Stair hall. Note original skirting and architraves, and modern fire doors. Note also the unsightly modern wiring.

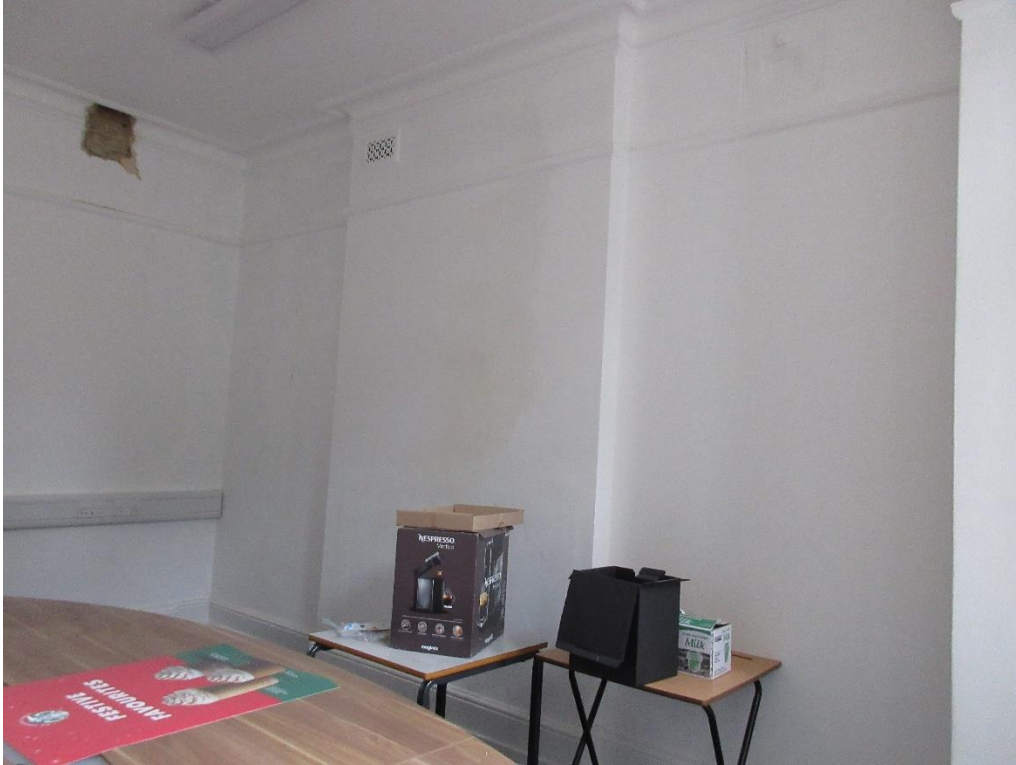
Figure 107: Ground floor of Red House – South-east room. Note original skirting, cornicing and picture railing, and chimney breast.

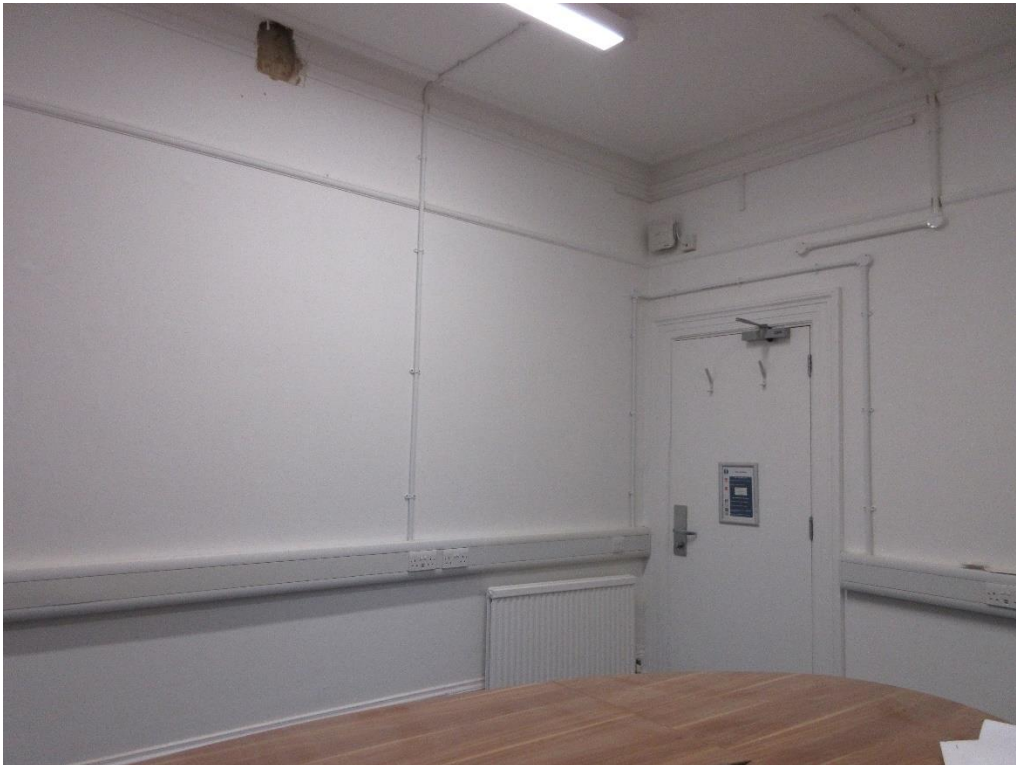
Figure 108: Ground floor of Red House – South-east room. Note original skirting, cornicing and picture railing, door architrave. Note also modern door, and unsightly modern wiring and boxing-in. The proposals involve the provision of a new opening to this wall (between the south-east and south-west rooms).

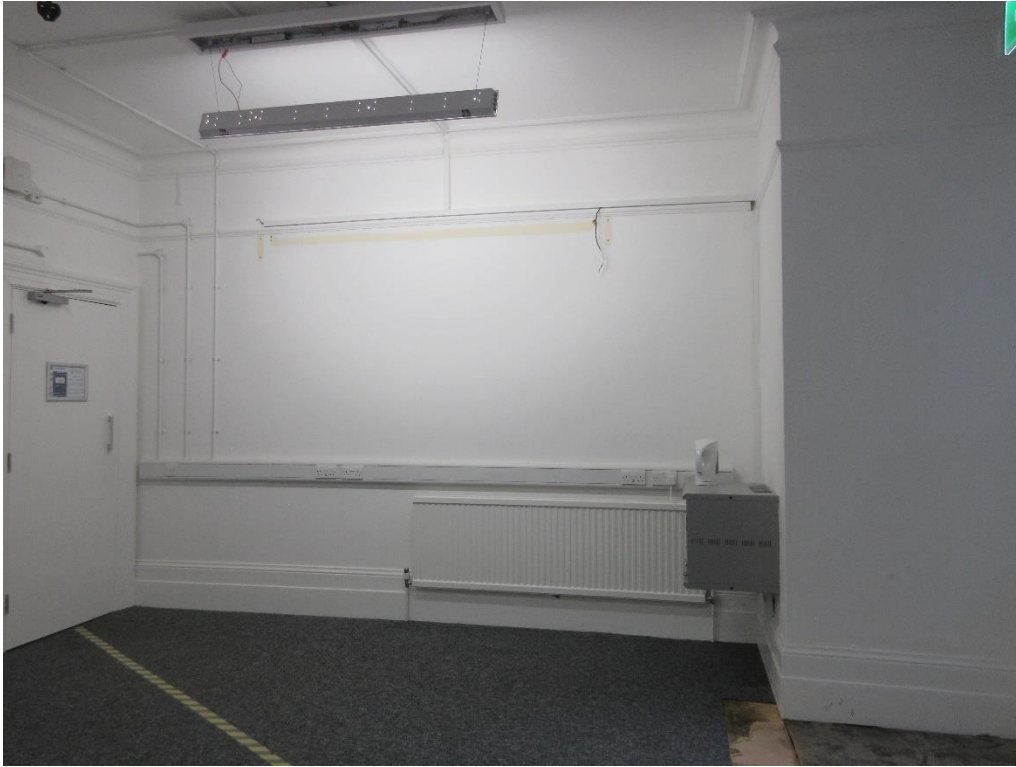
Figure 109: Ground floor of Red House – South-west room. Note original skirting, cornicing and picture railing, and architrave. Note also modern door, and unsightly modern wiring and boxing-in. The proposals involve the provision of a new opening to this wall (between the south-west and south-east rooms).

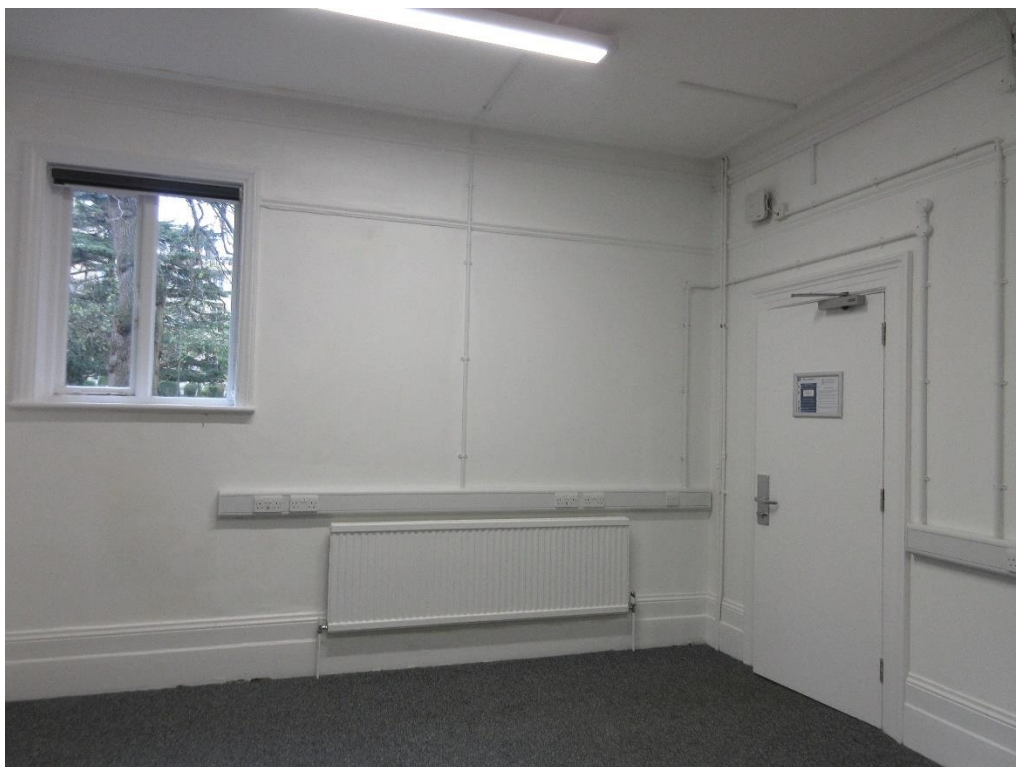
Figure 110: Ground floor of Red House – North-east room. Note original skirting, cornicing and picture railing, and architrave. Note also modern door, and unsightly modern wiring and boxing-in. The windows are likely to be modern replacements. The proposals involve the provision of a new opening to this wall (between the north-west and south-east rooms).

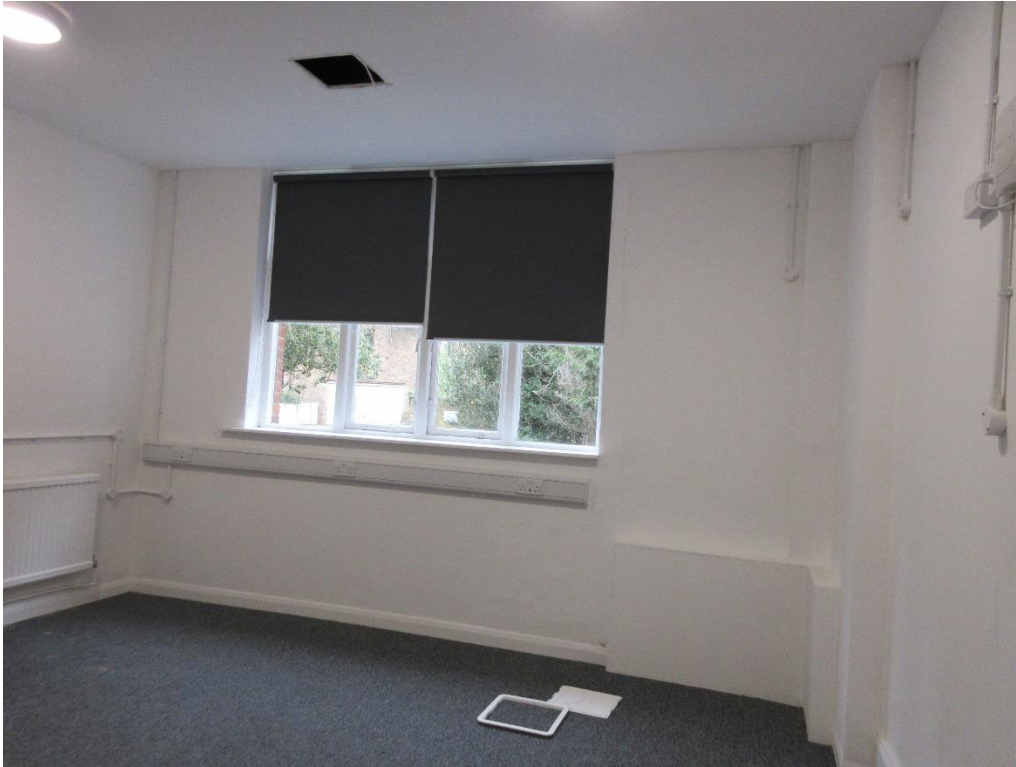
Figure 111: Ground floor of Red House – North-west room. Note modern lowered ceiling, modern skirting, and unsightly modern wiring and boxing-in.

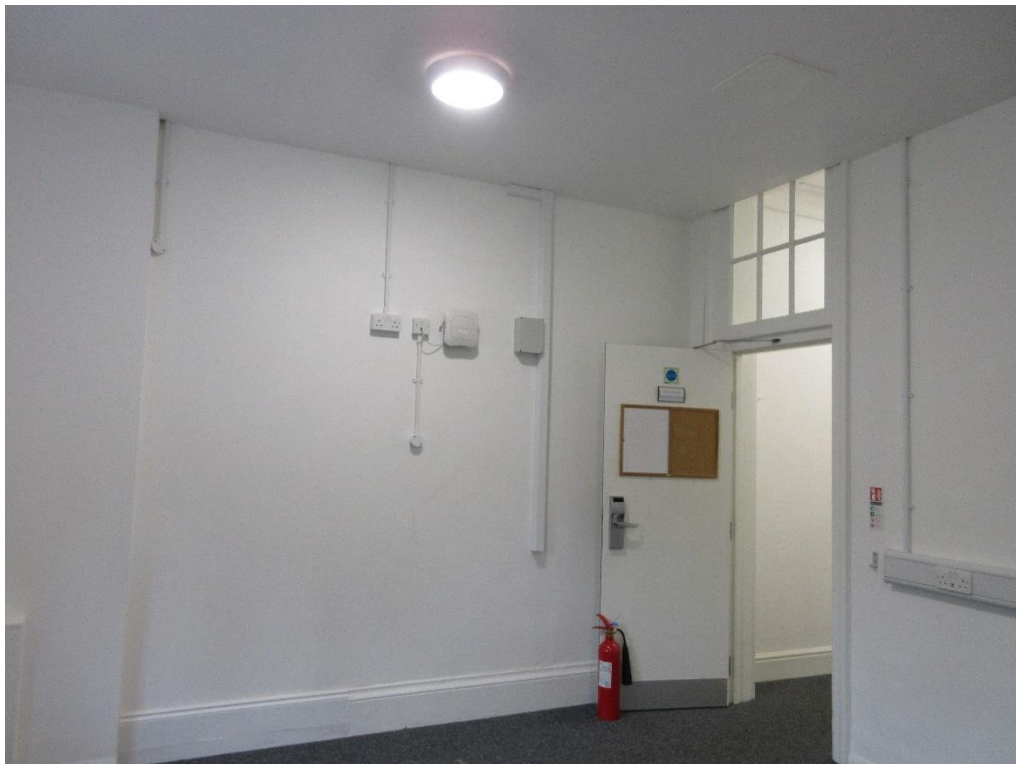
Figure 112: Ground floor of Red House – North-west room. Note modern borrowed light which has been cut off at the top by the modern lowered ceiling. Note original skirting and some replacement modern skirting. Note also the unsightly modern wiring and boxing-in.

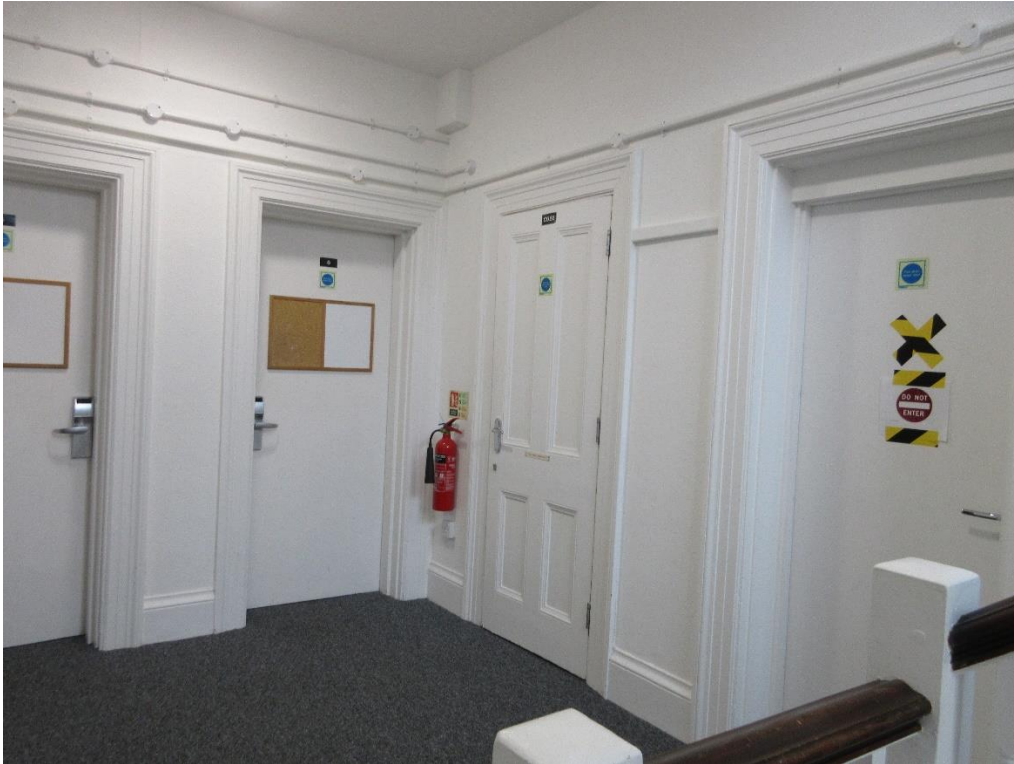
Figure 113: First floor of Red House – Landing. Note original skirting and architraves, and one original door. Note also modern fire doors, and unsightly modern wiring.

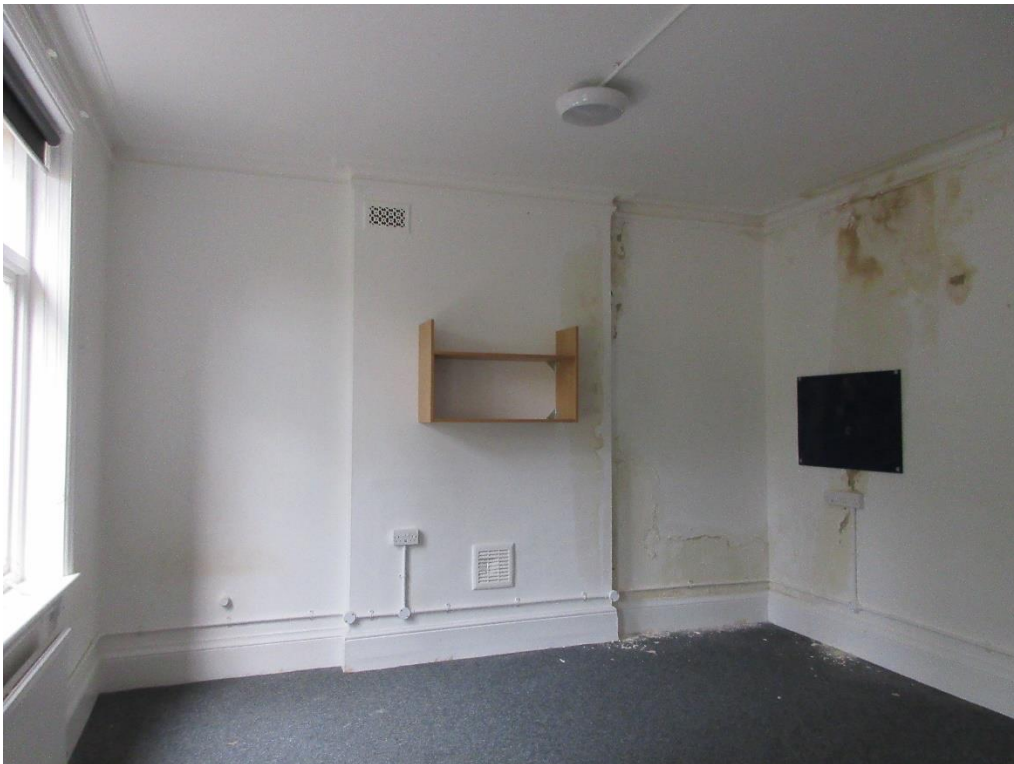
Figure 114: First floor of Red House – South-west room. Note original skirting, cornicing and chimney breast. Windows may be modern replacements. Note also unsightly wiring.

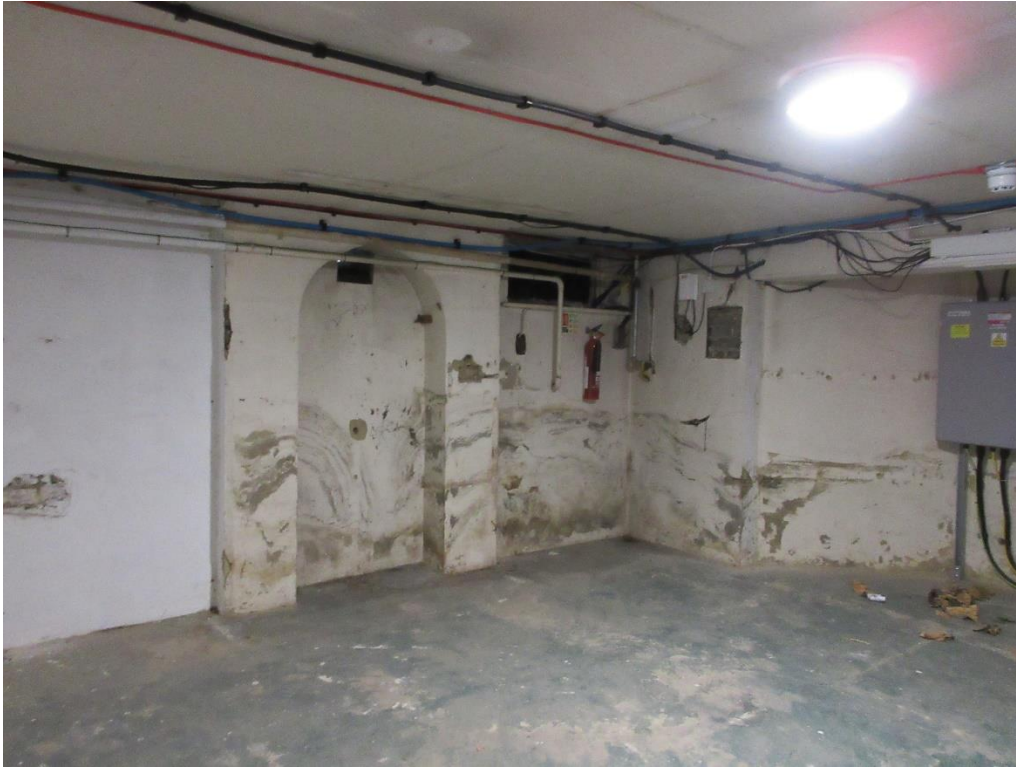
Figure 115: Basement of Red House. Note original chimney breast, and window. Ceiling appears to have been lowered.

- 5.5.2. There is anecdotal evidence that the Red House was built on the site of dairy. The existing basement may well be part of that. It appears that the ceiling of the basement has been lowered, and that it used to have windows [Figure 115].
