13. Red House

13.1 Existing structure

1399 SK80 Rev A	Richmond Hill Campus
Main Building Basement Existing Structure	Date 12/01/2024
  integral engineering design	Integral Engineering Design 84 Walcot Street Bath BA1 5BD

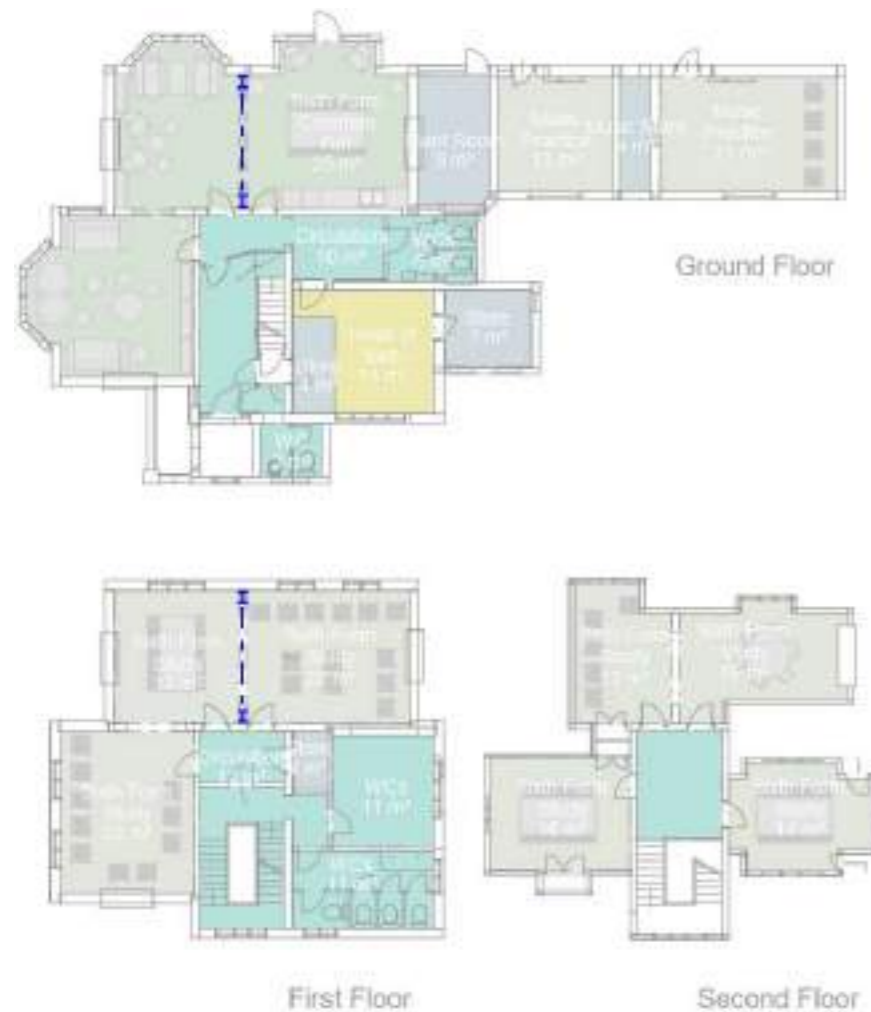
Extract from SK76 showing location of steel frame in Red House

There is one wall to be removed which may be providing lateral stability. A steel moment frame at each floor comprising 203 UC 46 for columns and beams with pad foundations at ground floor should be allowed for to frame the opening. This will be considered further at the next stage. Elsewhere PCC lintels will be used to form new openings.

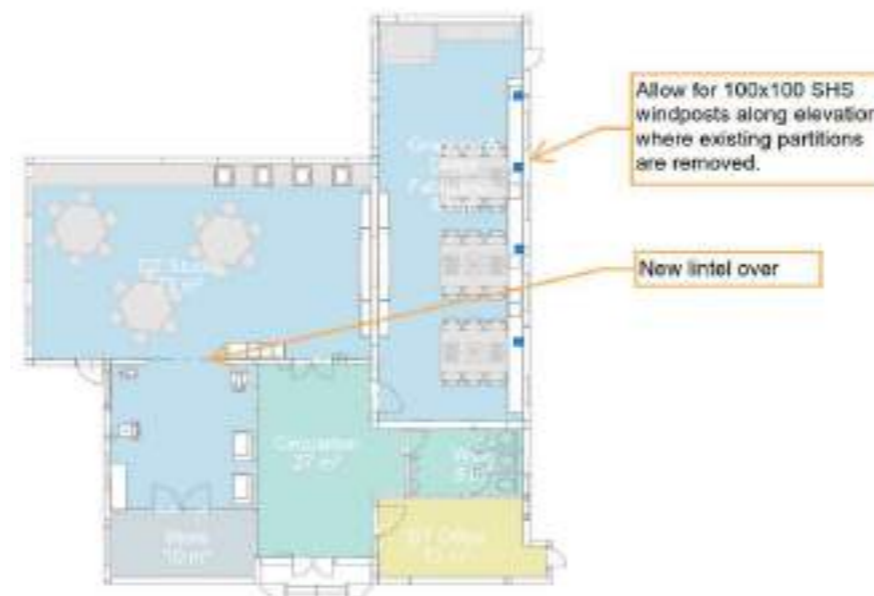
Extract from SK76 showing proposed structural alterations in Longley House

The proposal is to remove internal partitions within Longley House. Initial investigations suggest that the partitions in the east section of the building are not supporting the roof structure above, and no evidence of tying was found between them and the external masonry walls. However, the partitions may still be providing some lateral restraint to the masonry and so allowance should be made for windposts where partitions are being removed. This will be considered further at the next stage.

Opening up works are required to confirm if the walls to be removed in the eastern portion of the building support the roof. A new opening through a structural wall in this area will require a new lintel over.

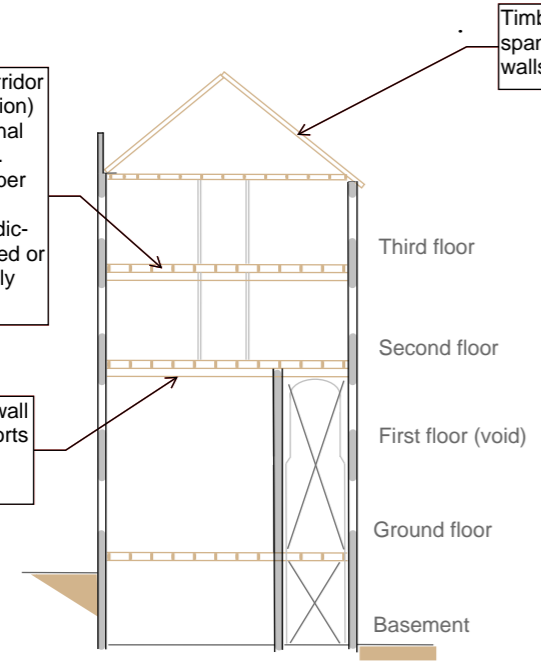
Section A-A

Timber roof structure spans between external walls

Solid masonry wall right up through building except where arches/beams have been formed at second and third floor levels

Basement appears to have reduced floor level as foundations are visible in all areas (typ)

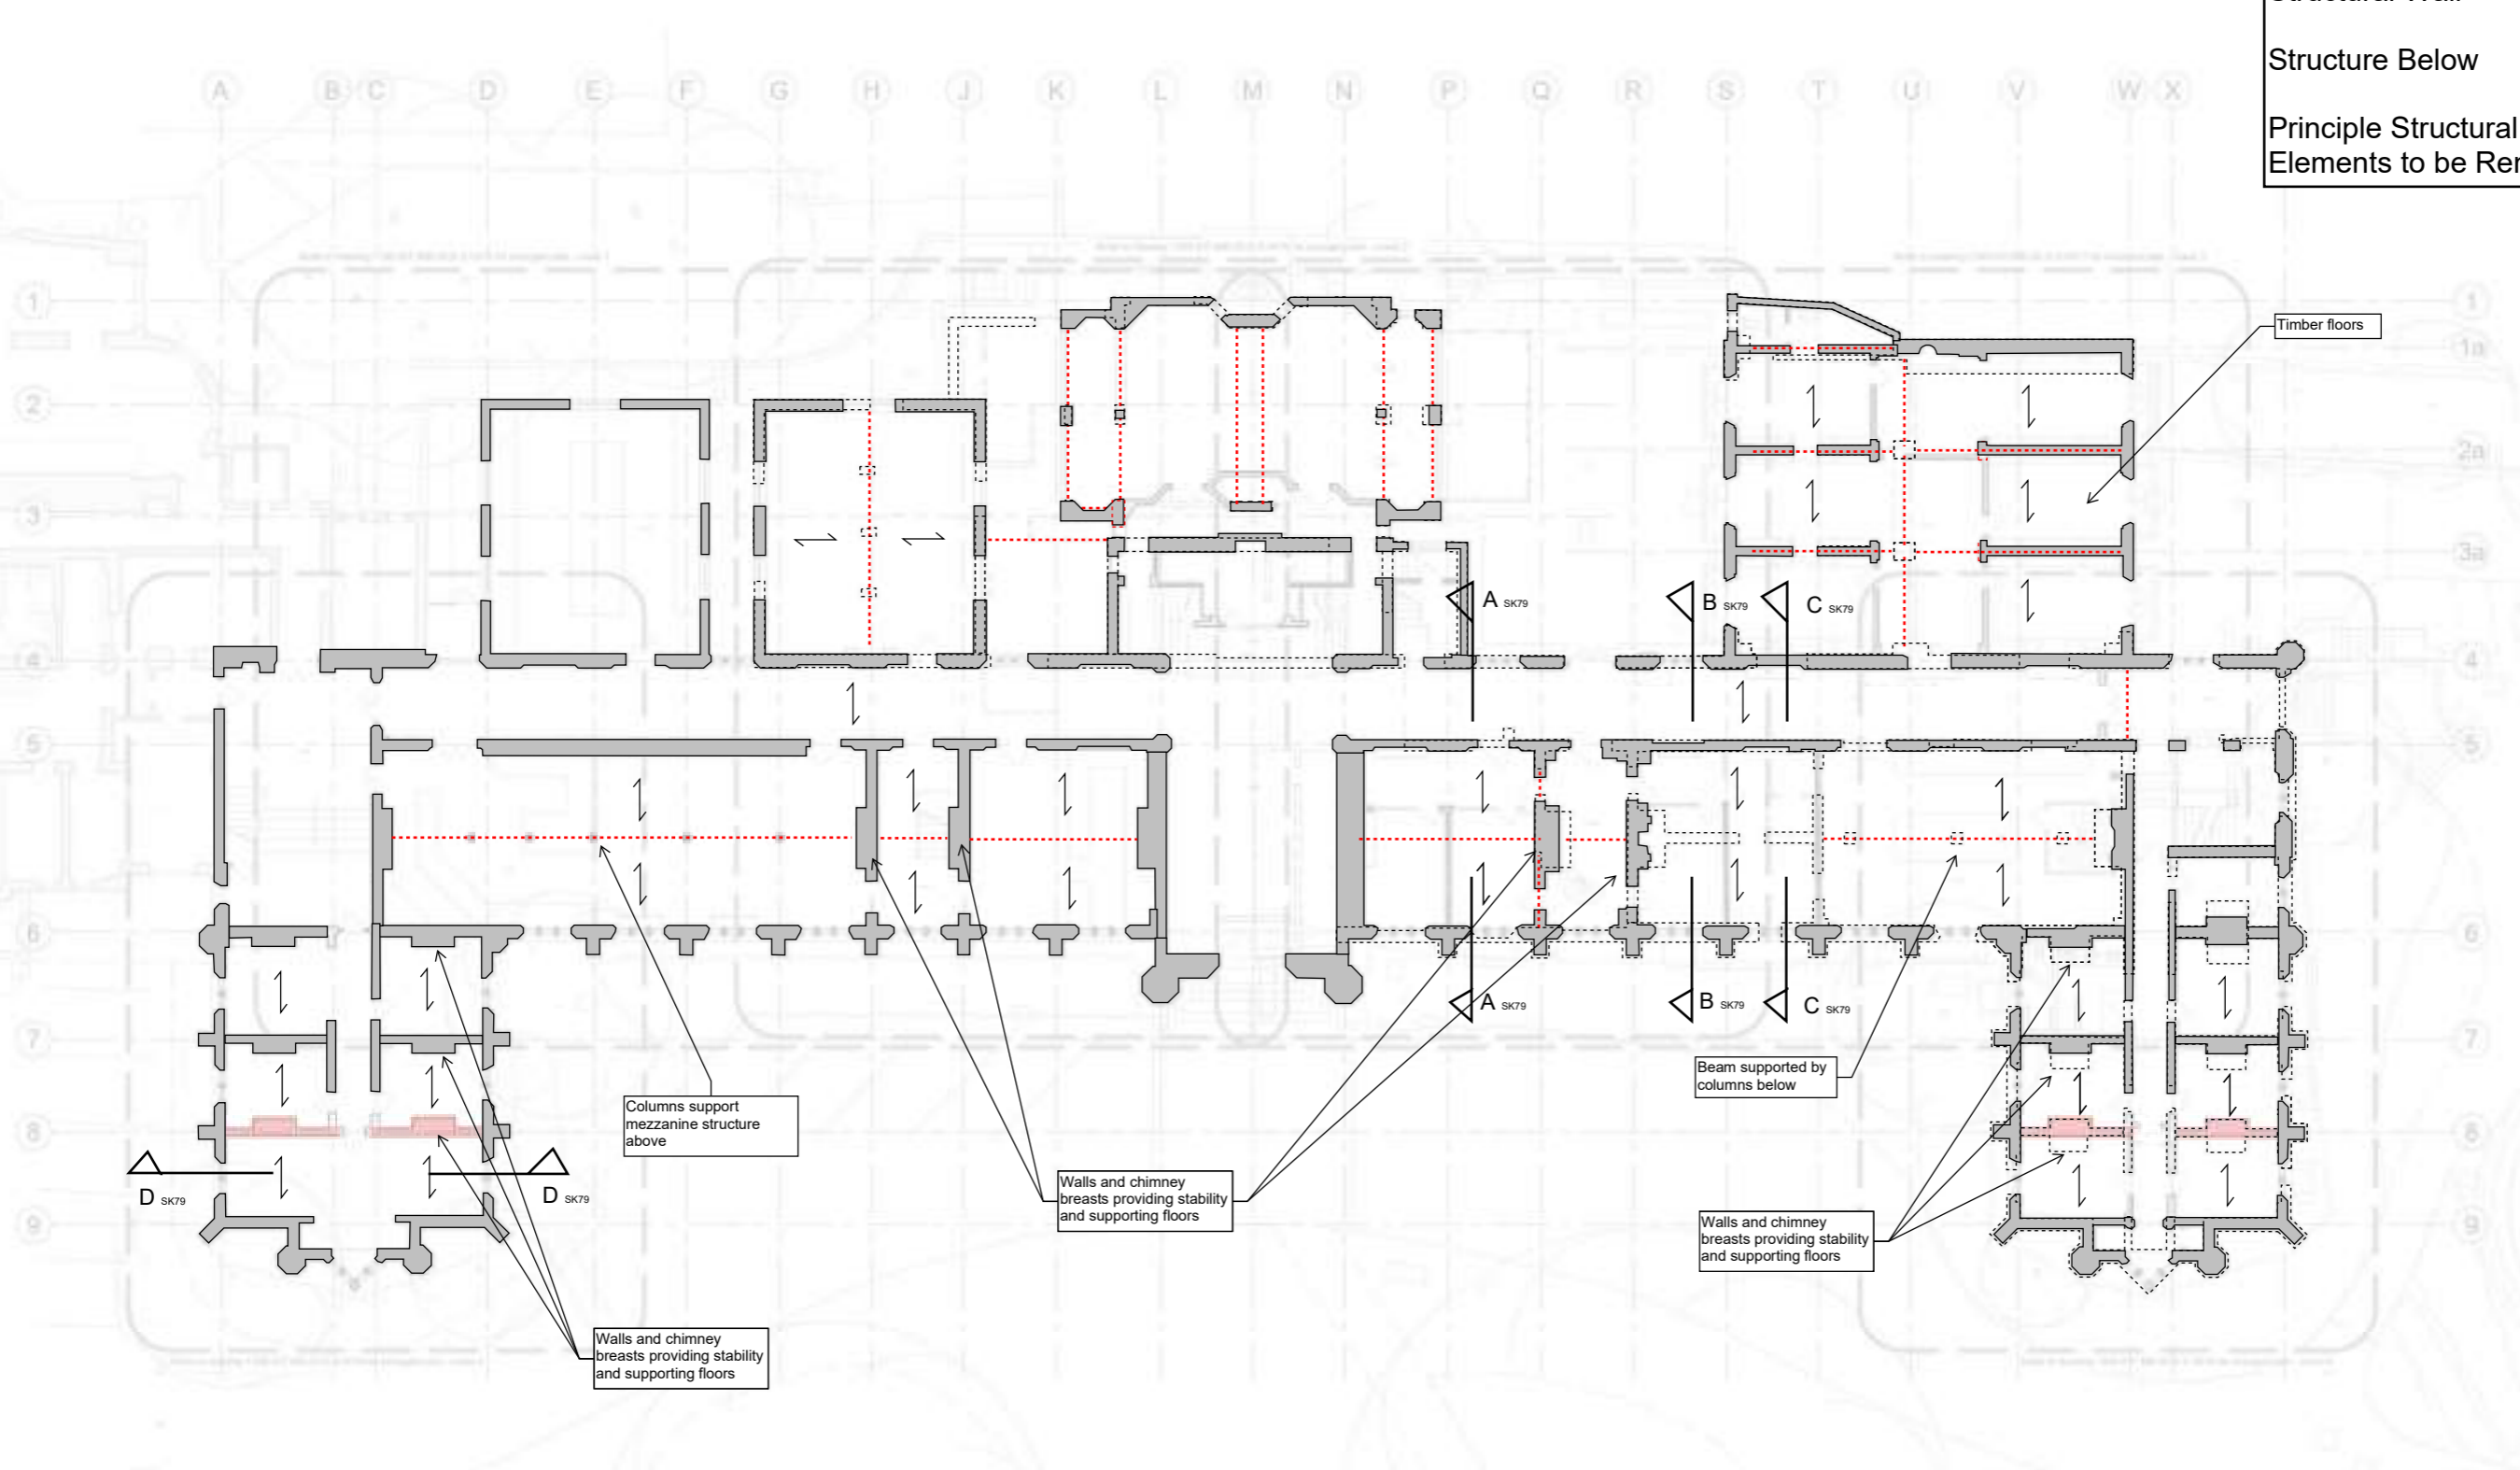
1399 SK81 Rev A	Richmond Hill Campus
Main Building Ground Floor Existing Structure	Date 12/01/2024
  integral engineering design	Integral Engineering Design 84 Walcot Street Bath BA1 5BD

Columns support mezzanine structure above

Walls and chimney breasts providing stability and supporting floors

Beam supported by columns below

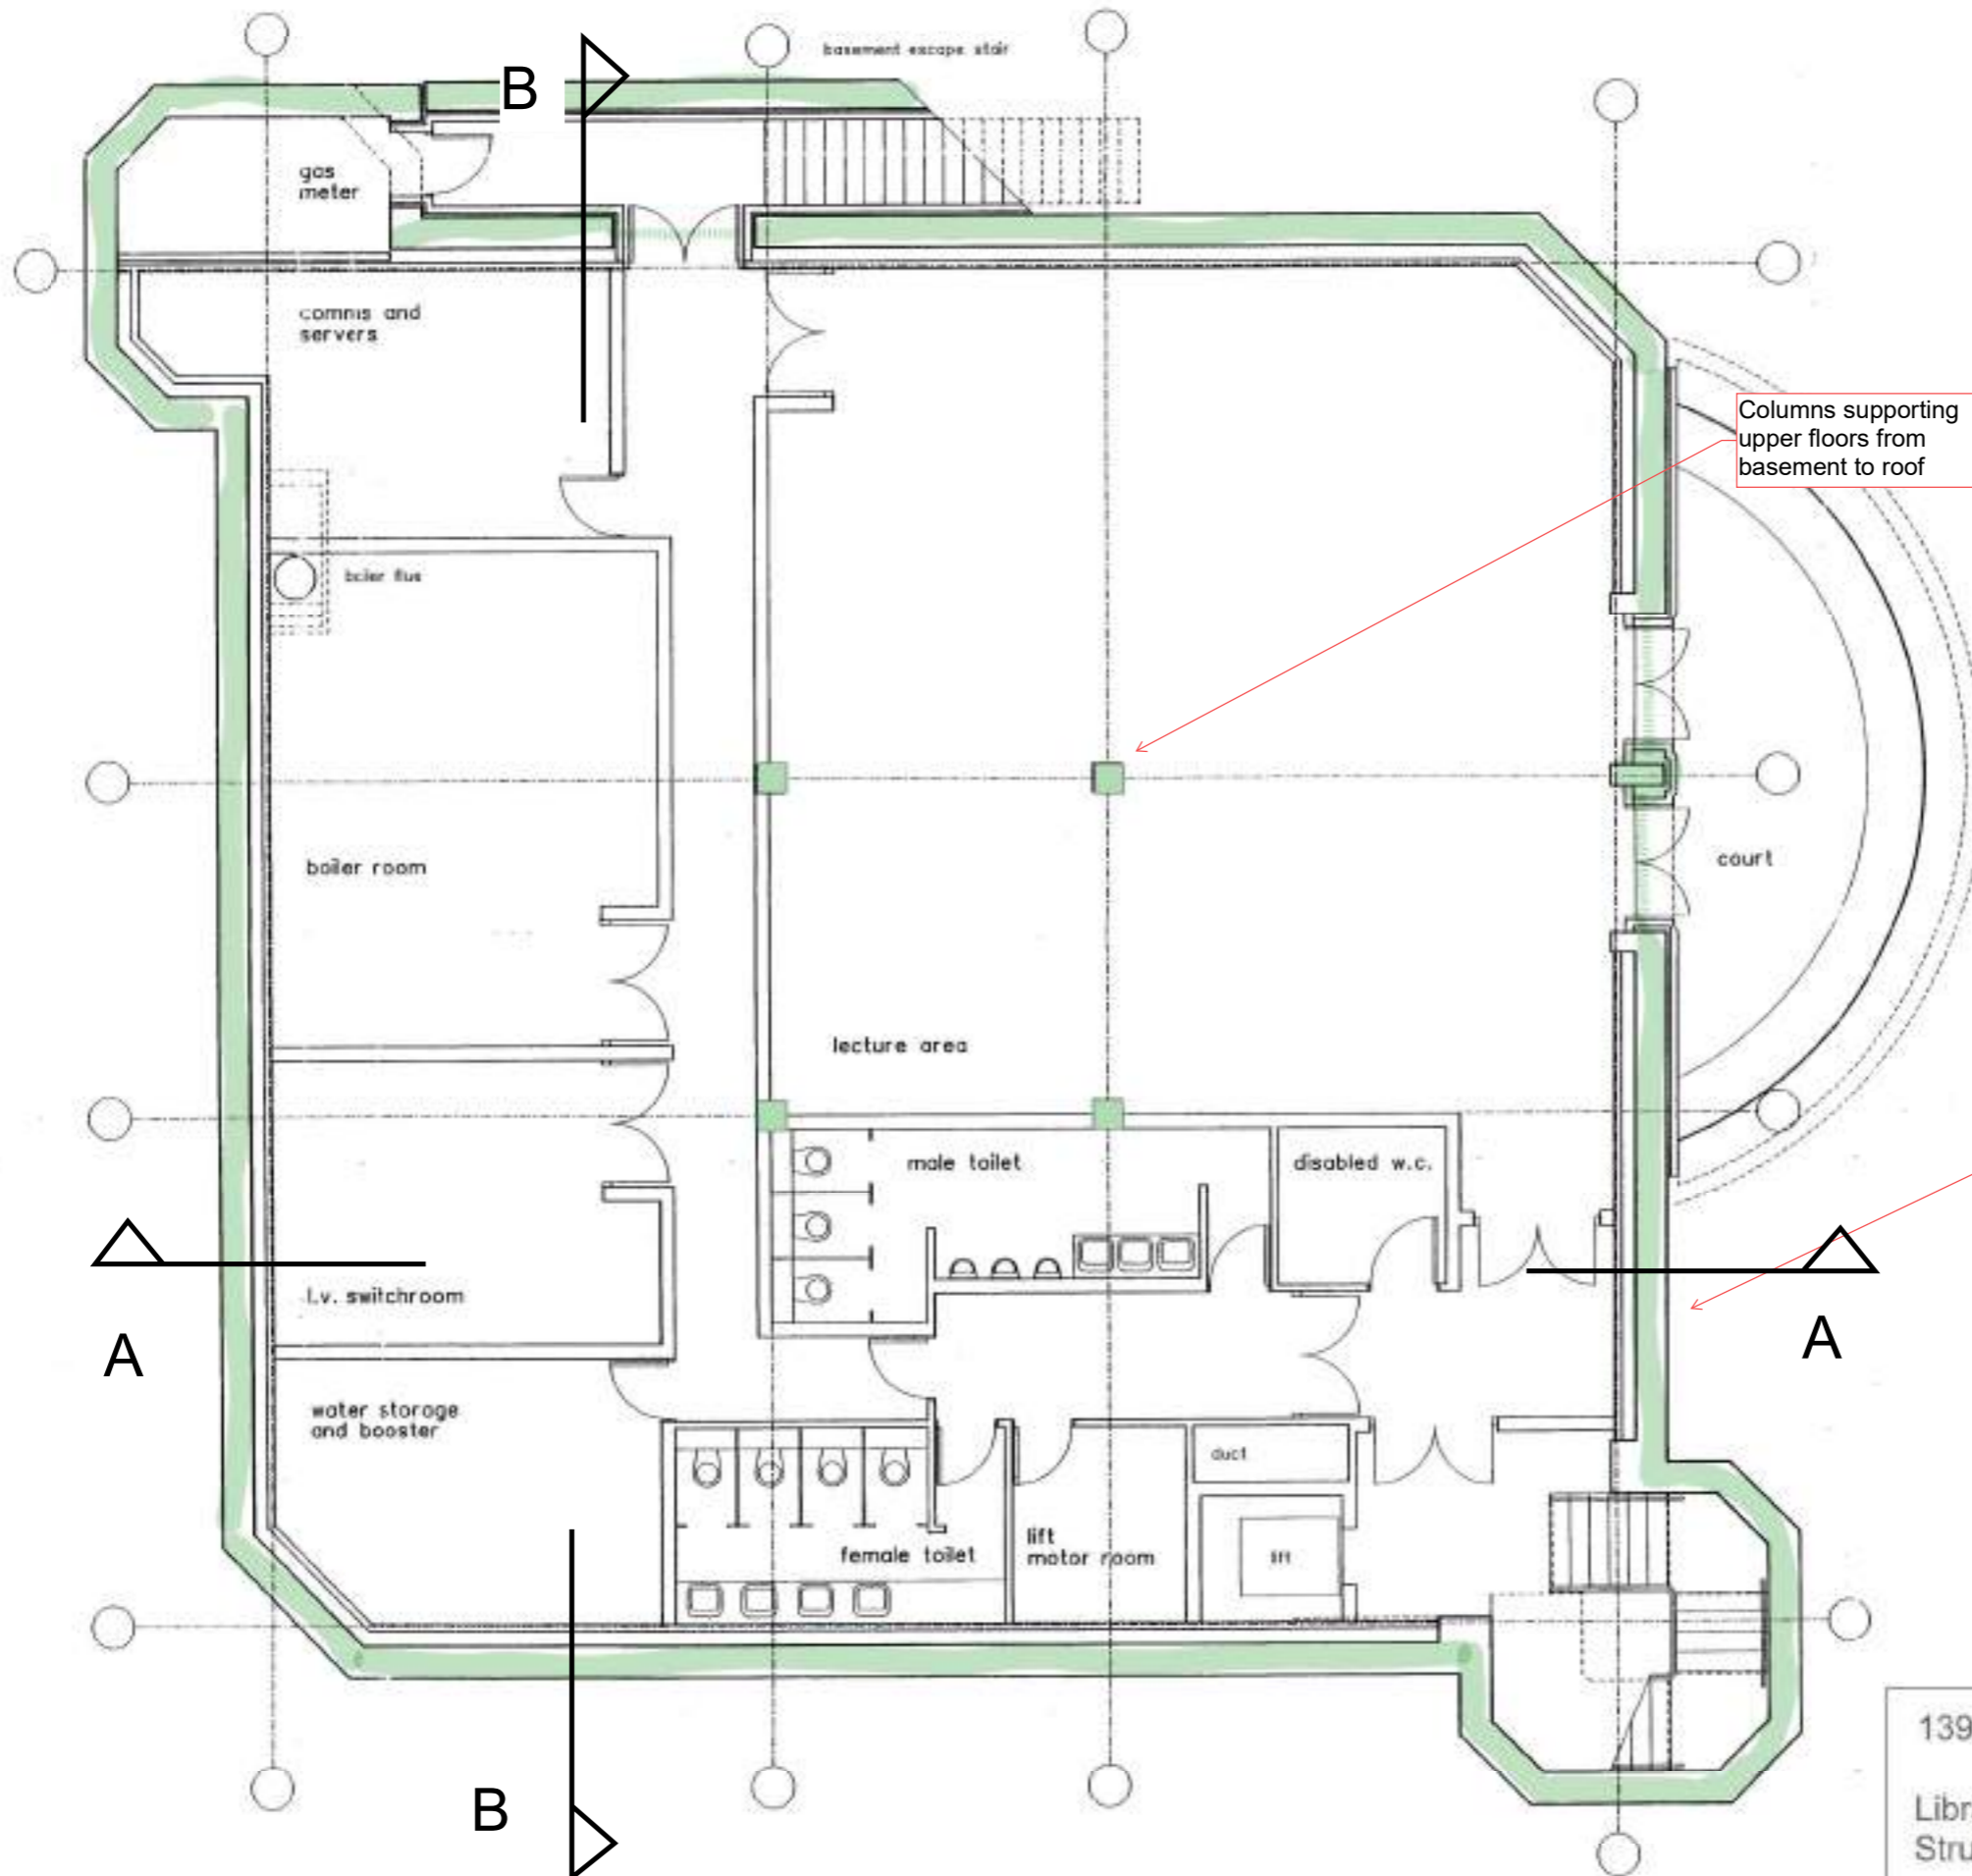
1399 SK08	Richmond Hill Campus
Library Existing Basement Structure Highlighted	Date 04/09/2023

Columns supporting upper floors from basement to roof

Basement retaining walls - from sketches look like piled walls

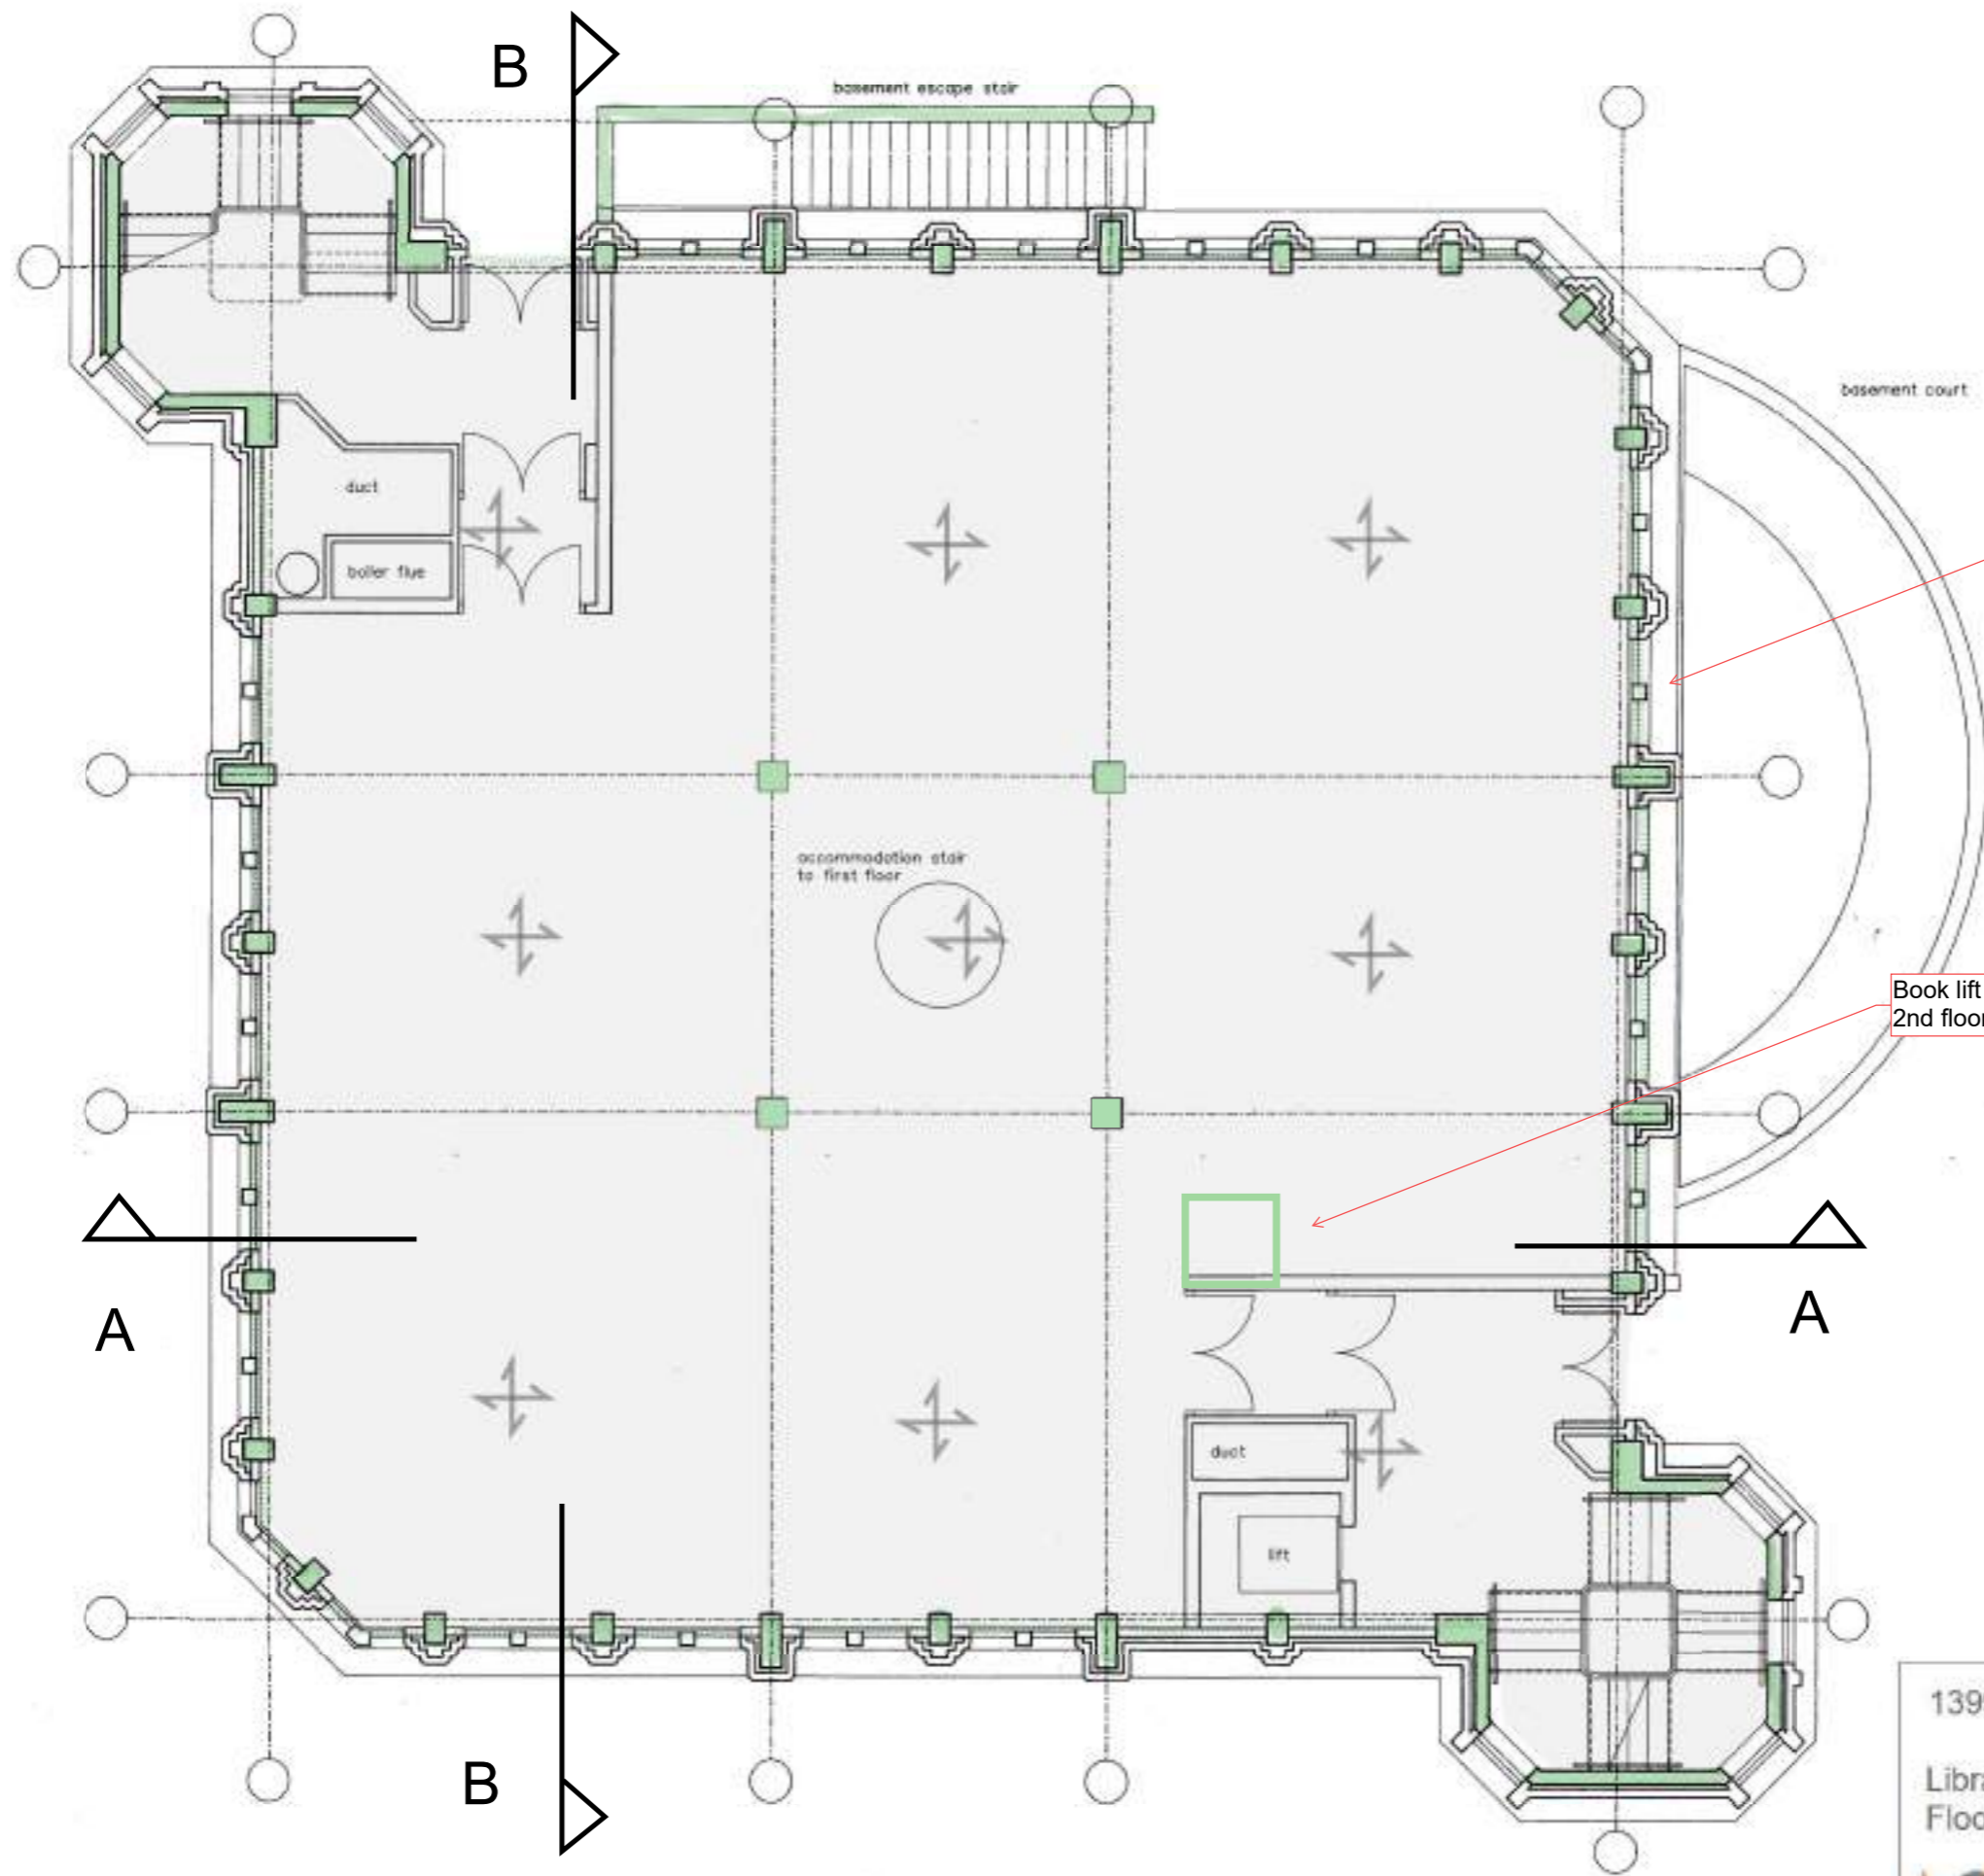
1399 SK09	Richmond Hill Campus
Library Existing Ground Floor Structure Highlighted	Date 04/09/2023
  integral engineering design	Integral Engineering Design 84 Walcot Street Bath BA1 5BD

Structural beams between windows

Book lift going up to 2nd floor

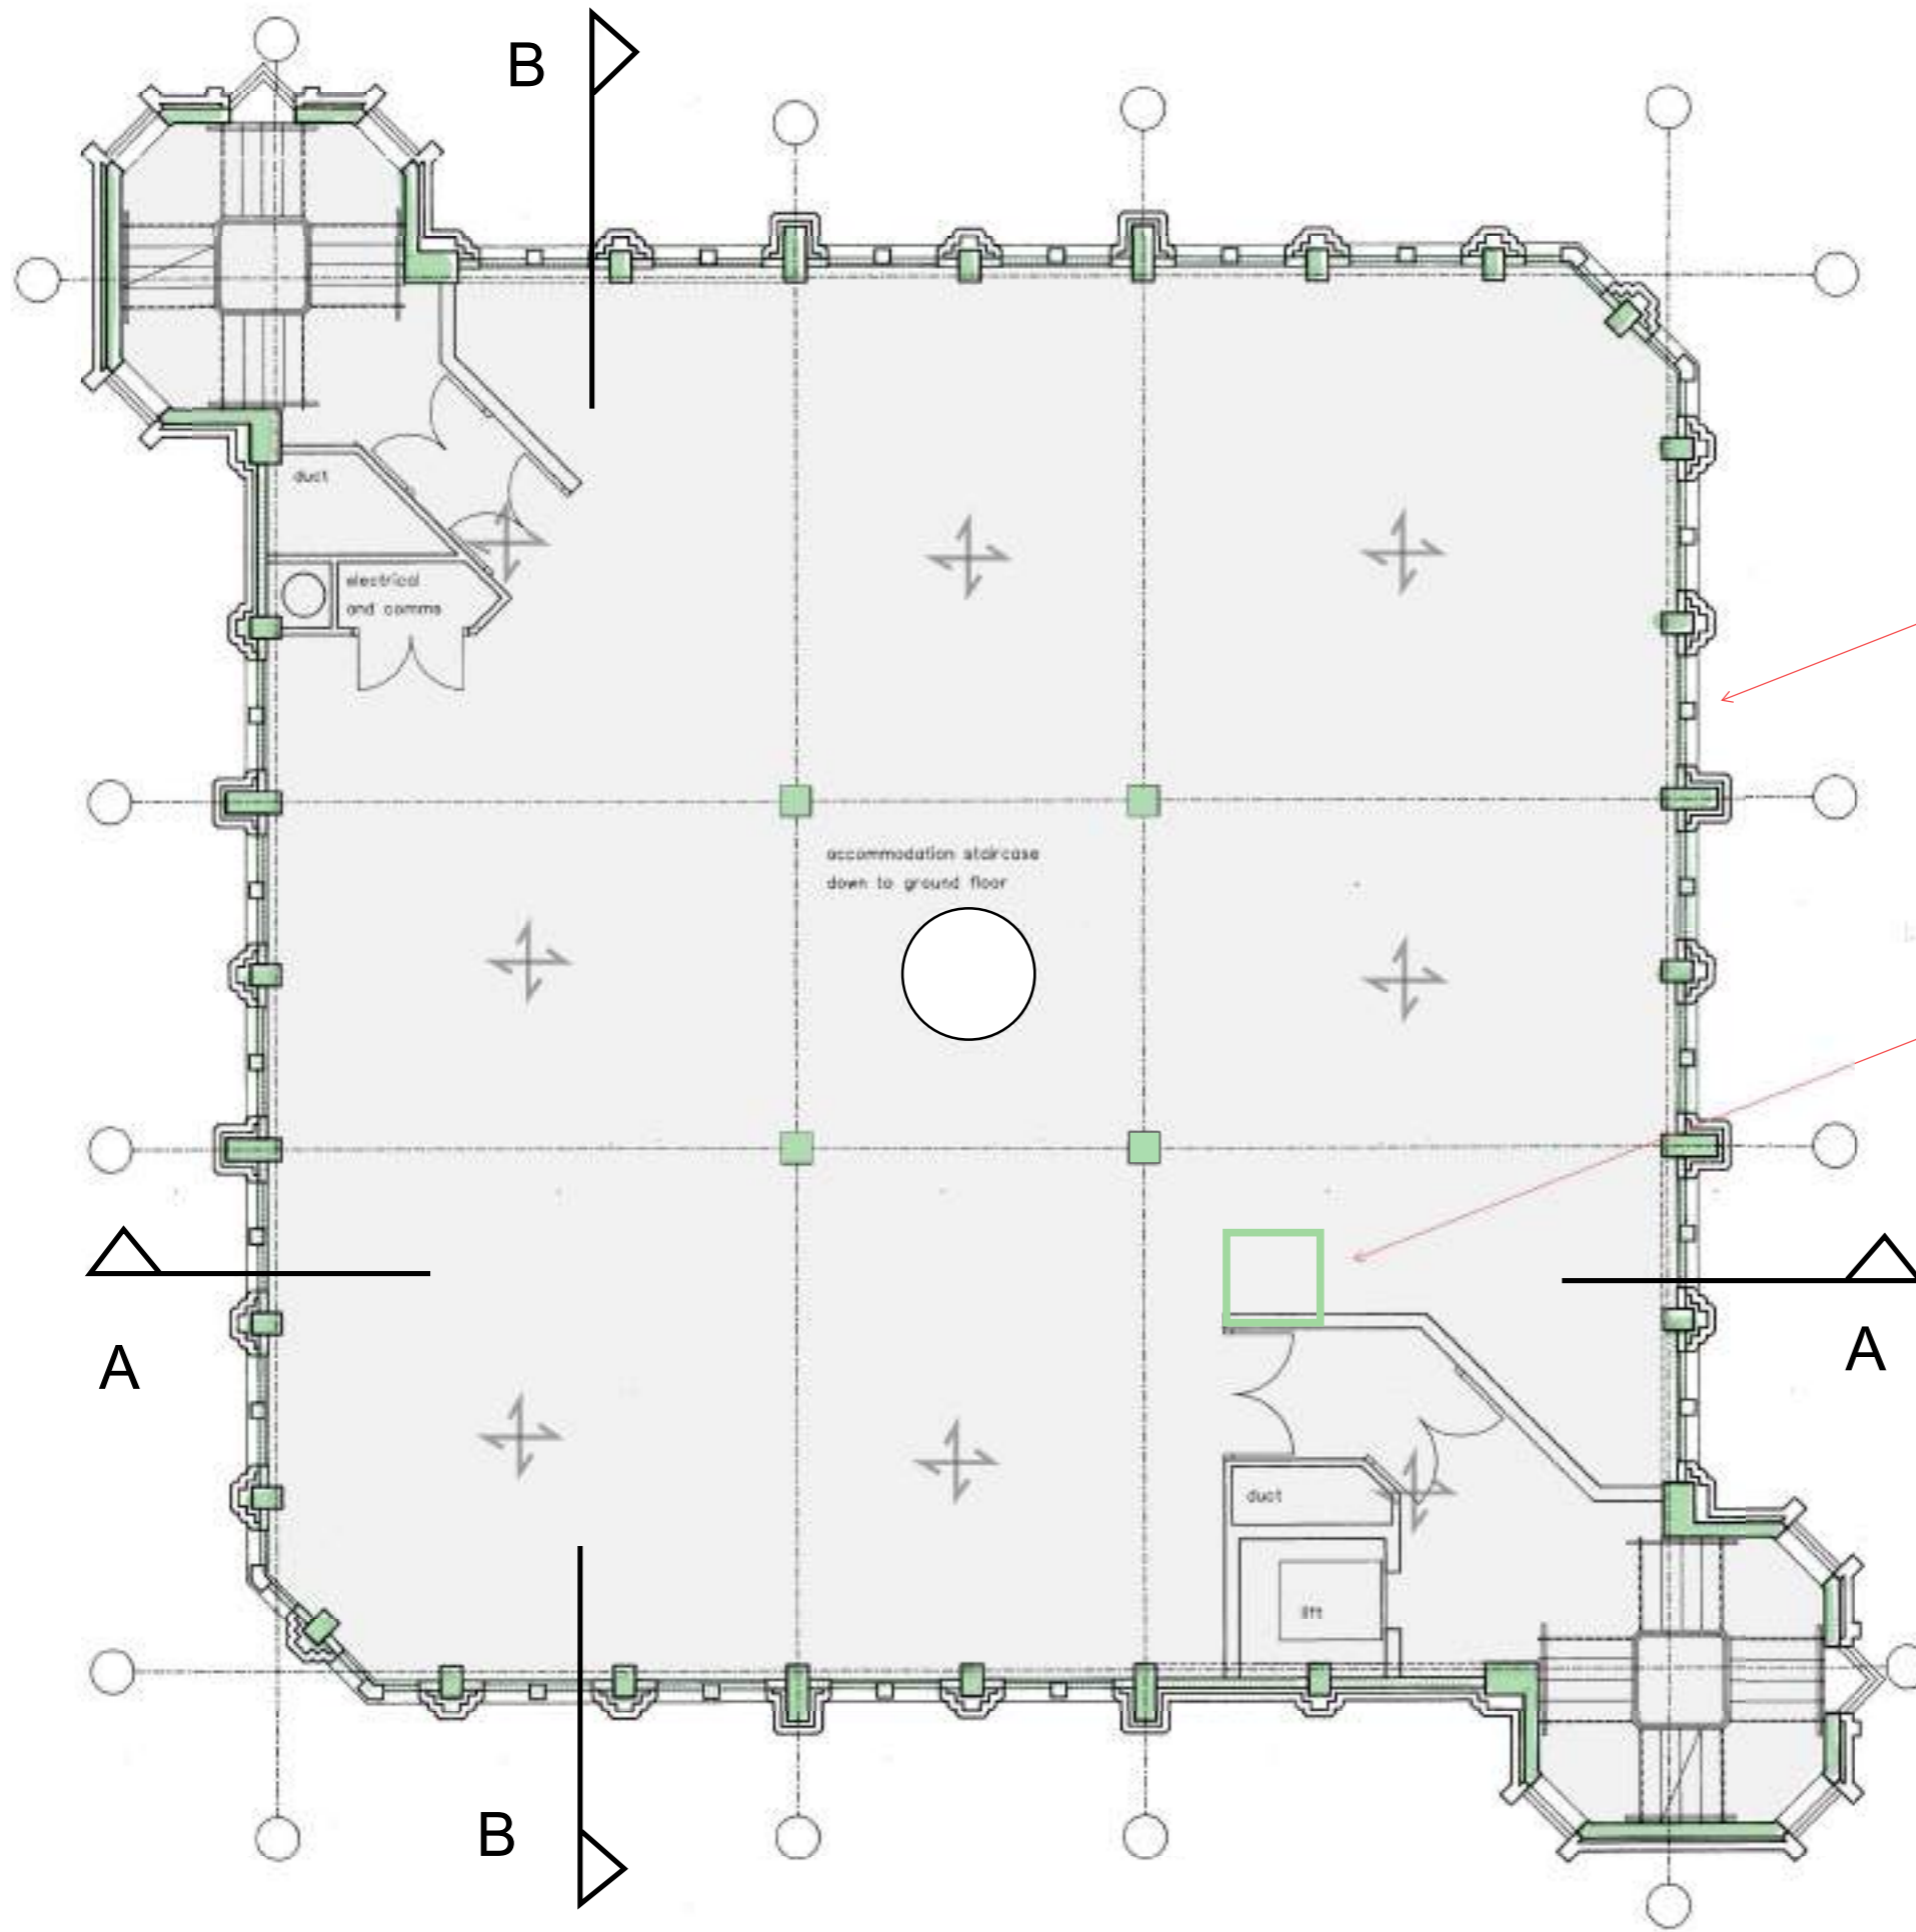
1399 SK10

Structural beams
between windows

Book lift going up to
2nd floor

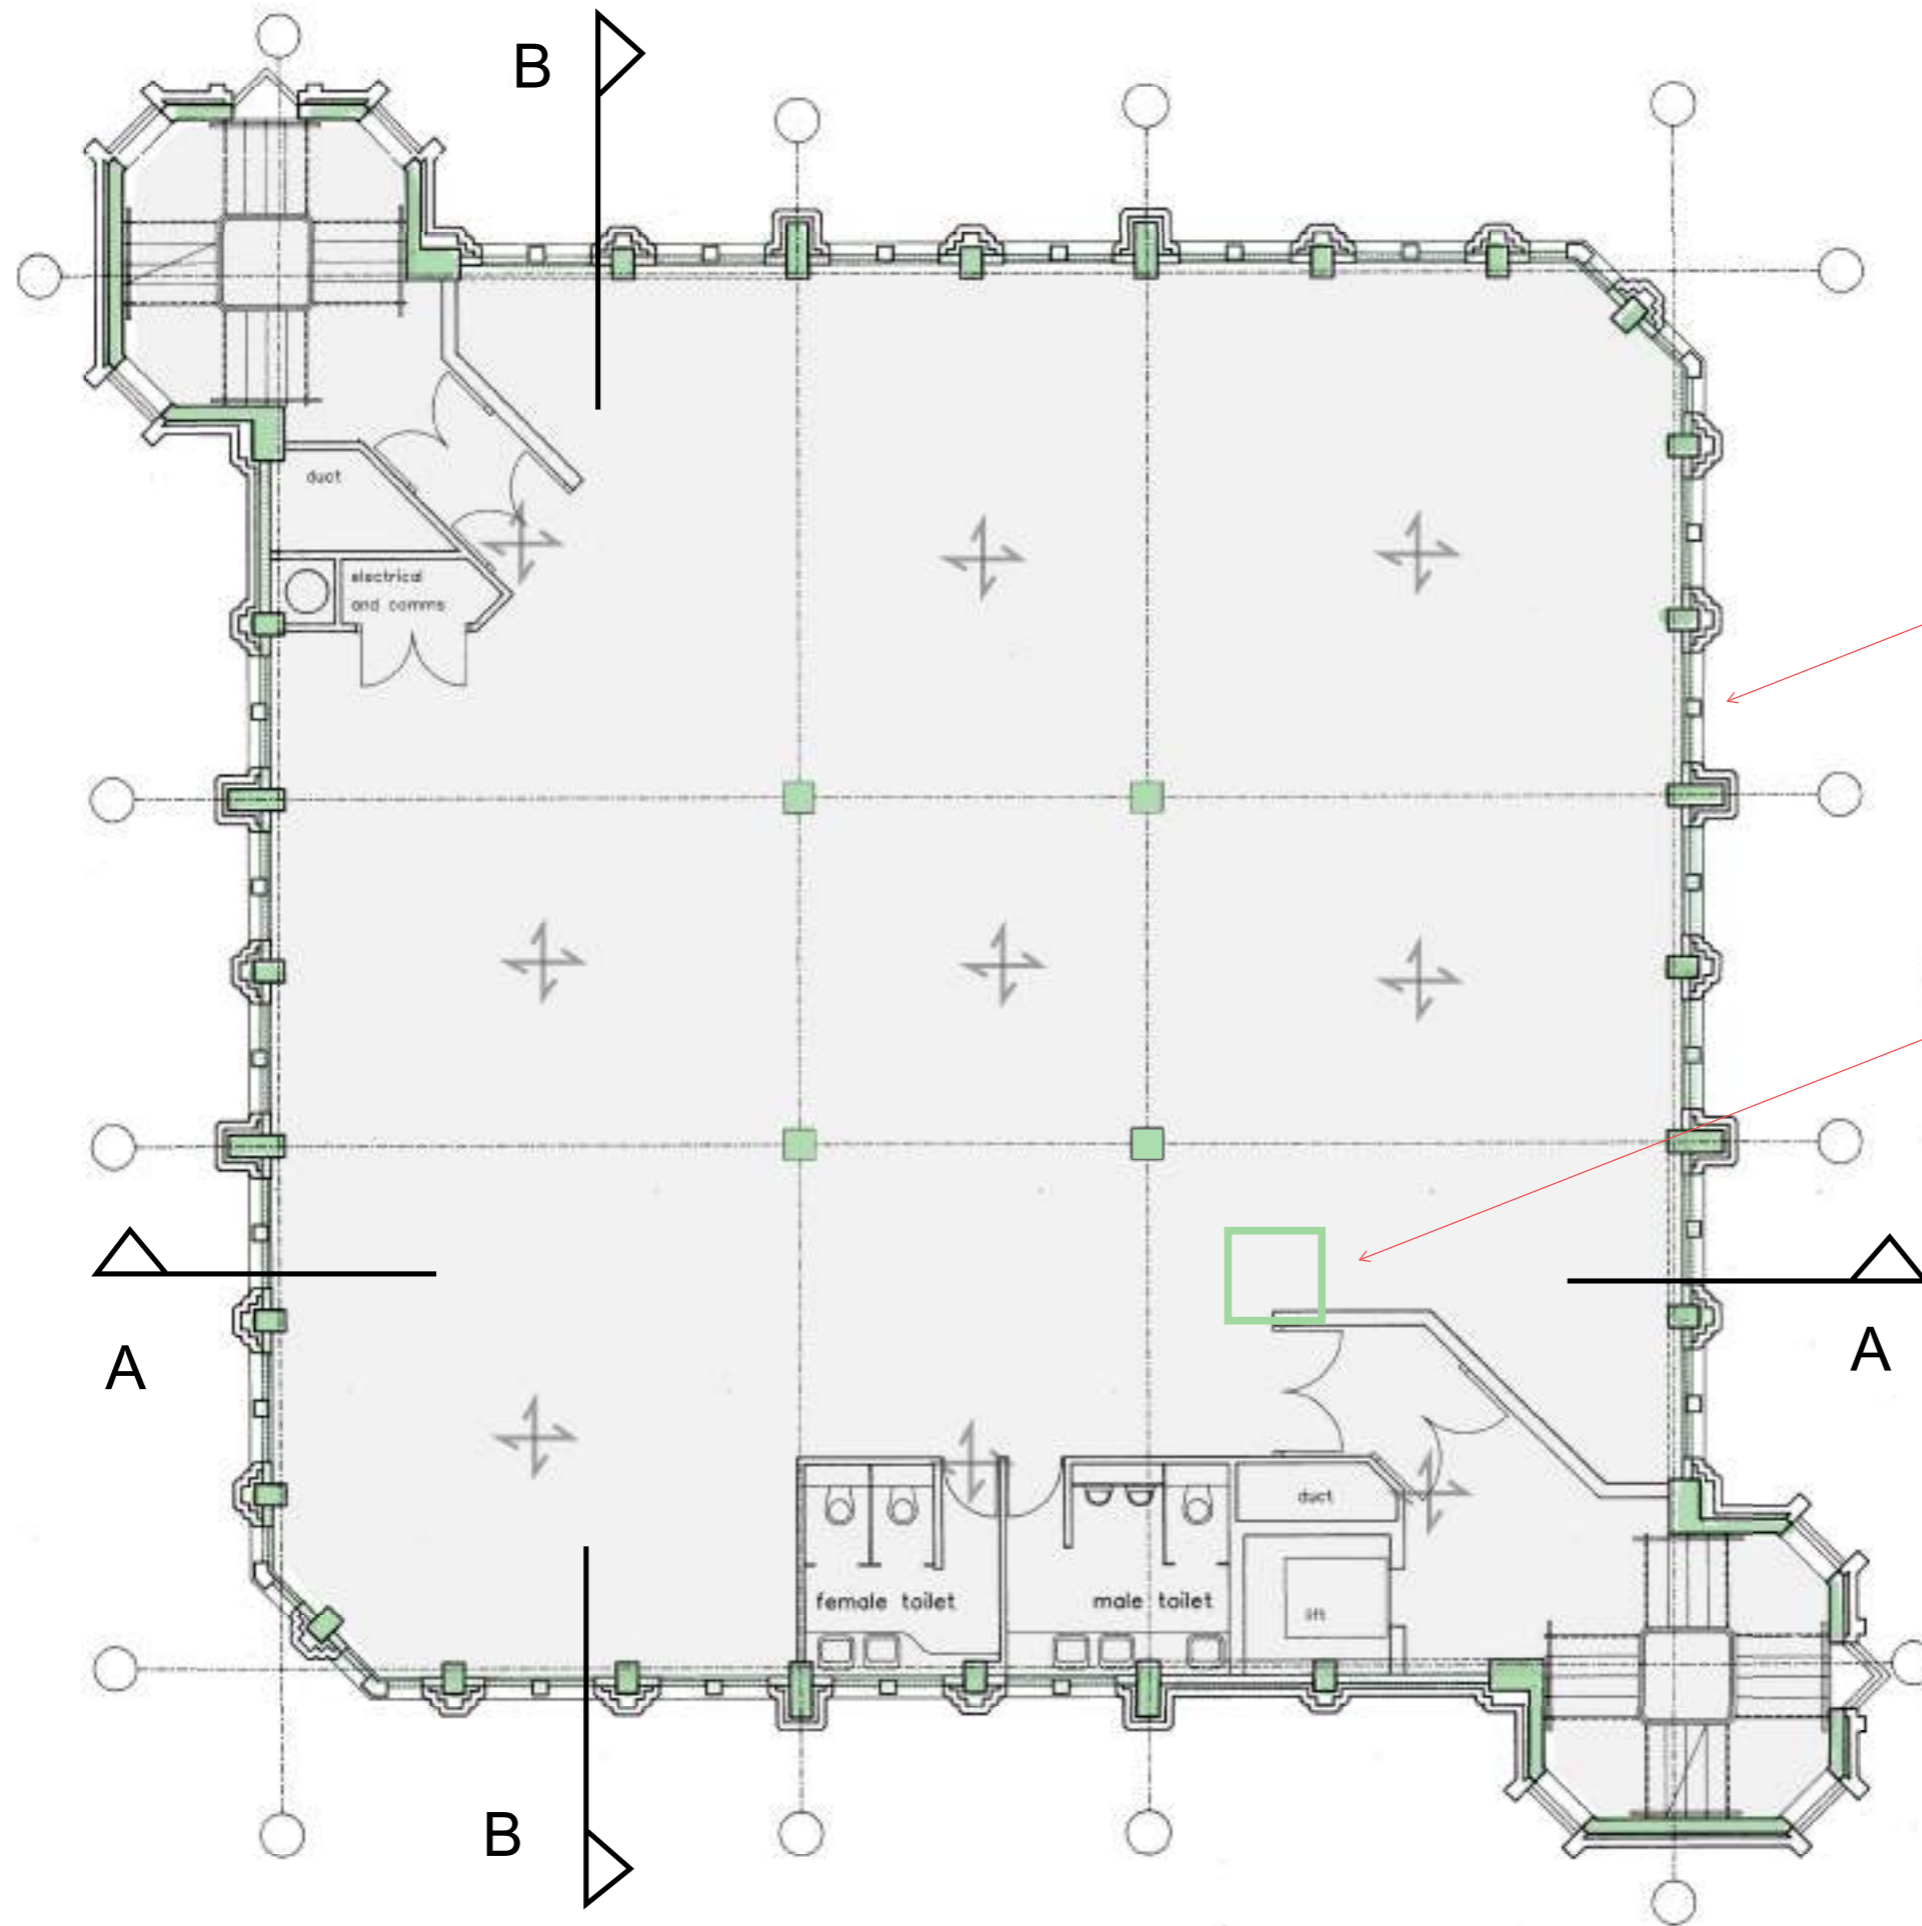
1399 SK11	Richmond Hill Campus
Library Existing Second Floor Structure Highlighted	Date 04/09/2023
  integral engineering design	Integral Engineering Design 84 Walcot Street Bath BA1 5BD

Structural beams between windows

Book lift going up to 2nd floor
