13. Red House

13.1 Existing structure

1399 SK80 Rev A	Richmond Hill Campus
Main Building Basement Existing Structure	Date 12/01/2024
  integral engineering design	Integral Engineering Design 84 Walcot Street Bath BA1 5BD

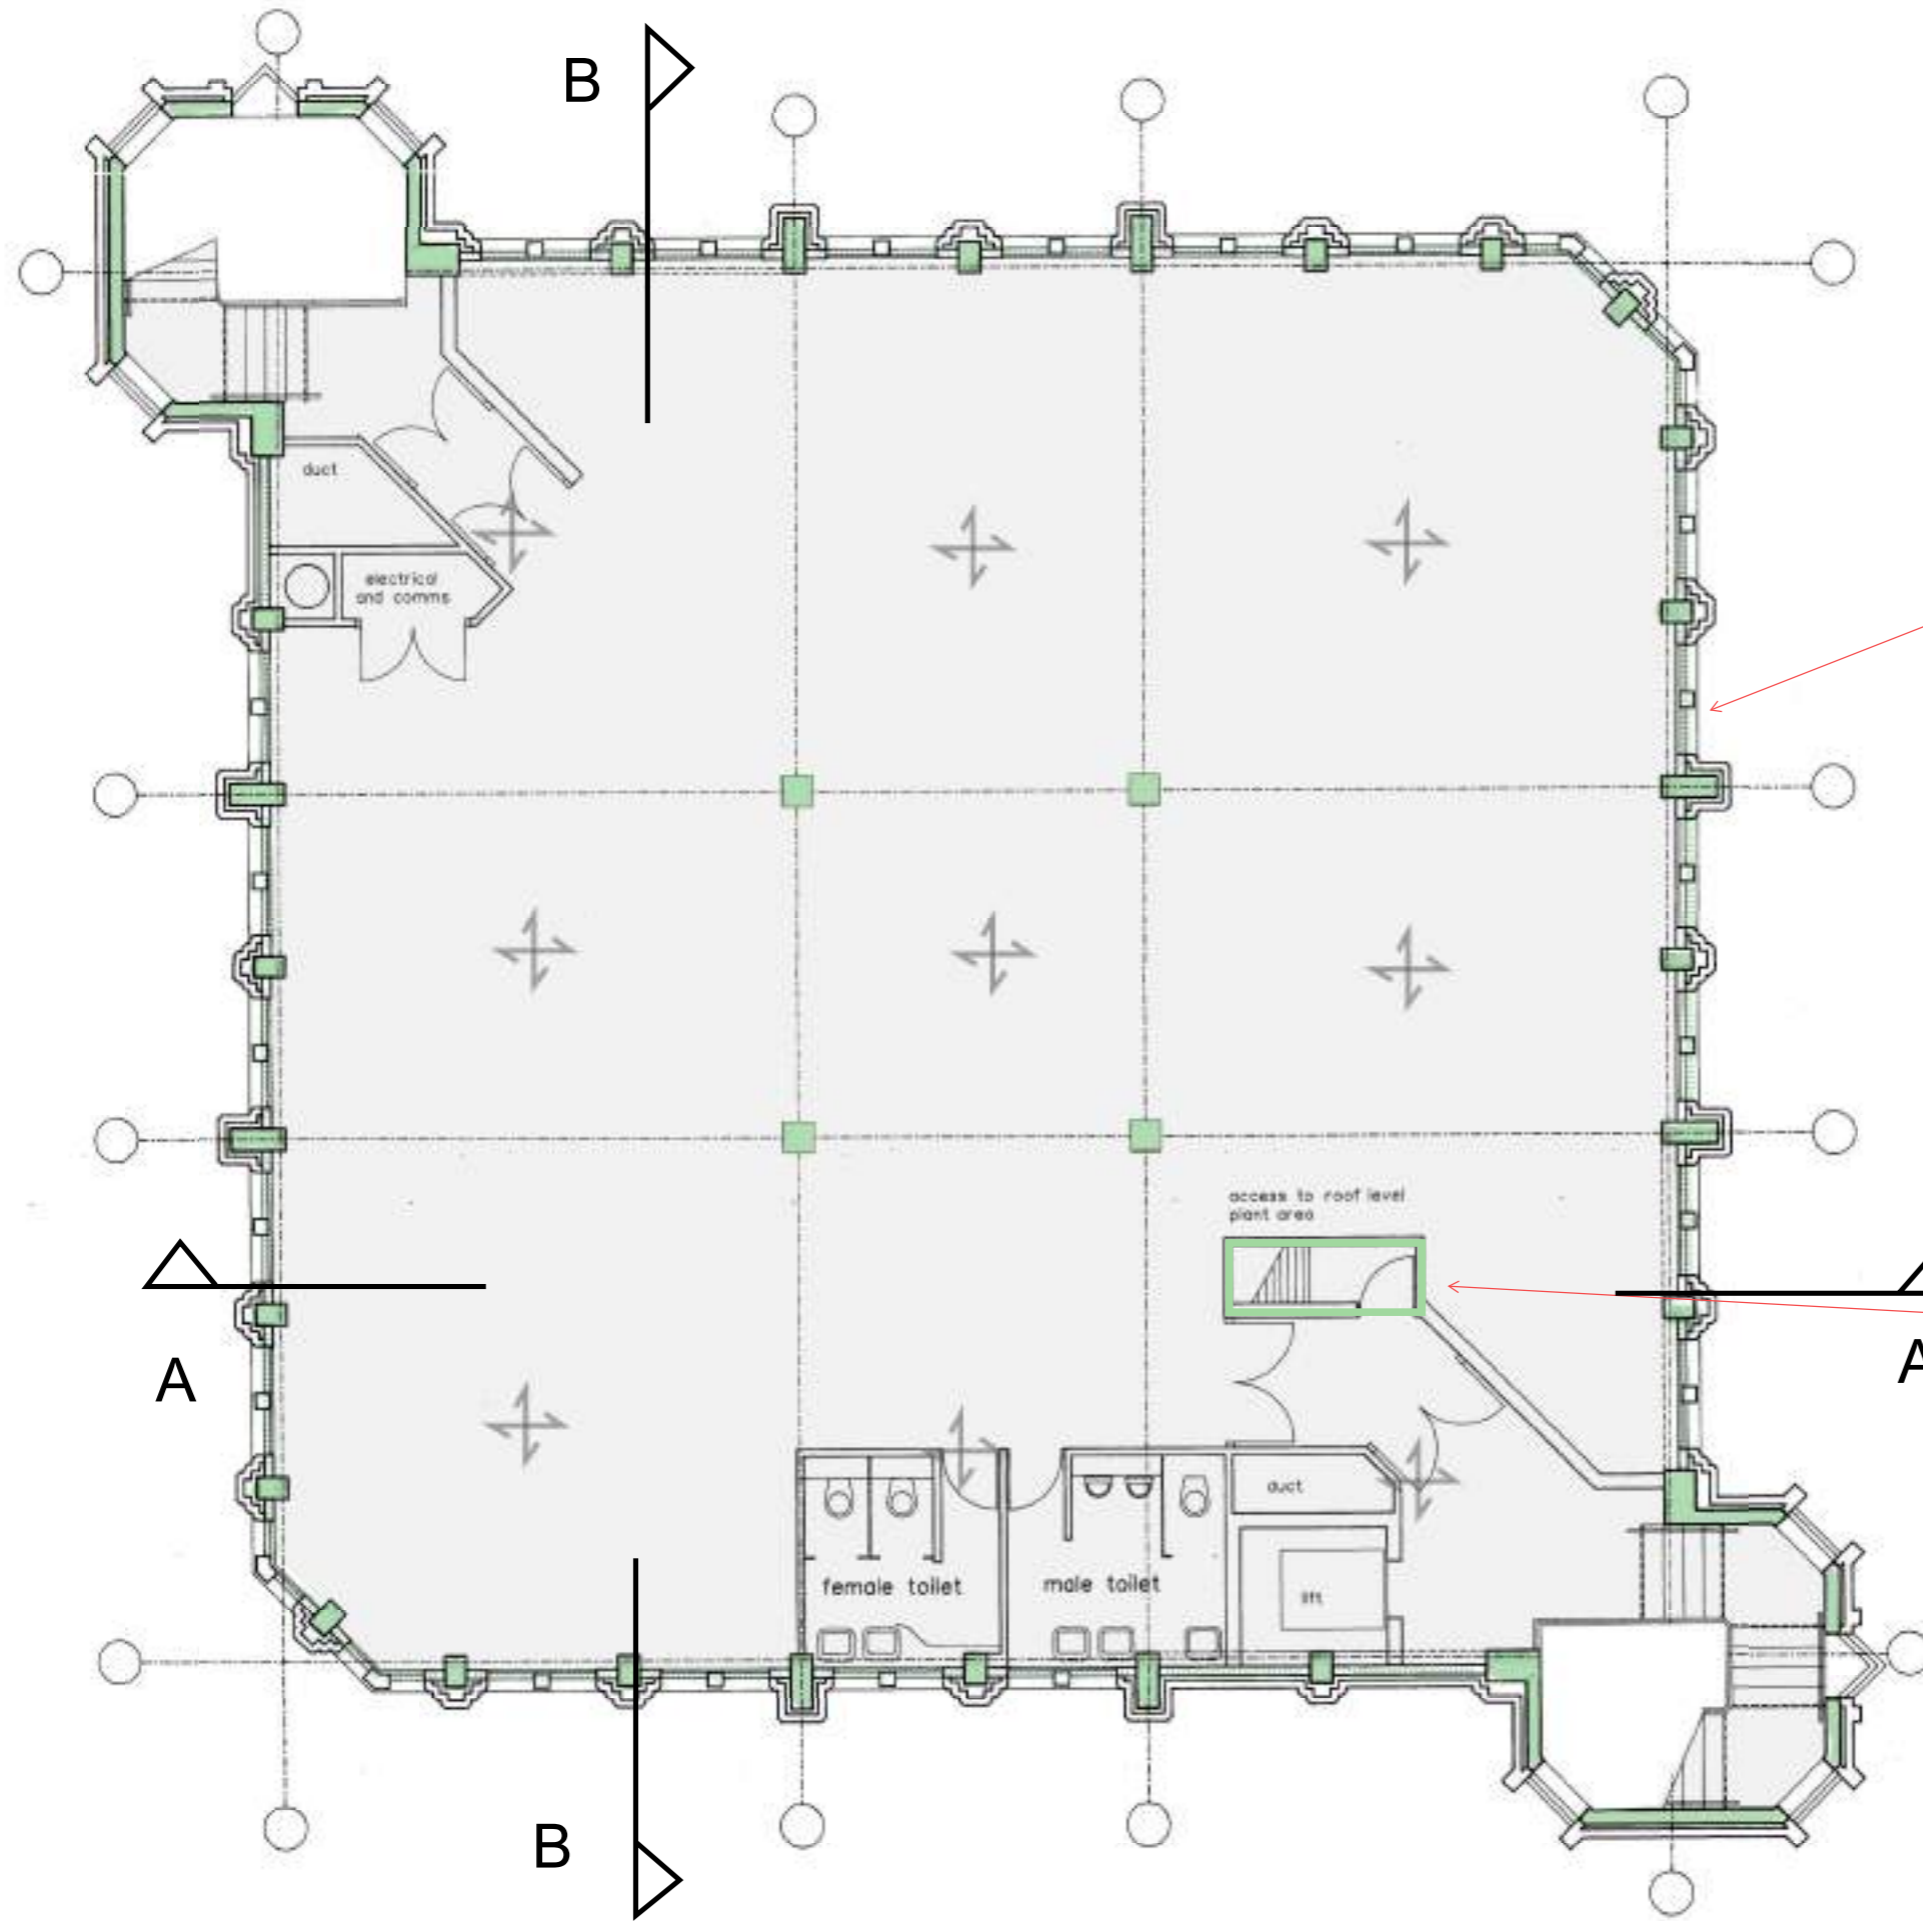
1399 SK12

Structural beams
between windows

Staircase to plant
area on roofs
